## **NATIONAL TRANSPORTATION SAFETY BOARD**

# **AIRFRAME AND ENGINE EXAMINATION NOTES**

**WPR12FA123**

Location: Brockton, MT  
Date: March 5, 2012  
Aircraft: Bellanca 7GCBC, Registration Number: N5542K, Serial #: 1030-78  
NTSB IIC: Jeffery Rich/Samantha Link

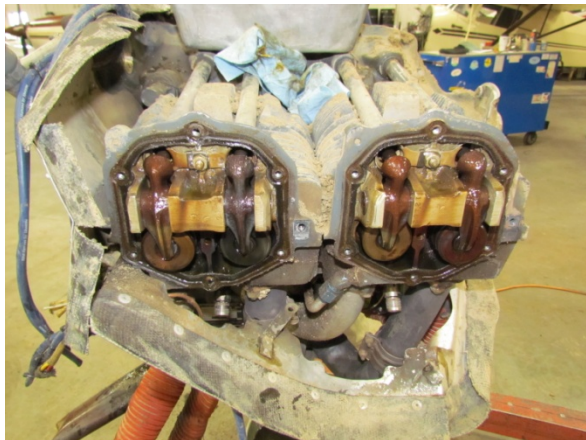
Figure 1: Ride side of Engine

During the engine examination all spark plugs were removed; normal wear signatures according to the Champion Check-a-plug chart were noted. The top number 1 and 3 spark plugs were oily; all other spark plugs contained consistent wear patterns. The valve rocker arm covers were removed and contained no thermal discoloration. All cylinders were borescoped; carbon deposits consistent with normal operations were noted.

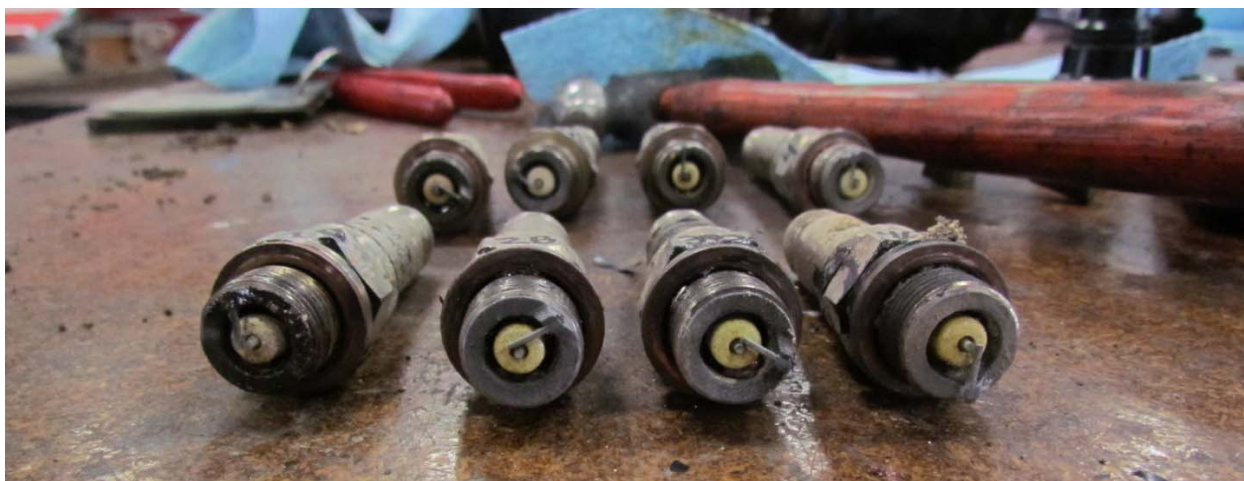
Figure 3: Spark Plugs (the forward plugs are the bottom spark plugs; the aft plugs are the top spark plugs)

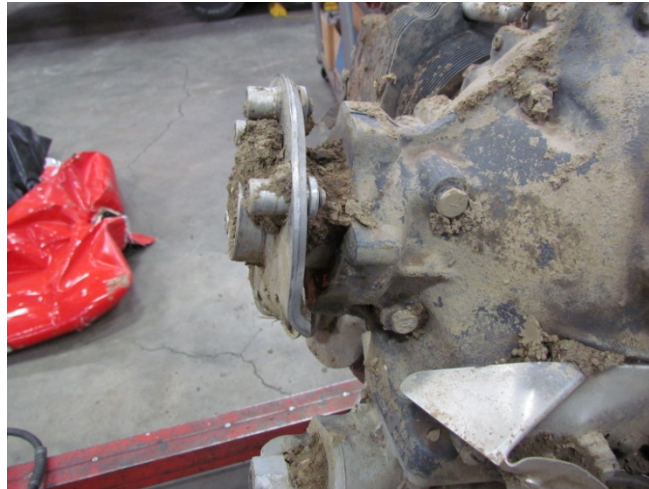
The propeller was separated at the propeller flange and the propeller flange was bent.

**Figure 4: Bent Propeller Flange**

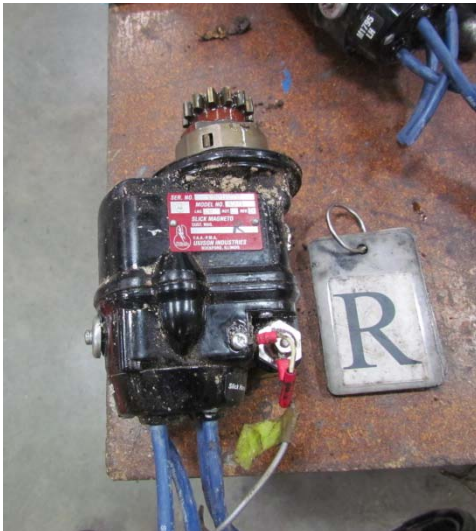
**Figure 5: Right Magneto**

The magnetos were intact. The left magneto was separated, and the right magneto remained secured to its engine attachment point. Both magnetos were removed from the engine and manually rotated by hand. The impulse couplings fired appropriately and spark was obtained from all ignition lead ends.

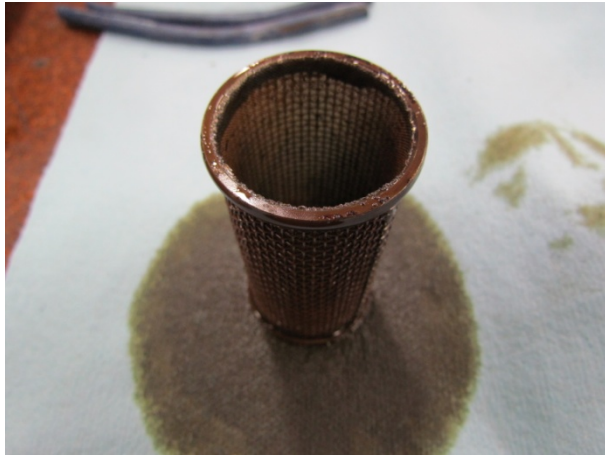
Figure 7: Oil Pressure Screen

The oil pressure and oil pick up screens were removed and found to be clear of debris. The oil sump was secured and contained about 4 quarts of oil.
