NATIONAL TRANSPORTATION SAFETY BOARD

AIRFRAME AND ENGINE EXAMINATION

WPR19FA263

Location: Nixon, NV
Date: September 19, 2019
Aircraft: Cessna 182H, Registration N1891X, Serial #18255991
NTSB IIC: Samantha Link

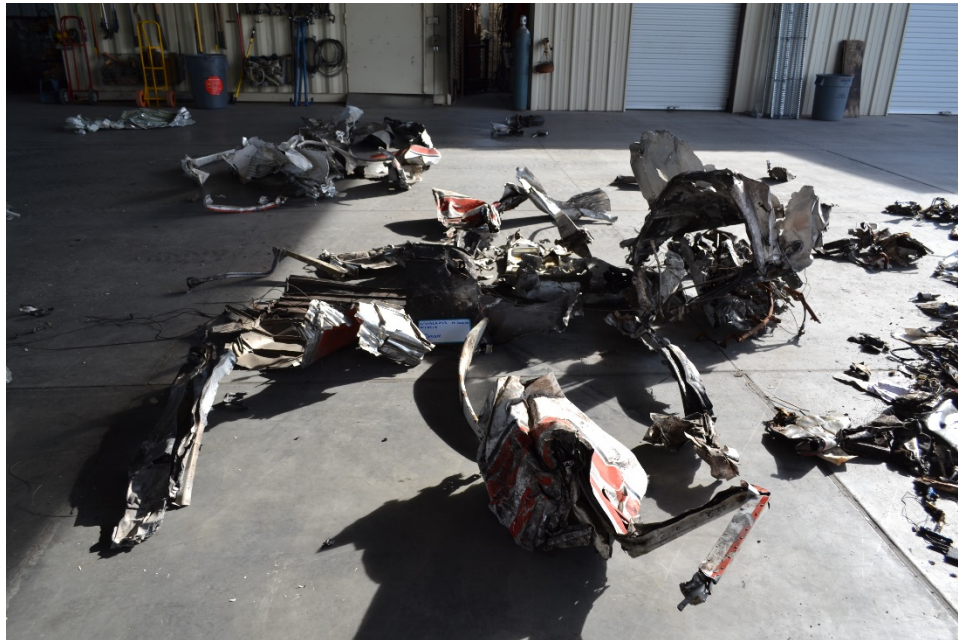
Figure 1: Cabin Area

- The airplane exhibited significant fragmentation throughout due to the impact sequence; The airframe components were laid out for further examination.
- The forward fuselage was destroyed.
 - The firewall was destroyed and fragmented.
- The cabin area between the firewall and front seats was heavily compressed aft and exhibited thermal damage.
 - All cabin and baggage doors were separated from the airframe and exhibited crush damage.

- The two front seats and seat belts were heavily damaged and present.
 - The aft seats were not present. (According to the flying club, the aft seats were removed before the accident flight.)

- The instrument panel was destroyed, and all the instruments were heavily fragmented.
- Components from two bicycles were present within the wreckage and were significantly fragmented.

- The aft cabin floor was mostly intact and exhibited thermal damage.
- The fuel selector valve remained attached to the fuel line within the cabin area. It was removed from the fuel lines.

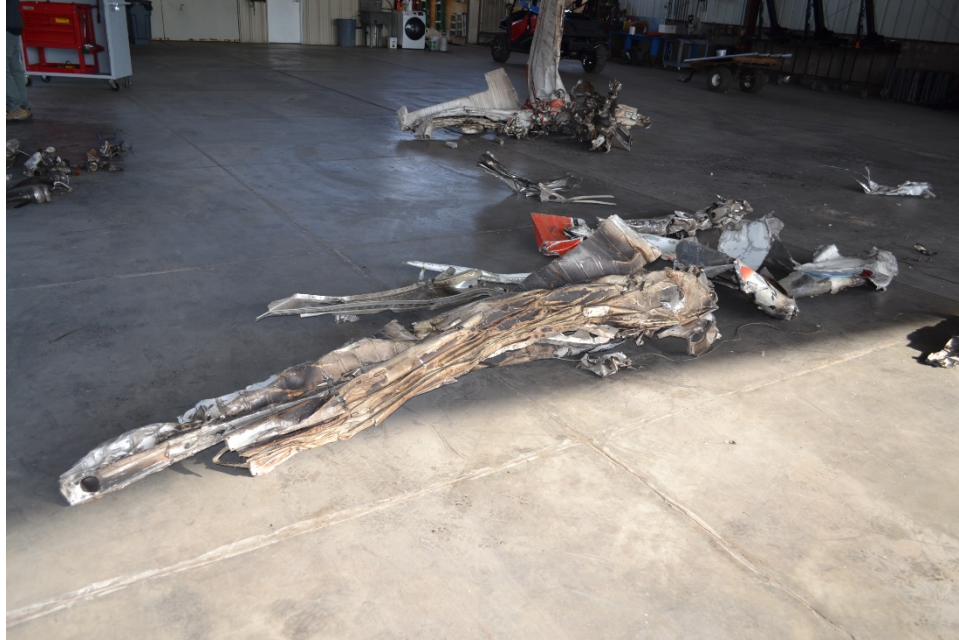
Figure 2: Right Wing

- It was disassembled and the valve was found in between the “both” and left tank positions.
- The right wing was fracture separated from the fuselage. It was destroyed and heavily fragmented.

- The fuel filler cap was present and remained secured to its chain, however, it was not secured in the fuel cap port.
 - The fuel cap was otherwise unremarkable.

- The bladder fuel tank was not present and the area where it would be exhibited thermal damage.
 - The inboard about 1/3 of the right wing was heavily fragmented.

- The outboard about 2/3 of the right wing leading edge was crushed heavily aft almost to the aileron attachment points. It also exhibited thermal damage.

- The right flap exhibited heavy crush damage and was fractured into two pieces
 - The right aileron was fractured into two but remained secure at most of its attachment points. It also exhibited thermal damage.

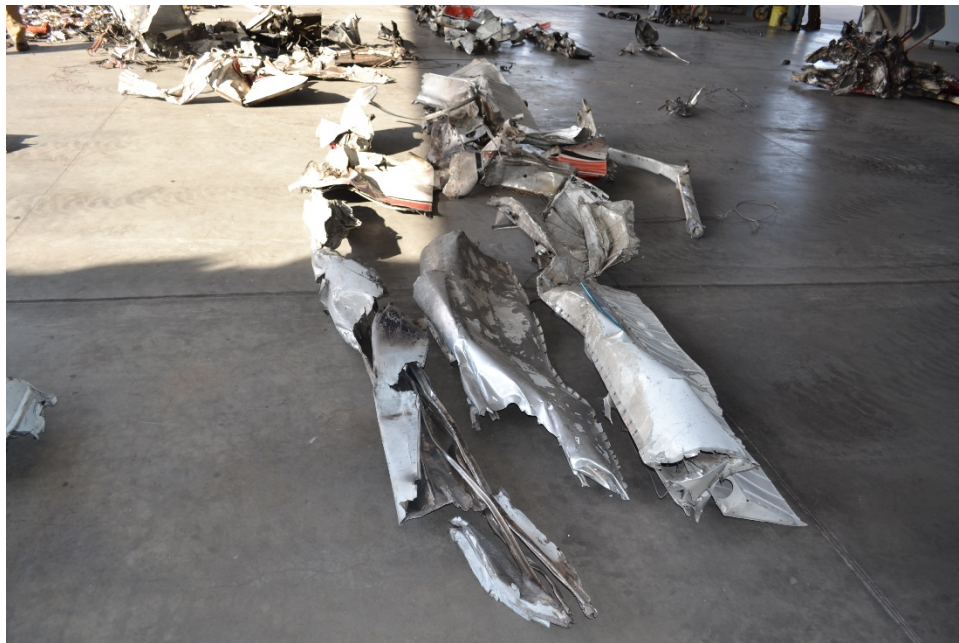
Figure 3: Left Wing

- The left wing was fracture separated from the fuselage and fragmented throughout.
 - The inboard portion of the wing exhibited thermal damage
 - The fuel filler cap was present and remained secured to its chain, however, it was not secured in the fuel cap port.

- The fuel cap was otherwise unremarkable.
 - The bladder fuel tank was not present and the area exhibited thermal damage.
 - The leading edge of the left wing was fracture separated and exhibited aft crush damage.

- The upper wing surface was fractured into several pieces and exhibited aft crush damage.

- The left flap was fracture separated into two major pieces. The inboard portion of the flap remained attached to the wing, and the outboard portion of the flap was fracture separated.

- The left aileron was fracture separated into two major pieces. The inboard portion of the aileron was fracture separated and curled upward. The outboard portion of the aileron remained attached to the wing.

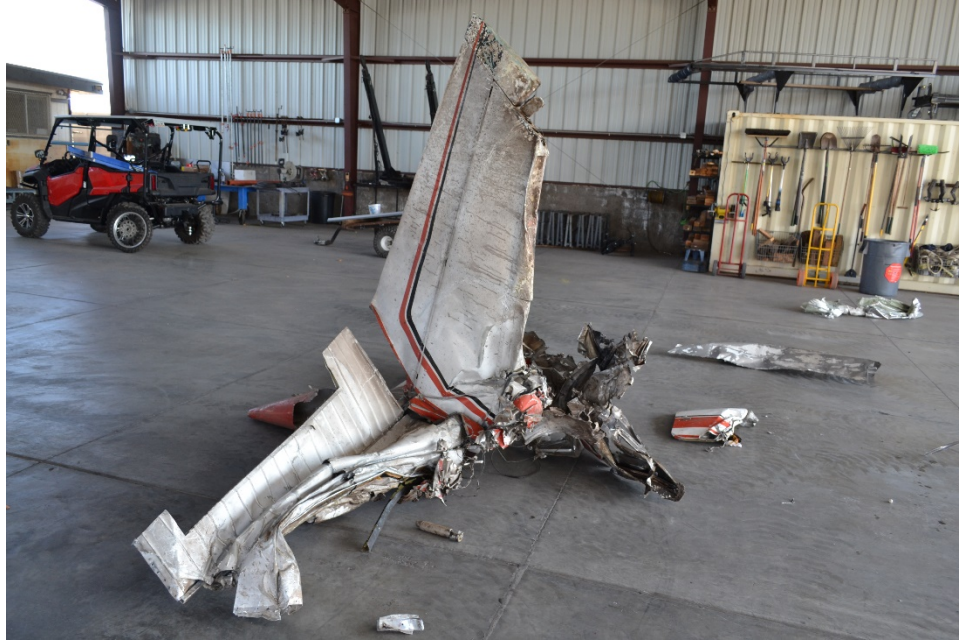
Figure 4: Right side of Empennage

- The aft fuselage was heavily fragmented and exhibited heavy aft crush damage consistent with impact.
 - It also exhibited thermal damage.
- Empennage was mostly whole but exhibited crush and thermal damage.

- The vertical stabilizer was mostly intact
 - The leading edge exhibited some aft crush damage.
 - The rudder remained attached to the vertical and exhibited minimal damage.

- The vertical and rudder exhibited soot and some residue from an unknown fluid consistent with oil.
 - The right horizontal exhibited heavy aft crushing

- The right elevator remained attached at most of its attachment points
 - It moved when manipulated by hand, but was restricted by crush damage.
 - The elevator trim remained attached along most of its span, and it moved freely when manipulated by hand.

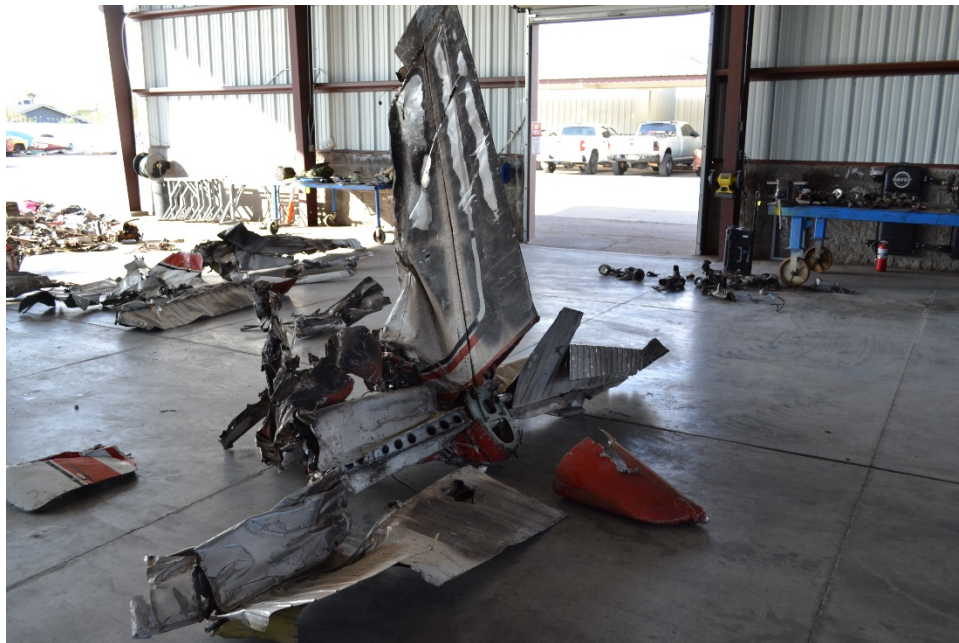
Figure 5: Left Side of Empennage

- The Left horizontal stabilizer remained attached to the empennage, but was fracture separated about midspan
 - The inboard (about half) of the left horizontal exhibited aft crush and thermal damage.

- The outboard left horizontal was fracture separated about midspan.
 - The elevator remained attached to the outboard portion of the horizontal, but fracture separated from the inboard.

- The elevator remained whole, but exhibited a tear about midspan.
 - The inboard portion of the elevator exhibited some thermal damage.
- The fuel system was heavily fragmented throughout.

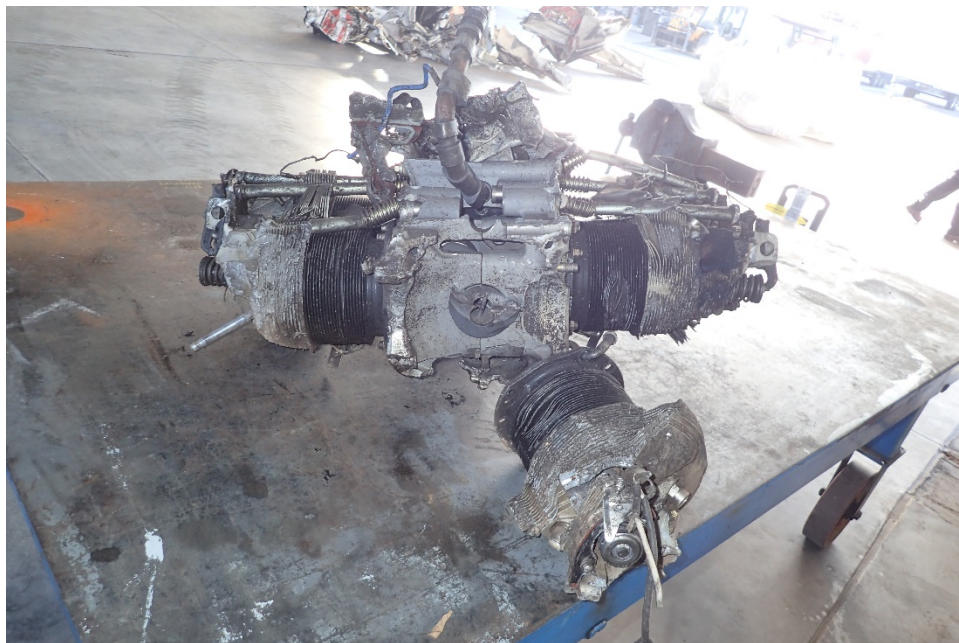
Figure 7: Front of Engine

- The engine was heavily fragmented and covered in an unknown fluid, dirt, and grime consistent with the accident site.
 - The propeller hub, front two cylinders, forward portion of the crankcase, and forward part of crankshaft were fracture separated from the rest of the engine.

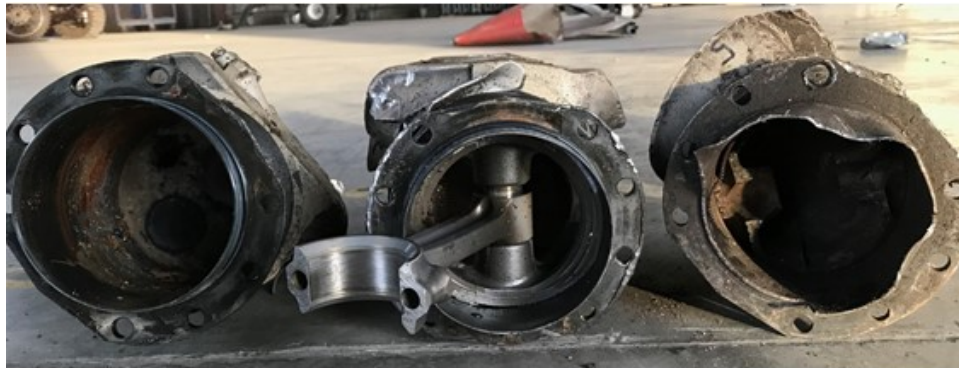
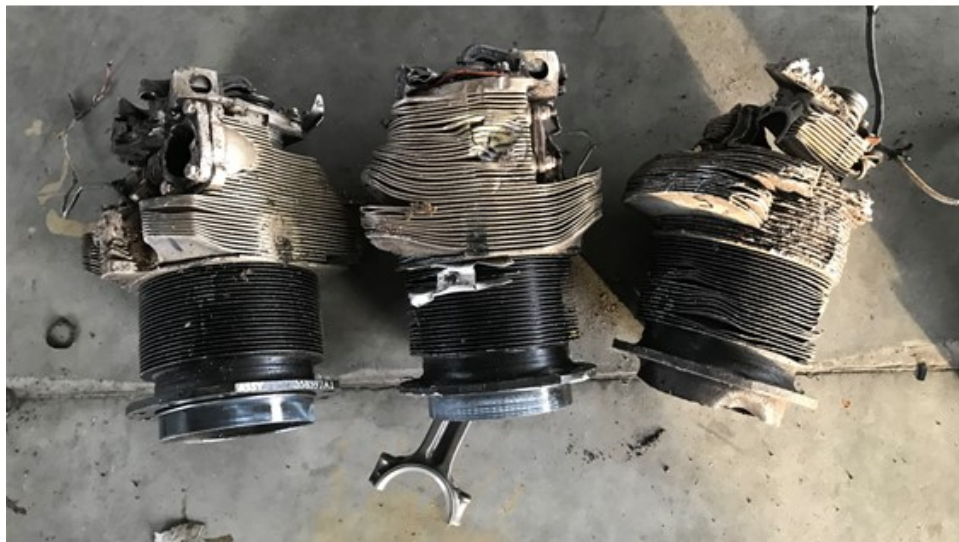
Figure 11: Cylinders from the Right Side of Engine

- All cylinders exhibited extensive crush damage throughout.

- Fragments of cylinders and crankcase were found within the wreckage.
- Cylinders number 4 and 6 exhibited the most damage.
 - The number 6 cylinder was found fracture separated from the engine and was completely missing its the cylinder head.

- The number 4 cylinder was found missing most of the cylinder head to include rocker arms, exhaust spring, and push rod.
- The Number 5 cylinder was mostly fracture separated from the crankcase; it remained attached via one through bolt.

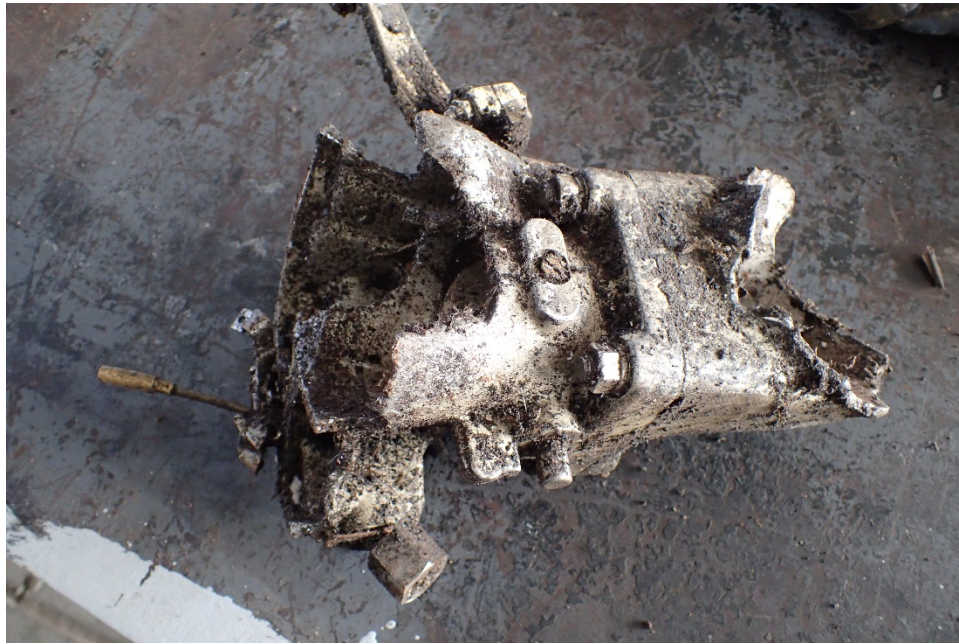
Figure 13: The Carburetor

- The carburetor was fragmented and mostly destroyed.

- The fuel screen was removed and was mostly clear of debris.
- The valve was intact and operated when manipulated by hand.
- The jet and floats were fracture separated; most of the bowl was not present.

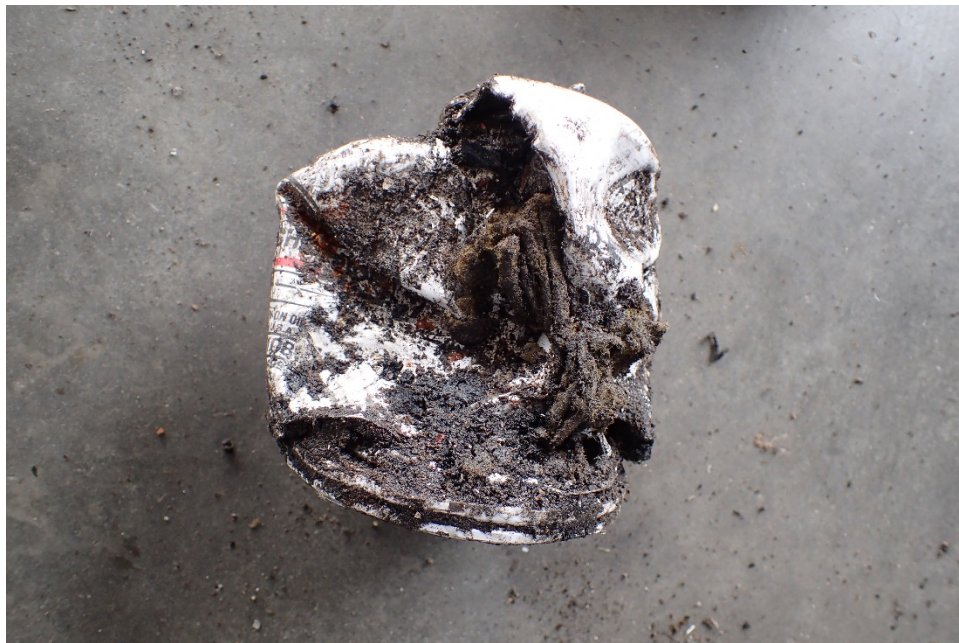
Figure 14: Oil Filter

- The oil filter exhibited crush damage and was breached.
- The oil cooler exhibited crush damage and was fragmented.
- The exhaust system was crushed, heavily fragmented, and mostly not present.

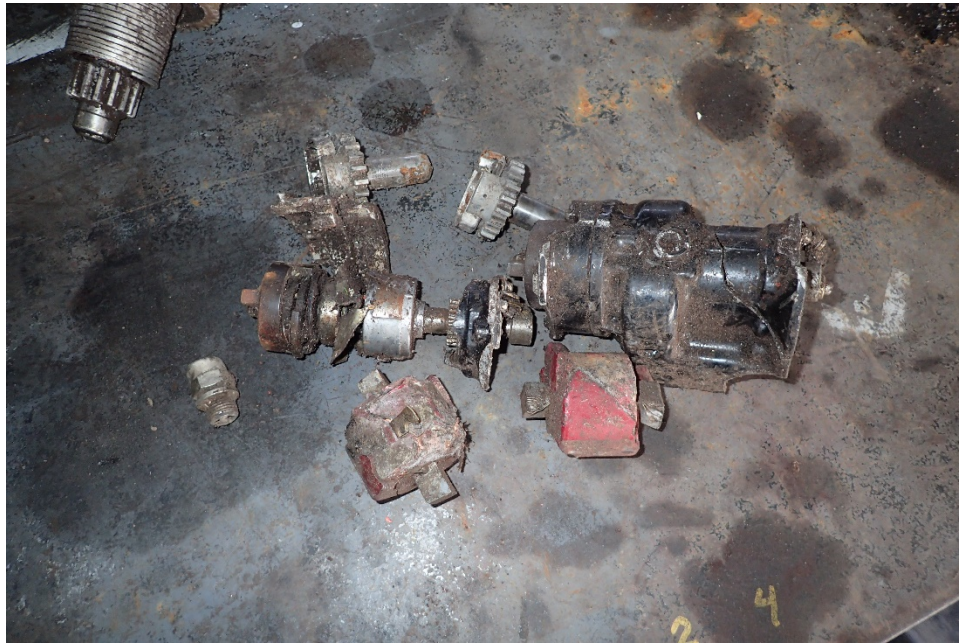
Figure 15: Both Magnetos

- Fragments of both magnetos were located within the wreckage. Given their condition they were unable to be tested.
- The propeller governor was fracture separated and fragmented.

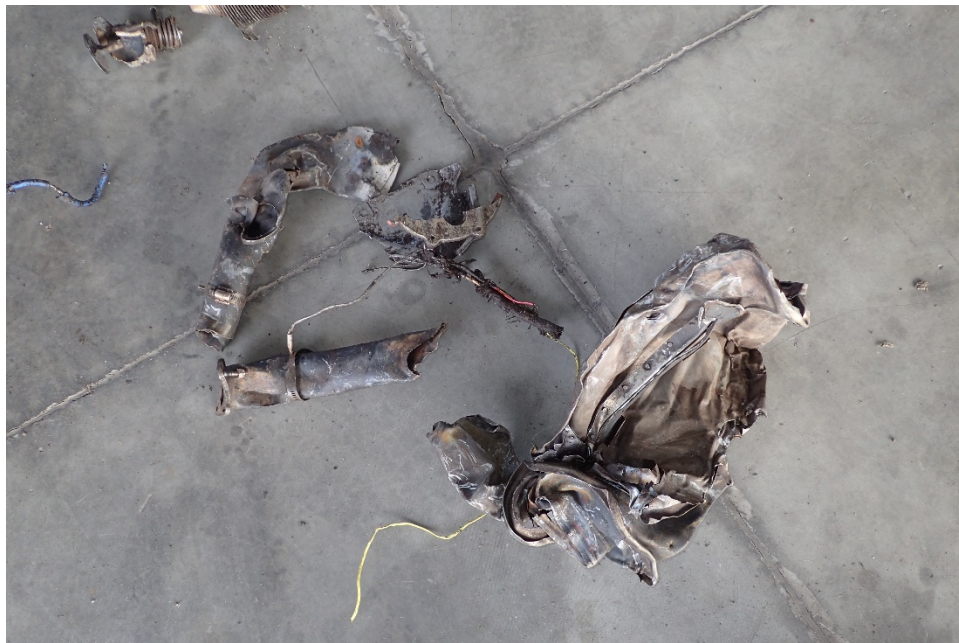
Figure 16: Exhaust System

- The located pieces did not exhibit any signs of an exhaust leak
- The heat exchanger was located and was significantly crushed.
- The induction system was destroyed and mostly not present.

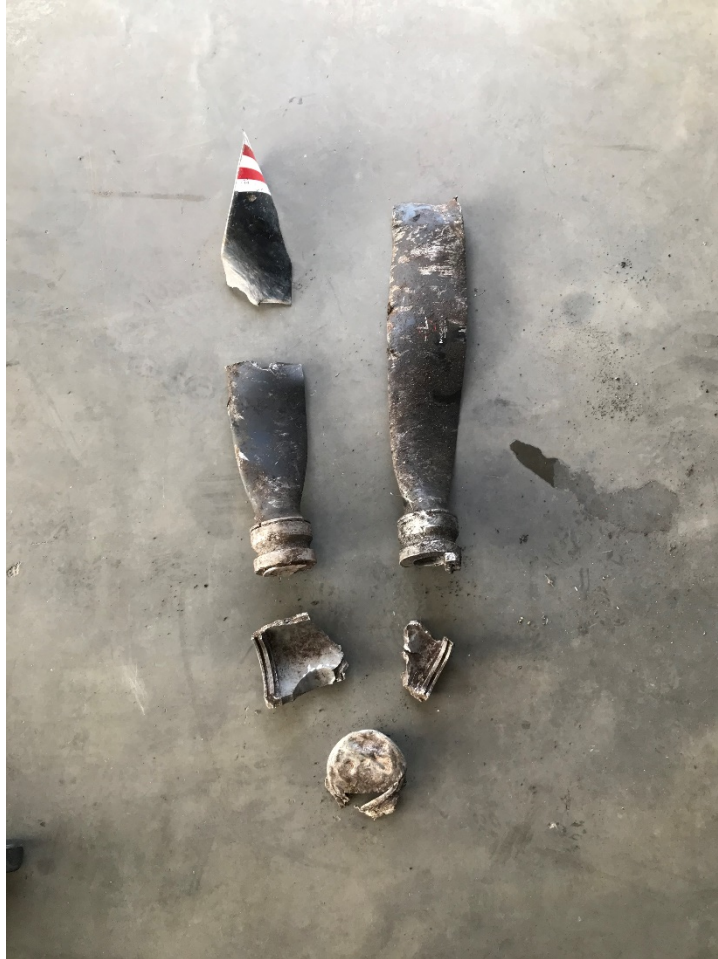
Figure 18: Propeller Blades, Hub Fragments, and Front of piston cylinder

- The two propeller blades were fracture separated from the hub and found within the wreckage.
 - The propeller hub was heavily fragmented and only a few pieces were located

- The front of propeller piston housing was crushed aft and mostly flat.
- One blade was mostly whole and exhibited a slight S-bend.
 - The outboard tip was fracture separated, and it had a slight aft curl to it.

- The second blade was separated from the hub and fracture separated into three pieces.
 - The inboard portion of the blade exhibited large leading edge dents/gouging

- The middle section of the blade was missing and was not located within the wreckage.
 - The outboard portion of the blade was curled aft.
 - The face side of the blade exhibited some longwise gouging.

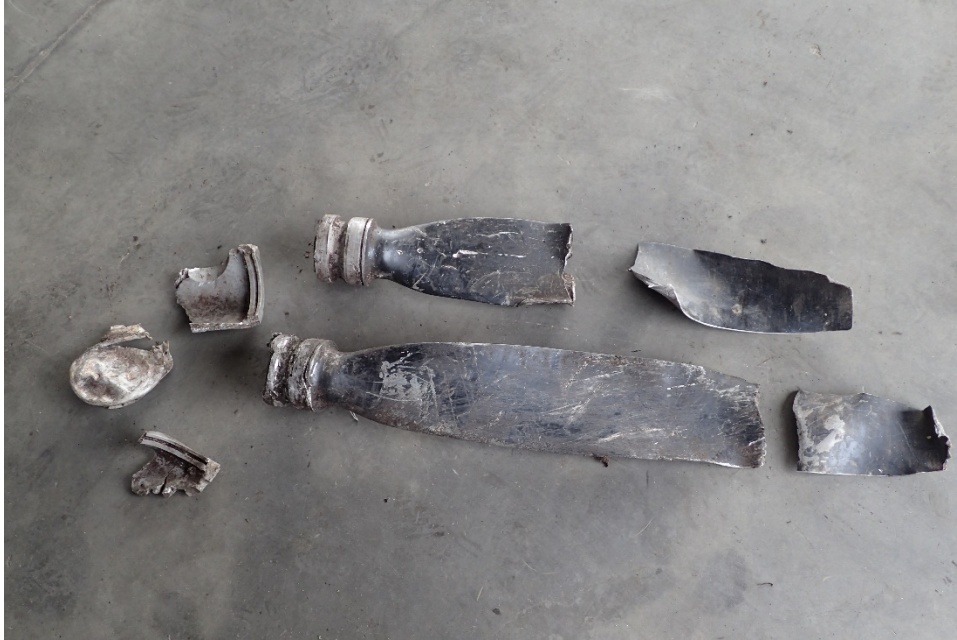
Figure 19: The Face Side of the Blade

- The blade exhibited chordwise scratching and gouging throughout.
 - The face side of the blade exhibited mostly longwise scratching with some minor chordwise scratching.
