## **NATIONAL TRANSPORTATION SAFETY BOARD**

### **NTSB ON SITE EXAMINATION NOTES**

**WPR13FA388**

Location: Desert Center, CA  
Date: August 26, 2013  
Aircraft: Grumman AA-1A, Registration Number: N61VT, Serial #: AA1A-0047  
NTSB IIC: Howard Plagens

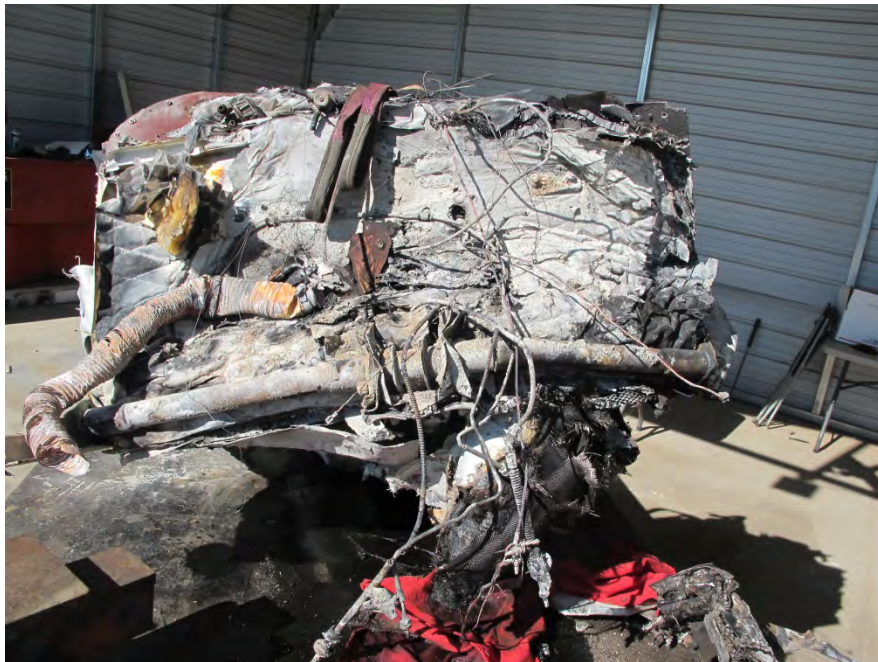
The airframe sustained severe thermal damage.

Photo 2 Cabin Area Aft of Firewall

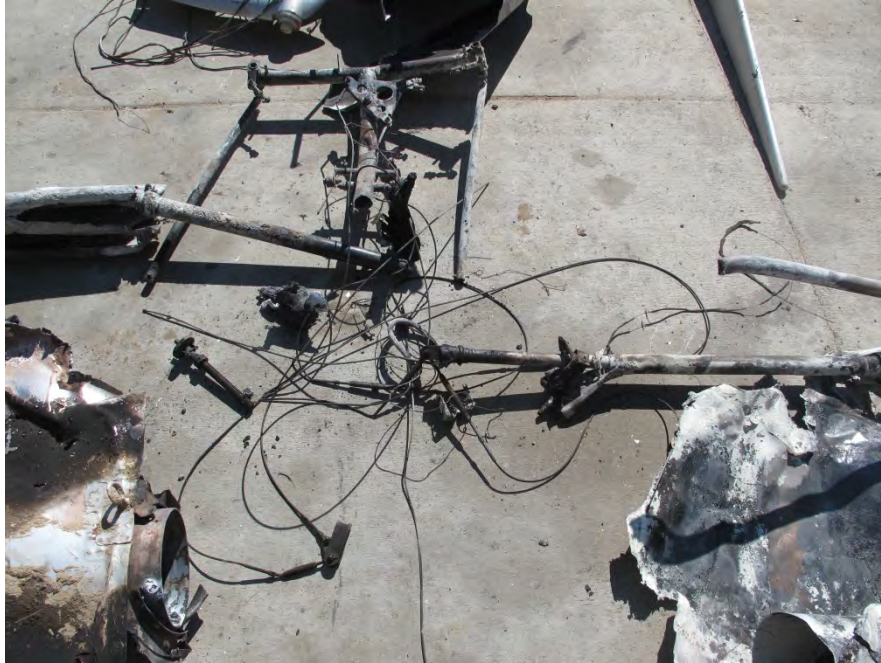
Flight control disconnects were angled and irregular.

Photo 3 Cockpit Flight Control Components and Cables

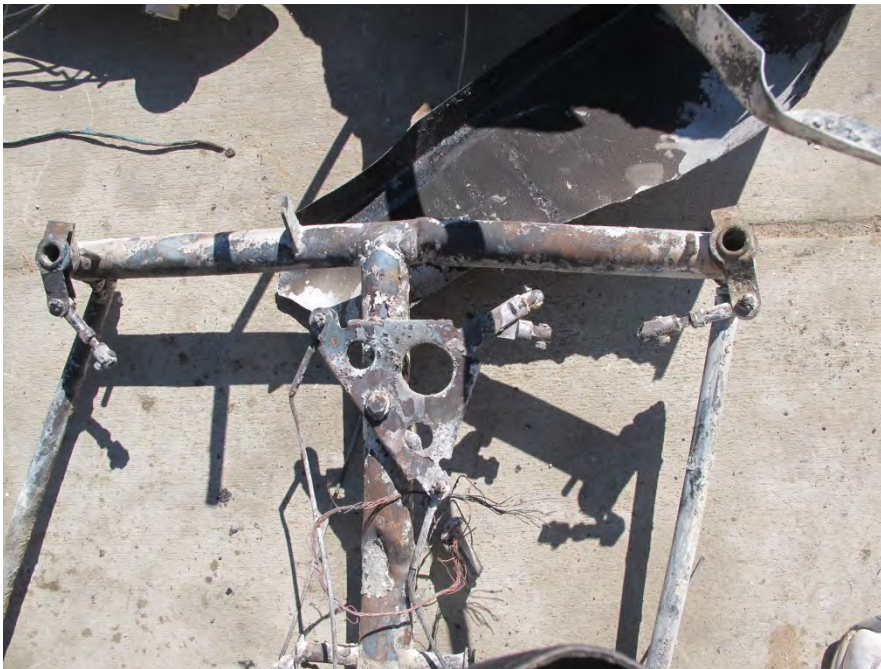
Photo 4 Cockpit Control Connections

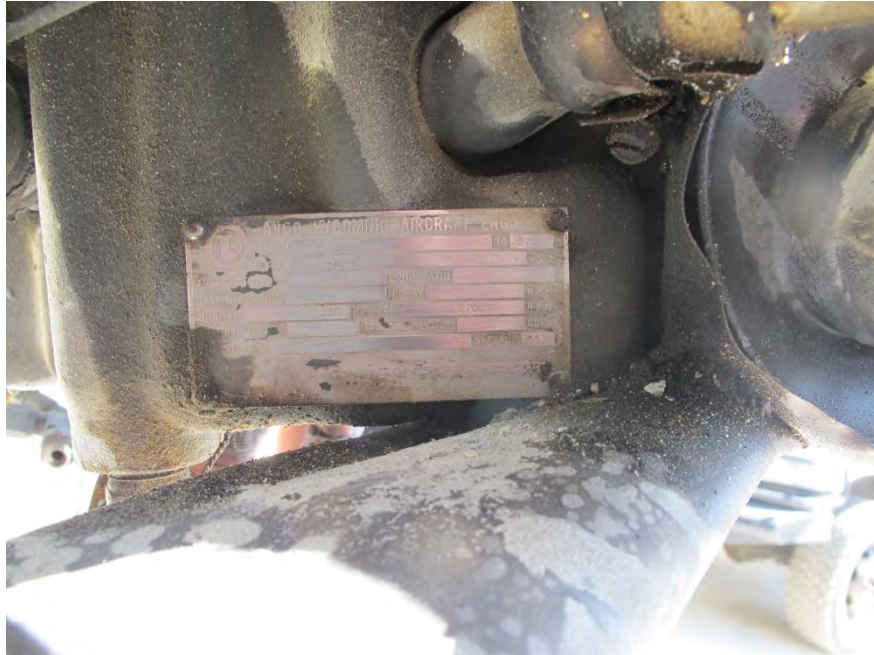
Photo 5 Engine Data Plate

The engine was a Lycoming O-320-E2G, serial number L-48438-27A. It produced 150 hp at 2,700 rpm.

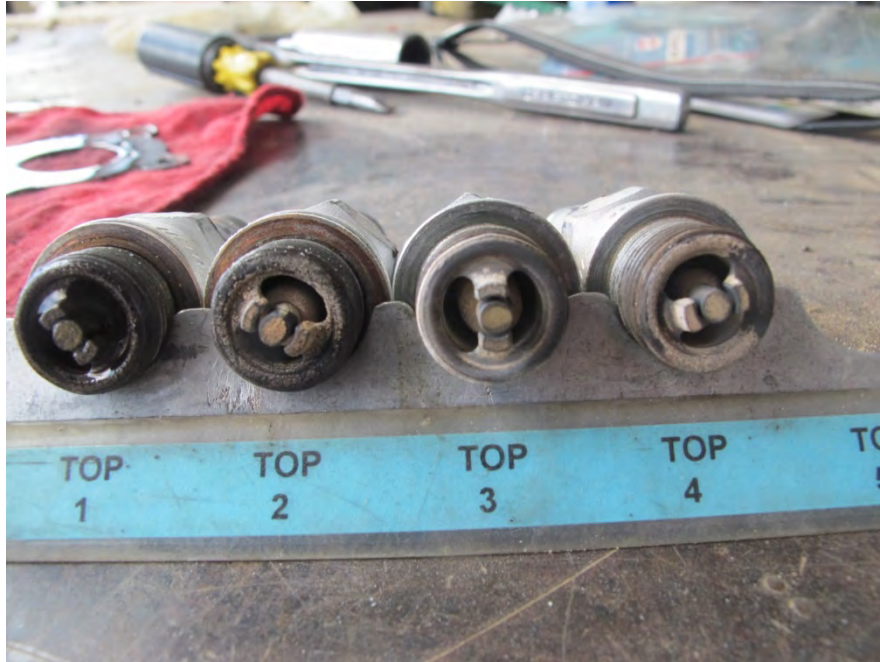
Investigators removed the top spark plugs; all center electrodes were circular, and clean with no mechanical deformation. Number one was wet from a black fluid; the other three spark plug electrodes were gray, which corresponded to normal operation according to the Champion Aviation Check-A-Plug AV-27 Chart.

Photo 11 Top Spark Plugs

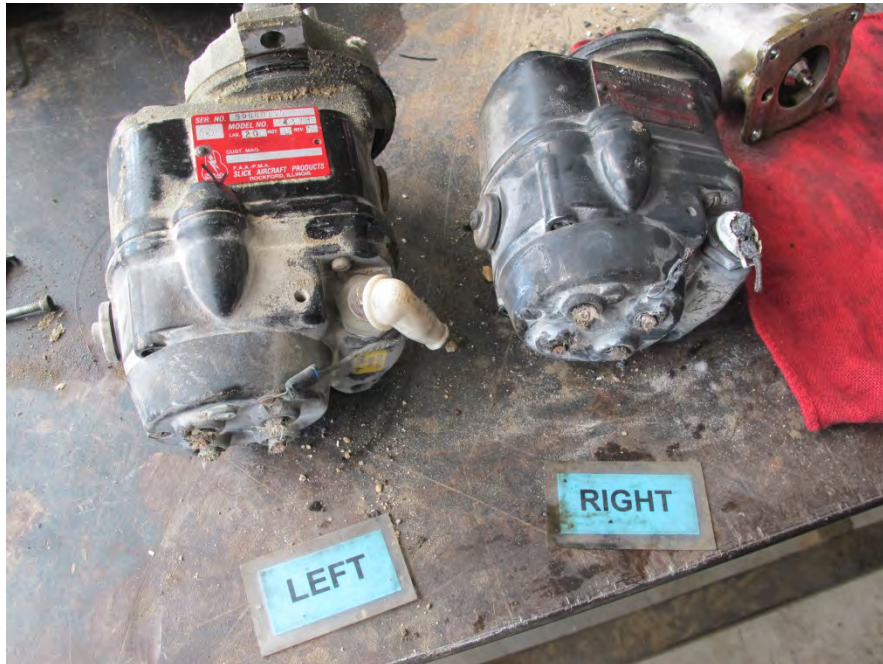
The ignition harness was attached to each magneto and each spark plug, but sustained thermal damage. The left magneto was a Slick 4371, serial number 95080150, and it had an impulse coupling. The right magneto was a Slick 4370, serial number 94010184. Investigators manually rotated the magnetos, and both magnetos produced spark at all posts.

Photo 12 Magnetos

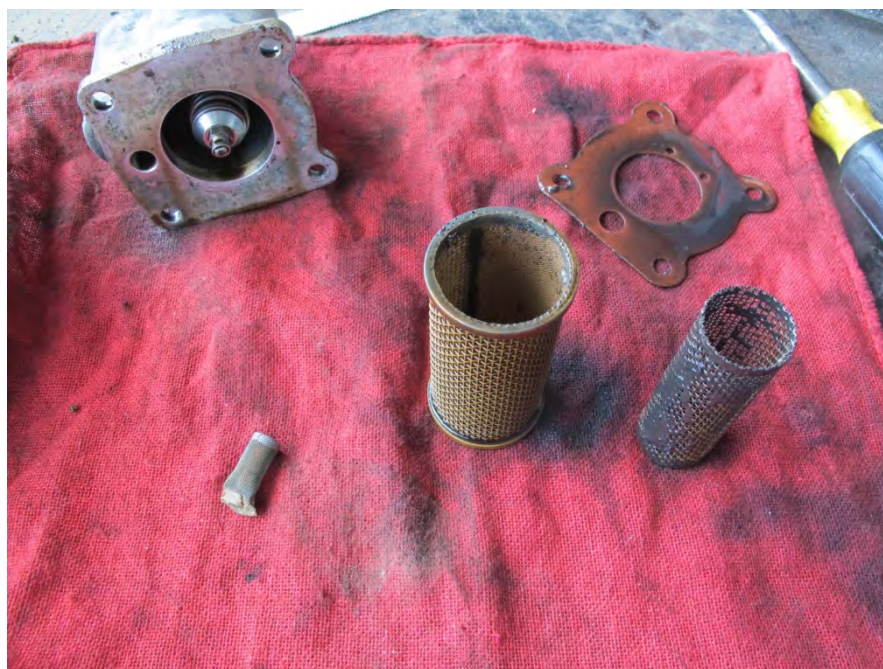
The oil suction screen and the oil pressure screen were clean.

Photo 13 Oil Suction and Oil Pressure Screens

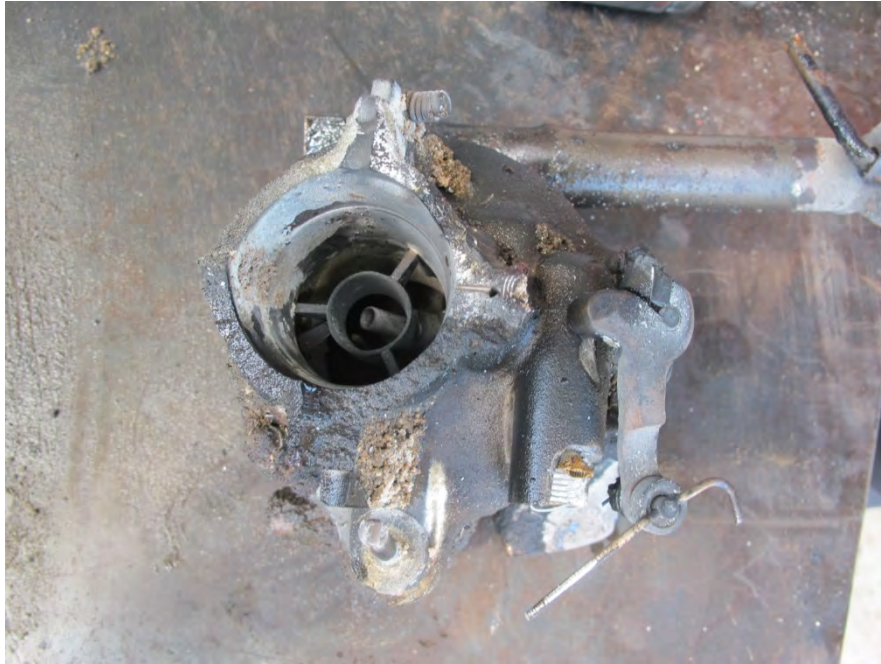
The Marvel Shebler MA-4SPA carburetor, serial number BL 198648, sustained crush damage. The throttle and mixture controls remained securely attached at their respective control arms. The metal floats exhibited inward hydraulic crush damage. One float separated, and was in the bottom of the float bowl; the float had a molten solder joint. The finger screen was clean.

Photo 14 Top View of Carburetor

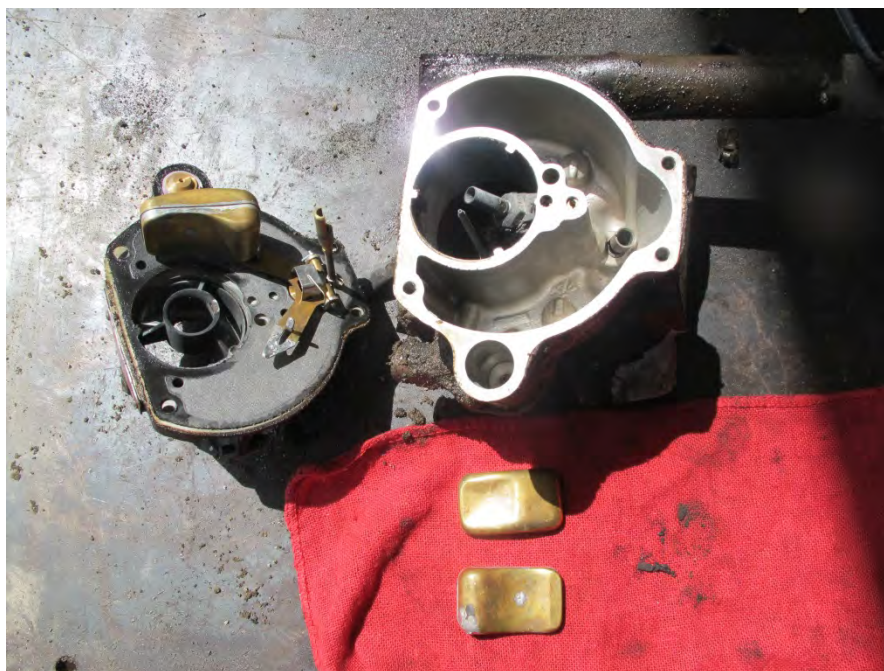
Photo 15 Disassembled Carburetor

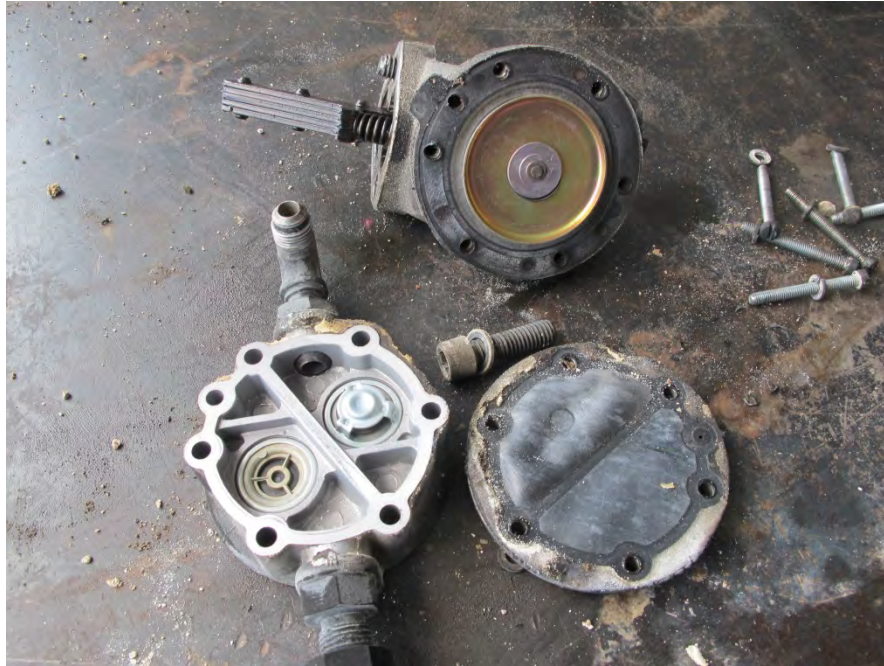
The fuel pump remained attached to the engine at its mounting pad, and the fuel lines were secure at their respective fittings. Disassembly of the fuel pump revealed that the rubber diaphragm was unbroken, and there were no visible obstructions.

Photo 16 Disassembled Fuel Pump

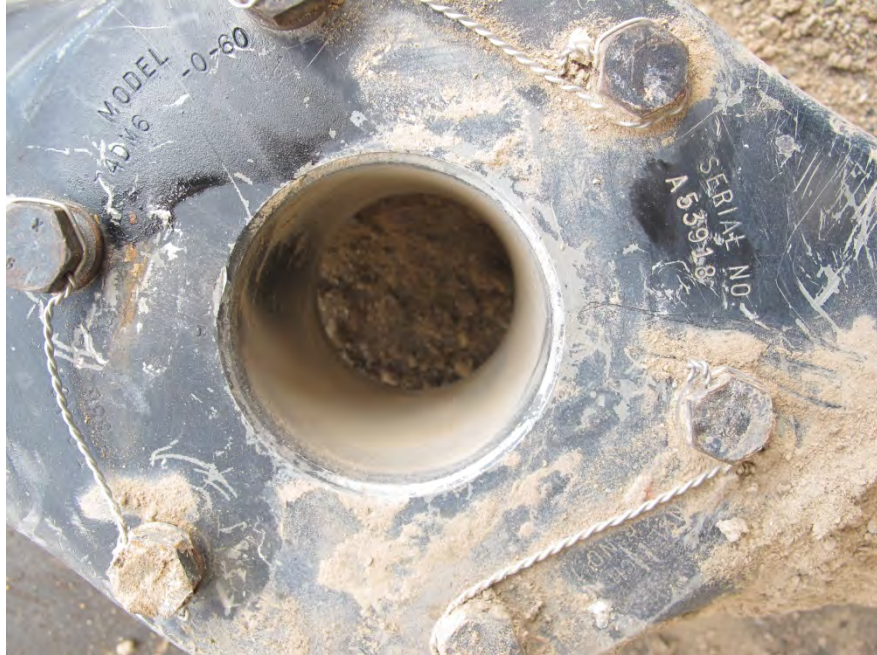
The spinner was crushed aft to the hub. One blade had leading edge polishing, and was twisted toward the low pitch, high rpm position. The other blade was twisted toward the low pitch, high rpm position.

Photo 17 Propeller Hub

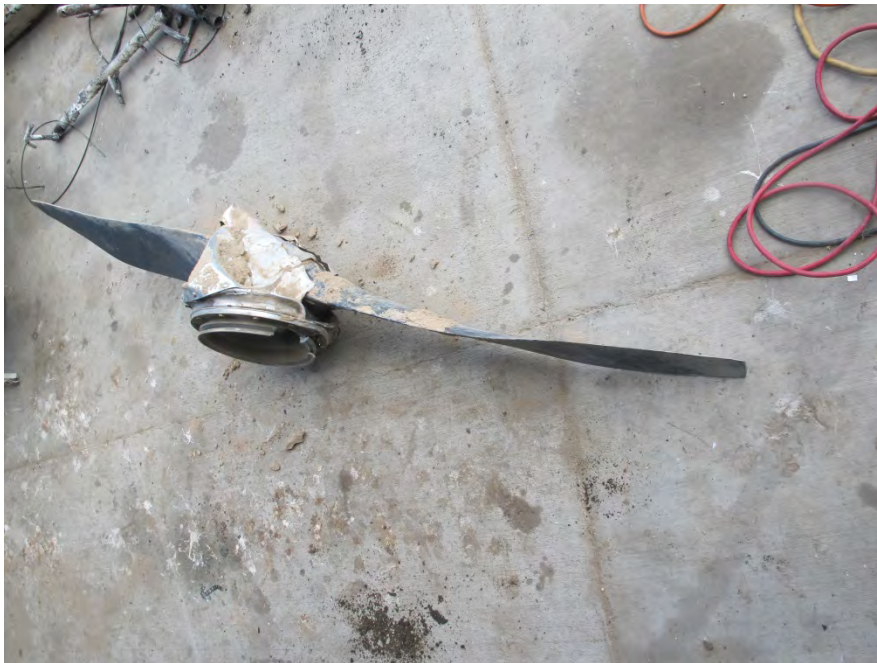
Photo 18 Propeller
