NATIONAL TRANSPORTATION SAFETY BOARD

AIRFRAME AND ENGINE EXAMINATION

**NTSB Accident: WPR12GA106
Accident Date: February 15, 2012**

Location: Moran Junction, WY
Date: February 15, 2012
Aircraft: Bell 407, N407HL, Serial # 53869
NTSB IIC: Michael Huhn

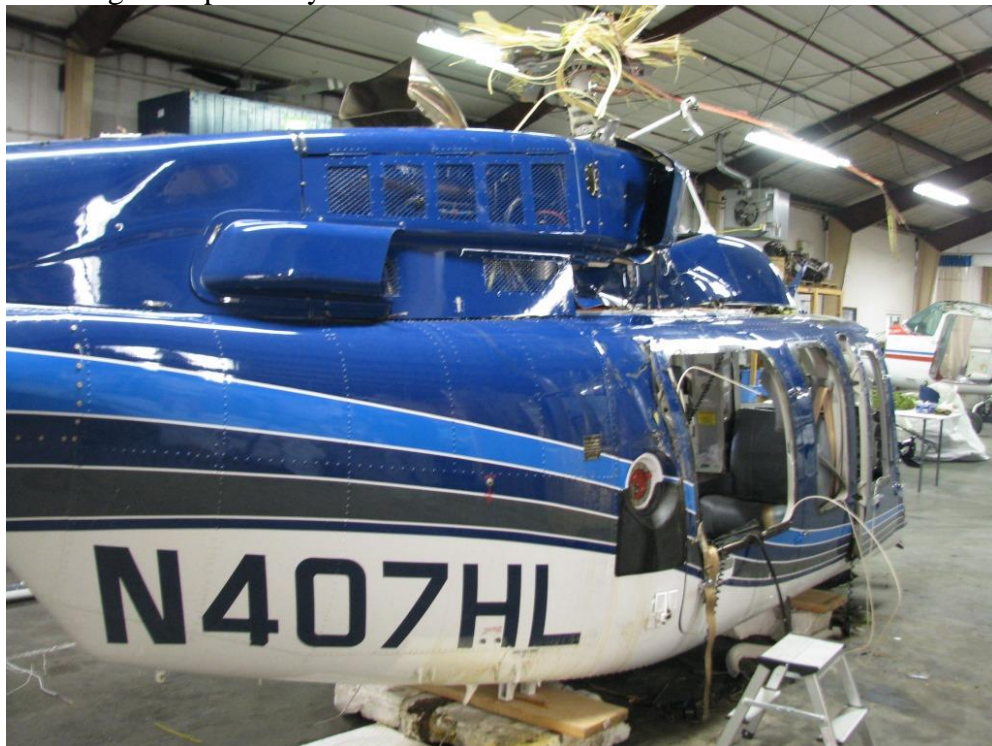
- The fuselage was primarily intact

Figure 1 - Aft Right View of Fuselage

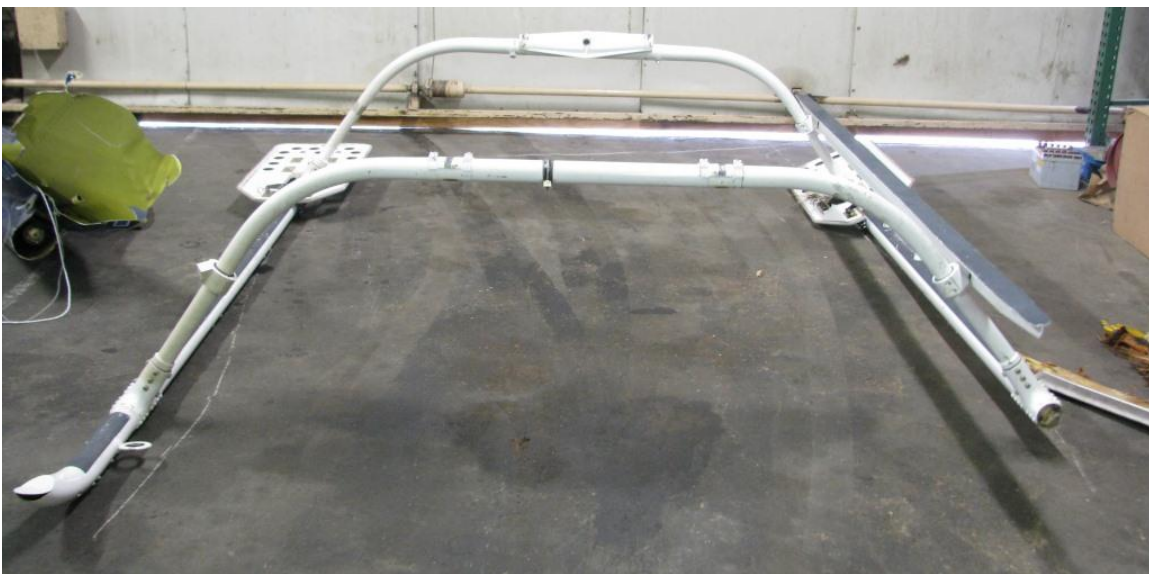
- The skid assembly was essentially intact, except
 - The left section was twisted a few degrees nose up
 - The forward stub end of the left skid was fracture separated from the rest of the assembly

Figure 5 - Front View of Skid Assembly (removed for recovery)

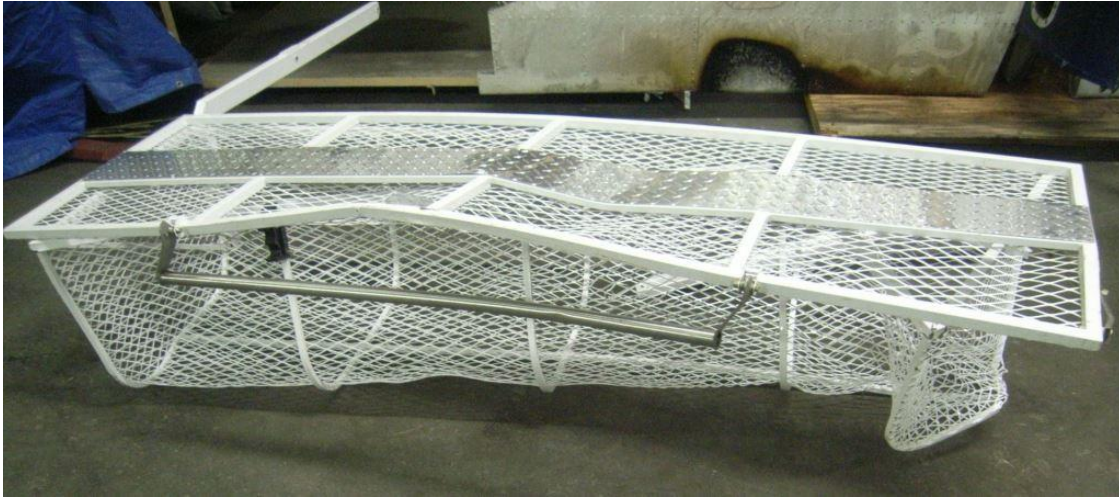
- The quick-release litter was crushed aft and up at its forward section

Figure 6 - Front Right View of Litter

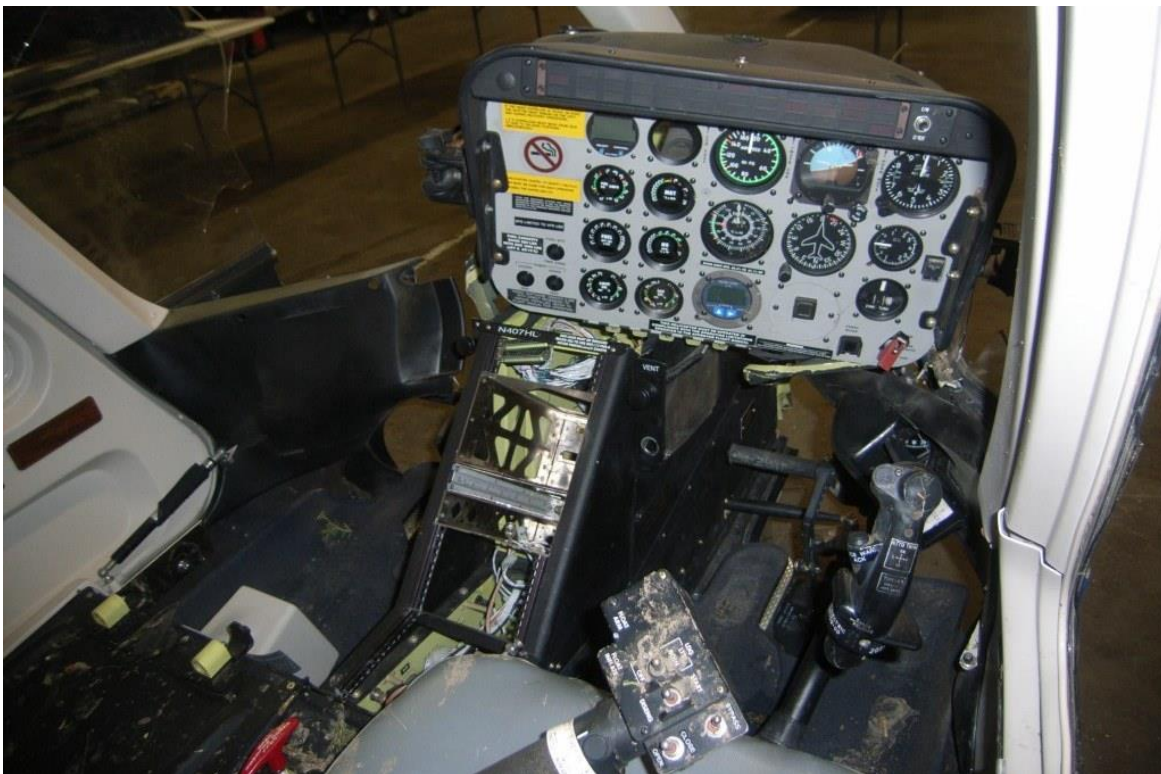
- All cabin doors were attached and operable, but not necessarily undamaged
- Of the ten cabin transparencies, only the one for the aft left door was intact; all others were fracture-separated from their frames
- The nose section which enclosed the two sets of anti-torque pedals was partly crushed or torn/displaced, but remained attached
- Aside from the footwell area for the pedals, the cabin volume was not compromised

Figure 7 - Cockpit Looking Forward

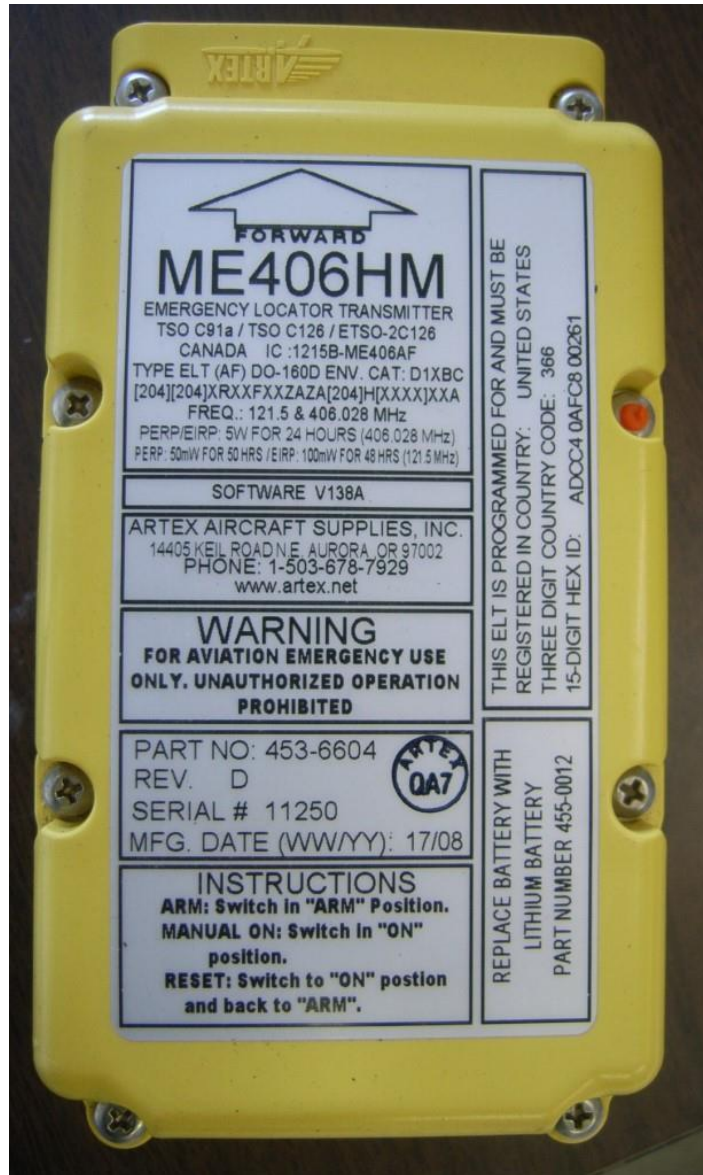
- The Artex ME406HM ELT had been removed from its mount on a shelf aft of the cabin; the switch had two positions (ARM and OFF), and was found in the ARM position

Figure 8 - ELT

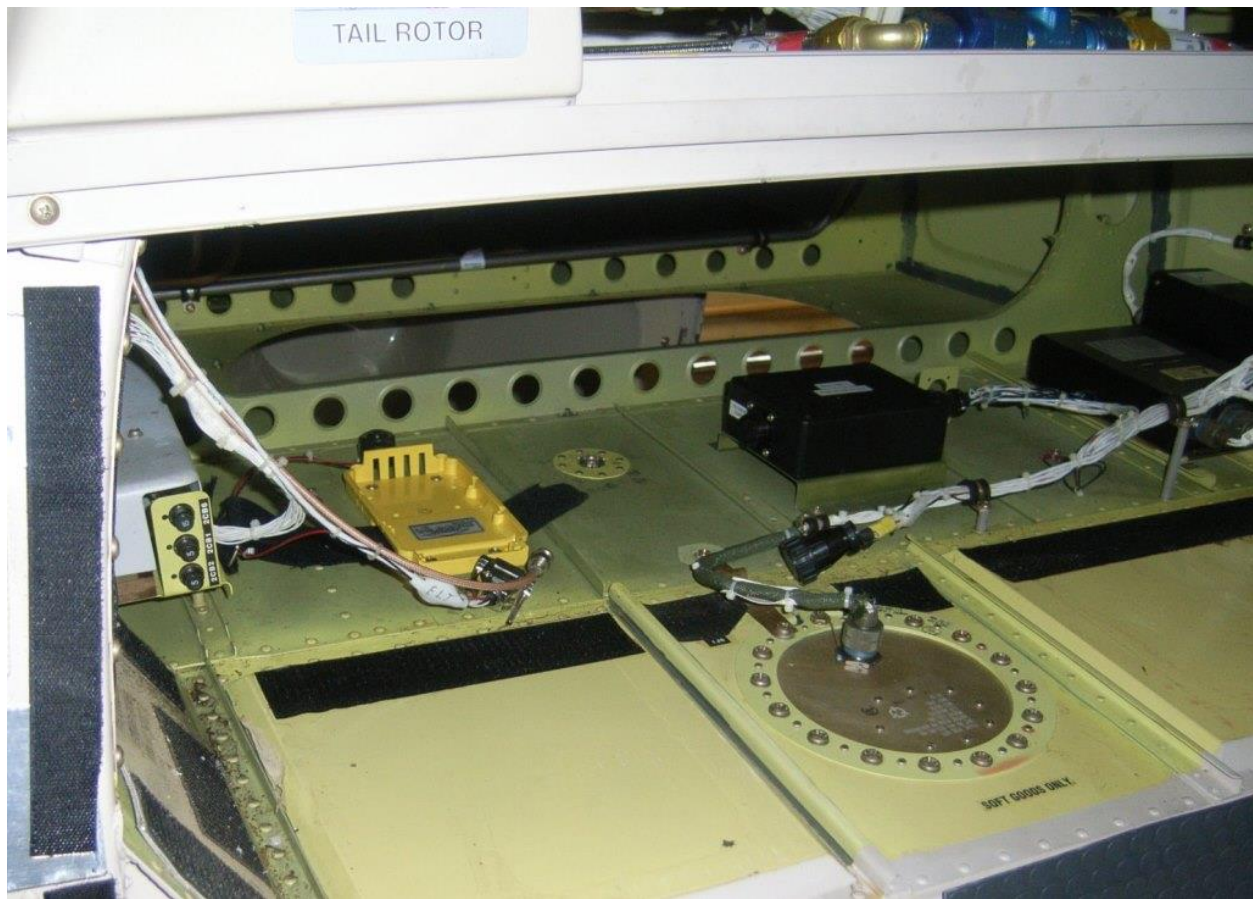
- Attempts to trace the ELT antenna wiring from the ELT mount to the antenna were unsuccessful; the location and condition of the ELT antenna was not determined

Figure 9 - ELT Tray in Aft Fuselage

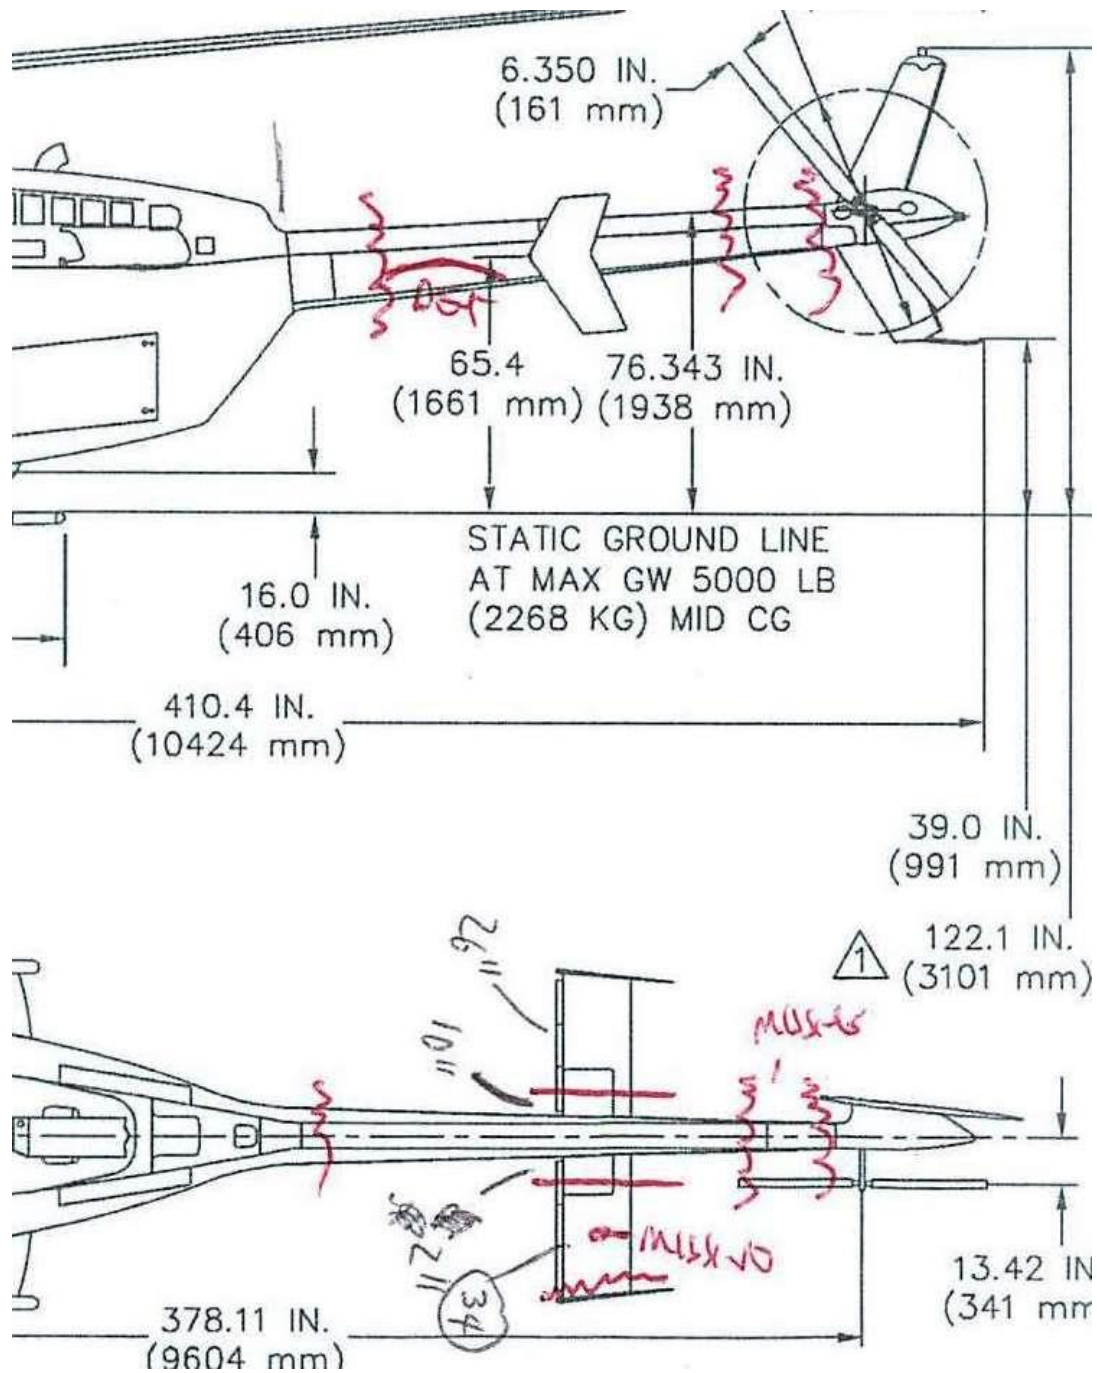
- The tail boom was fracture separated into 4 main sections
 - Approximate 2 foot stub from fuselage ('Section C')
 - Section aft of Section C to about 2 feet forward of empennage juncture ('Section B')
 - Empennage/TR section ('Section A')
 - Approximate 2 foot section between Sections A and B was not recovered
- The empennage (Section A) was fracture-separated from the tail boom at the empennage junction, but the TR drive shaft had fractured about 2 feet forward of that break

Figure 10 - Annotated Line Drawing Showing Fractures (jagged) and Cuts (straight)

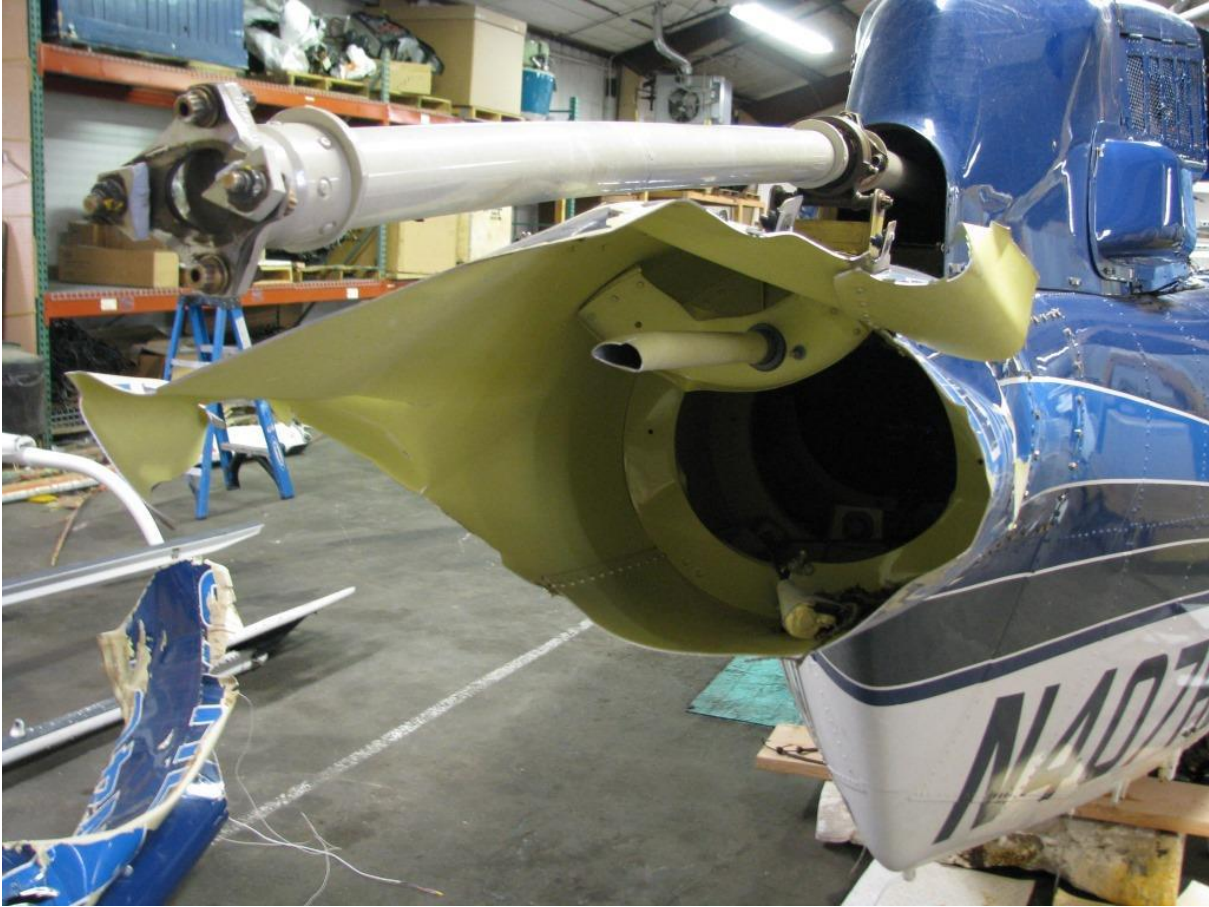
Figure 12 - Tailboom/Fuselage Fracture (Note TR drive shaft)

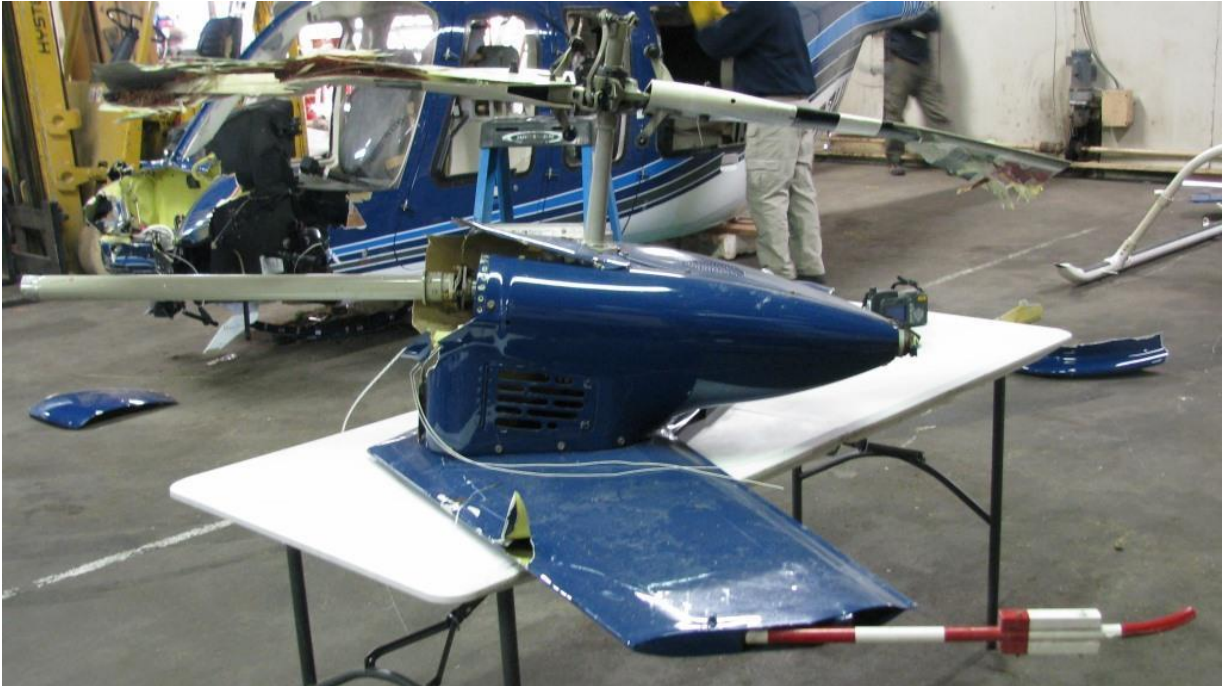
Figure 14 - Empennage with TR

- The empennage (aft) vertical stabilizers exhibited minor damage
- The horizontal stabilizers had been cut from the tail boom for recovery
- The lower RH vertical stabilizer exhibited LE damage
- The upper RH vertical stabilizer exhibited minor LE damage
- The LH vertical stabilizer had fracture separated from the LH horizontal stabilizer, and its upper section exhibited impact damage

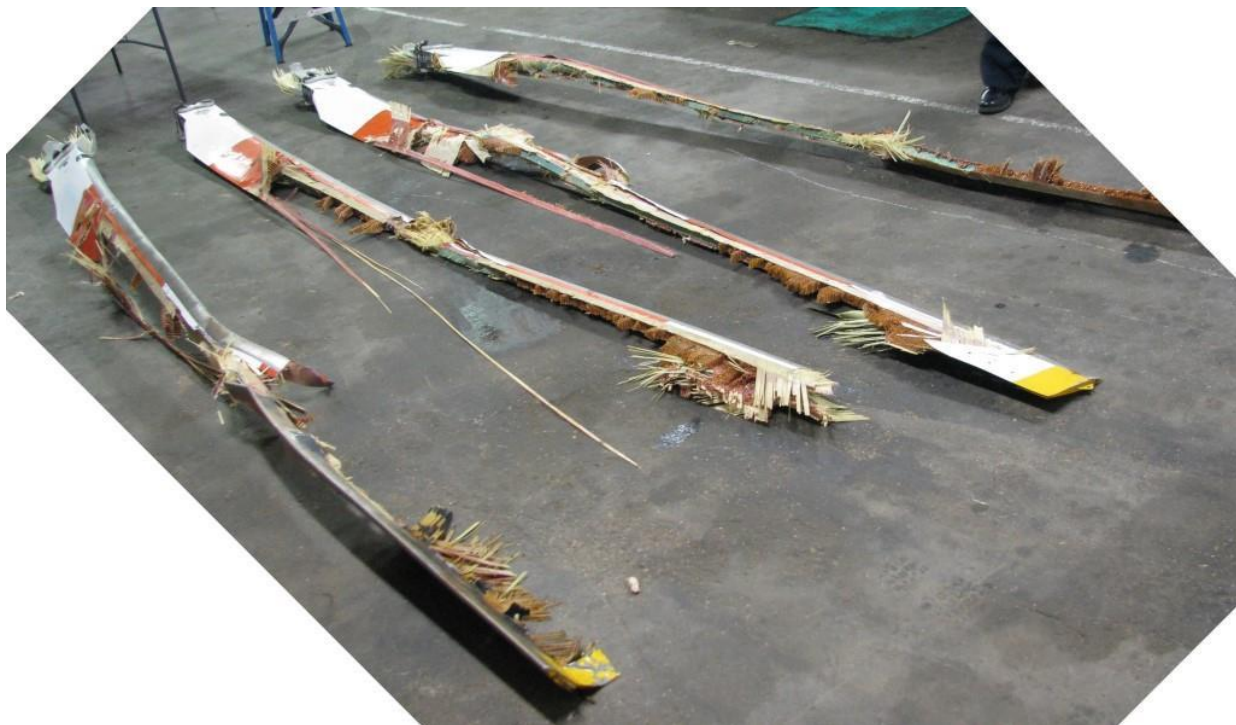
Blade	As-Found Length	Observations (measurements from root end of blade fitting, not CL of blade bolt)
Blue Diamond	Spar 188" Leading edge 174"	41" - downward bend in blade 122" - LE crack
Orange Square	Full	48" - LE crack 71" - LE crack 104" - LE full fracture Root fitting cracked
Red Triangle	175"	105" - Crease
Green Circle	Full	110" - Crease 125" - LE fracture LE twisted up Significant vegetation scars/witness marks

Figure 15 - Main Rotor Blades (L to R: Green/circle, Red/triangle, Orange/square, Blue/diamond)

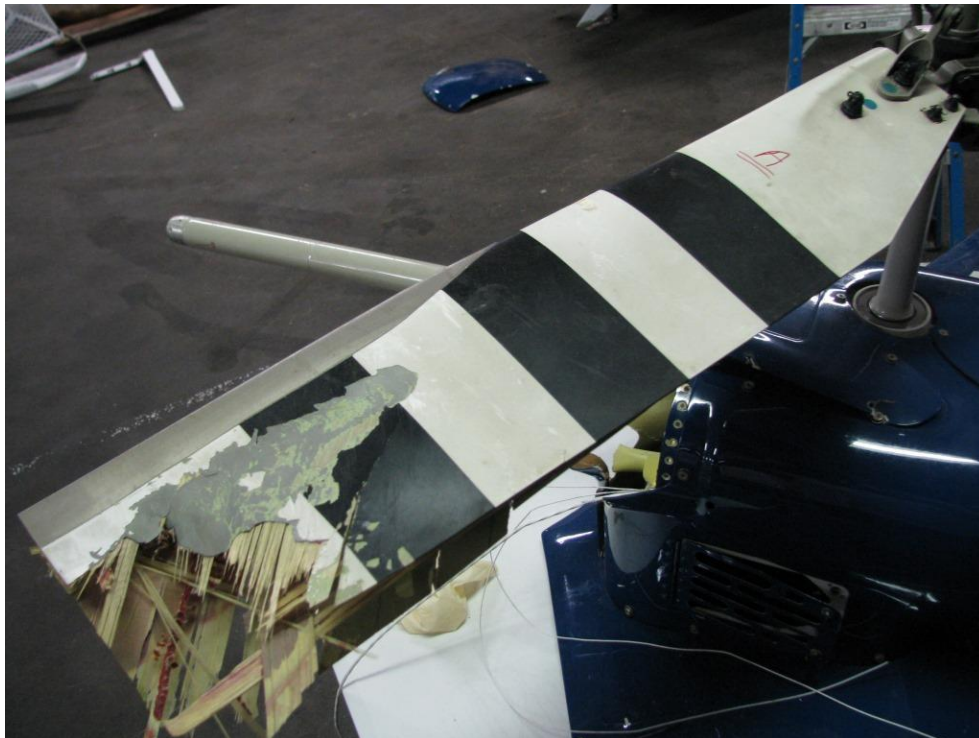
Blade	As-Found Length	Observations (measurements spanwise from root end of blade)
Green Circle 'A'	Full	18" – LE bend Outboard 9" impact damaged
Orange Square 'B'	Full	11" - LE fracture 18" – Large LE dent Afterbody delaminated along full span

Figure 18 - TR Blade 'A'

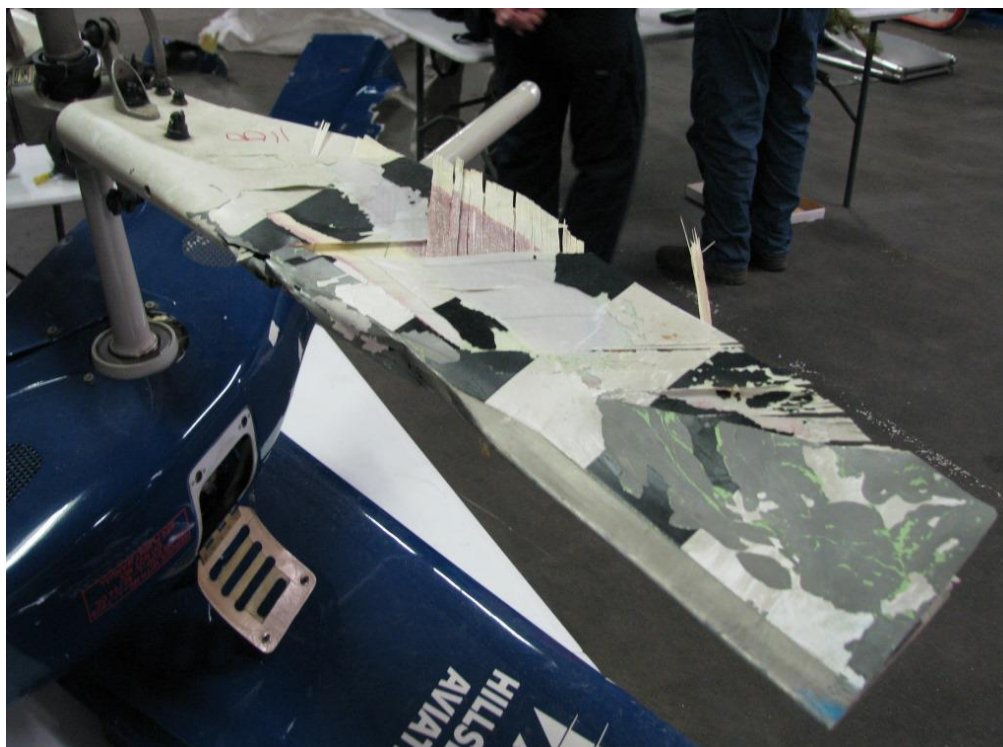
Figure 19 - TR Blade 'B'

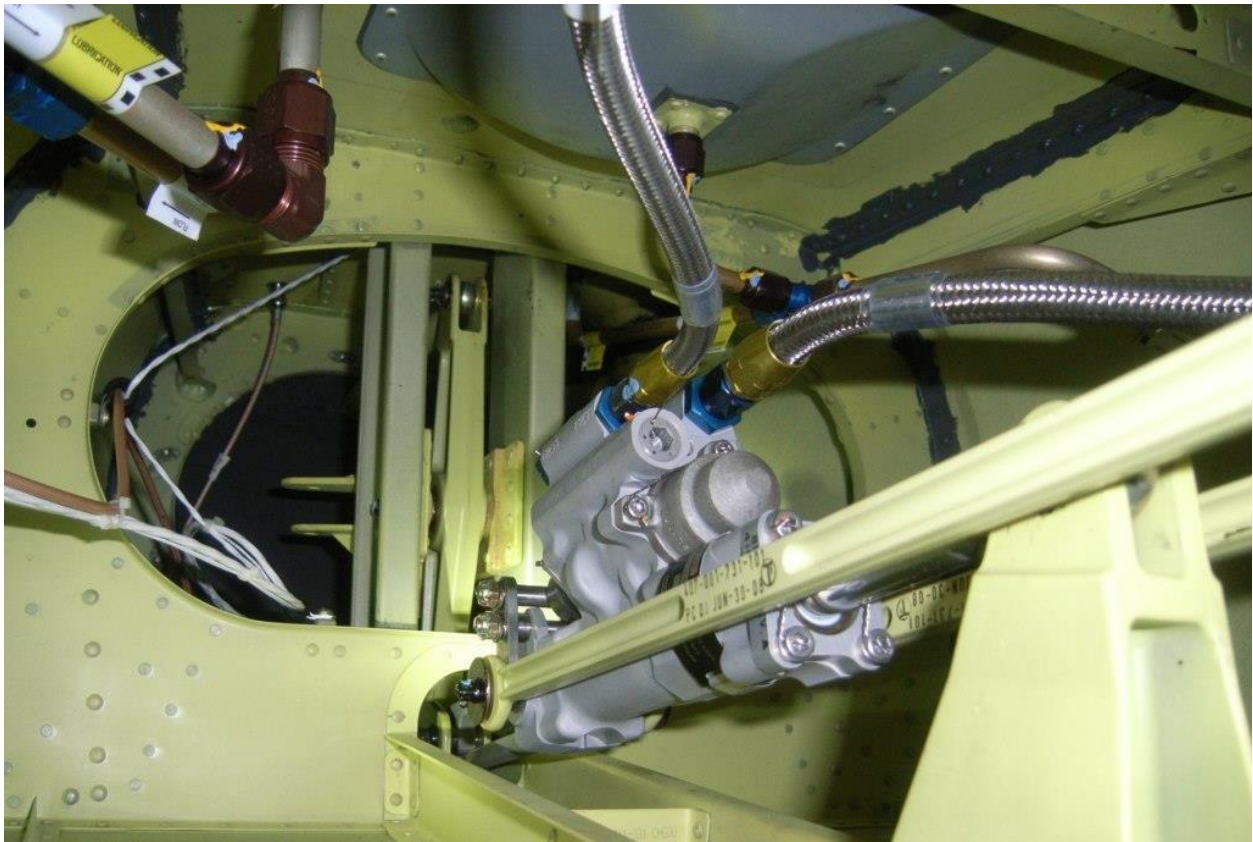
- The TR directional control actuator (DCA) remained installed and appeared undamaged
- Pre-removal visual inspection did not reveal any indications of leakage or other pre-existing anomalies
- The DCA was removed for shipment to the Bell helicopter facility for functional testing and detailed examination
- The DCA tested satisfactorily, and no conditions which could have contributed to a loss of directional control of the helicopter were detected.
- The test details are documented in a separate report

Figure 20 - DCA (installed/as found)

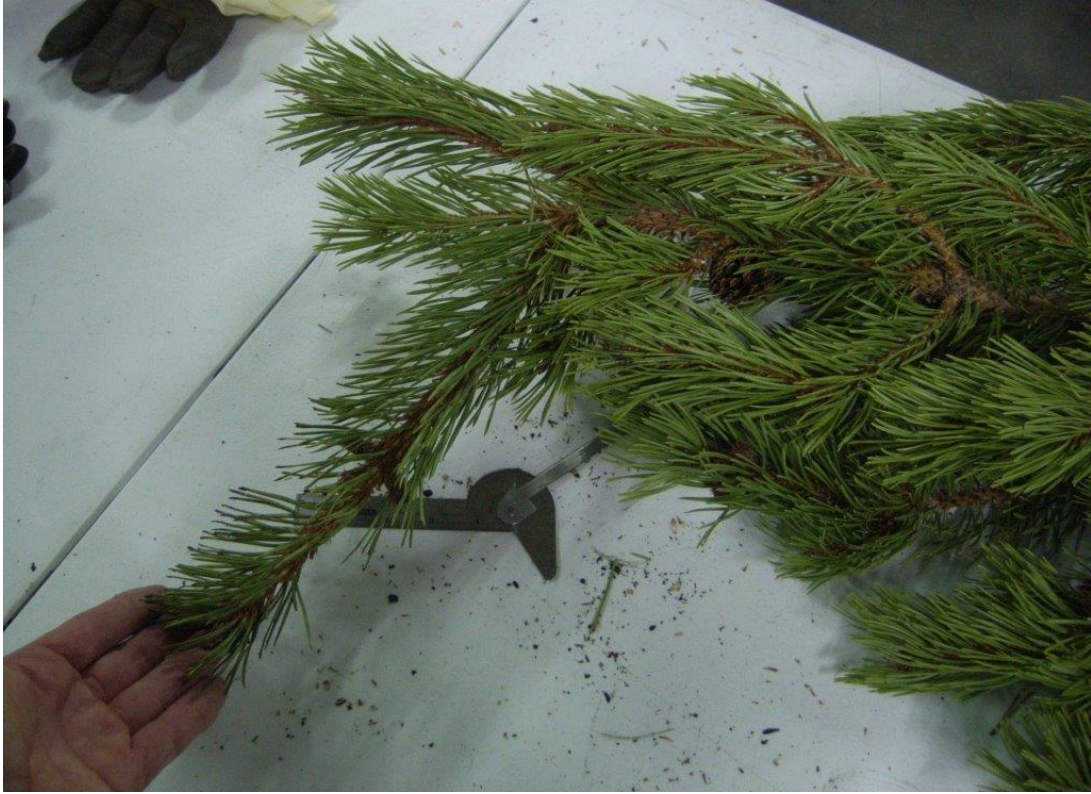
- The broken branch on the tree was about 3/4 inch in diameter, and the material was soft and flexible
- The break appeared to be either partial, or partially recovered/healed; it was not clean and did not sever/penetrate the majority of the branch

- No other branches were observed to be broken or missing from the recovered sample
- The aggregate evidence was consistent with the branch not being broken by a direct strike by the helicopter or the TR. The evidence was also not consistent with the possibility that the TR was damaged by the subject tree/branch.

Figure 22 - Tree with Broken Branch (6 inch scale on table)

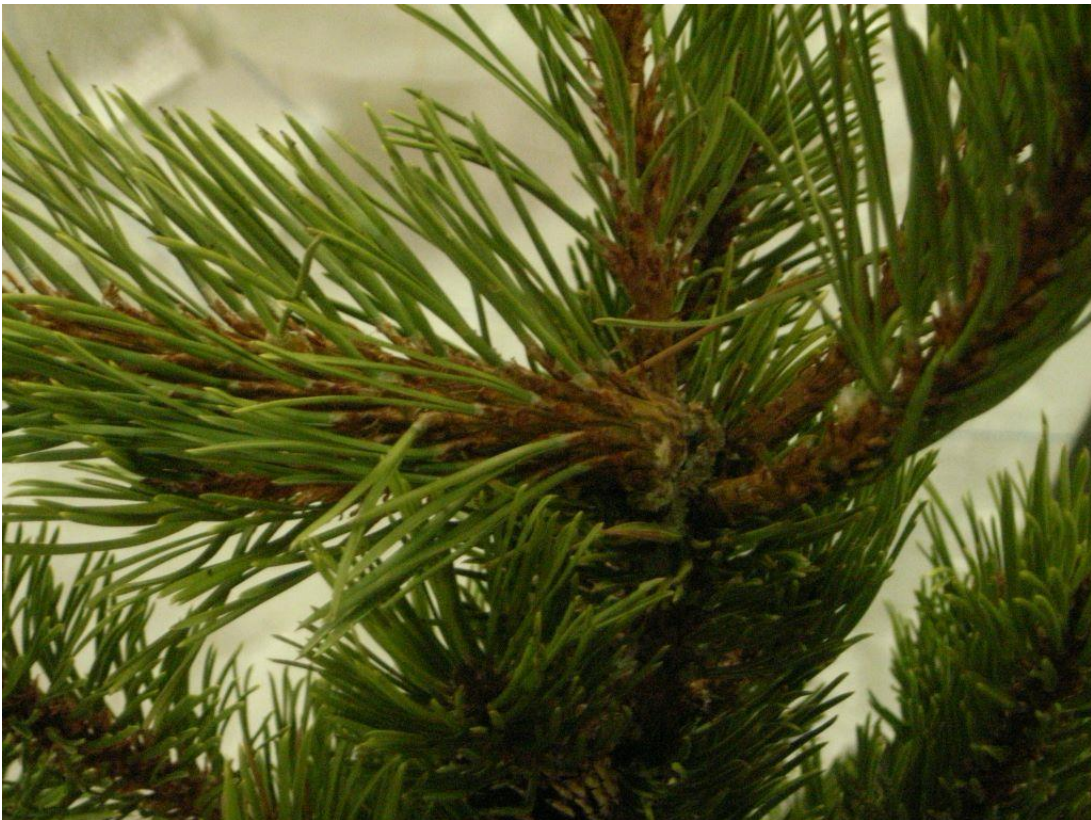
Figure 23 - Closeup of Branch Fracture

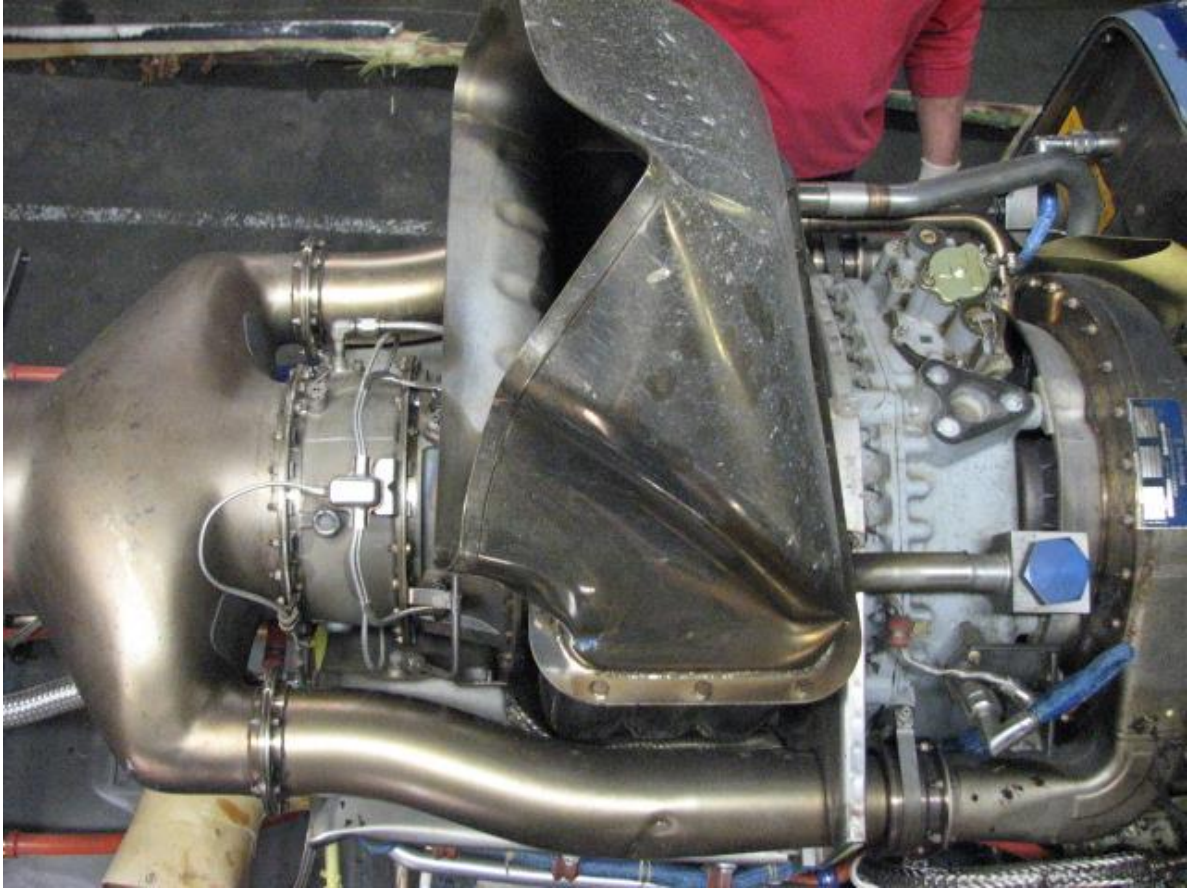
- The ECU data is published under separate cover
- All evidence was consistent with a rapid and catastrophic interruption of power
- Exclusive of impact damage, there was no physical evidence of engine failure or disruption

- All evidence was consistent with normal engine operation until an external event induced the overspeed and shutdown
- Based on the pilot's statement, the ECU data, and the physical evidence of the engine, it was decided that no additional engine examination or testing was warranted, and therefore none was conducted

Figure 24 - Engine Subsequent to Removal
