NATIONAL TRANSPORTATION SAFETY BOARD

AIRFRAME AND ENGINE EXAMINATION

WPR15FA147

Location: Lebec, CA
Date: April 15, 2015
Aircraft: Pitts S2E, Registration Number: N75BH, Serial #: 1251
NTSB IIC: Millicent Hoidal

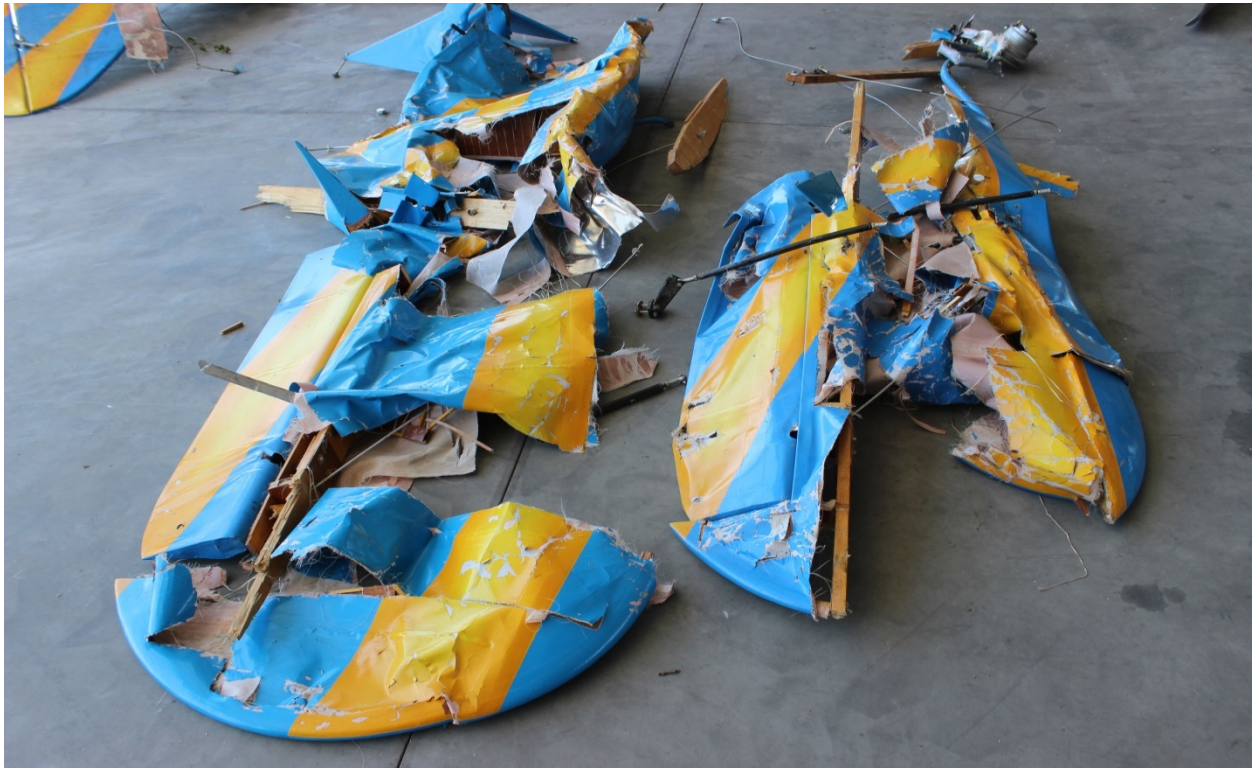
Figure 1: Right wings

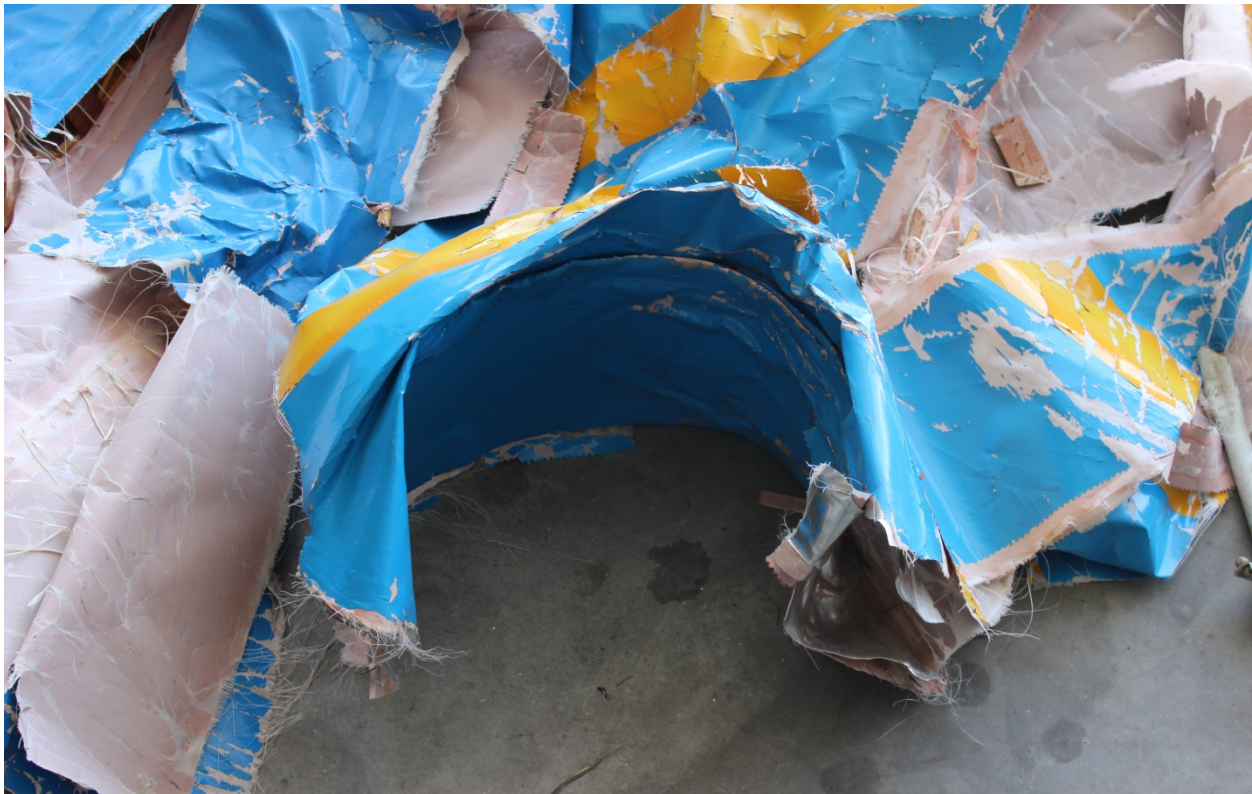
Examination of the airframe revealed that the airframe structure was highly fragmented. The left wing sustained significantly more damage than the right wing. The wing aileron was attached to the right airframe structure, there were numerous disconnects within the flight control system, all identified fractured surfaces were jagged and angular.

Figure 2: Lower left wing impact damage

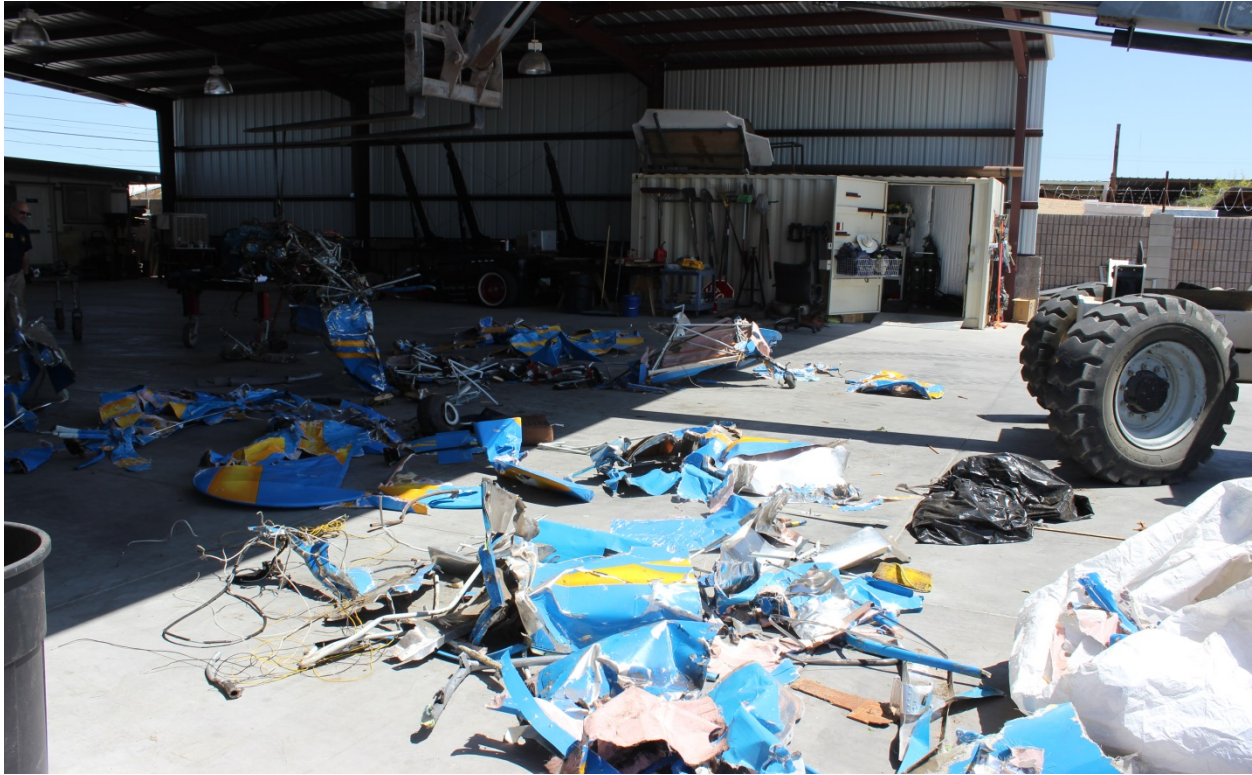
Figure 3: Wreckage layout

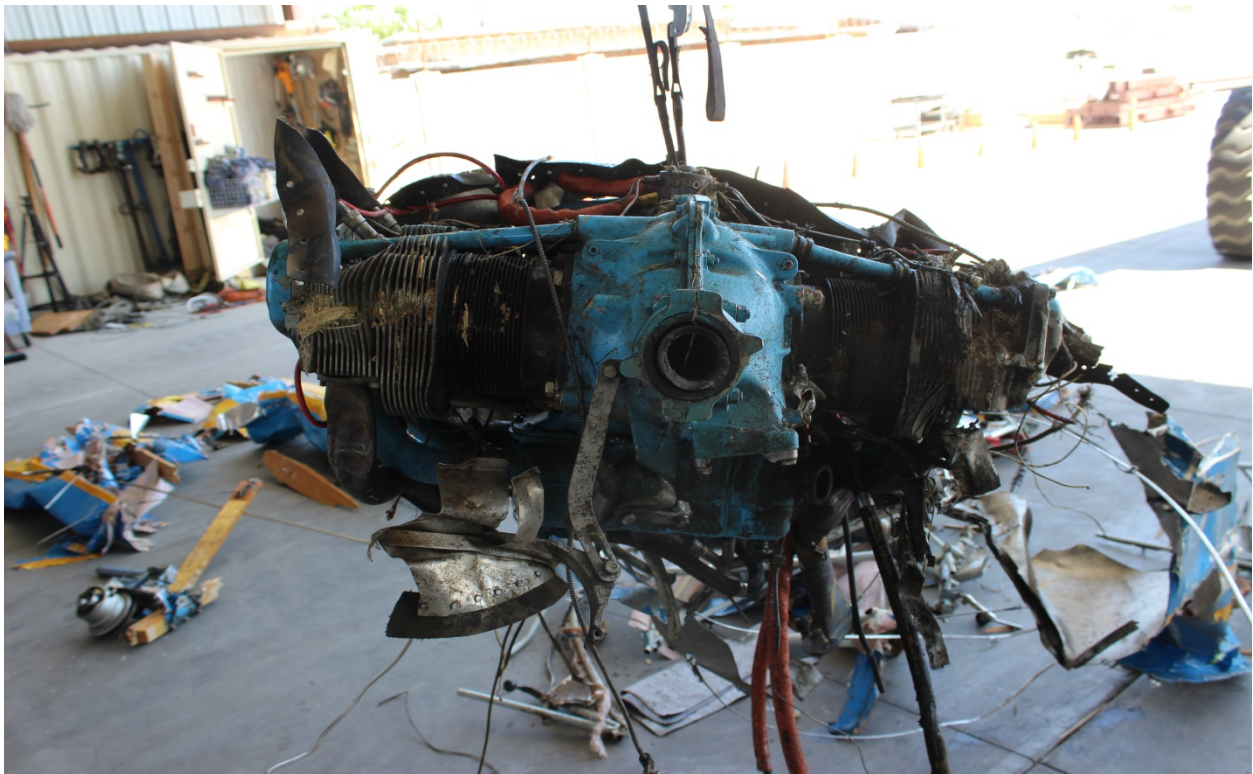
The engine separated from the airframe during the accident sequence and extensive impact related damaged was noted throughout. The propeller hub detached from the crankshaft flange; the propeller blades remained primarily intact, the end of one blade was found separated. The propeller blades were bent back with cordwise striations.

Figure 4: Front view of engine
