## **NATIONAL TRANSPORTATION SAFETY BOARD**

# **AIRFRAME AND ENGINE EXAMINATION**

**WPR16FA131**

Location: Coeur d'Alene, Idaho  
Date: June 25, 2016  
Aircraft: Cessna A185F, N4585F  
Serial 1851092  
NTSB IIC: Albert Nixon

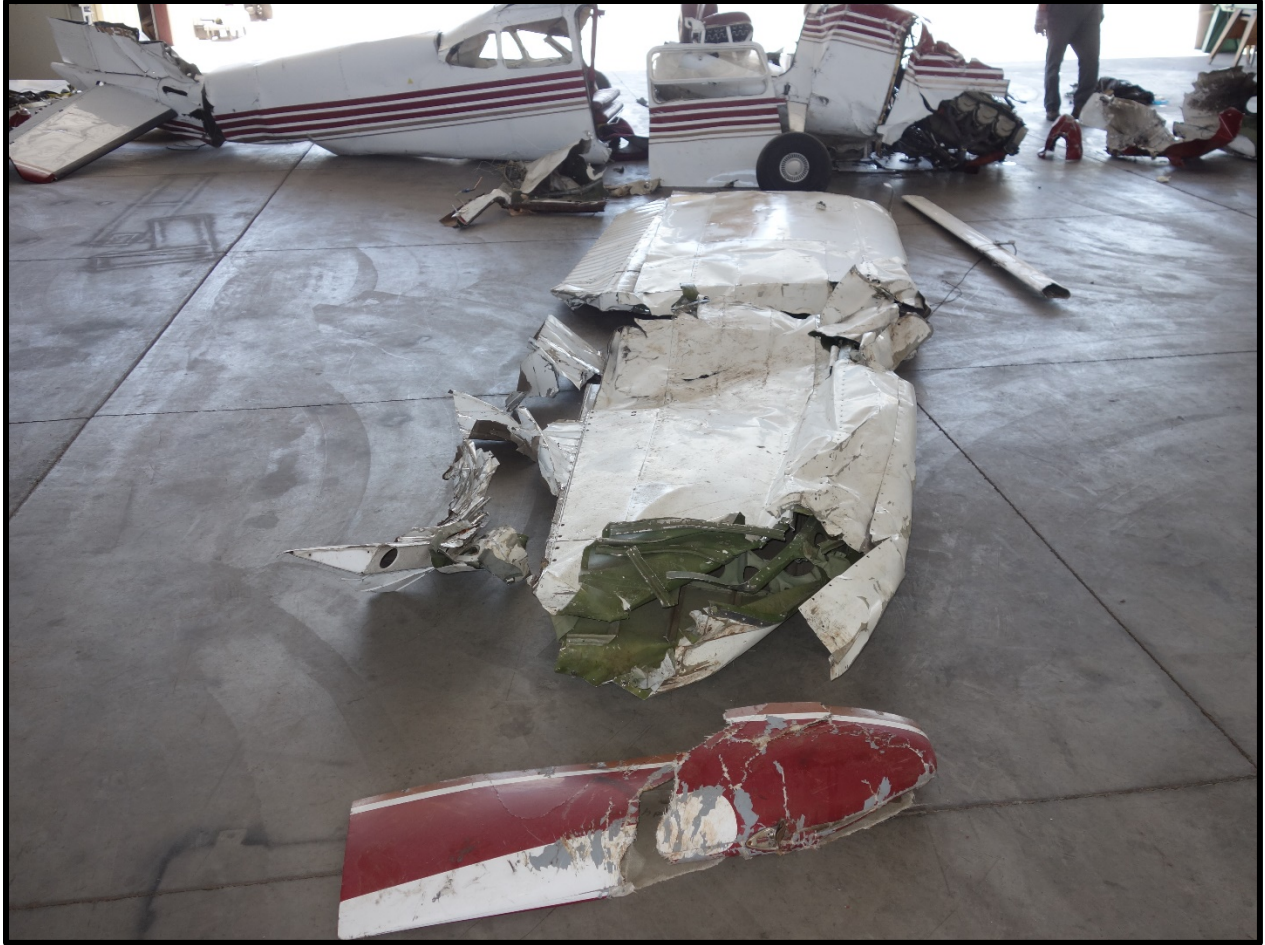
**Figure 1: Airplane Wreckage viewed from the Right Side.**

The left wing was separated in half about mid-span. The leading edge of the right wing exhibited indentations from multiple tree strikes. Recovered fragments of the windscreen showed no signs of oil leakage or a bird strike. Throttle control continuity was established.

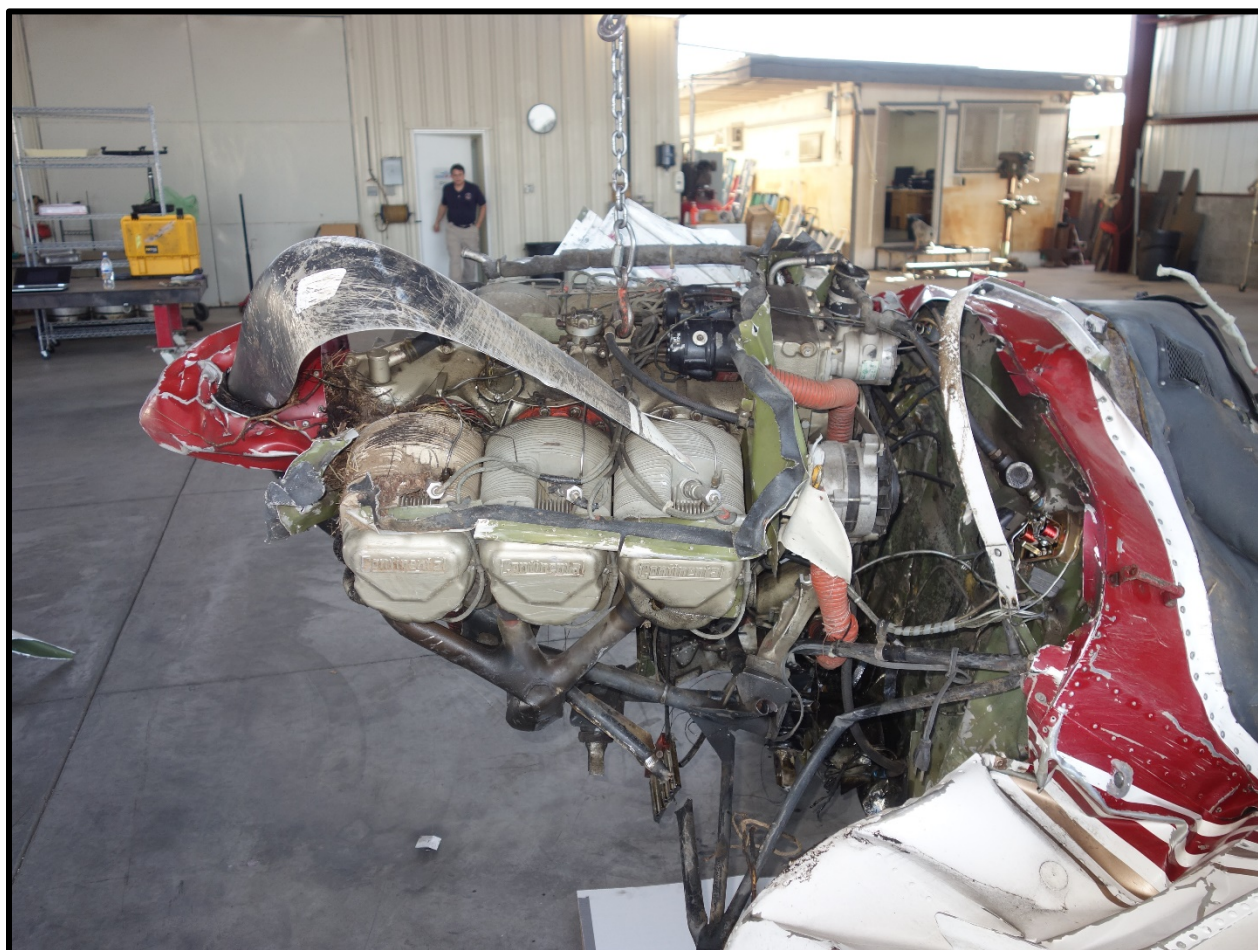
Figure 2: Airplane Engine viewed from the Left Side.

The two-bladed propeller remained attached to the crankshaft propeller flange with the blades attached. The propeller flange was bent from impact. One blade was bent aft about 90°, about mid-span and the other blade was bent aft on the outboard tip from about 2-3 inches.

A hole was observed in the oil sump next to drain plug, in the left rear portion. The damage was consistent with impact forces that pushed the engine rearward into the airframe firewall.
