NATIONAL TRANSPORTATION SAFETY BOARD

AIRFRAME AND ENGINE EXAMINATION

WPR17FA150

Location: Schellville, CA
Date: July 13, 2017
Aircraft: Cirrus Design Corp. SR22T, Registration Number: N821SG
NTSB IIC: Albert Nixon

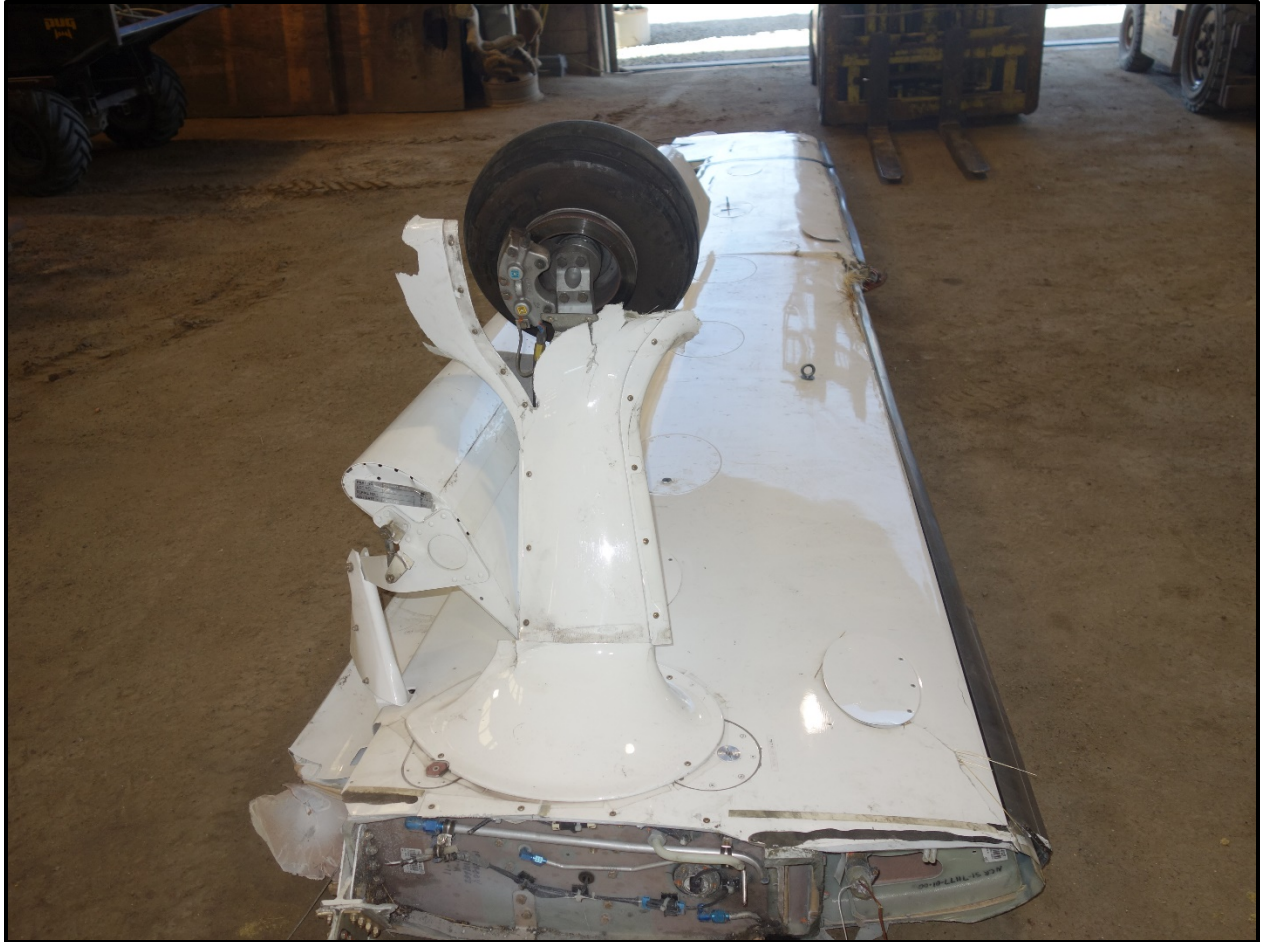
Figure 1: Right wing as viewed from the bottom side.

The right flap and aileron were attached. Leading edge damage was observed on the right inboard half of the wing, that was crushed aft. The right wing had residual fuel leaking out (about 2 cups). A crease was observed at the main spar.

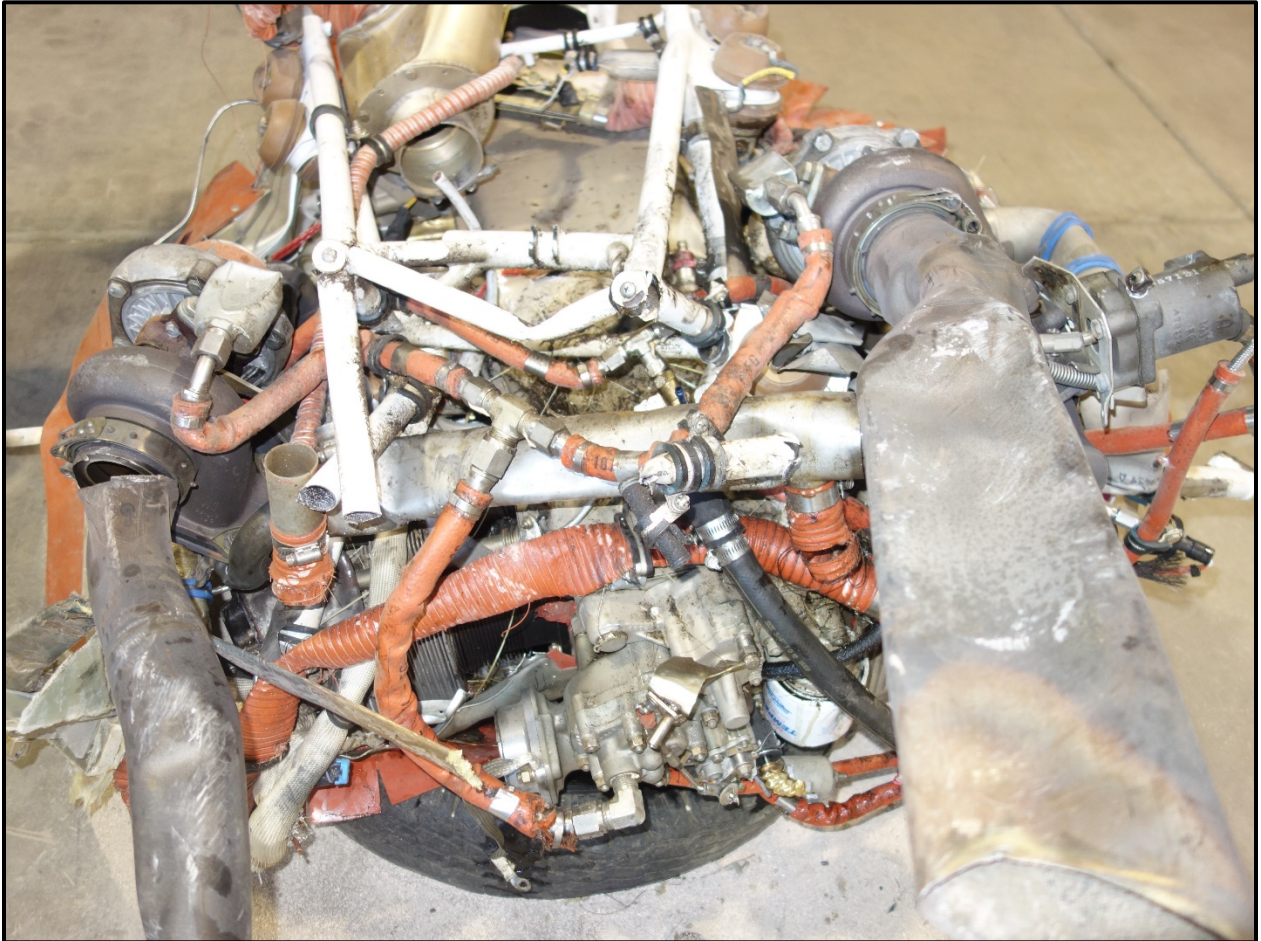
Examination of the Continental TSIO-550-K1B engine, revealed that the engine sustained impact damage that fractured all the engine mounts. The right magneto had separated, the engine driven fuel pump, some of the fuel pump fittings, and the oil sump, sustained impact damaged. All rocker covers were removed, and the cylinder overhead areas were lubricated and unremarkable. The crankshaft was rotated by hand, utilizing the propeller, and rotational continuity was established throughout the engine, accessory section, and the valve train. During crankshaft rotation, thumb compression and suction were attained on all cylinders. A borescope inspection of the cylinders revealed evidence of normal operational conditions.

Figure 2: Airplane Engine viewed from the Bottom Side.
