## **NATIONAL TRANSPORTATION SAFETY BOARD**

# **AIRFRAME AND ENGINE EXAMINATION**

**WPR18FA218**

Location: Baker City, Oregon  
Date: August 11, 2018  
Aircraft: Mooney M20K, Registration N231EC, S/N 25-0167  
NTSB IIC: Elliott Simpson

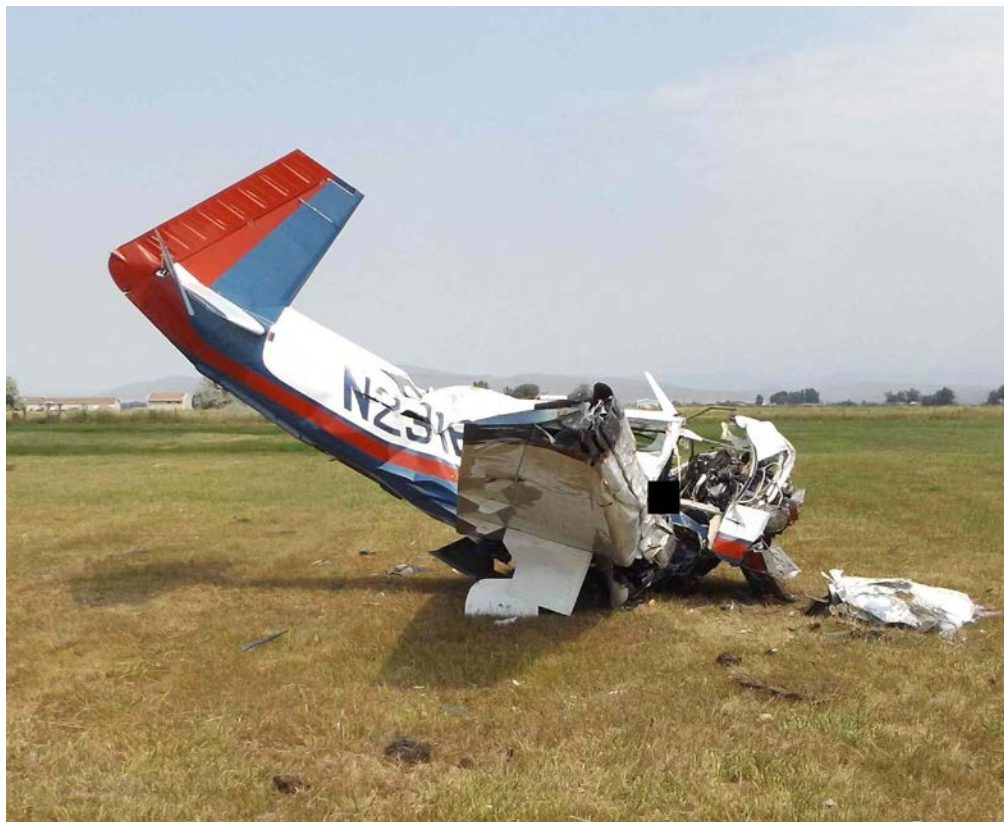
Photo 1 – Airplane at Accident Site

The fuselage sustained crush damage from the nose through to the leading edge of the vertical stabilizer (Photo 1). The flight controls and instrument panel were heavily fragmented and compressed such that a determination of flight instrument, avionics, autopilot, and circuit breaker settings could not be determined (Photo 2). The firewall had been pushed aft and in line with the wing leading edges, and the engine had folded and was resting over the crushed remnants of the instrument panel (Photo 1).

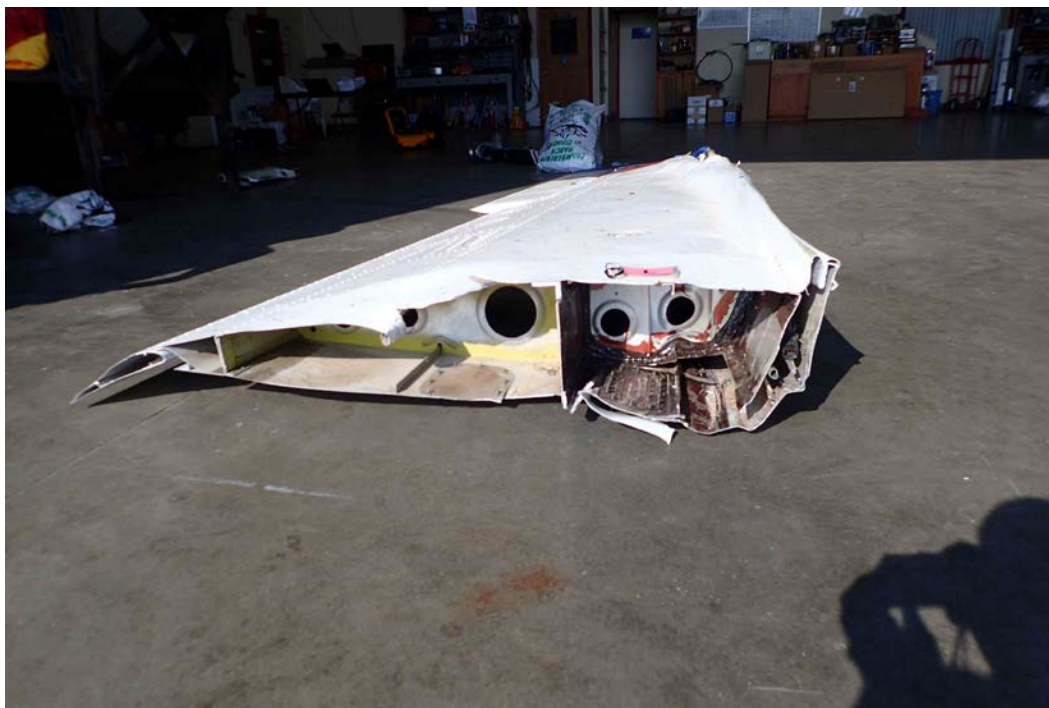
Photo 3 – Left Wing

Both wings remained attached to the main cabin, and both sustained leading-edge crush damage compressing the aileron control cavity and buckling the skins through to the main spar. The crush damage was about 90 ° relative to the wing chord on both wings (Photo 3).

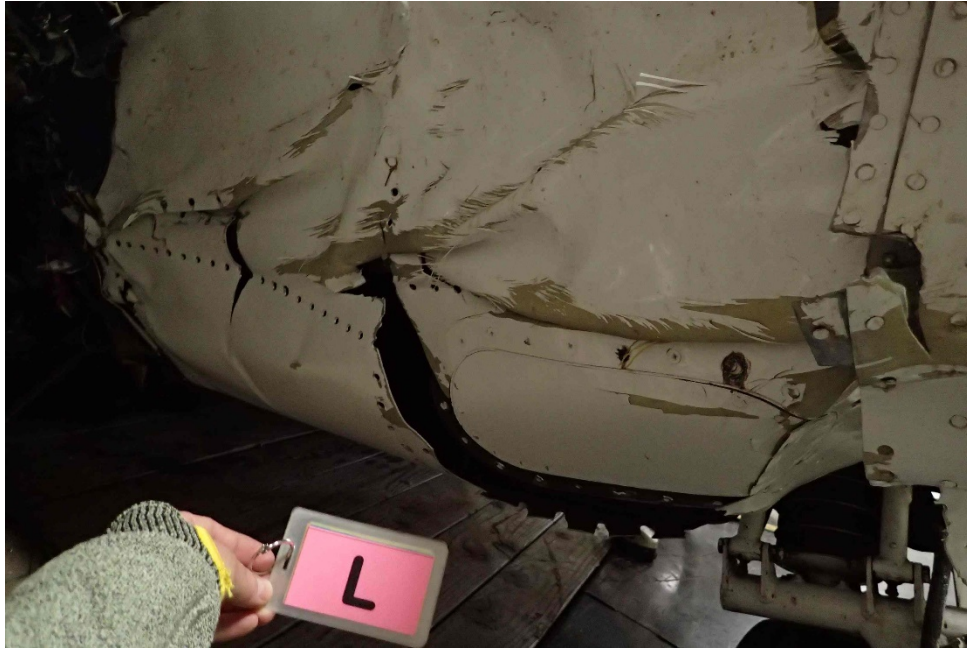
Photo 4 – Left Fuel Tank

The left wing remained attached to the airframe, and the inboard leading-edge skins of the fuel tank had split and opened forward at the inspection panel (Photo 4). The fuel cap was firmly secure at the filler neck.

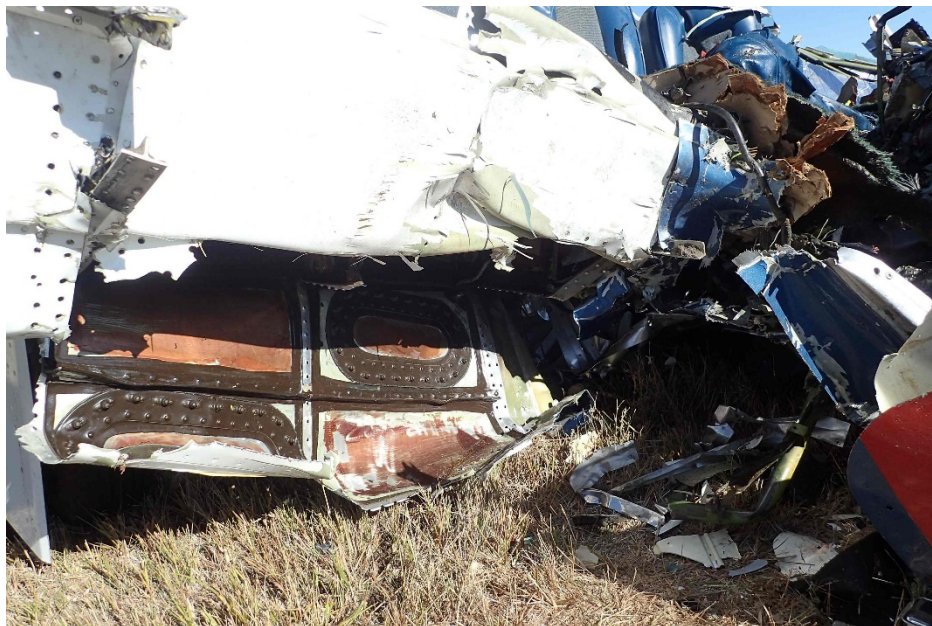
Photo 5 – Right Fuel Tank

The right wing remained attached to the airframe and the inboard leading-edge skins of the fuel tank had split and opened forward at the inspection panel (Photo 5). The fuel cap was firmly secure at the filler neck.

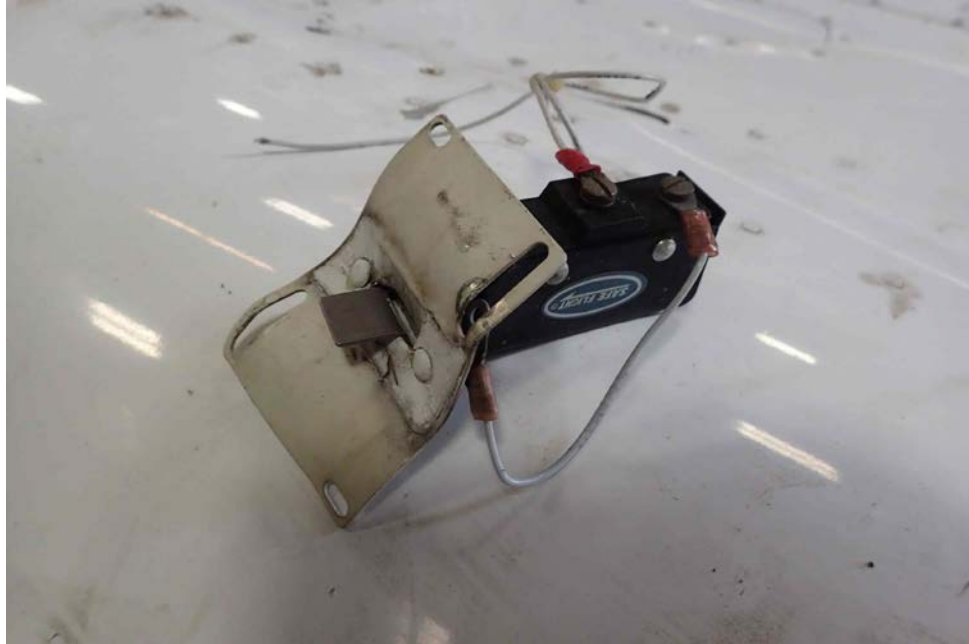
Photo 6 – Stall Warning Switch

The stall warning switch sustained crush damage to its forward bracket (Photo 6). The two electrical contacts on the switch were intact. The switch functionality was then tested with an ohm-meter; continuity could be interrupted with movement of the stall tab. The pitot heat probe had bent back against its mounting column.

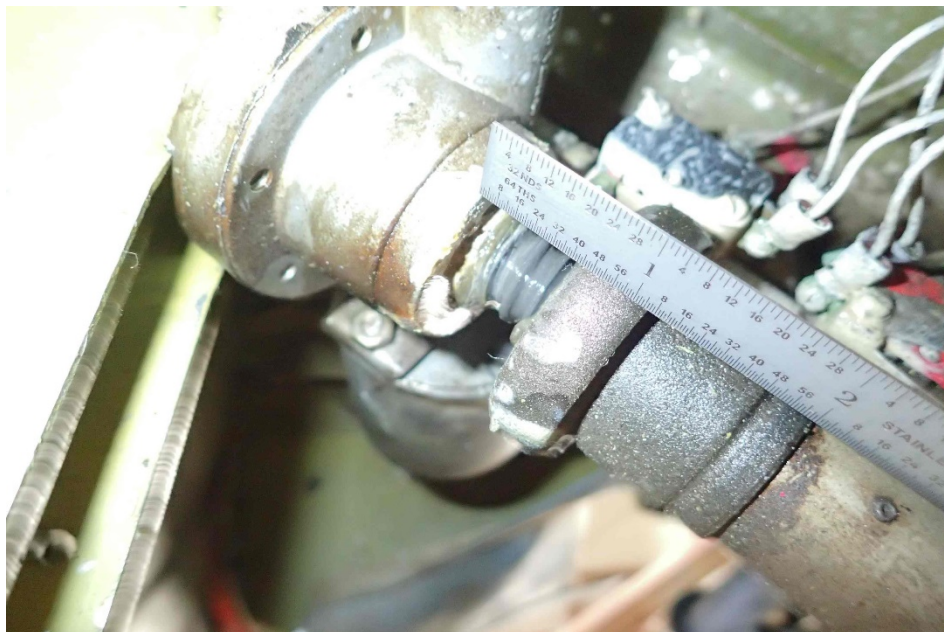
Photo 7 – Flap Actuator

The control arms for both flaps remained attached to the jack shaft. The rod end for the actuator had broken away from the shaft, and was bent 90 ° at the head. The actuator exhibited about 0.5 inches of exposed thread (Photo 7), which when compared to Mooney documentation represented full flaps.

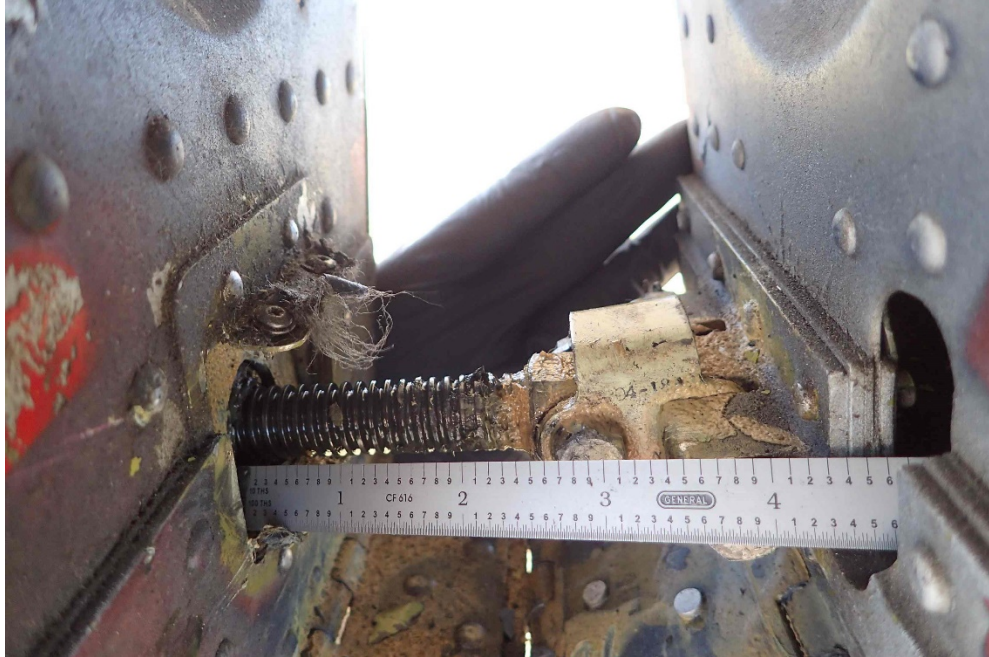
Photo 8 – Stabilizer Aft Jackscrew

The stabilizer aft jackscrew had about 16 exposed threads (Photo 8). According to Mooney documentation, this was consistent with a full nose-up setting, with 12 exposed threads consistent with a power-off landing trim setting. The elevator trim assembly stop was in the forward position, reflecting a similar nose-up setting (Photo 9). The trim actuator torque tube had pulled away from the actuator, but was continuous through to the forward cabin. Separated tube sections were examined, and exhibited crush damage consistent with fuselage contact at impact. The autopilot elevator trim servo remained attached to the trim shaft via its sprocket and chain. Rotation of the shaft by hand resulted in rotation of the servo input shaft clutch.

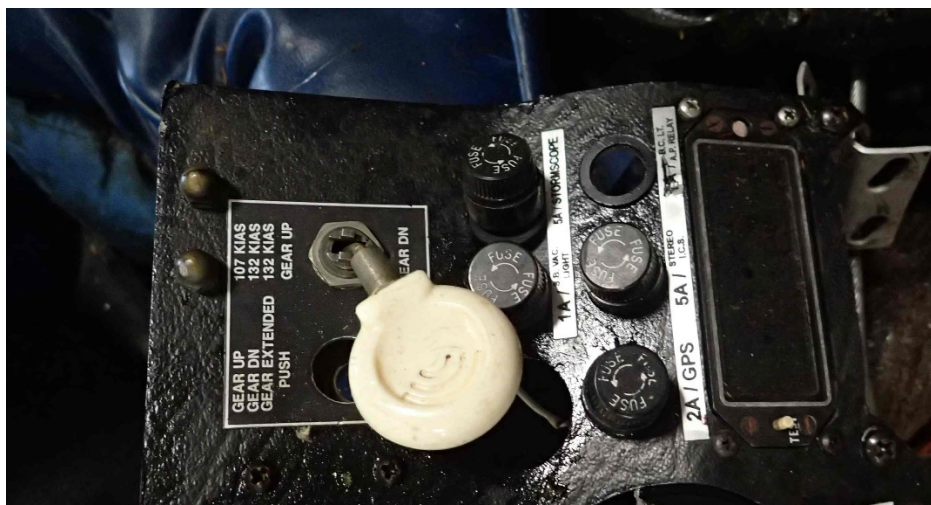
Photo 10 – Landing Gear Switch

The landing gear switch had bent to the left and was in the gear-down position (Photo 10). The entire nose landing gear assembly was crushed underneath the forward belly (photo 11).

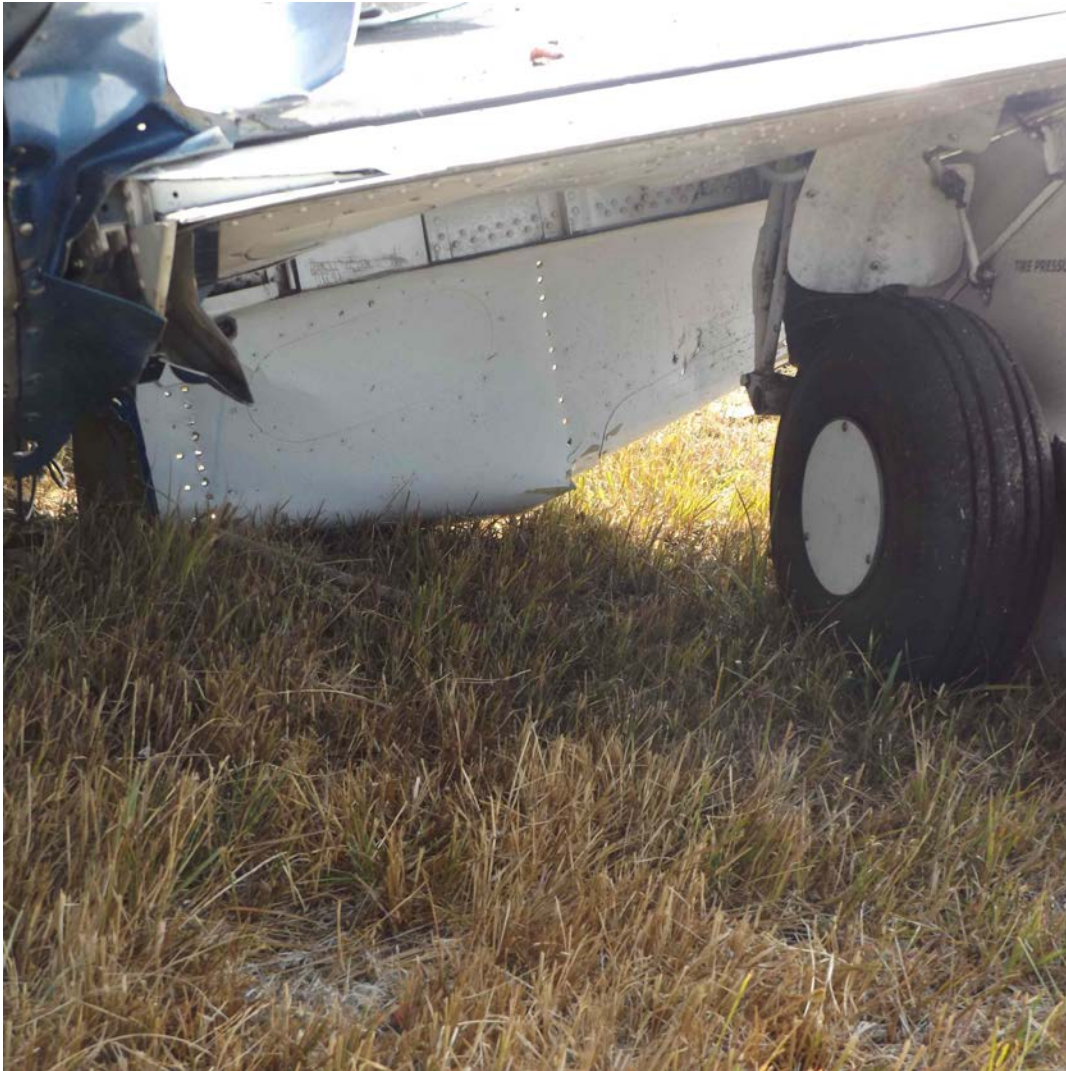
Photo 12 – Right Main Landing Gear

The right main landing gear appeared extended at the accident site (Photo 12). The front and rear pivot shaft of the main gear leg assembly had come away from the attach points on the main and rear spars, and the rear shaft of the assembly was protruding through the upper wing skin. The truss assembly and retracting links and spring were intact, and the gear could be moved up and down. The shock disks appeared undamaged.

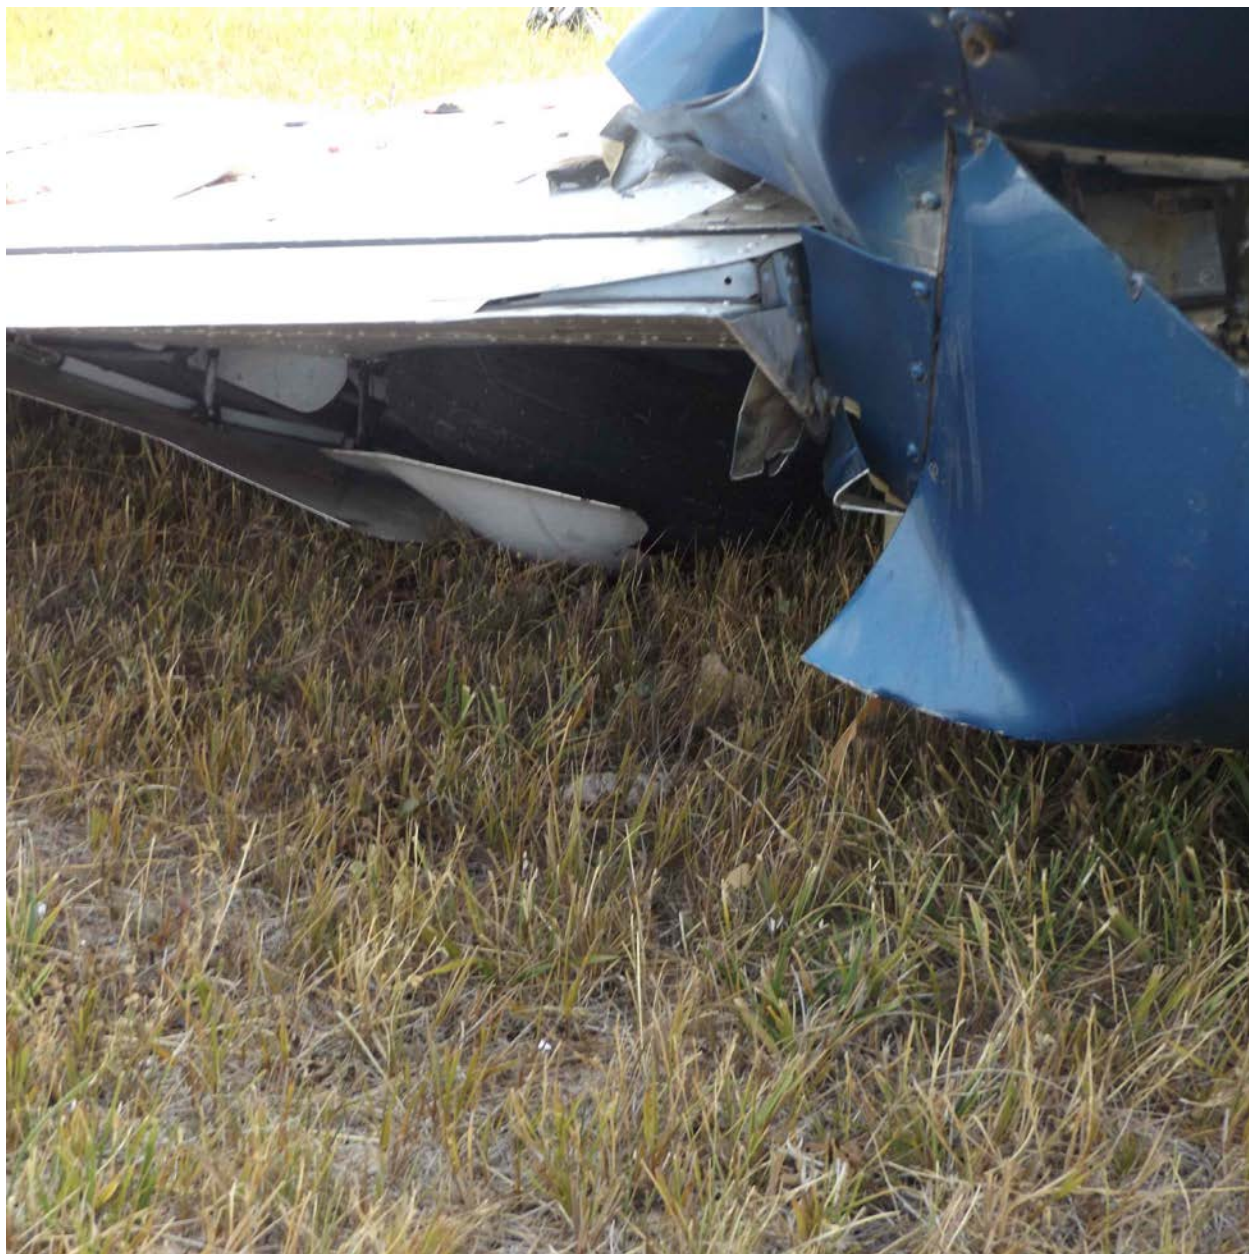
Photo 13 - Left Main Landing Gear

The left main landing gear had folded partially up against the wing at the accident site (Photo 13). The front and rear pivot shaft of the main gear leg assembly had come away from the attach points on the main and rear spars, and the rear shaft of the assembly was protruding through the upper wing skin. The truss assembly and retracting links and spring were intact, and the gear could be moved up and down. The retracting spring mounting bracket had pulled away from the wing structure; the separation surfaces all had a shiny appearance. The shock disks appeared undamaged.

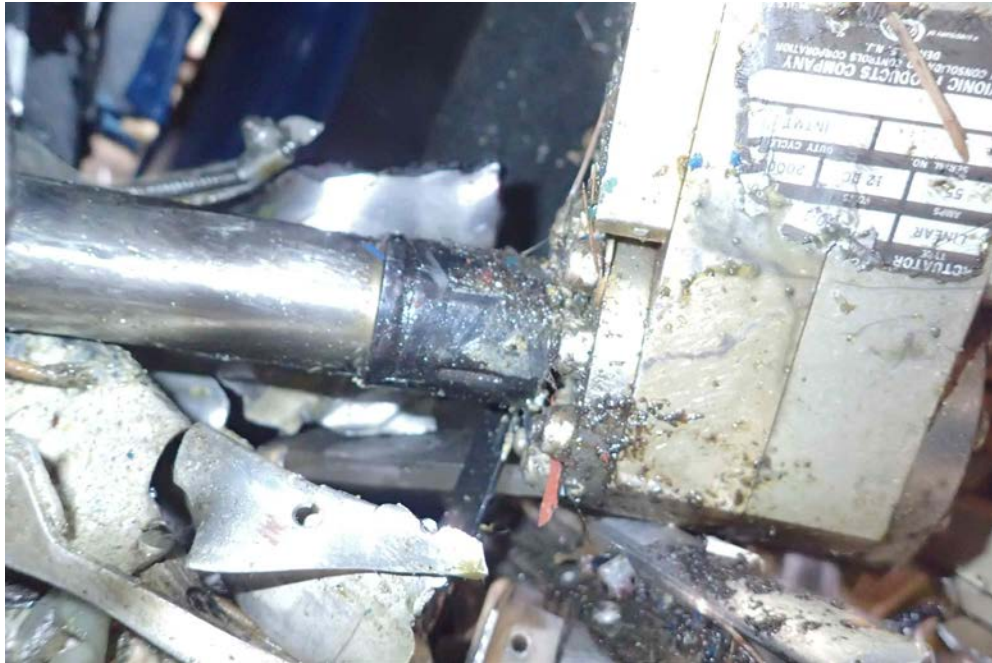
Photo 14 – Landing Gear Actuator

The push-pull tubes were continuous from both main landing gear through to the actuator, although the tubes sustained bending damage in the forward cabin compartment. The jack screw of the landing gear actuator was fully retracted, consistent with a fully extended landing gear (Photo 14).

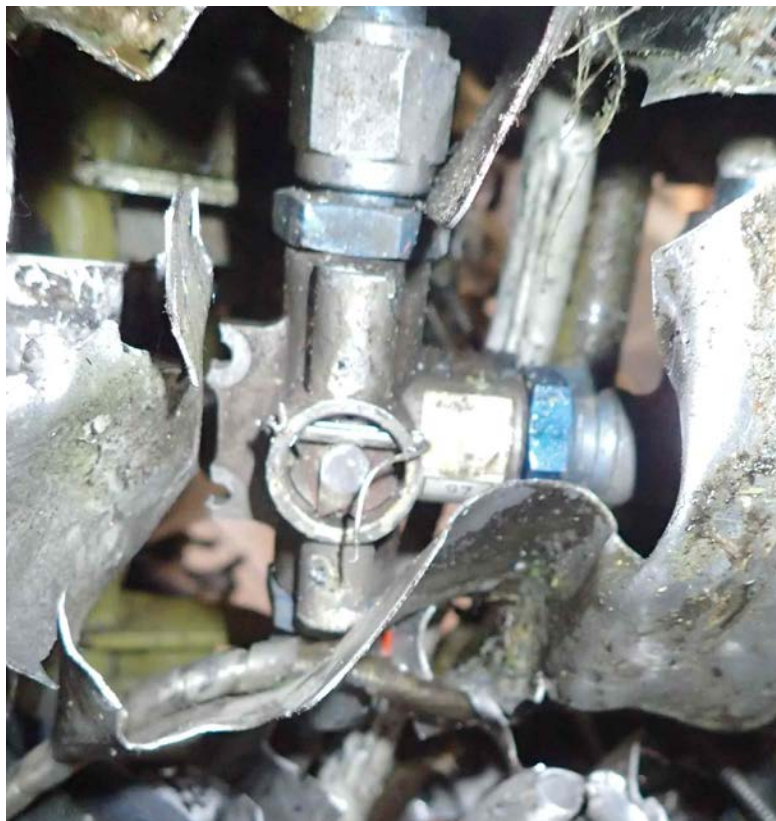
Photo 15 – Fuel Selector Valve

The fuel supply lines from the tank through to the forward cabin were intact and all fittings were secure. The remaining components of the fuel system sustained significant crush and fragmentation damage. The gascolator sustained crush damage and was breached. The gascolator fuel filter was clear. The fuel selector valve had become twisted within the cabin frame members and the handle had detached (Photo 15). According to Mooney representatives, the valve was in the left tank position.

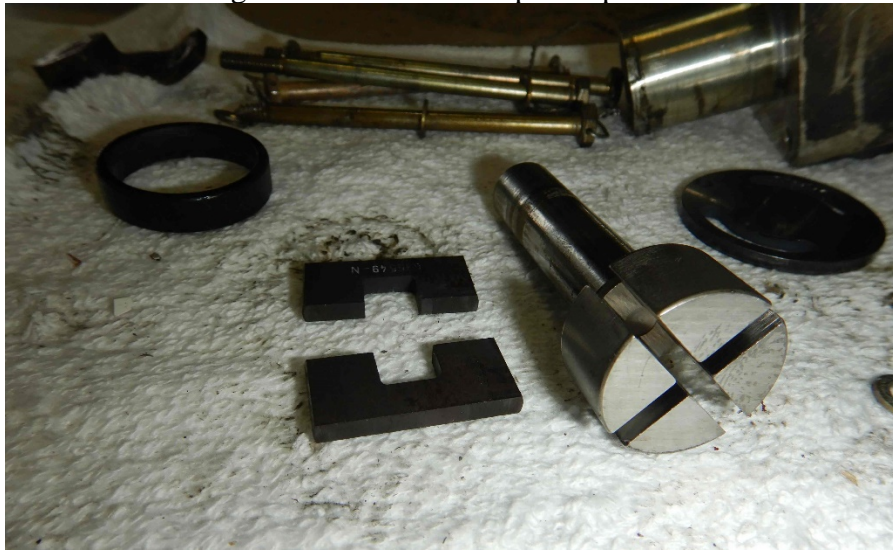
Photo 16 – Engine Driven Fuel Pump Components

The engine driven fuel pump remained attached, although its fuel lines and fittings had detached. The pump was removed and a small quantity of fuel (about 1 teaspoon) flowed from the supply line. The fuel pump drive coupling was intact, and the input drive shaft rotated freely. The unit was disassembled, and both the rotor and blades were intact (Photo 16).

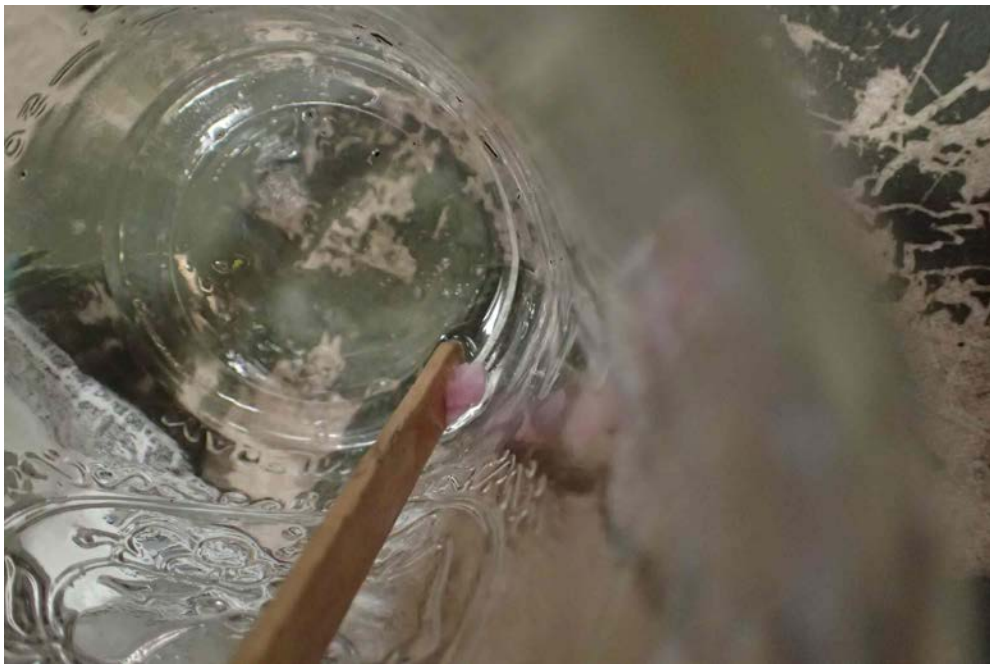
Photo 17 – Fuel Recovered from Manifold Valve

The fuel manifold valve remained attached to the top of the engine. The unit was opened, and its screen was clear. About 1 tablespoons of fuel issued from the internal cavity. The fuel had the odor of aviation gasoline and was negative for water when tested with water detecting paste (Photo 17).

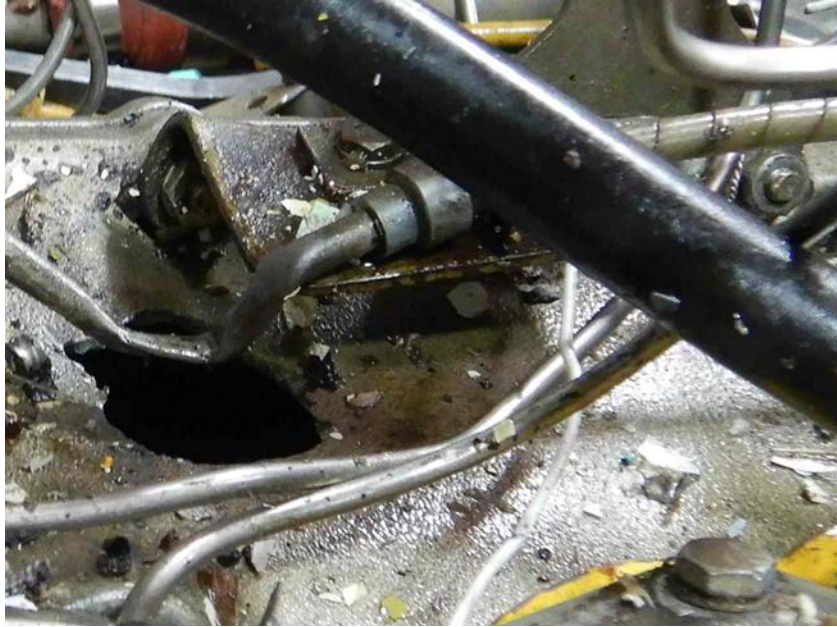
Photo 18 – Hole in Engine Crankcase

A 1-inch square hole was noted in the top of the engine crankcase, adjacent to the manifold valve. A steel control line had been compressed down into the hole. The edges of the hole exhibited slight inward deformation into the case (Photo 18). The engine crankcase was examined through the hole utilizing a borescope. There was no indication of internal damage, and all components appeared to be coated in oil.

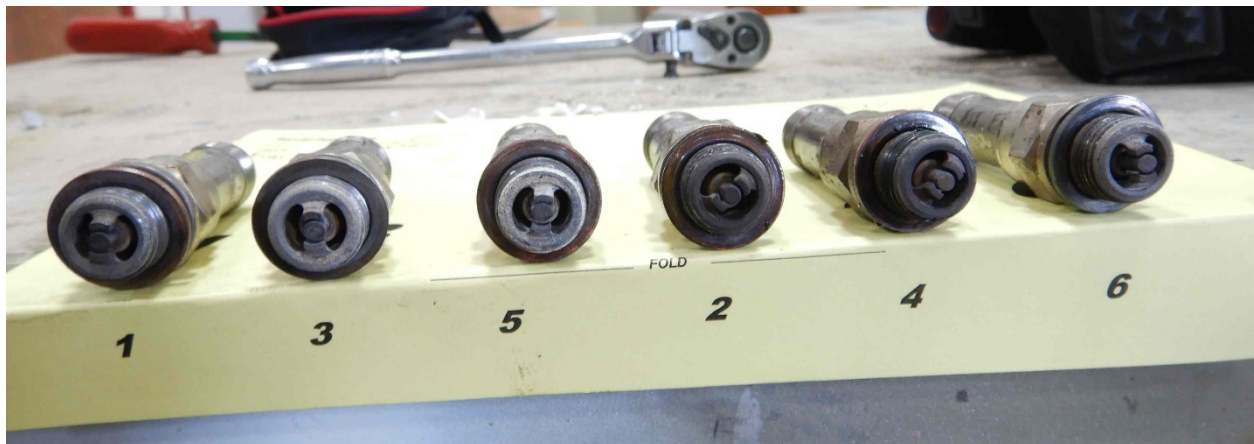
Photo 19 – Top Spark Plugs

The right magneto remained firmly attached to its mounting pad. The left magneto had detached, and its flange had fractured in the area of the engine mounting studs. The magnetos and upper spark plugs were removed to facilitate inspection. The damaged ignition leads were cut away and magnetos rotated by an electric drill and sparks were observed at all of the cut leads. The top spark plugs were undamaged, and their electrodes were coated in light grey deposits (Photo 19), and exhibited “worn out – normal” wear signatures when compared to the Champion AV-27 Aviation Check-A-Plug chart.

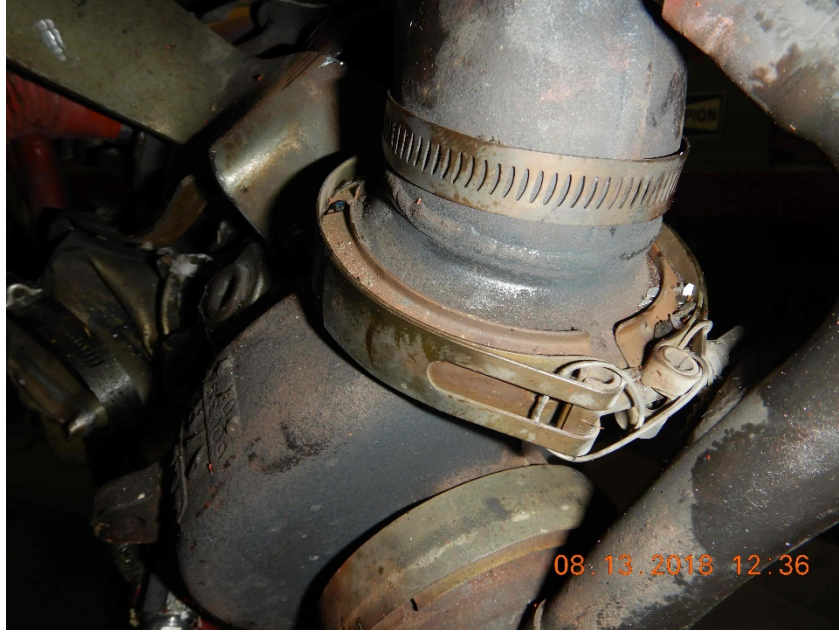
Photo 20 – Turbocharger V-Band Clamp

The turbocharger remained attached to the engine, and its v-band clamps were secure (Photo 20). The inner surface of the tailpipe was coated in light brown deposits. The turbine wheel was coated in similar deposits, appeared undamaged, and could be rotated smoothly by hand (Photo 21).

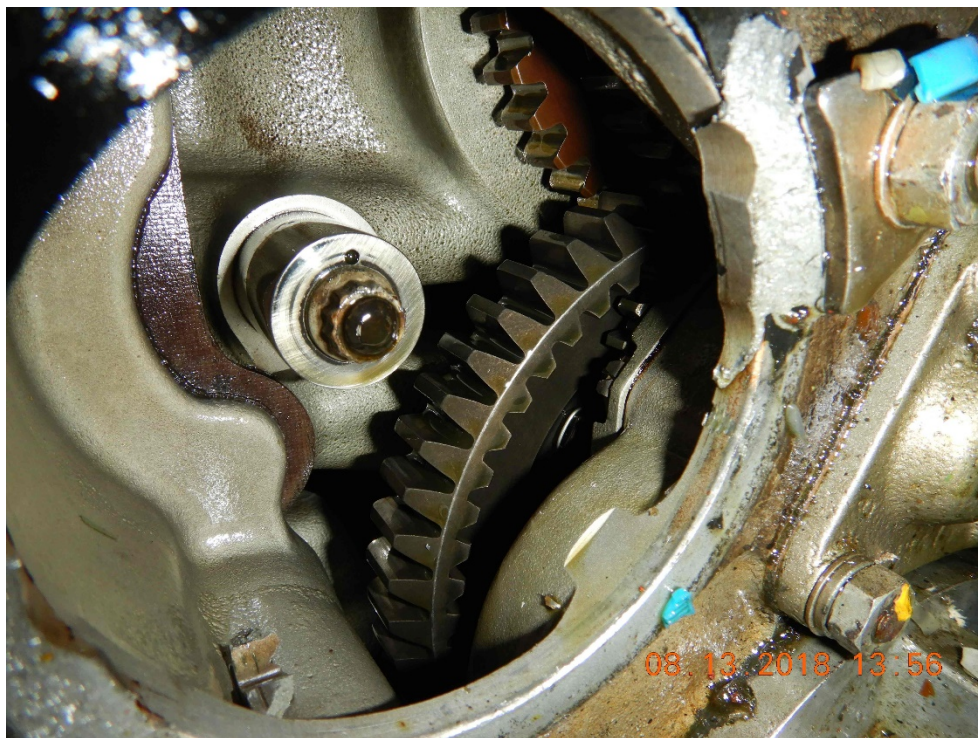
Photo 22 – Accessory Gears

The oil filter and mounting bracket had broken away from the engine, and the filter canister was crushed. The rocker covers were removed, and all components were coated in oil. The accessory case gears appeared undamaged and coated in clean oil (Photo 22). The engine was rotated by hand via an adapter fitted to the accessory drive. The engine turned freely, and “thumb” compression was noted on all cylinders. Mechanical continuity was established throughout the rotating group, valve train, and accessory section, and the rockers all moved similar heights.

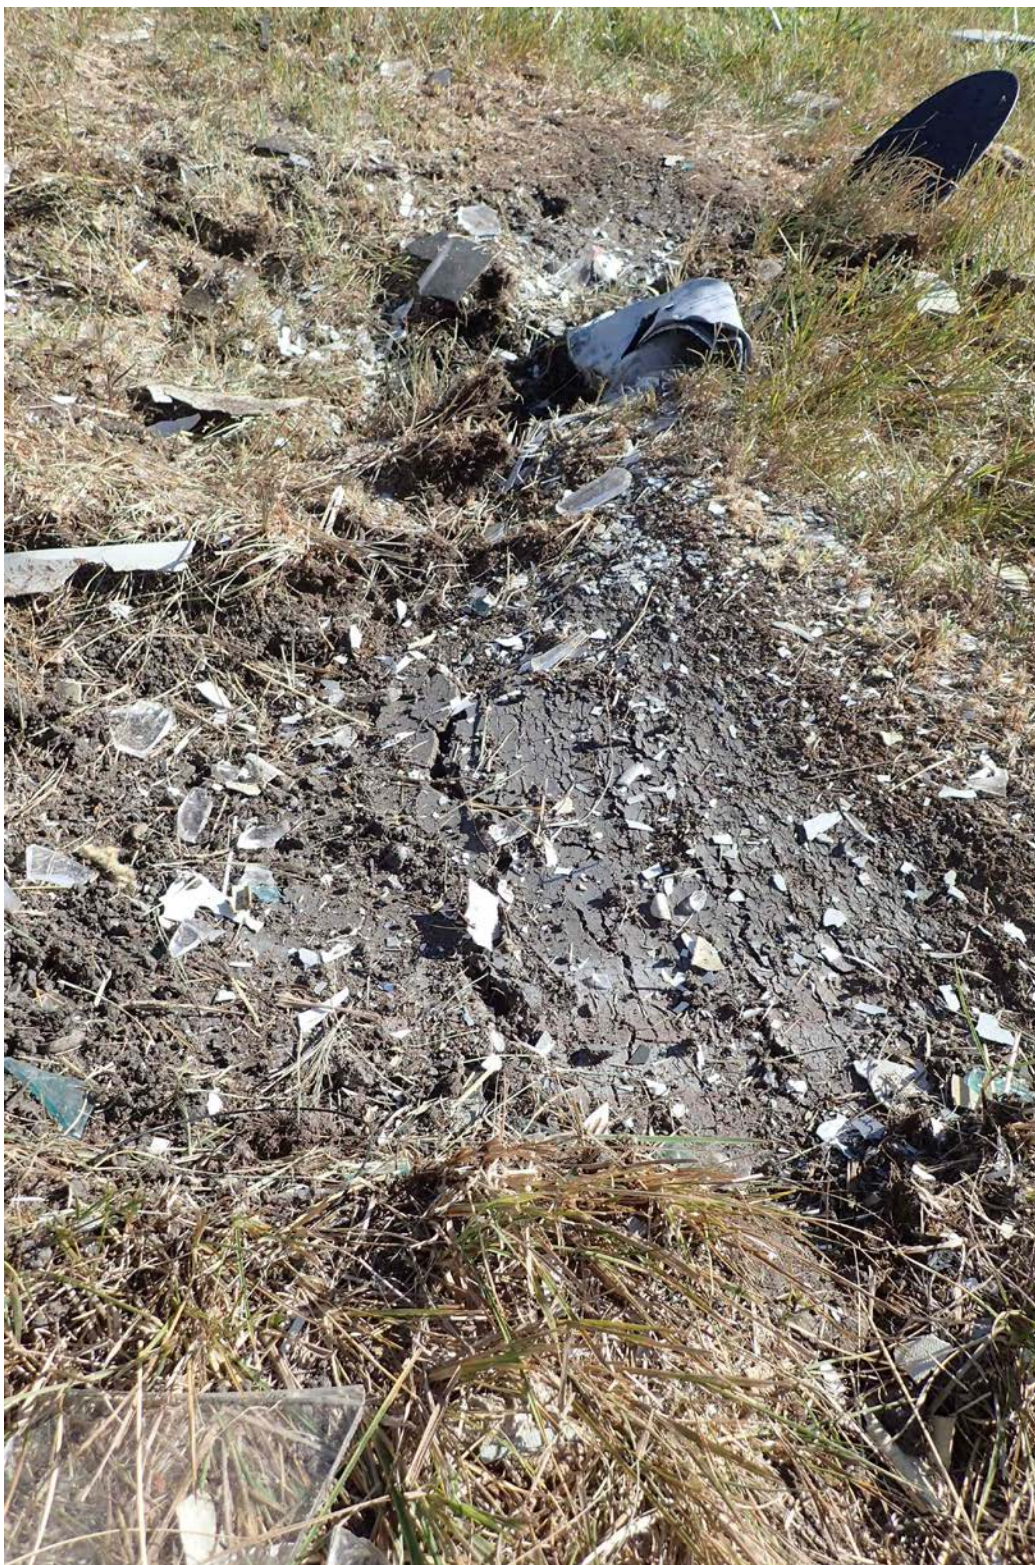
Photo 23 – Propeller at Accident Site

The propeller assembly had separated from the engine and become partially buried about 12 inches into the turf just forward of the main wreckage at what appeared to be the first impact point (Photo 23). The turf surrounding the propeller had been sliced open, and an 18-inch square scallop of sod was ejected about 5 ft to the south (Photo 24). Both blades appeared to have sliced through the turf, screwing the propeller into the ground.

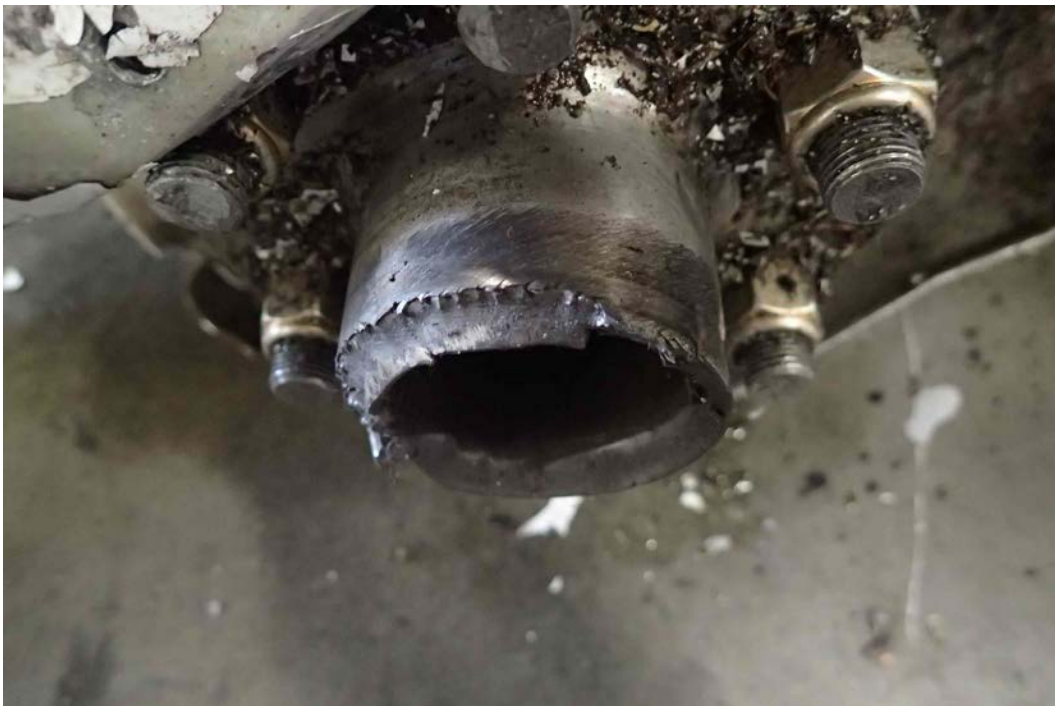
Photo 25 – Propeller Flange

The spinner had crushed around the propeller hub. The hub remained attached to the crank flange, which had separated from the crankshaft. The shaft exhibited a conical 45° shear lip around its entire circumference, with serrated, ratchet-like tear features around most of the crown. Circumferential crack marks were present on the radial surface of the shaft adjacent to the ratchet marks. (Photo 25)

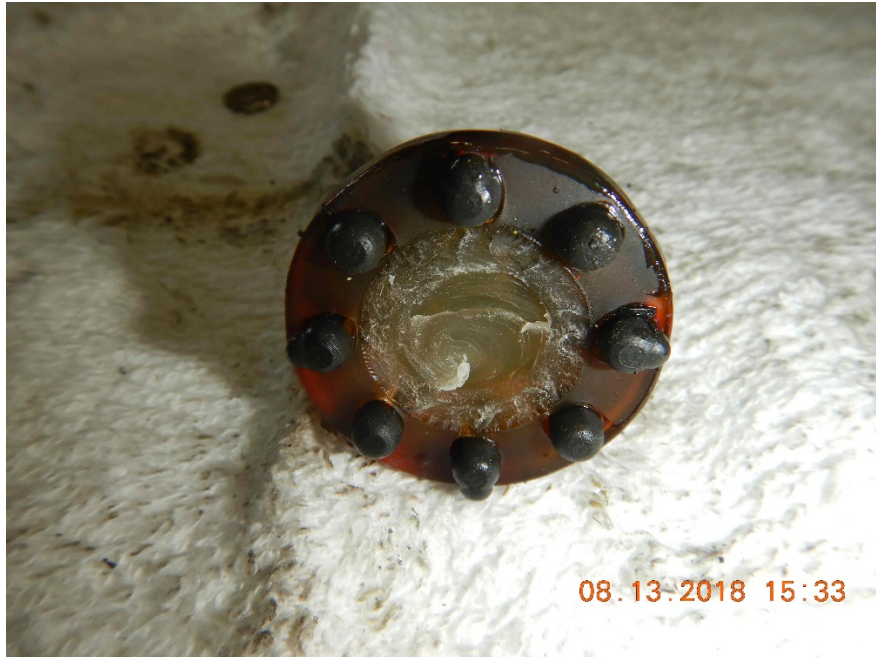
Photo 26 – Vacuum Pump Coupling

The vacuum pump remained attached to its accessory pad. The unit was removed, revealing that the plastic drive coupling had sheared. The separation surfaces exhibited a spiral scar at the core, with smear damage to the outer radius (Photo 26). Oil was noted within the cavity, the rotor had shattered, and all six blades were intact. (Photo 27). The standby vacuum actuation cable had broken away from the actuation handle, so the operational status of the standby system could not be determined. (Photo 28)
