## **NATIONAL TRANSPORTATION SAFETY BOARD**

### **Airframe & Engine Exam Summary**

**WPR14FA194**

Location: Fort Huachuca, Arizona  
Date: May 17, 2014  
Aircraft: Aero Commander 500S, N40TC  
NTSB IIC: Samantha Link

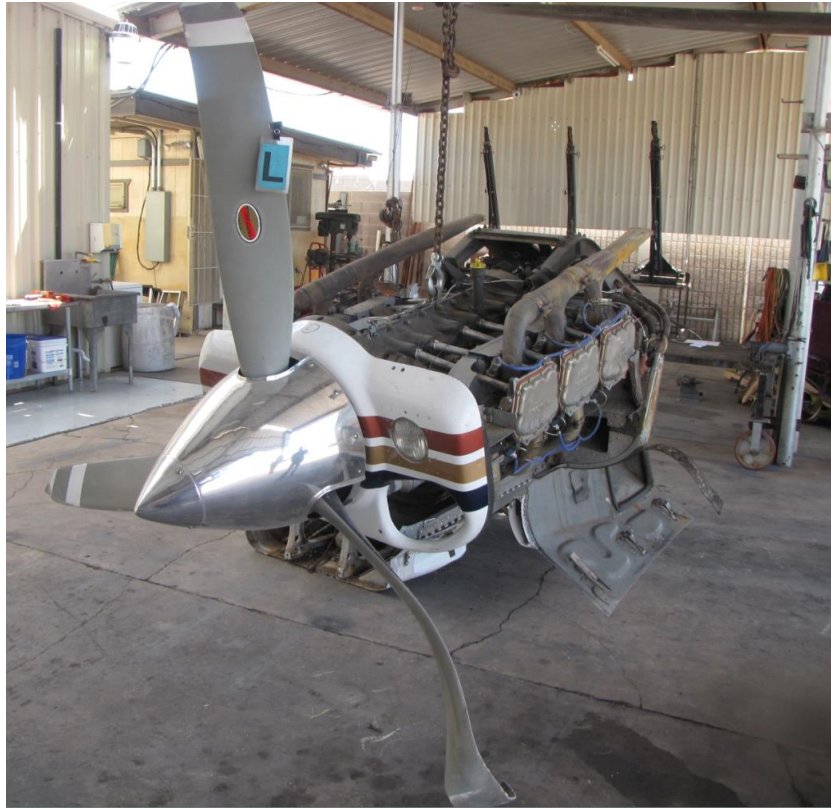
Figure 1: Left Engine

Visual examination of the left engine showed no evidence of crankcase breach or cylinder displacement; the overhead components and engine accessories were in place and no impact related damage was noted. The oil sump was intact and there was no indication of pre impact oil seepage or leakage. The oil filler cap was in place and secured to the oil fill tube. The exhaust and intake tubing was in place and no visual obstructions or impact damage was noted. All fuel lines and associated fuel accessories were in place and no damage was noted. The ignition system, to include both magnetos, was in place and no damage was noted.

The top and bottom spark plugs were removed and visually inspected. No mechanical damage was noted; the center and fine-wire electrodes exhibited light grey deposits and normal wear signatures (referencing the Champion Aviation Check-A-Plug AV-27 Chart) were noted. Visual inspection of the combustion chambers was accomplished through the spark plug bores, utilizing a borescope. There was no evidence of foreign object damage, or detonation, and all combustion surfaces exhibited light grey deposits consistent with normal operation. None of the pistons, intake/exhaust valves, and cylinder barrels displayed evidence of operational distress. The crankshaft was rotated manually and cylinder compression, valve train and accessory gear

Disassembly and examination of the left engine revealed no evidence of a pre accident malfunction or failure that would have precluded normal operation.

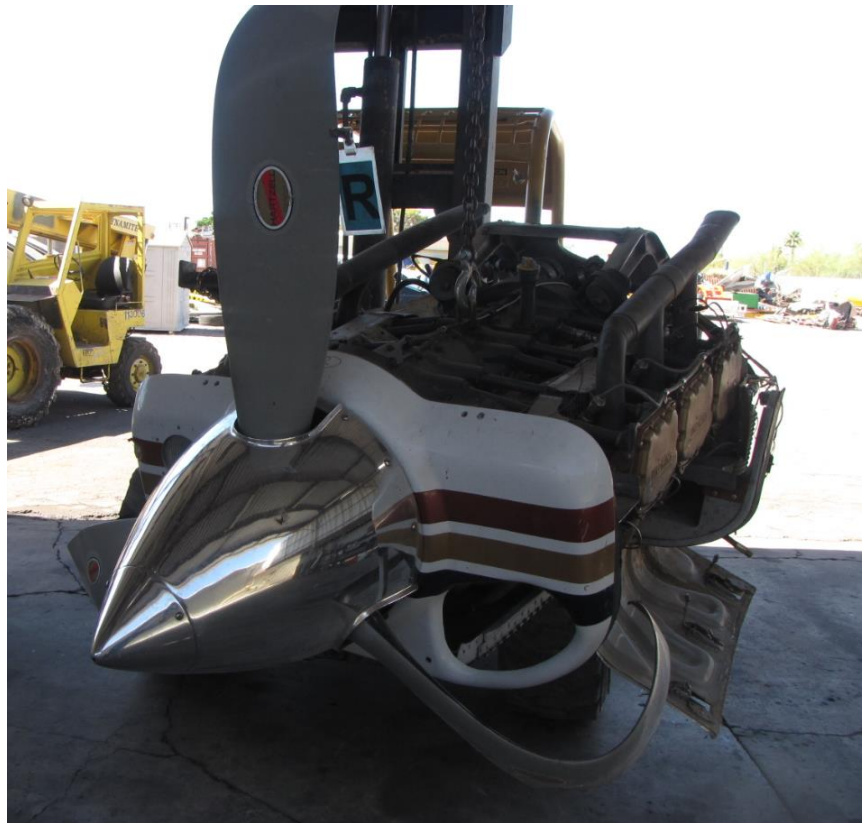
**Figure 2: Right Engine**

Visual examination of the right engine showed no evidence of crankcase breach or cylinder displacement; the overhead components and engine accessories were in place and no impact related damage was noted. The oil sump was intact and there was no indication of pre impact oil seepage or leakage. The oil filler cap was in place and secured to the oil fill tube. The exhaust and intake tubing was in place and no visual obstructions or impact damage was noted. All fuel

lines and associated fuel accessories were in place and no damage was noted. The ignition system, to include both magnetos, was in place and no damage was noted.

The top and bottom spark plugs were removed and visually inspected. No mechanical damage was noted; the center and fine-wire electrodes exhibited light grey deposits and normal wear signatures (referencing the Champion Aviation Check-A-Plug AV-27 Chart) were noted. Visual inspection of the combustion chambers was accomplished through the spark plug bores, utilizing a borescope. There was no evidence of foreign object damage, detonation, and all combustion surfaces exhibited light grey deposits consistent with normal operation. None of the pistons, intake/exhaust valves, and cylinder barrels displayed evidence of operational distress. The crankshaft was rotated manually; cylinder compression, valve train and accessory gear continuity was established. The magnetos were removed and mechanically rotated. Spark was observed on all six ignition wires for the right and left magnetos. The fuel injector nozzles were removed; the nozzles were clear and no debris, blockage, or corrosion was noted. The oil filter was removed and opened; no visible metallic debris or contaminants was noted. The oil suction screen was removed. The screen contained a piece of metal that was later identified as a piece of the left magneto bearing retainer cage. The oil filter was removed and opened; no visible metallic debris or contaminants was noted. The fuel manifold valve was disassembled and the screen was free of debris. The diaphragm was intact and the cavity was clear of debris.

Disassembly and examination of the engine revealed no evidence of a pre accident malfunction or failure that would have precluded normal operation.

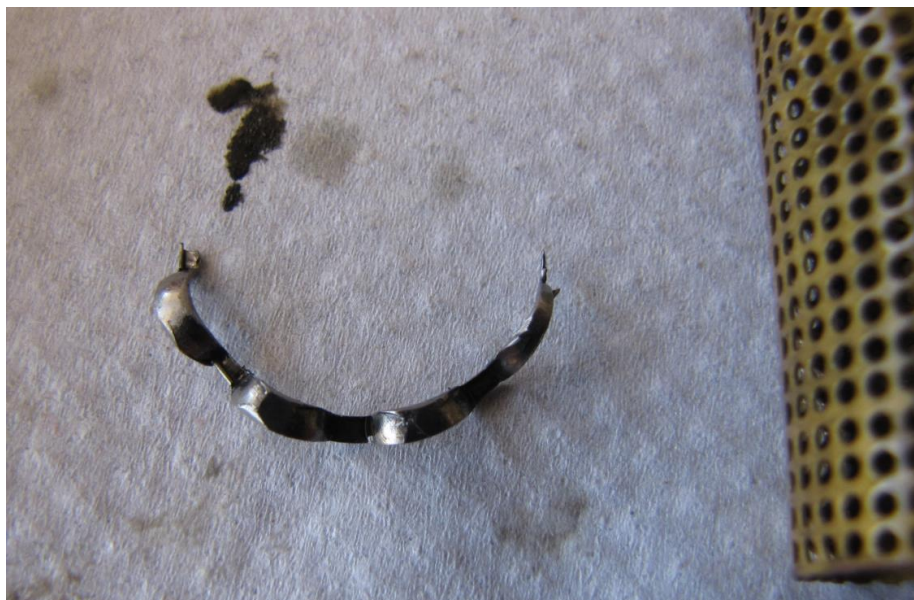
continuity was established. The magnetos were removed and mechanically rotated. Spark was observed on all six ignition wires for the right magneto. Spark was initially observed on all six ignition wires of the left magneto; however, after multiple rotations the magneto stopped producing spark. The magneto was later functionally tested at a magneto facility; the magneto functioned without incident and no anomalies were noted. The injector fuel nozzles were removed; the nozzles were clear and no debris, blockage or corrosion was noted. The oil filter was removed and opened; no visible metallic debris or contaminants were noted. The oil suction screen was removed. No debris or contamination was noted. The fuel manifold valve was disassembled and the screen was free of debris. The diaphragm was intact and the cavity was clear of debris.

Figure 3: Piece of the left magneto bearing retainer cage

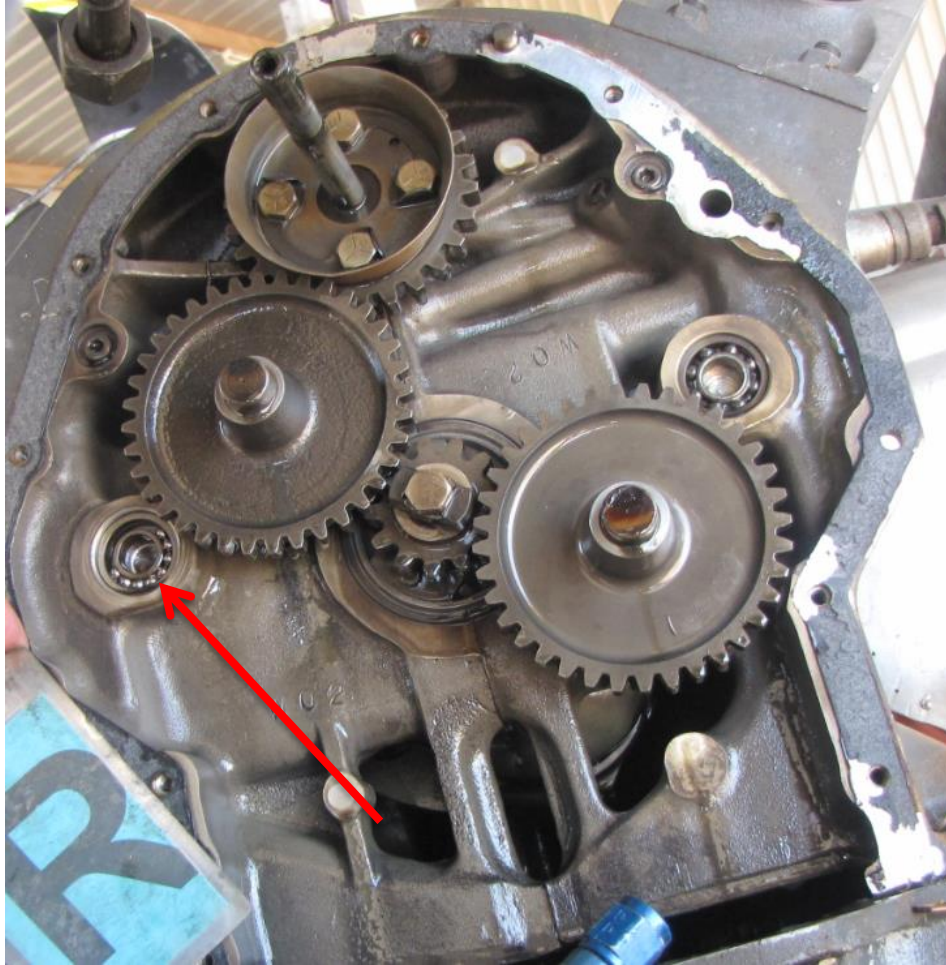
Figure 4: Left Magneto Drive Bearings
