## **NATIONAL TRANSPORTATION SAFETY BOARD**

# **AIRFRAME AND ENGINE EXAMINATION**

**WPR14LA271**

Location: Big Creek, Idaho  
Date: June 29, 2014  
Aircraft: Cessna 182Q, N132K, Serial # 18266782  
NTSB IIC: Michael Huhn

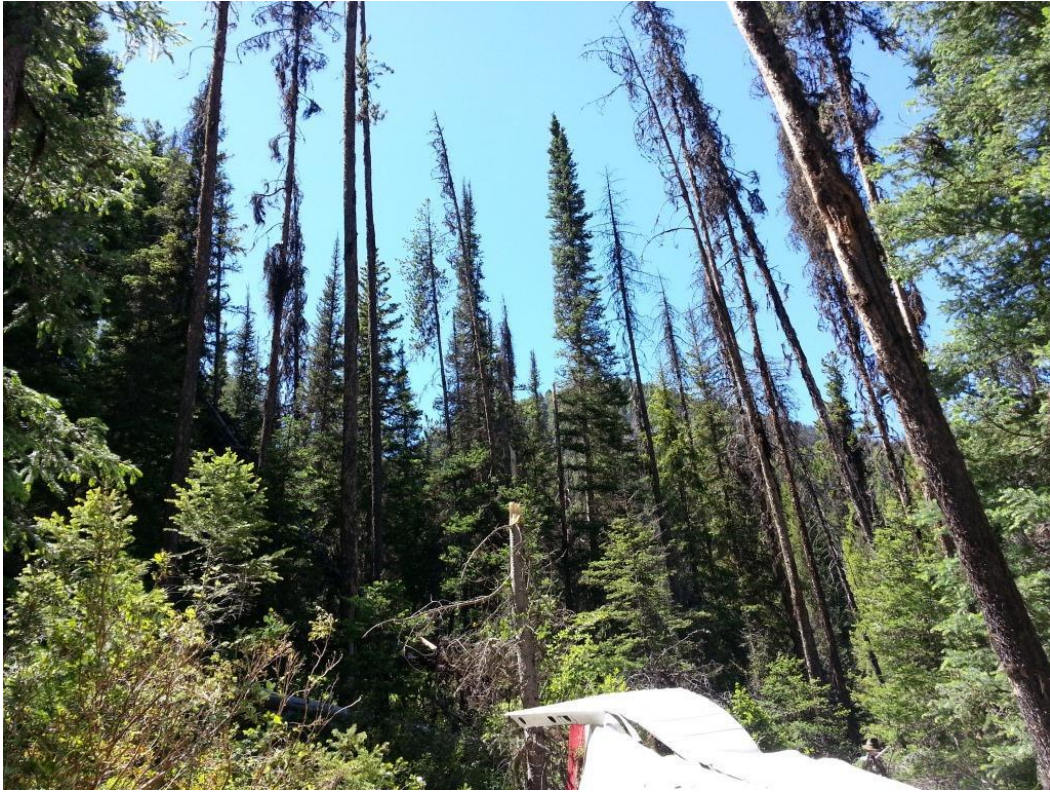
- Airplane impacted ground in a near vertical (nose down) pitch attitude
- Numerous broken and/or sections of 6-inch or more diameter trees were found in the debris field

**Figure 1 - Entry Path Through Trees**

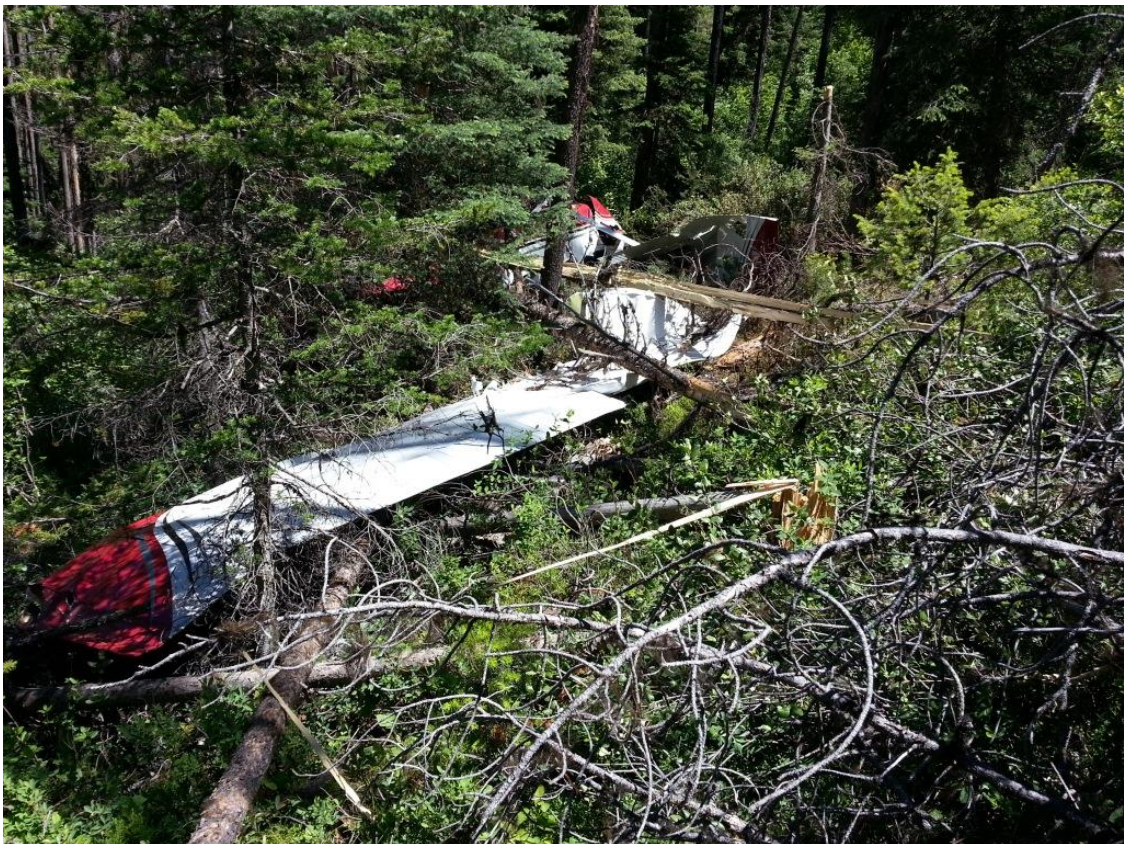
- Right wing fracture-separated from airplane at the root
  - The right wing was just aft & outboard of the left wing
  - The aileron crossover/balance cable was the only remaining attachment between the wing and the airplane

**Figure 2 - Wreckage In Situ (right wing in foreground)**

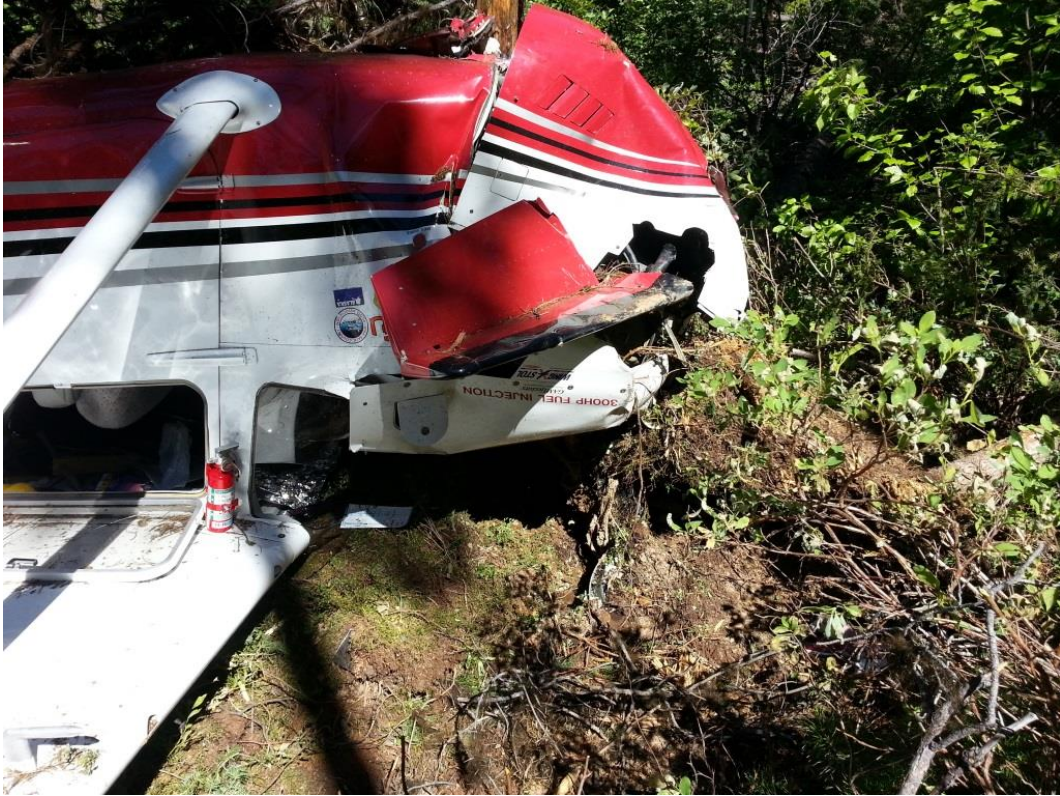
- Aircraft came to rest in an inverted position in a heavily wooded area adjacent to the impact mark left by the engine and propeller
- A linear ground impact mark was noted in front of the left wing resting area

**Figure 3 - Forward Fuselage and Ground Impact Location**

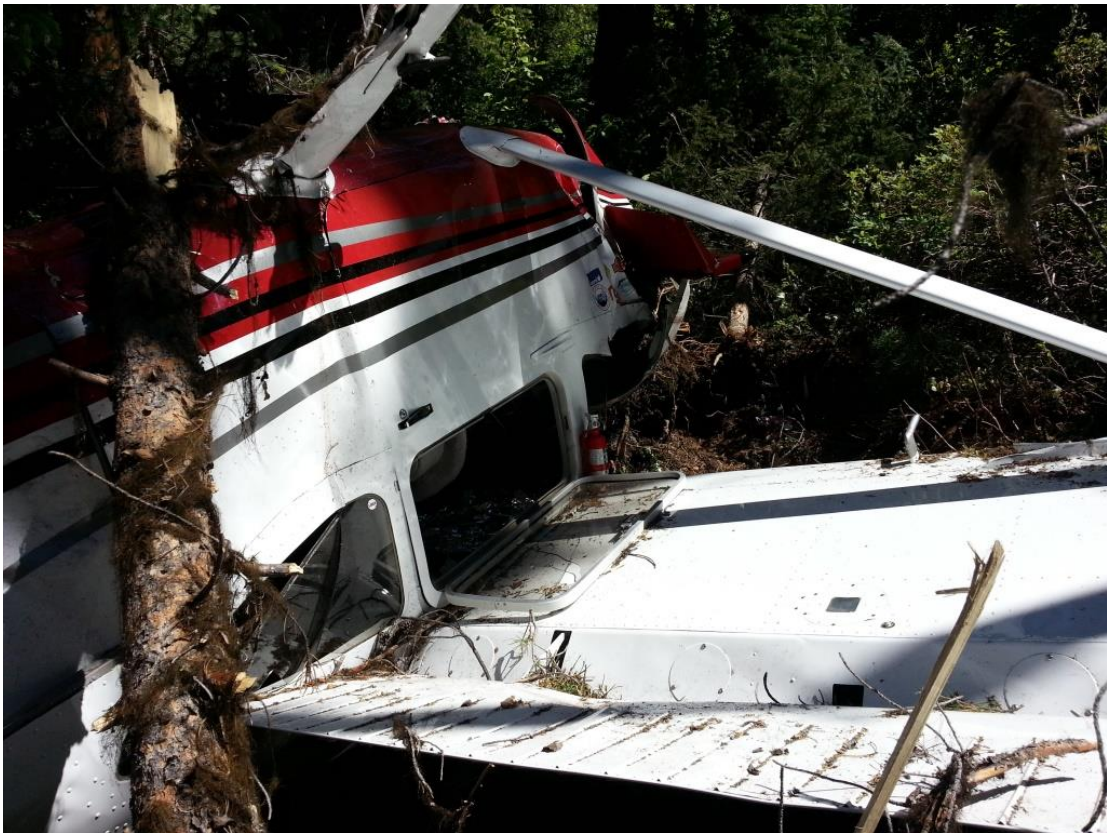
- Photographs indicated that the left flap was extended to approximate 15 degrees
- Engine cowl flaps closed
- Nose gear (with fork and strut segment attached) was found approximately 40 feet forward of the main wreckage area.

**Figure 4 - Left Side of Fuselage (note flap extension angle)**

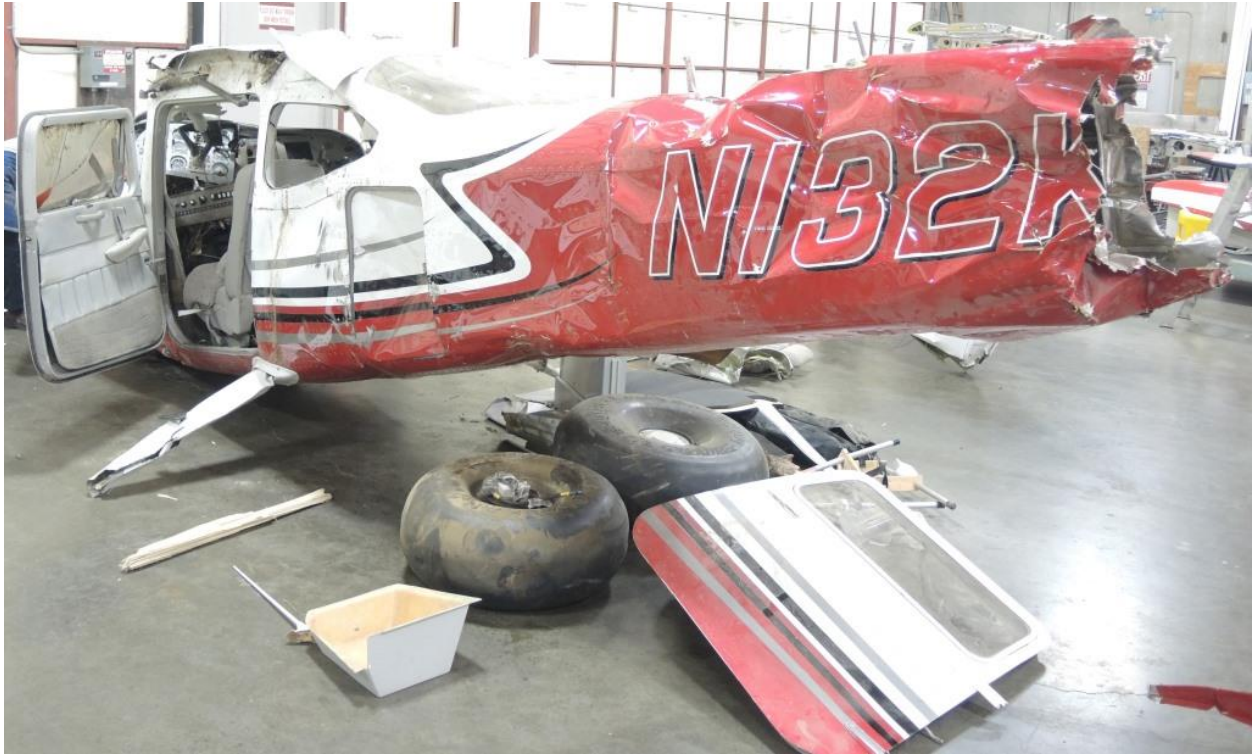
**Figure 5 - Fuselage and Items at Exam**

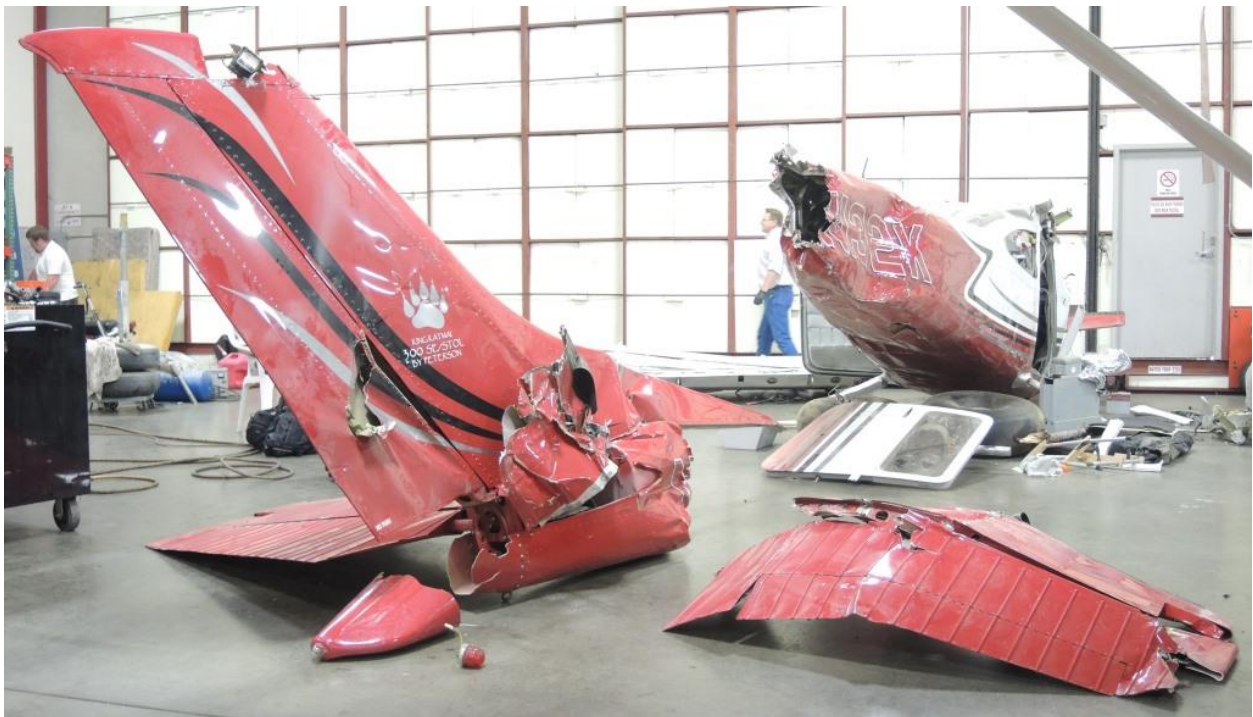
**Figure 6 - Empennage at Exam**

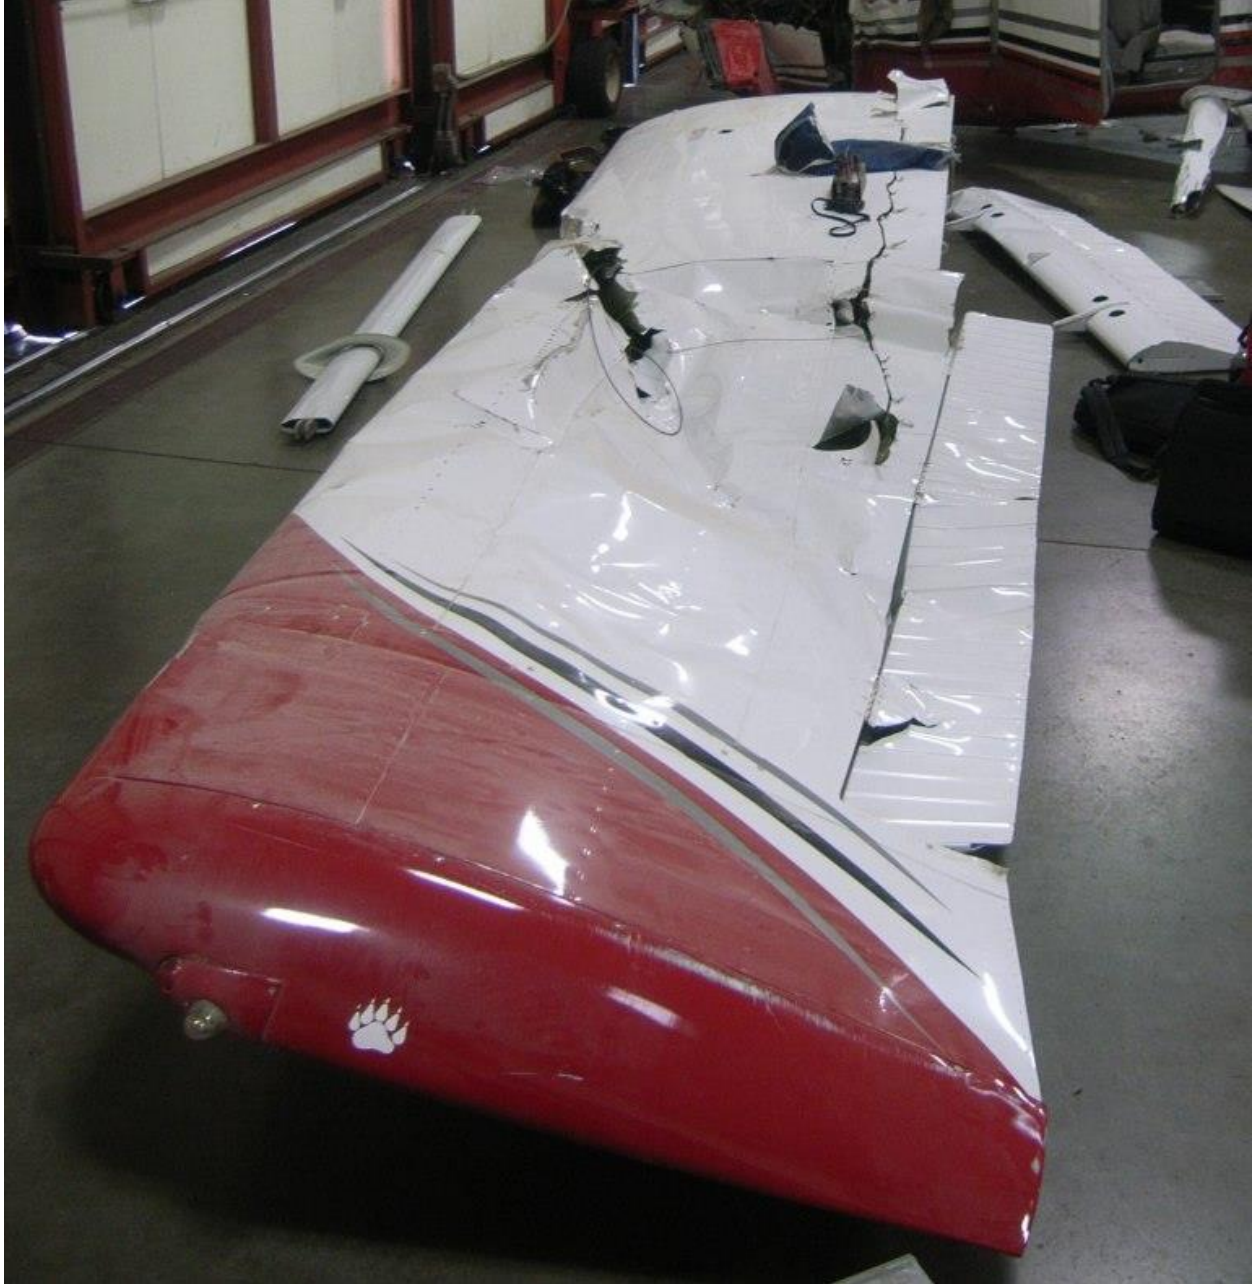
**Figure 7 - Left Wing (note aileron crossover cable tear-out)**

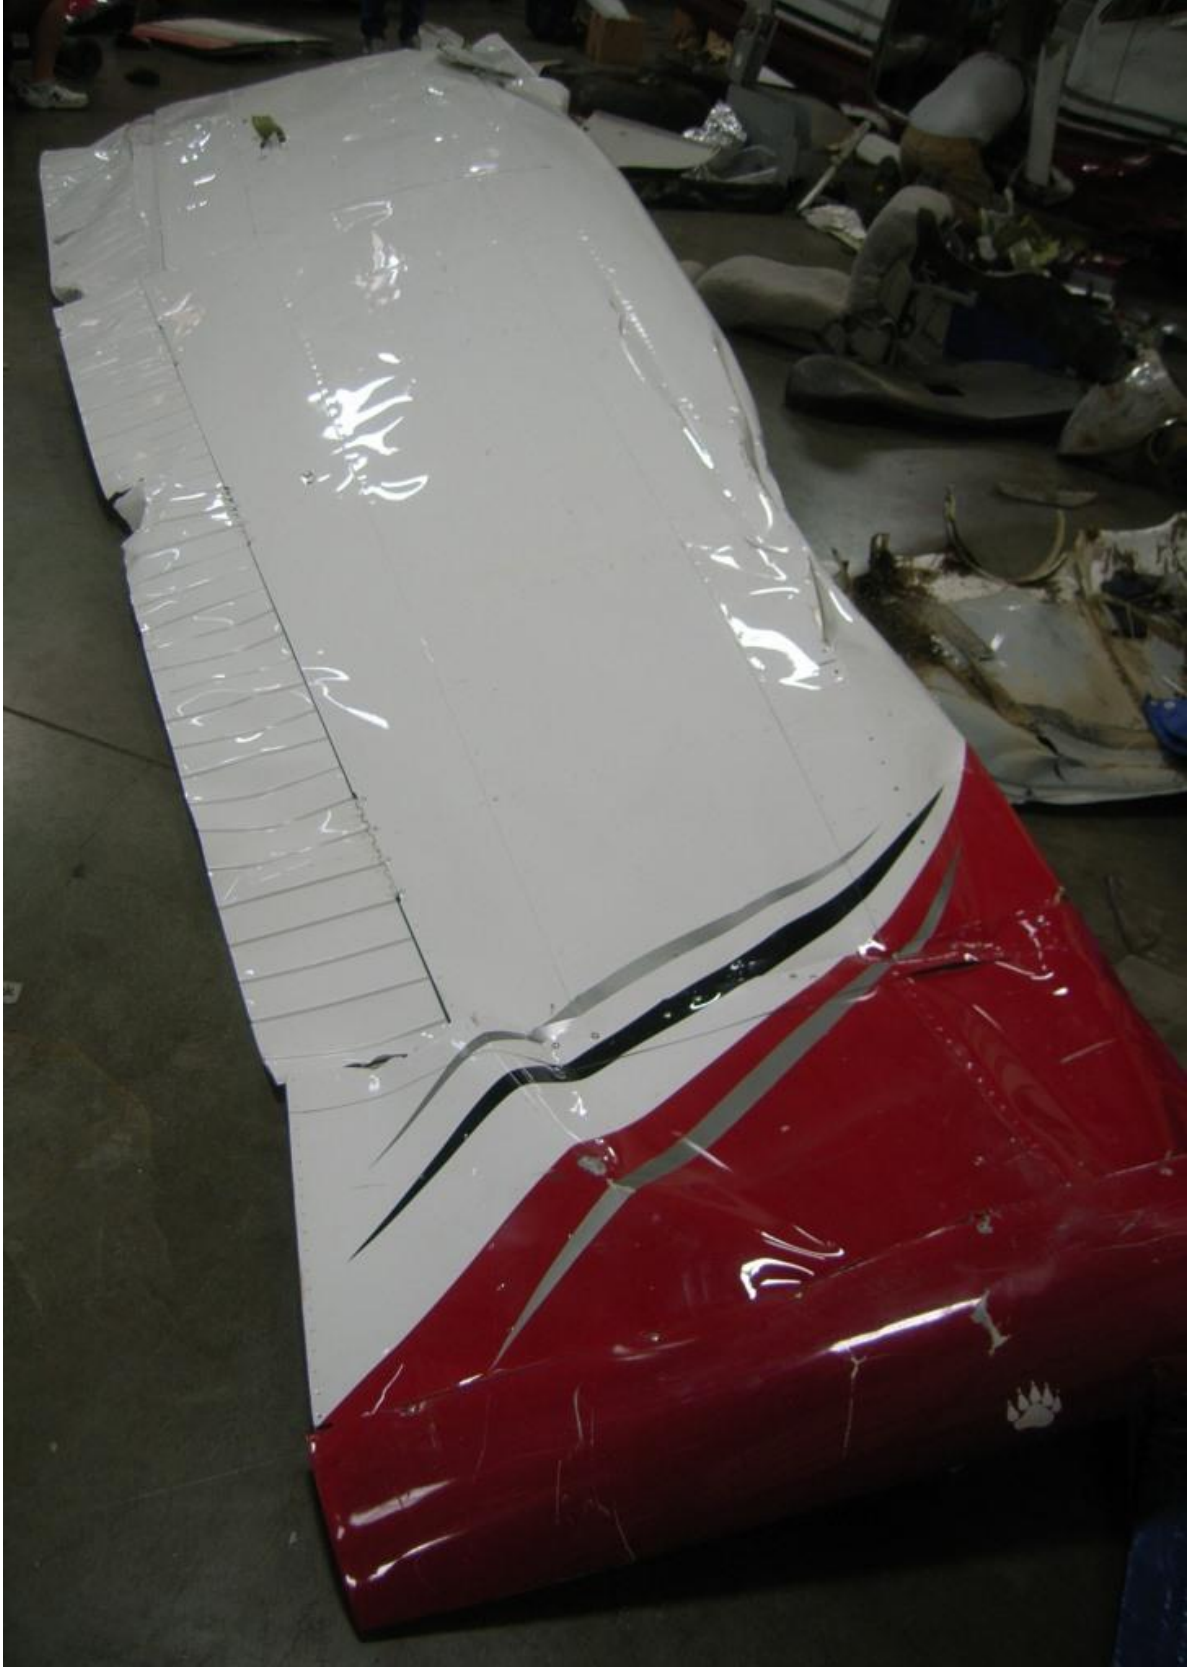
- Right wing was fracture separated from the root
  - Right flap and aileron remained attached to right wing
- Left wing was unbolted from the root by recovery personnel

**Figure 8 - Right Wing (separated at impact)**

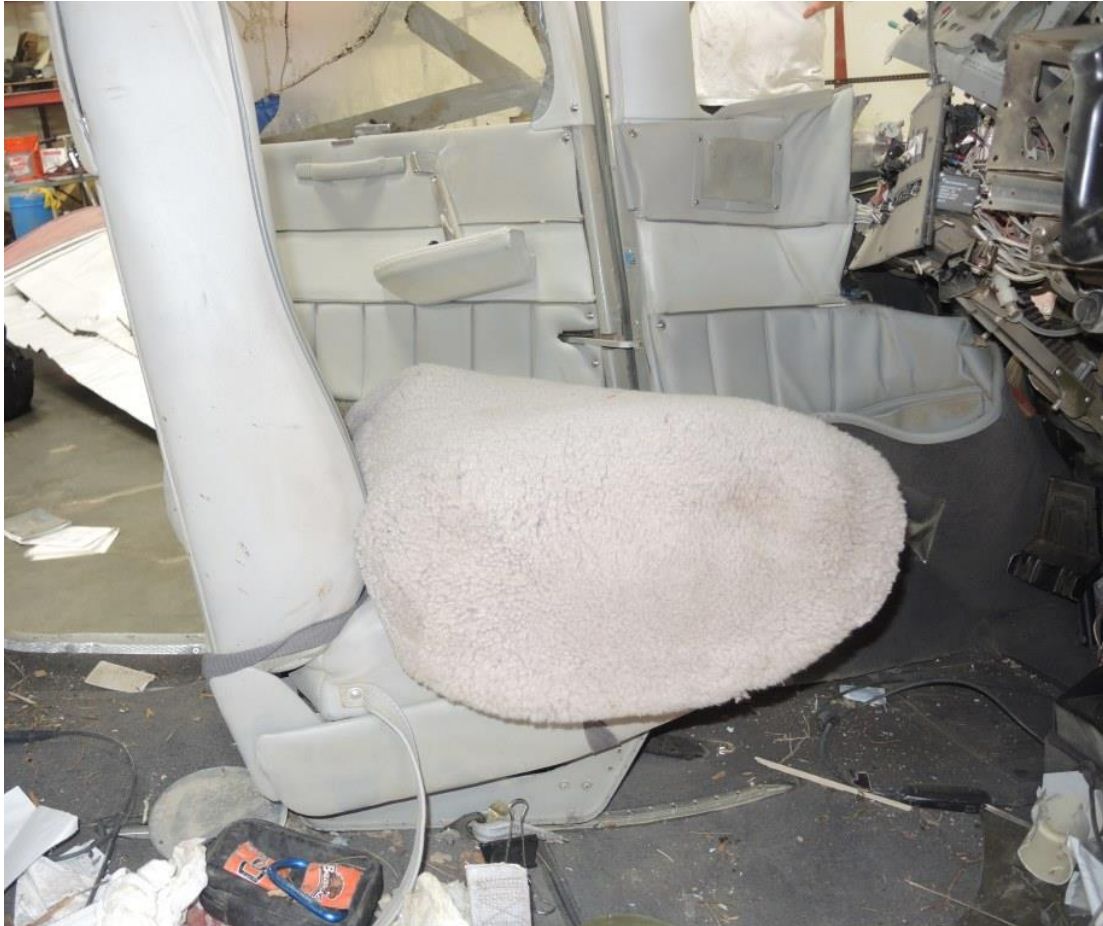
- Left front (pilot) seat was attached to seat tracks both adjustment pins were engaged in the #12 holes (counted from front end) and was intact
- Left front (pilot) seat incorporated a secondary anti-slip mechanism that was intact
- Forward sections of seat tracks were buckled upward

**Figure 9 - Pilot's Seat (note cabin integrity, plus deformed seat tracks)**

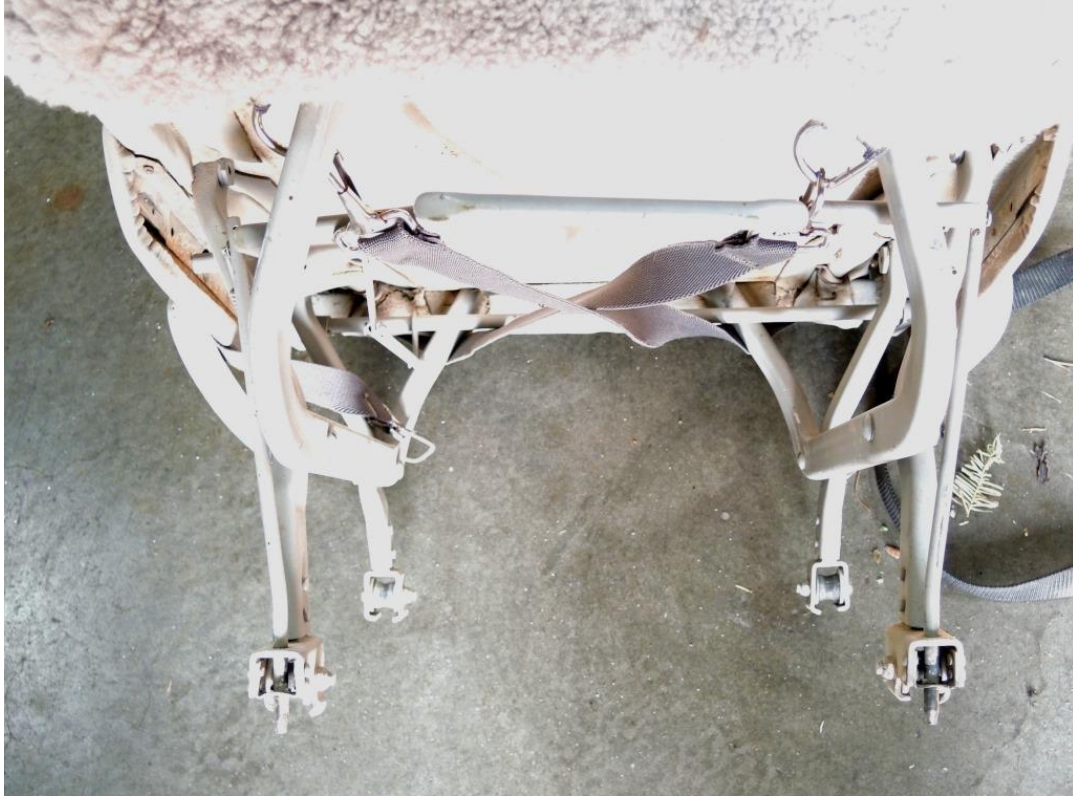
- Right front (copilot) seat was impact separated from the aircraft (feet were spread but adjustment pins were intact)

Figure 10 - Copilot Seat Feet (seat unoccupied for accident but separated from tracks)

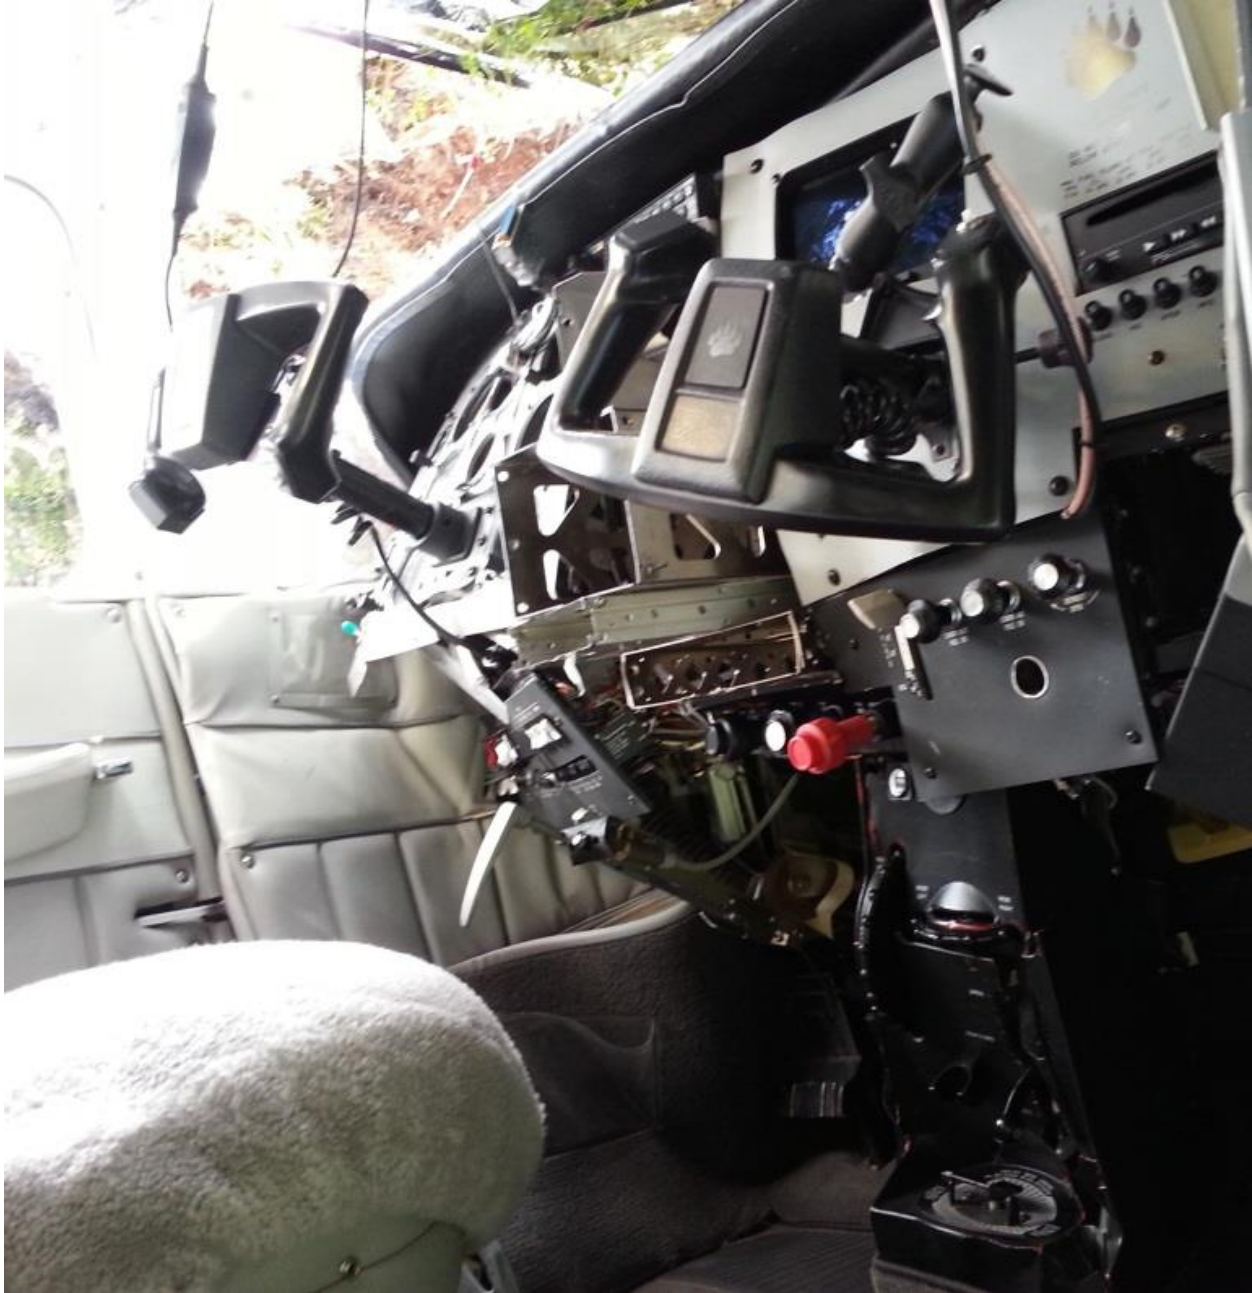
Figure 11 - Pilot Station (photo taken on-scene while airplane still inverted)

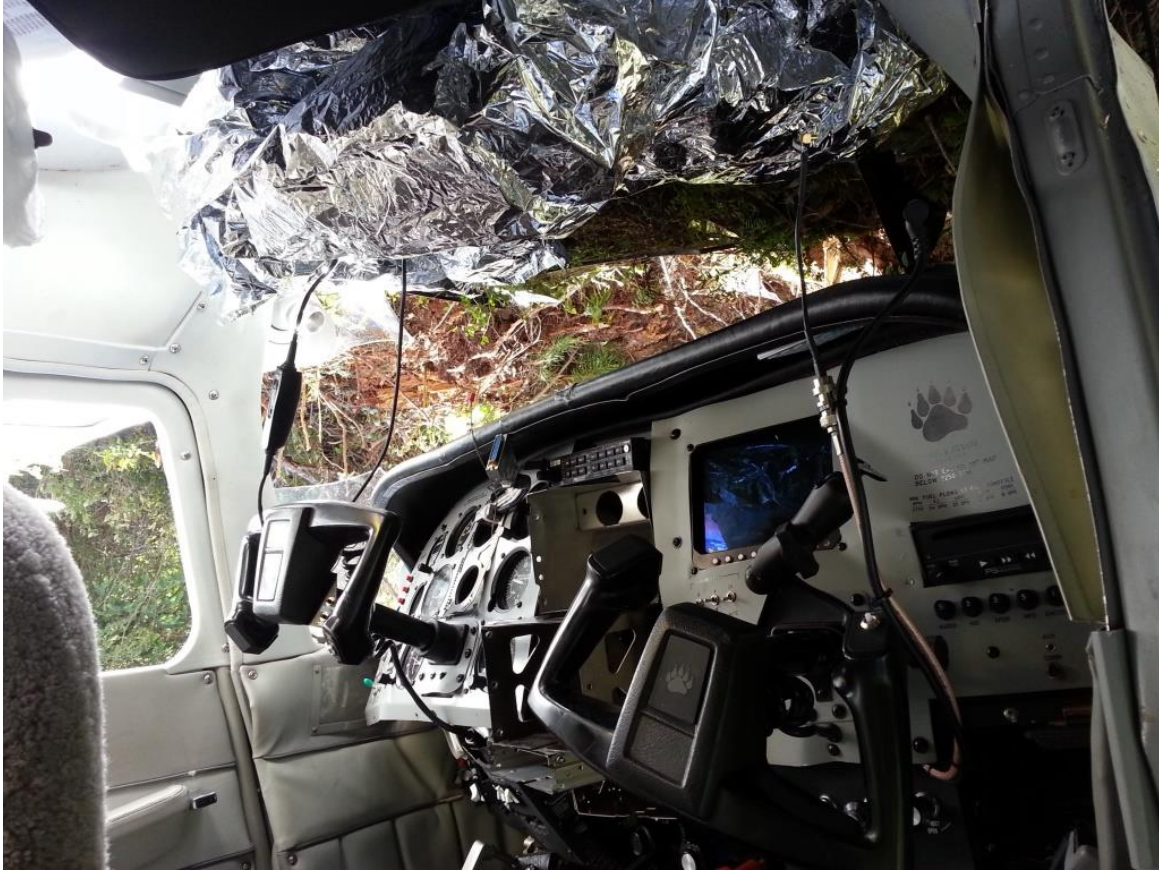
- Instrument panel was displaced with the top part distorted forward
- Panel was post Cessna delivery aluminum face
- Avionics and instruments differed significantly from original stock Cessna configuration

Figure 12 - Instrument Panel (photo taken on-scene while airplane still inverted)

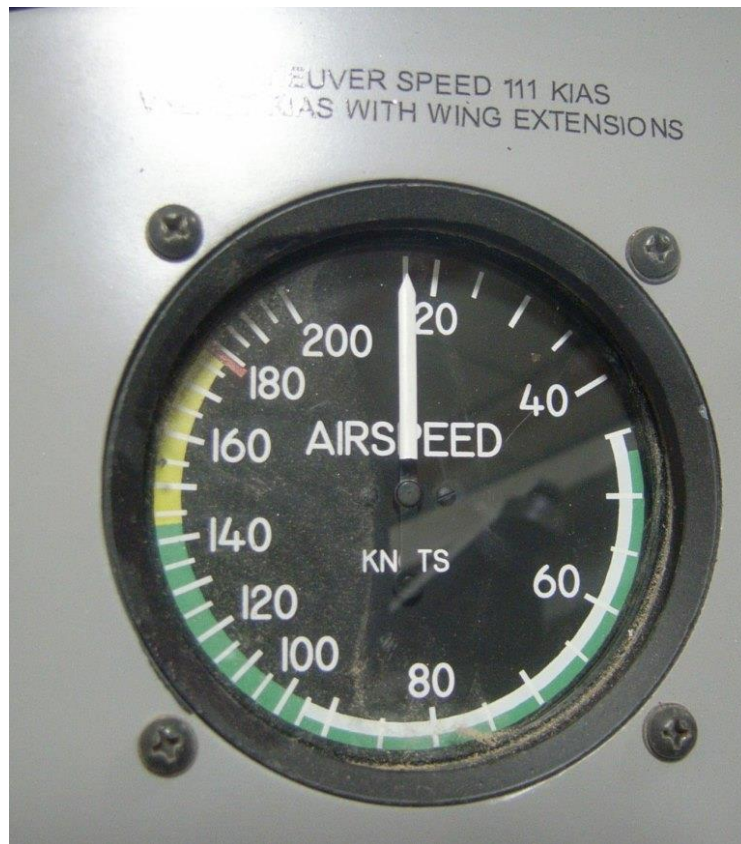
Marking	Observed Value (KIAS)	Cessna C-182Q POH (KIAS)
White Arc	45-95	45-95
Green Arc	48-143	48-143
Yellow Arc	143-179	143-179
Red Line	179	179

Figure 13 -Airspeed Indicator (note arcs and redline)

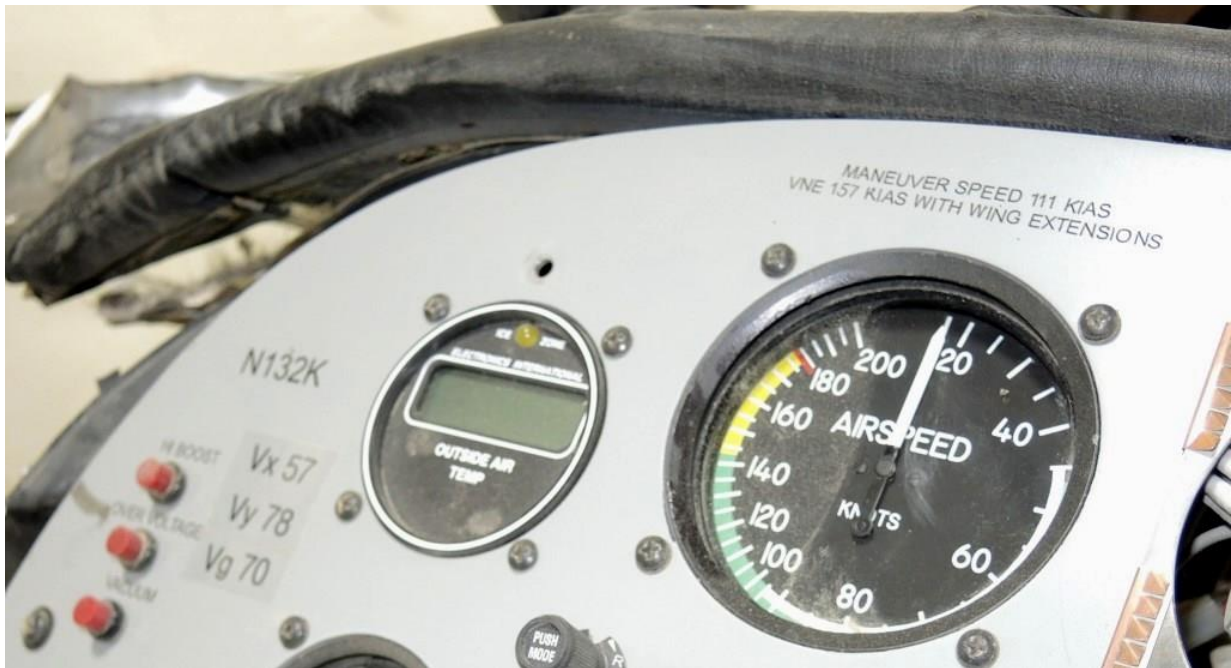
- Observed placard/notation above Airspeed Indicator:
  - "V<sub>A</sub> 111KIAS"
  - "V<sub>NE</sub> 157 KIAS with wing extensions"
- Observed placard/notation located to the left of the OAT gauge:
  - "V<sub>X</sub> 57"
  - "V<sub>Y</sub> 78"
  - "V<sub>g</sub> 70"

Figure 14 - Airspeed Placards/Notations (note VNE discrepancy)

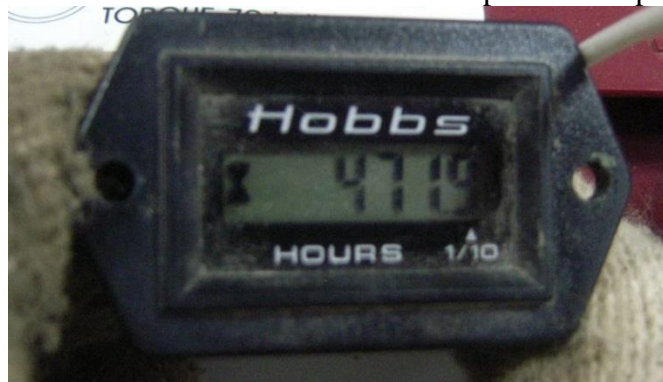
- Airspeed Indicator = 0
- Vacuum = 0
- OAT = blank (digital)
- Hobbs Meter = blank (digital)
  - 471.8 at initial application of 12VDC
  - Photos show 471.9 because device became operational upon power application

Figure 15 - Hobbs Meter Shortly After 12VDC Application

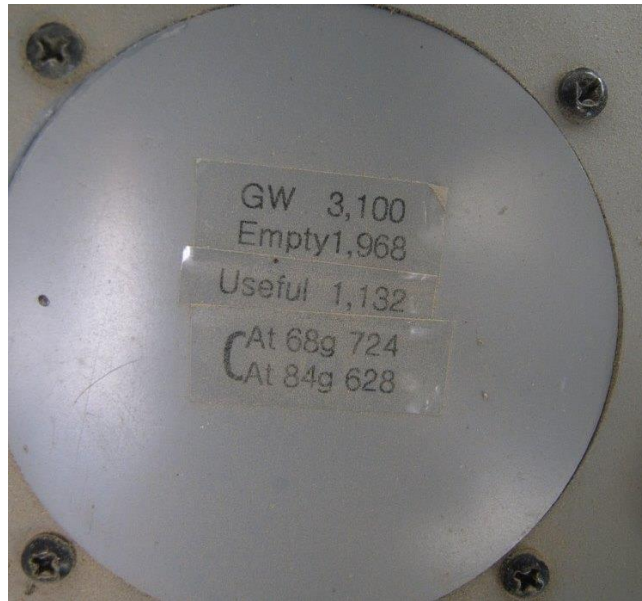
**Figure 16 - Cockpit Placard/Notations re Weights**

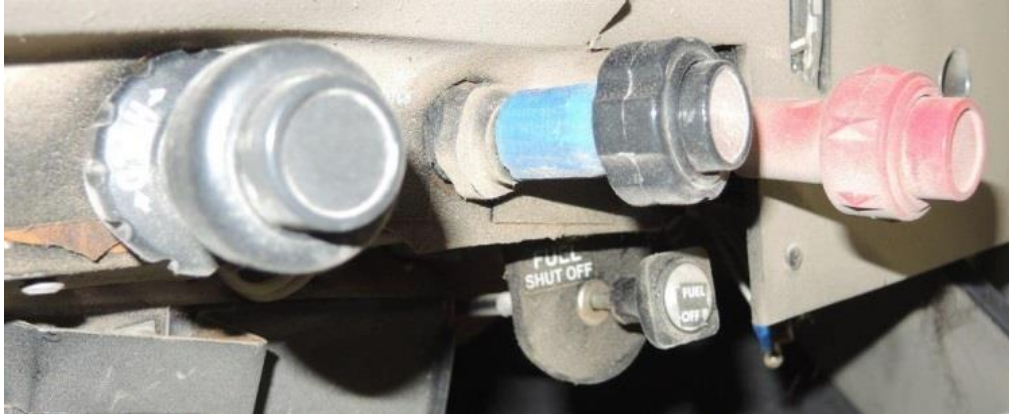
- Cowl flap handle "CLOSED"
  - Cowl flaps also observed to be closed
- Fuel selector handle and valve: LEFT
  - Conflicts with Cessna POH and installed selector valve placard, which mandate "BOTH" for landing
- "Fuel off" knob full forward (located under mixture control)
- Mixture, Prop, & Throttle controls found full forward

Figure 17 - Engine Controls and Fuel Shutoff

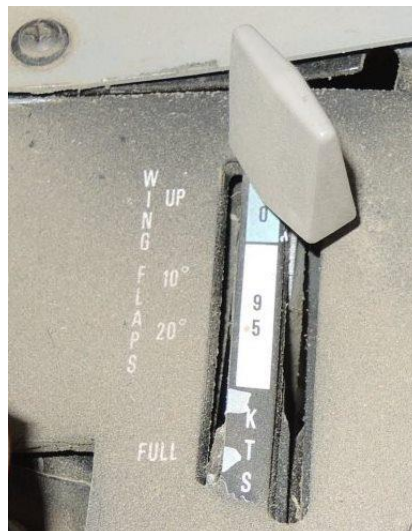
- Flap position selector control/handle found positioned full up/retracted
- Flap position indicator found indicating 40 degrees (full down/extended)
- Flap position indicator system sustained impact damage behind panel
  - Cable fracture-separated from indicator lever/pointer
  - Housing partially crushed
- NOTE: Pilot's written statement dated July 9, 2014 reported that flaps had been set to 40 degrees on downwind leg

Figure 18 - Flap Control and Indicator

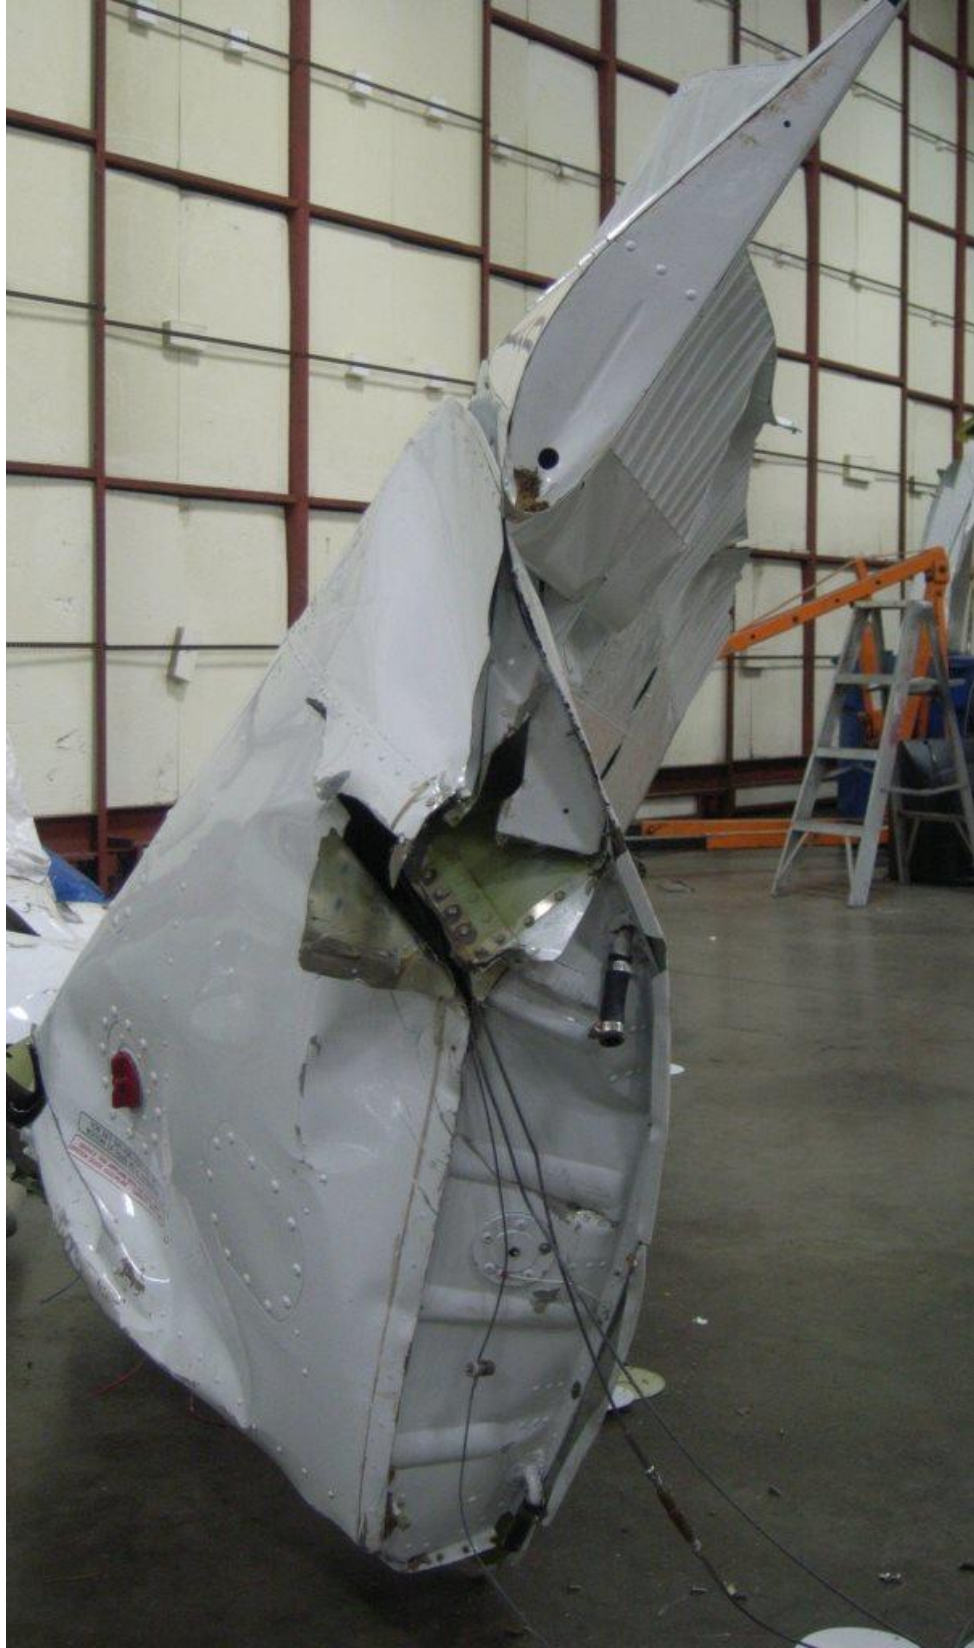
- Flap jack screw measured 3 1/4", which equates to 15° flaps down
- Right flap was approximately 15° down and was fixed into position due to impact damage

**Figure 19 - Right Wing Root (note flap deflection)**

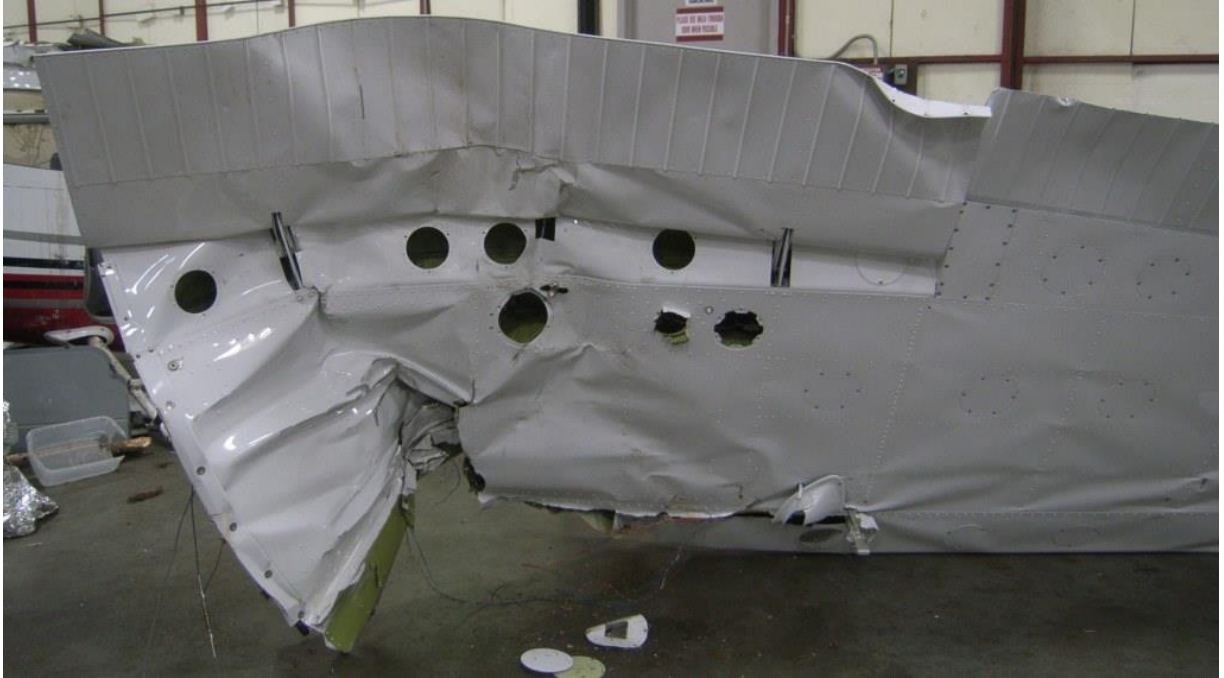
**Figure 20 - Right Wing (separated at impact)**

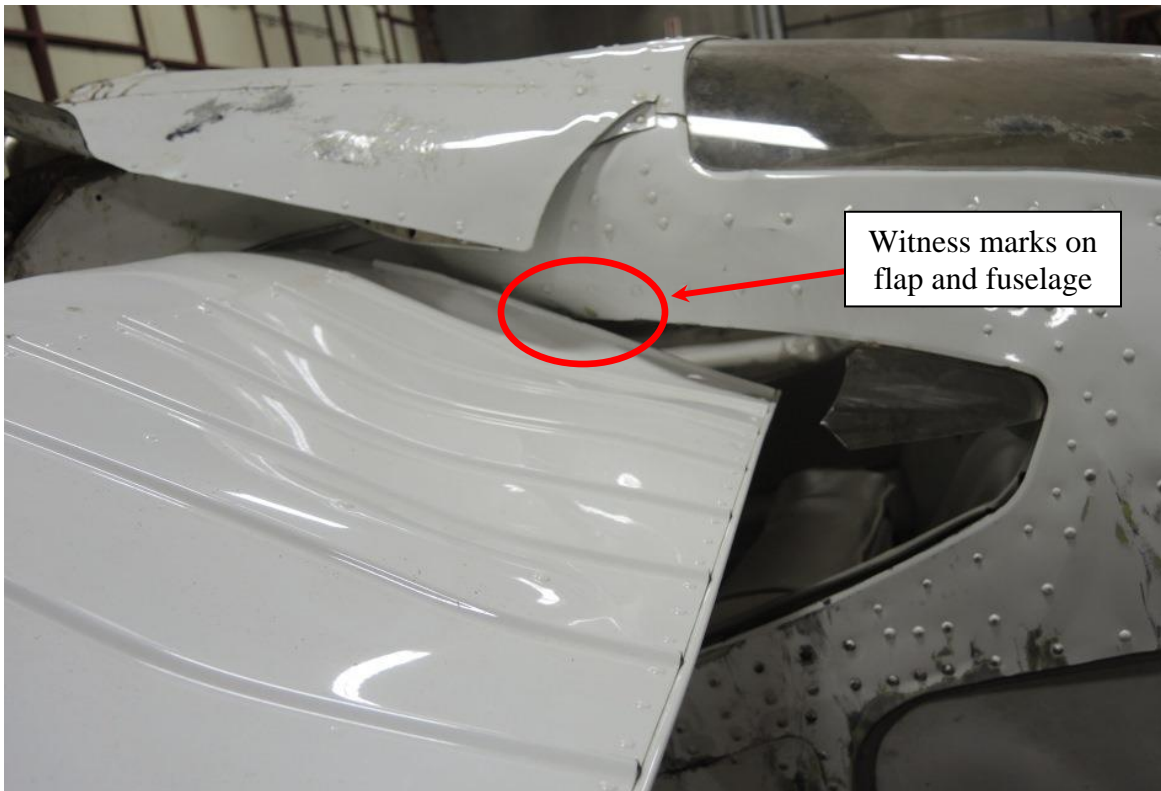
- Left flap witness marks on flap inboard end and fuselage indicated that left flap was extended approximately 15° down at impact

**Figure 21 - Left Flap (manually positioned to align witness marks)**

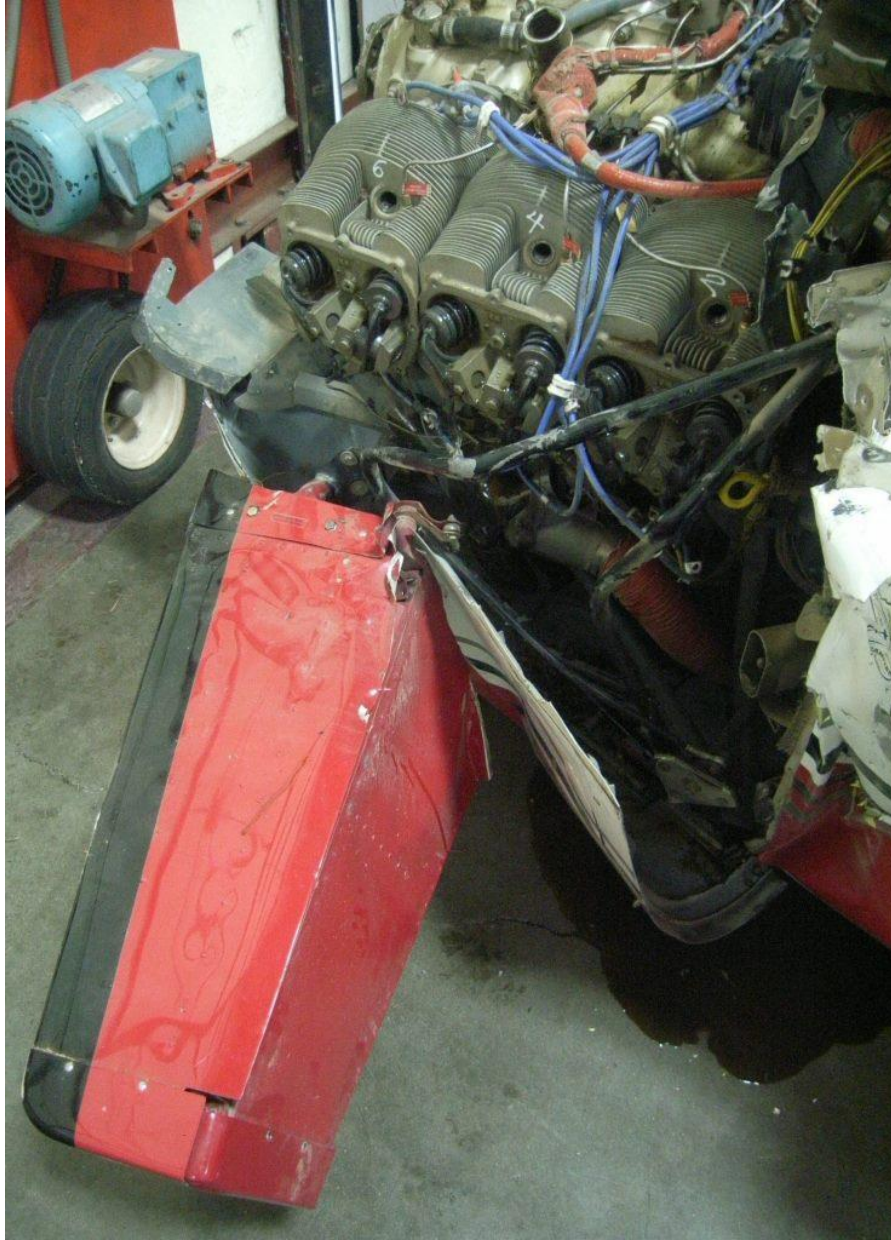
- Peterson canards:
  - Two total, one per side, located approximately mid height on engine cowl
  - Each canard consisted of a fixed LE segment and movable TE segment.
  - Both movable portions remained affixed to their stationary segments
  - Left canard impact damaged with the TE in down position
  - Right canard displaced aft with TE in a slight up position
  - Movable portions are actuated by left side control yoke through push-pull rods and pivots, including a transverse torsion bar.
  - Per pilot, directionality is "opposite elevator": Elevator TEU = canard TED, and vice versa
  - Rod end at left canard was fracture separated from its actuation rod
  - Right side movable canard controls were intact

Figure 22 - Left Canard (outboard end displaced aft)

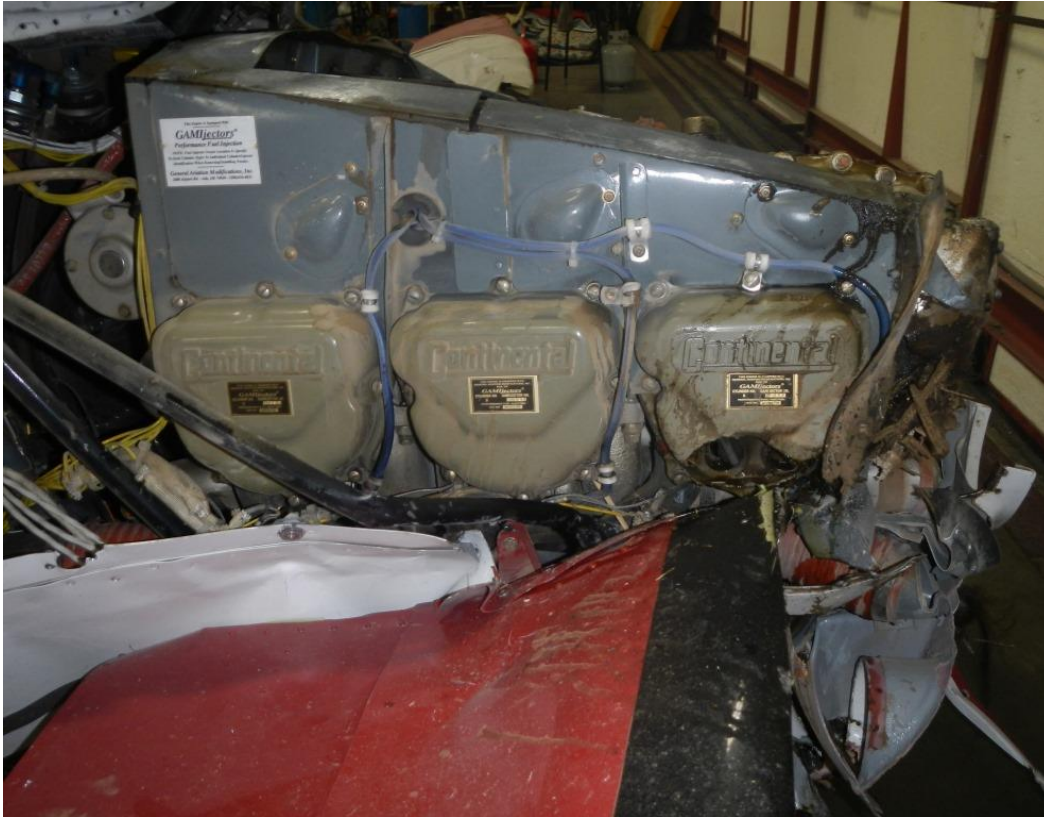
Figure 23 - Right Canard
