## **NATIONAL TRANSPORTATION SAFETY BOARD**

# **AIRFRAME AND ENGINE EXAMINATION**

**WPR14LA271**

Location: Big Creek, Idaho  
Date: June 29, 2014  
Aircraft: Cessna 182Q, N132K, Serial # 18266782  
NTSB IIC: Michael Huhn

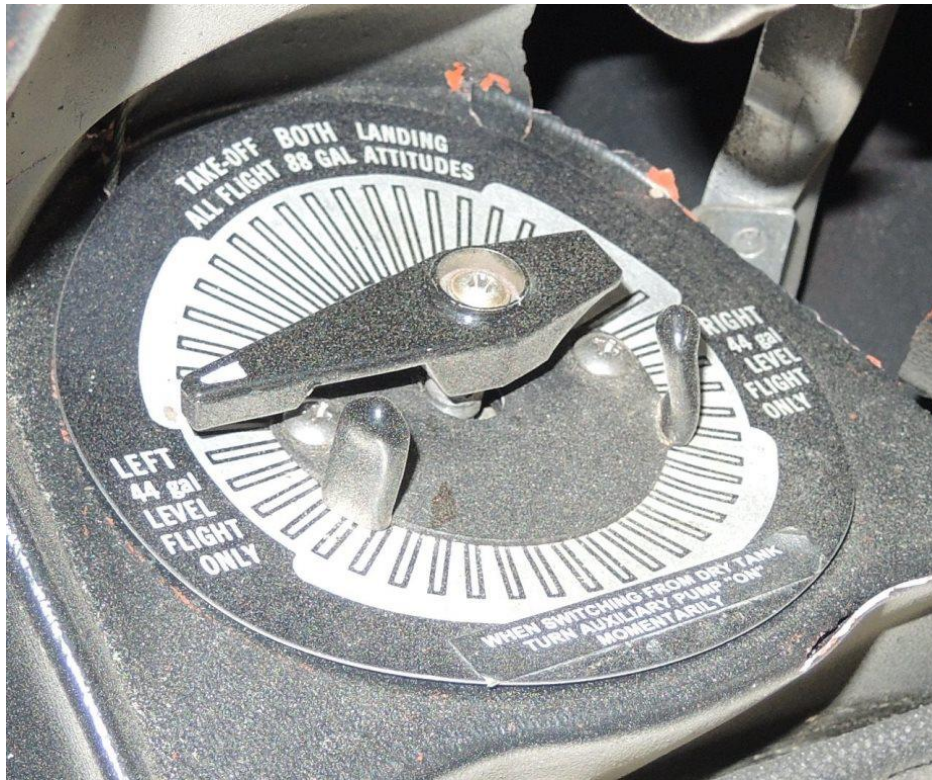
- POH = 46 G per tank, Total Usable = 88 G
- POH Limitation “Takeoff and land with fuel selector handle in BOTH position”
- POH Limitation “Operation on either left or right tank limited to level flight only”
- Standard Cessna fuel selector is 4-position valve (OFF, LEFT, RIGHT, and BOTH)
- Accident airplane fuel selector was 3-position (LEFT, RIGHT, and BOTH)
  - Two stops had been added to what appeared to be the standard Cessna fuel selector panel to prevent handle travel to the standard Cessna OFF position, and thereby limited travel to selection of LEFT, RIGHT, or BOTH tanks
  - It was/was not determined whether the original Cessna 4 position valve was replaced with a 3 position valve

Figure 24 - Fuel Selector (note stops)

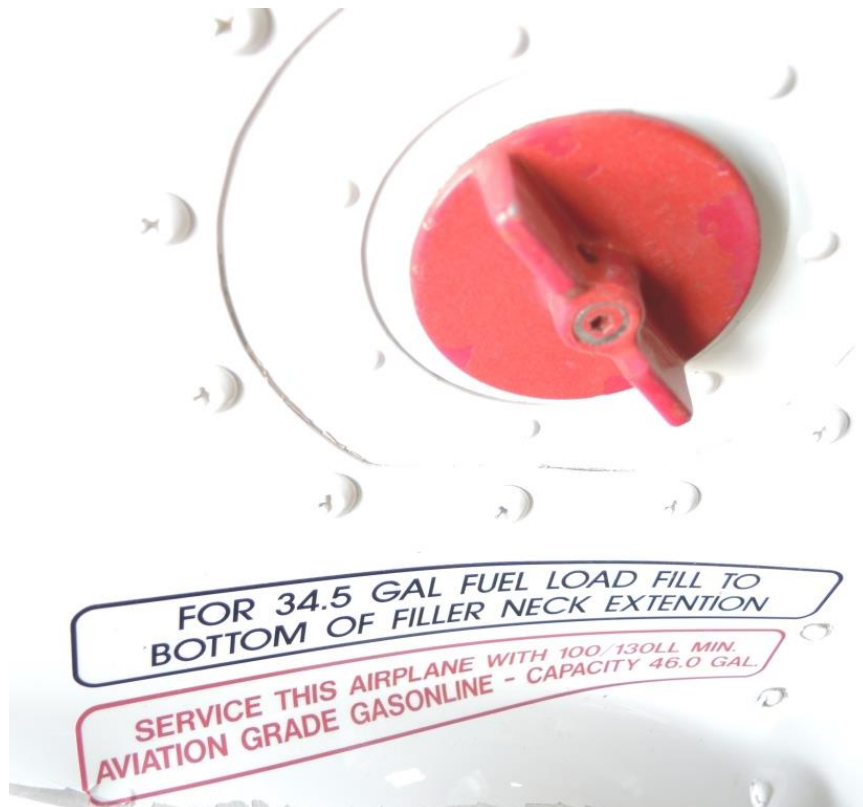
Figure 25 - Right Fuel Tank Filler Port/Cap (note misspellings in placards)

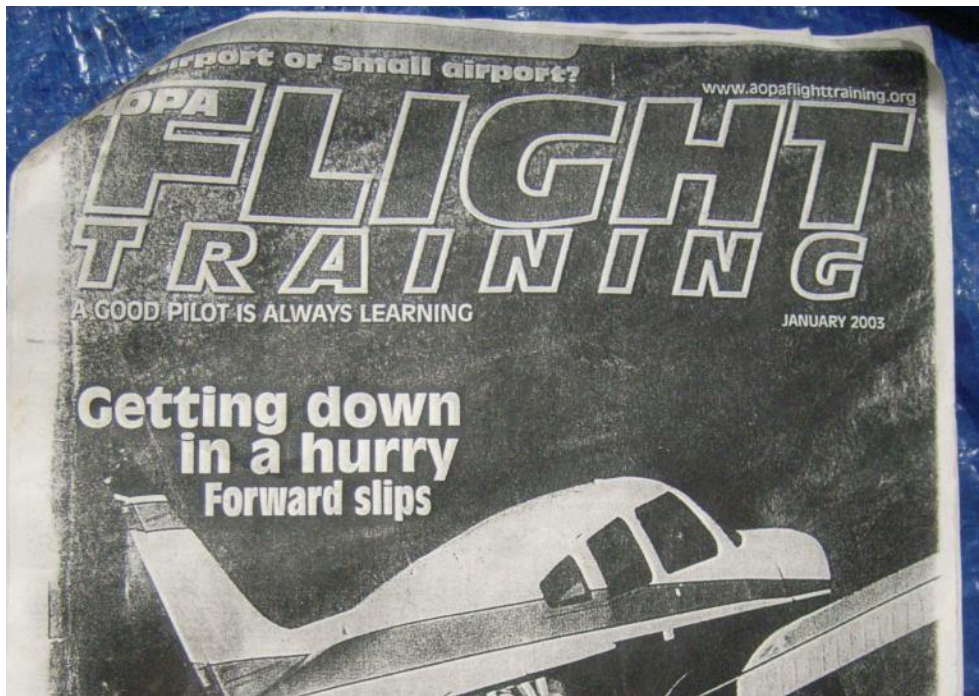
- A copy of a "Flight Training" magazine article entitled "Getting Down in a Hurry-Forward Slips" (dated January 2003) was found in the recovered items
  - In his written statement to the FAA re the accident, the pilot noted that he attempted to use a slip to increase his descent rate on the base and/or final legs

Figure 27 - Magazine Article Copy re Slips

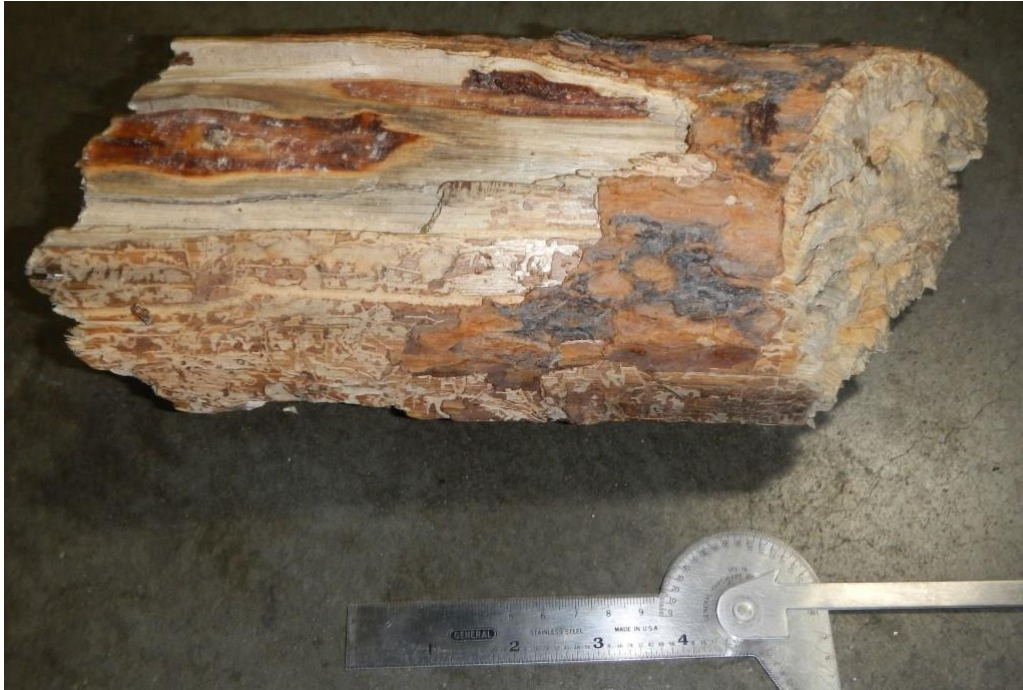
- One segment of a tree trunk, approximately 6 inches in diameter and 12 inches long, was cut from the tree at both ends. The cuts were consistent with propeller slashing.

**Figure 29 - Tree Fragment with Both Ends Cut**

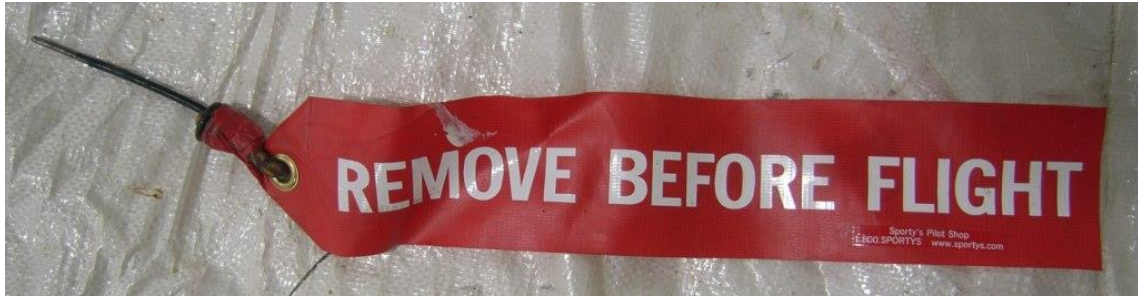
Figure 30 - Home-made Cockpit Control Lock

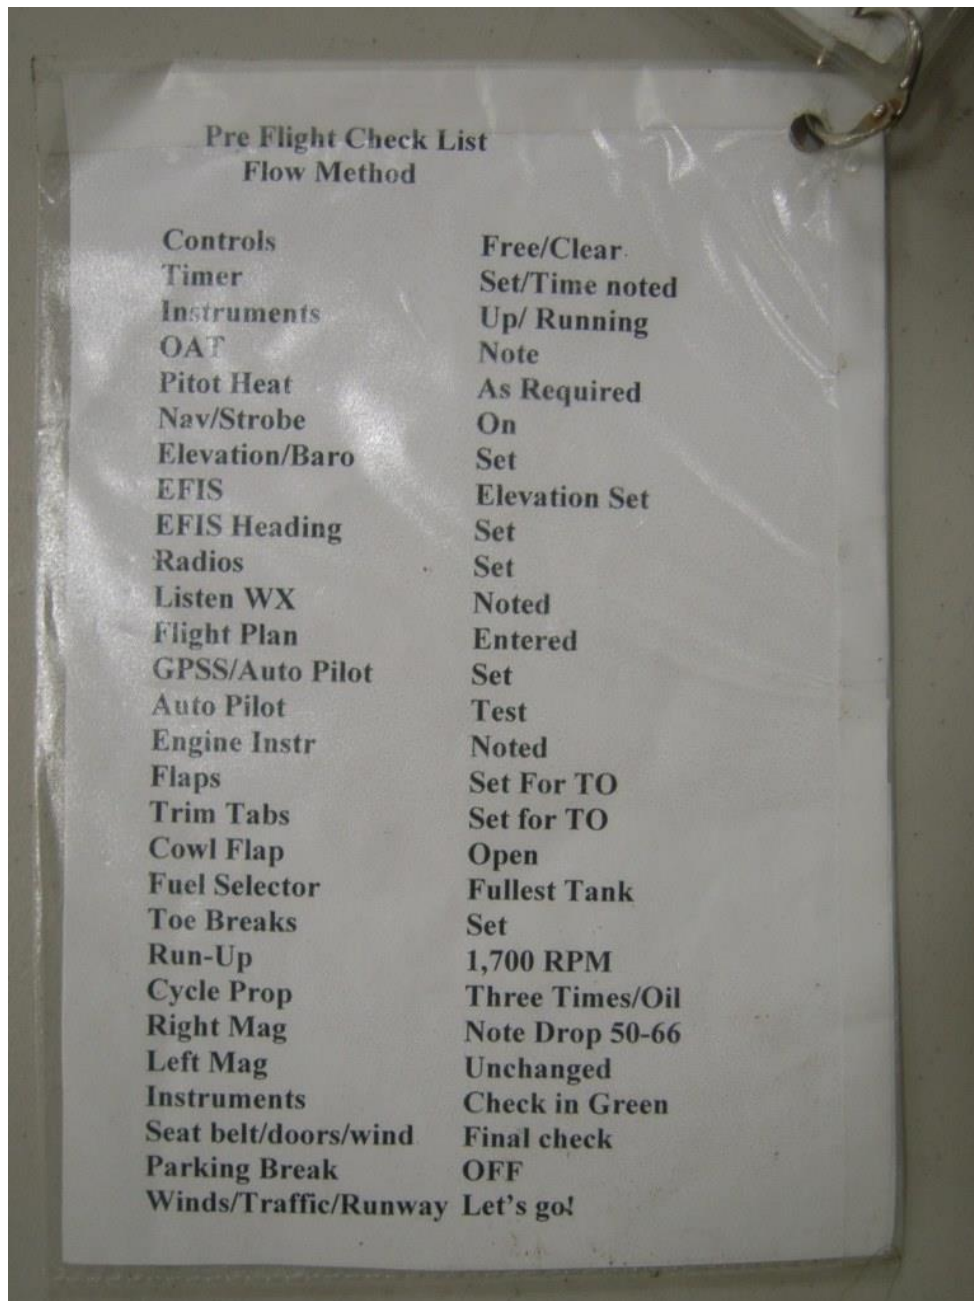
- No POH or other operational guidance/information (aside from a "homemade" checklist) was located in the airplane or amongst the recovered items
  - NOTE: The recovered checklist contained some unusual, unclear, or incorrect information. The checklist items are addressed in a separate document.
- No performance guidance/documentation was located in the airplane or amongst the recovered items
- Aside from the notations on the instrument panel, no weight and balance information, guidance, or documentation was located in the airplane or amongst the recovered items
- Several miscellaneous items that were artifacts or possibly instructional material – (Decals/stickers, cases, brochures, charts, etc) of mountain and/or "back country" flying courses and/or associations were found in the airplane or amongst the recovered items

Figure 31 - Home-made Checklist (Note fuel selector and magneto references)
