NATIONAL TRANSPORTATION SAFETY BOARD

AIRFRAME AND ENGINE EXAMINATION

WPR13FA430

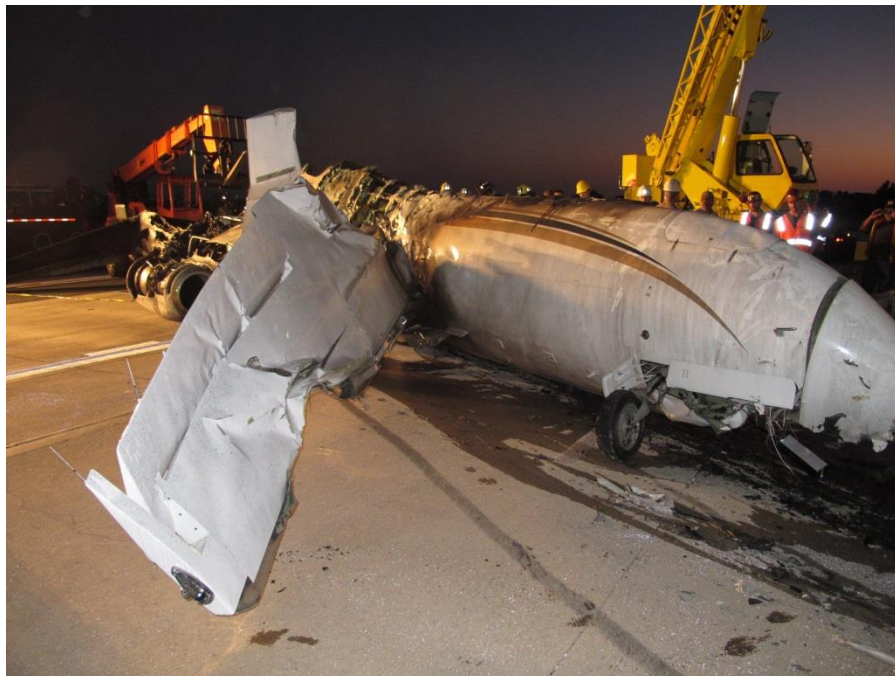
1- Right side of the airplane after it was removed from the hangar.

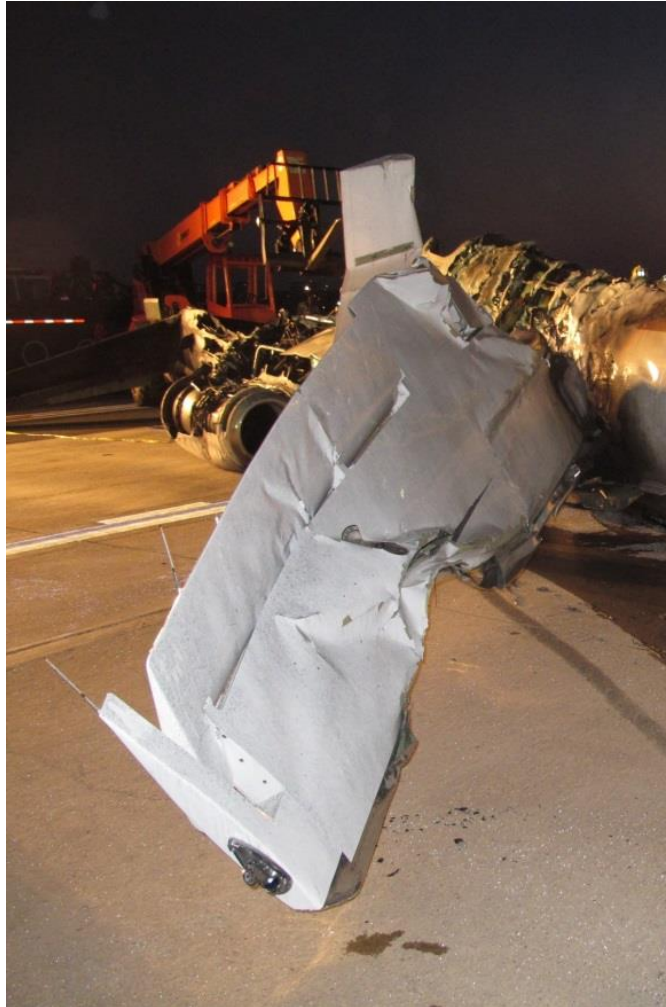
2- Right wing

- Right Wing
 - Wing separated from the fuselage at the attach points
 - Right hand wing (wing spar) broken at the outboard wheel well rib.
 - Leading edge impact to outboard section of the wing at the fuel filler cap.

- The inboard 8 feet of wing was damaged by extreme fire and heat.
 - 3 ft x 2 ft elongated hole was over the main landing gear wheel well
 - Ailerons and flaps were present on the wing. Aileron cables were traced from the aileron bell crank to the centerline bell crank. The aileron bell crank was connected to aileron.

- Flap actuator was attached to flap. The flap actuator was fully extended. Flap was separated from the wing. Speed brakes/spoilers deployed
 - Right main landing gear extended. Wheel and tire attached. Tire inflated, no bald or flat spots on tire tread observed. Brake wear looked unremarkable. Tire pressure was 98 psi (recorded Oct 3).

- 15 ft of wing tip separated from wing at the landing gear wheel well. The separated wing structure was not fire damaged. The spoiler was deployed, but had been cut through by recovery personnel to move the wing.

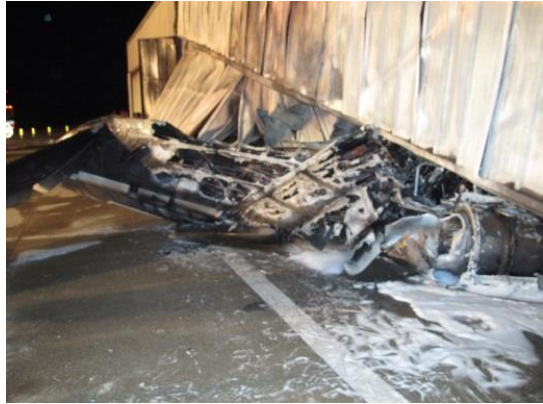
3- Right side of the tail.

- Tail Section
 - Tail section aft of the rear pressure bulkhead separated from airframe due to extreme fire damage.
 - Both engines remained attached their engine mounts

- Elevators in place on the horizontal stabilizer. Elevator position was down and the control cables were stretched taut.
 - Vertical stabilizer leading edge destroyed by fire

- Rudder present on the vertical stabilizer, rudder positioned to the left.
 - Flight control cables to the tail visible, fire bottles present, environmental ac components observed.

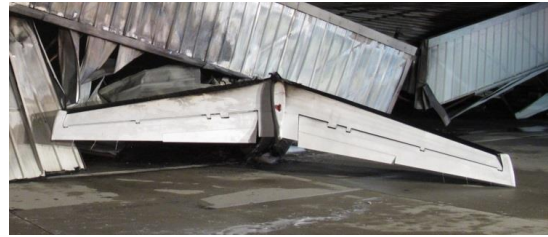
4- Rear view of the tail (horizontal stabilizer)

- ELT - ACR Electronics, TSO C126/C142, SN 357585-075, activated and was transmitting after the accident. Signal received by AFRCC.
 - No leading edge damage to horizontal stabilizer.

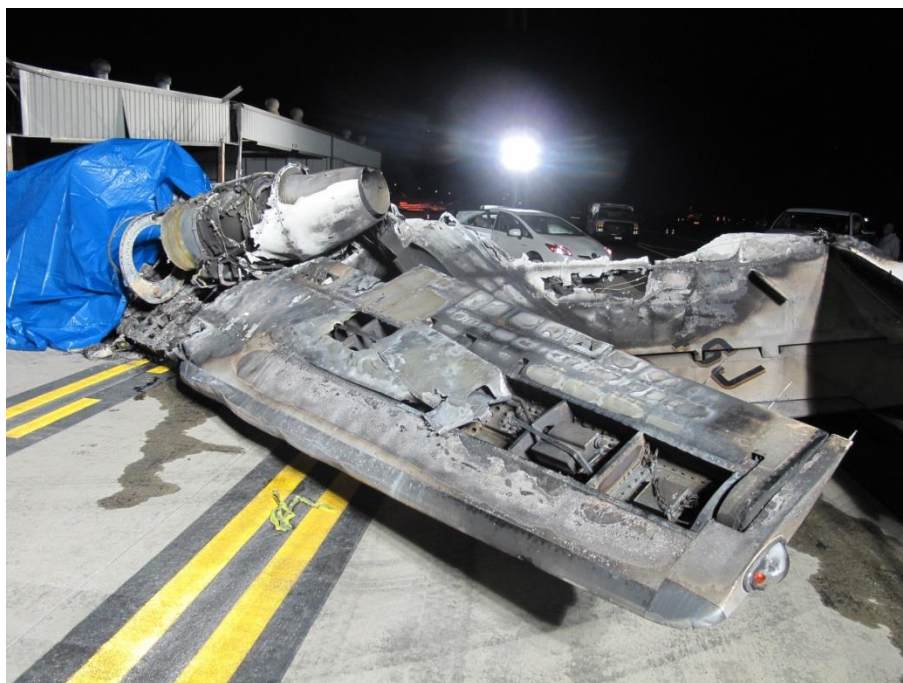
5 - Left wing

- Flap was attached to the wing and extended (deployed).
- Spoiler/Speed Brake attached to wing and deployed
- Slight leading edge denting
- Wing discolored black and gray - heat damage
- Extreme fire damage at the wing root. Heat and fire damage outboard of wing centerline.
- Left tire was on the wheel, and wheel attached to the main mount strut. Tire inflated, and heat damaged, no flat spots observed. Landing gear in the down position. Tire pressure: 102 psi (recorded Oct 3).
- 4 ft x 2 ft hold above the wheel well
- Aileron attached to wing. Aileron cables attached to aileron bell crank and traced to the center of the fuselage.

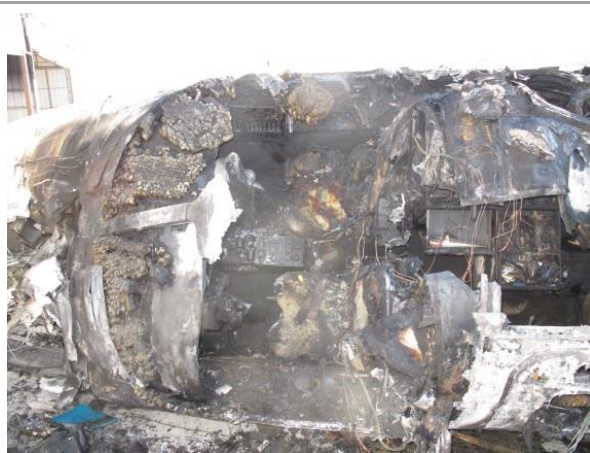
6 – Cockpit, view from above looking down

- All occupants were unbuckled from their seat belts
- Both cockpit seats were in the full aft position. Seat belts were not buckled.
- Fire extinguishers were found discharged and the activation pins not present.

- Right rudder pedal was forward of the left pedal in both sets of rudder pedals
- Instruments
 - Garmin 530 (2x)
 - Collins Pro-Line 21 (center console)
 - Attitude gyro - 5° right bank

- Altimeter - 1,000 ft, 29.96 inHg
 - Differential pressure - 1
 - AOA - 10
 - Amps - 0
 - Amps - 40
 - Volts - 6
 - Gear handle - down
 - Parking brake - IN (brake handle corresponded with parking brake valve rod position)

- Throttle - Left 1/4 forward (idle), Right- 1/3 forward
 - Flap - Handle full down (ground operation) position, indicator showed- UP (unreliable indication - cabled pulled)

- Aileron trim - indicator full left (unreliable- cable pulled)
 - Elevator trim indication showed takeoff trim set
 - Rudder trim - indicator full left (unreliable- cable pulled)

- Anti Skid - ON
 - Speed brake – EXTENDED
 - Attenuation switch - AUTO
 - Annunciator panel was heat damaged. Annunciator module was removed for further examination

- Emergency brake handle - IN

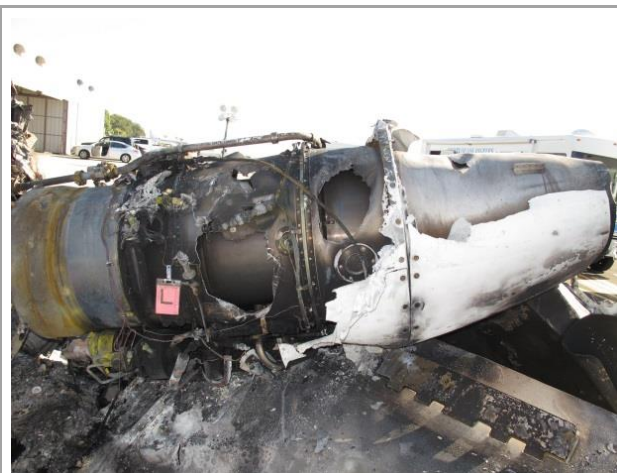
8 - Left Engine

- SN 126257
 - TSMO- 1932.8
 - Fuel control cables connected to the fuel control (FCU) - position consistent with throttle position.
 - No rotating components exited the engine case

- Bleed valve was movable
 - Inlet not present - destroyed by fire
 - N1 section seized
 - Bypass duct melted
 - Intake fan (N1) blades clean
 - Fuel line severed

- HP compressor rotated by hand.
 - Bore scope examination of the HP compressor (N2) showed soot and small particulate matter compressor section.
 - External heat damage observed at the center of the engine case (by the burner section). Molten holes in the aluminum located at the 12, 11, & 1 o'clock positions.

- No damage observed on the turbine section.
 - Engine outer nozzle melted and deformed.
 - Attenuator seized in the deployed position.

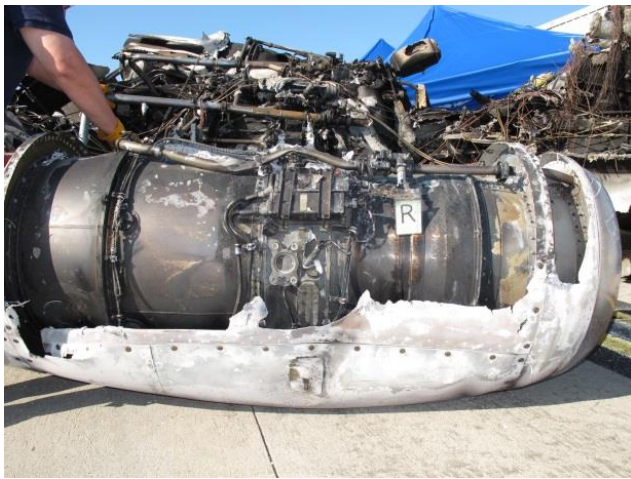
10 - Right Engine

- Right Engine
 - Williams International FJ44-2C
 - SN 126256
 - TSMO - 1932.8

- Fuel control cables connected to the fuel control (FCU) - FCU positioned to idle.
- Bleed valve was movable
- N1 wheel rotated by hand
- Intake fan (N1) blades were evenly coated with black soot. Induction soot pattern consistent with engine running while ingesting smoke, soot, ash.
- Bore scope examination of the HP compressor (n2) showed soot and small particle debris in compressor section.
- External heat damage at the center of the engine (burner section) at the 1 o'clock position.
- Attenuator connected to linkages and actuator, could be moved by hand. Position at the time of impact could not be determined.
