**NATIONAL TRANSPORTATION SAFETY BOARD**

**AIRFRAME AND ENGINE EXAMINATION**

**WPR14FA316**

Location: Lolo Pass, Idaho  
Date: July 28, 2014  
Aircraft: Meyer-Lancair Legacy, N29MM, Serial #: L2K-197  
NTSB IIC: Albert Nixon

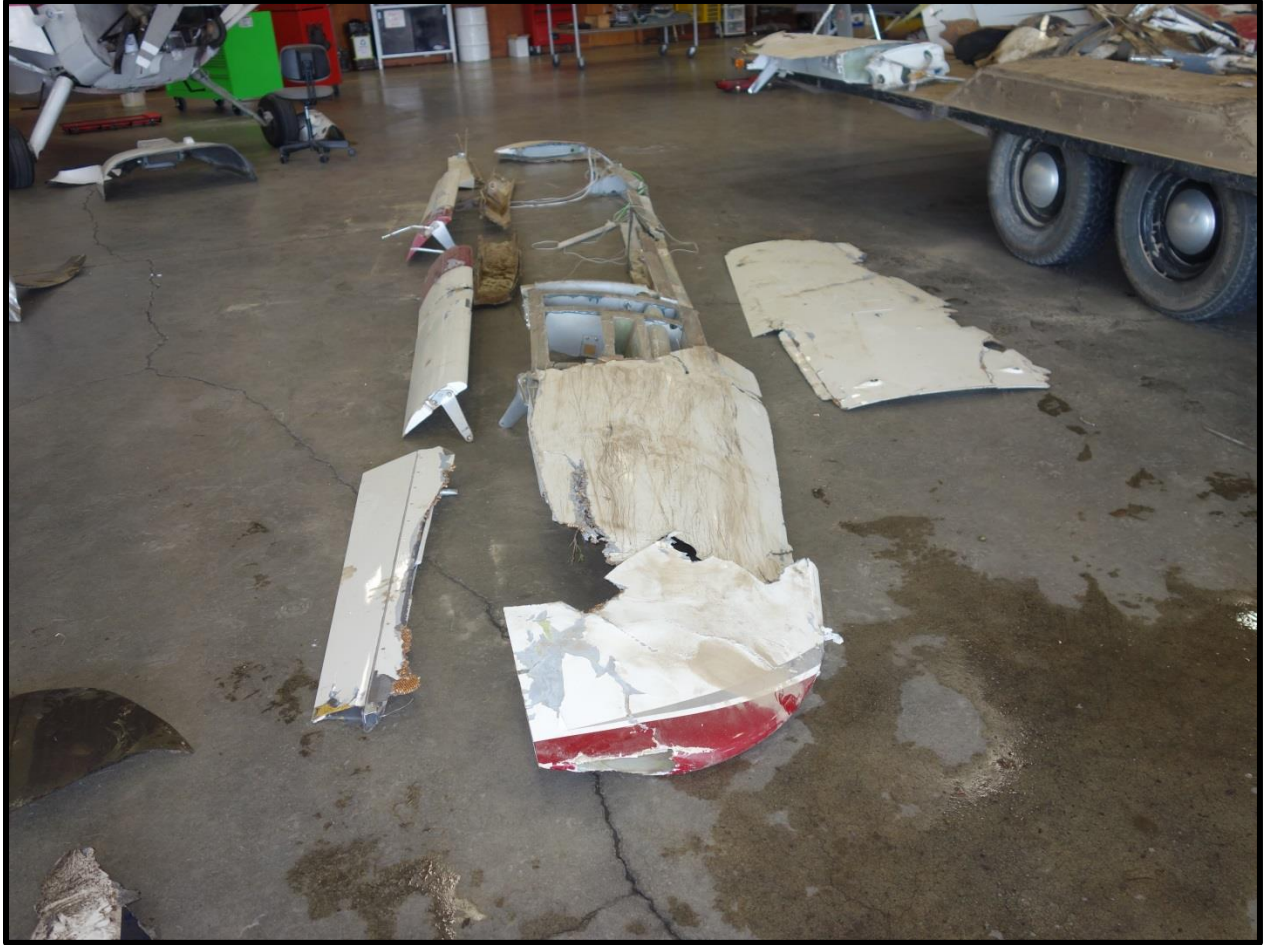
**Figure 2:** The right wing viewed from the right side.

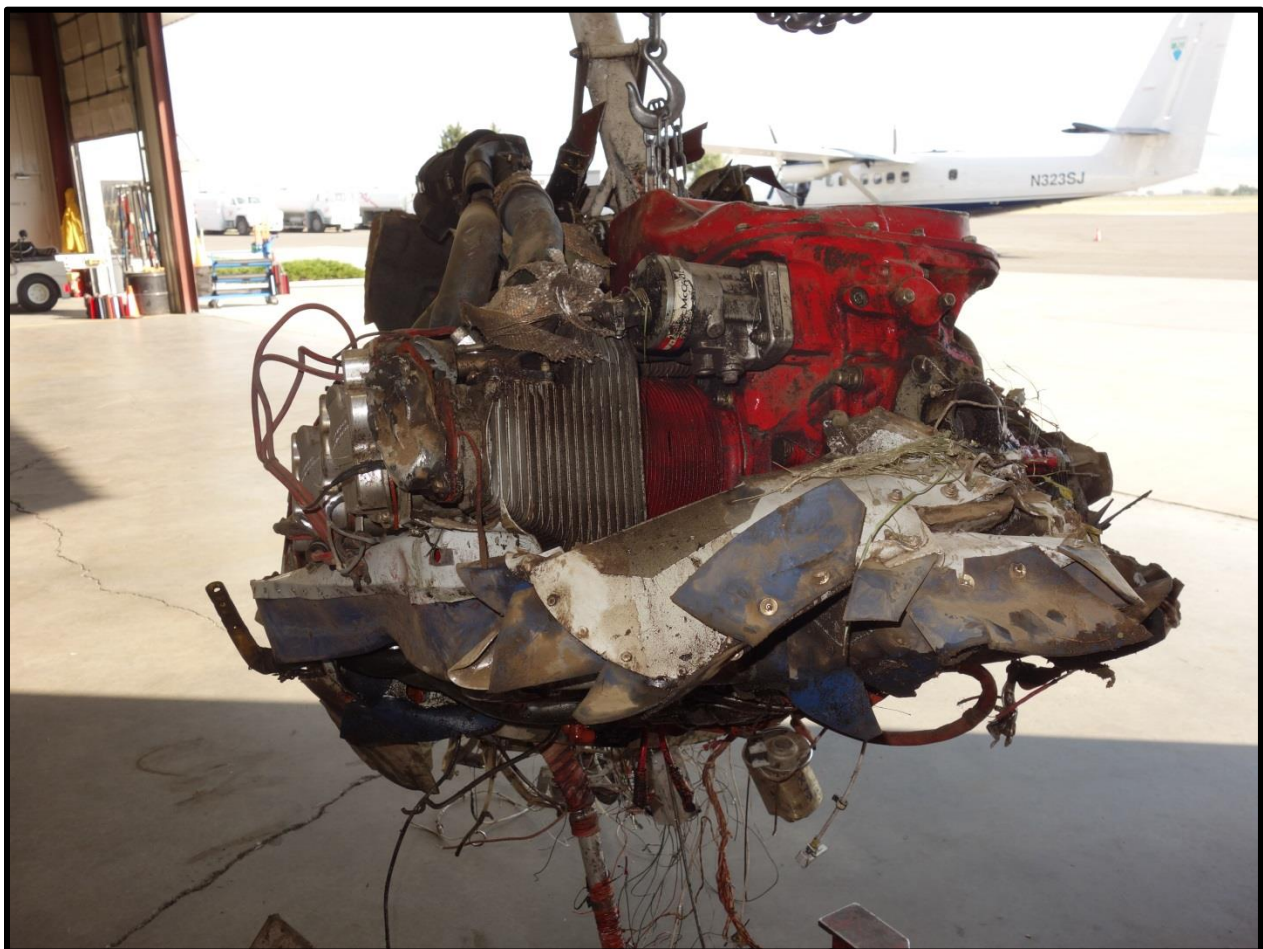
**Figure 3:** The airplane engine hoisted up for examination.

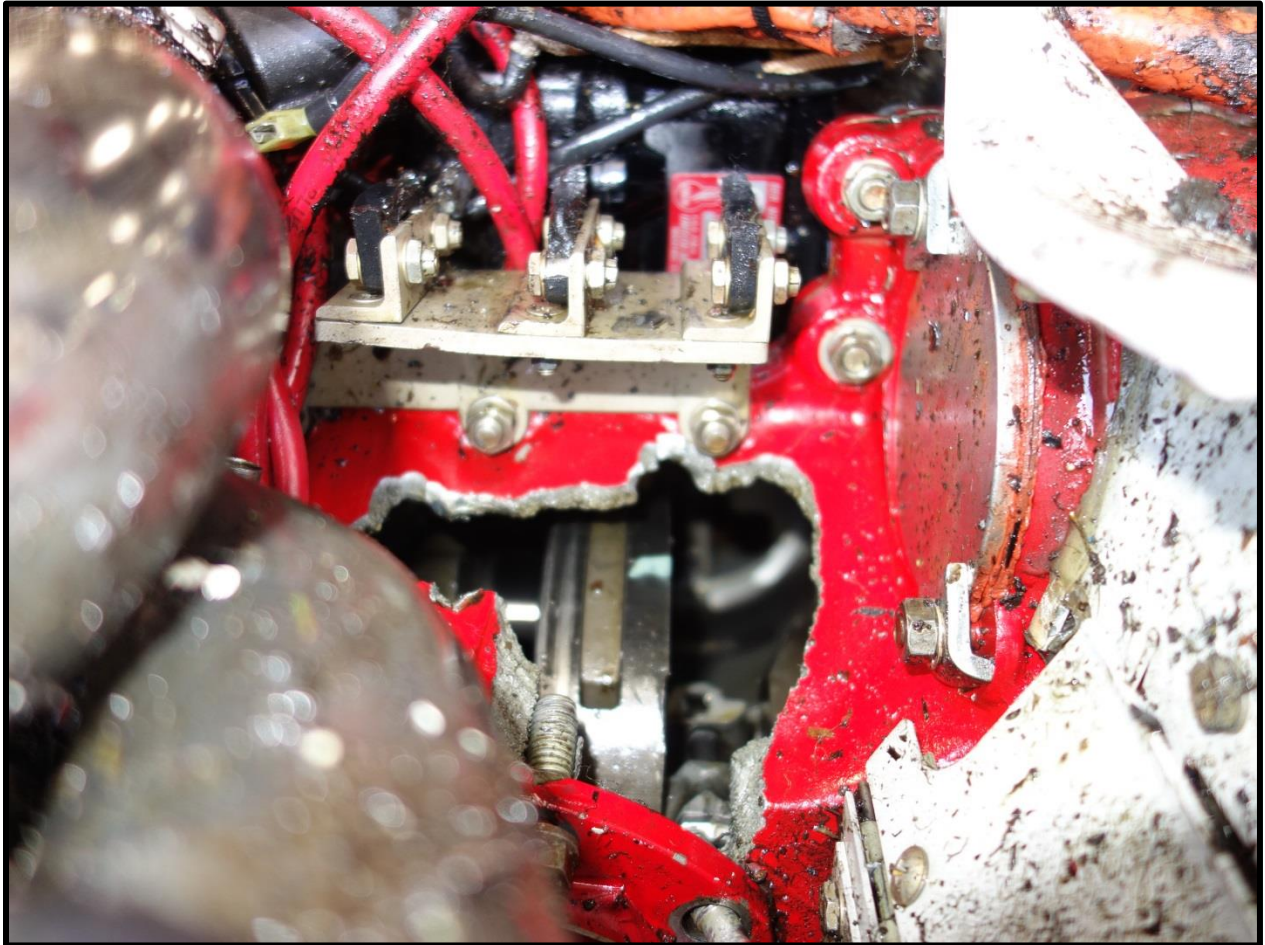
The engine was separated from the airframe. The engine was originally a Continental Motors I0550N model that was converted to an I0550-EXP by Performance Aircraft Engines. The current engine data plate was provided by Performance Aircraft Engines and listed the serial number as TC-5826 and the horsepower as 370. Examination of the engine revealed that a large hole was observed in the upper left portion of the crankcase, located above number 2 cylinder. Visible through the hole, was a broken connecting rod for the number 1 cylinder. Further observation revealed that the connecting rod for cylinder number 2 was also broken.

**Figure 4:** The Hole Observed on the Engine Crankcase.
