# **NATIONAL TRANSPORTATION SAFETY BOARD**

## **AIRFRAME & ENGINE EXAMINATION**

**NTSB Accident: WPR18FA112  
Accident Date: March 26, 2018**

Location: Marina, California  
Date: March 26, 2018  
Aircraft: Mooney M20E, N213EJ, Serial # 939  
NTSB IIC: Michael Huhn

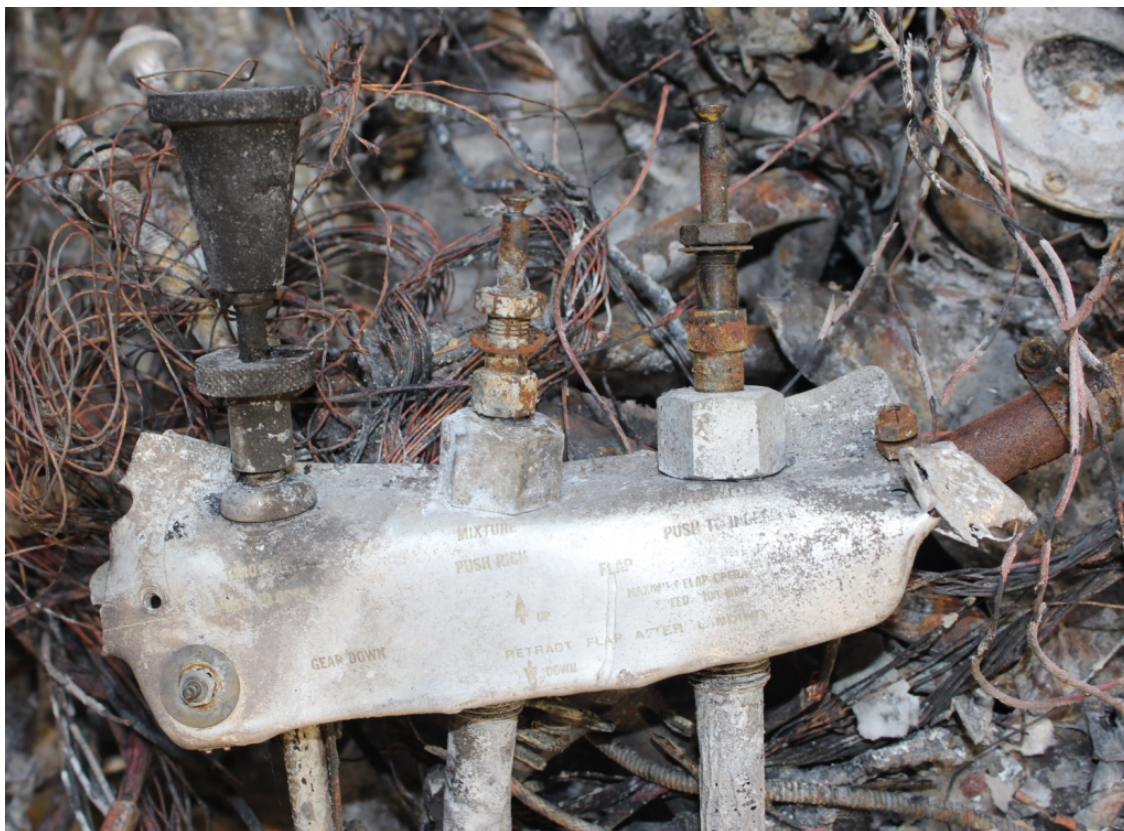
**Figure 1 - Cockpit Engine Controls**

- The steel-tube fuselage structure exhibited substantial impact crush damage
- Fire consumed most of the cabin/cockpit and its contents
- Flight and engine instruments and controls were significantly damaged by impact and fire
- Flight control continuity in all 3 axes was confirmed on scene
- The stall vane assembly was present in the leading edge of the wing but was impact damaged
  - Damage prevented accuracy or functionality determination
  - The remainder of the system was destroyed by impact and fire
  - No useful information regarding the stall warning system was able to be determined

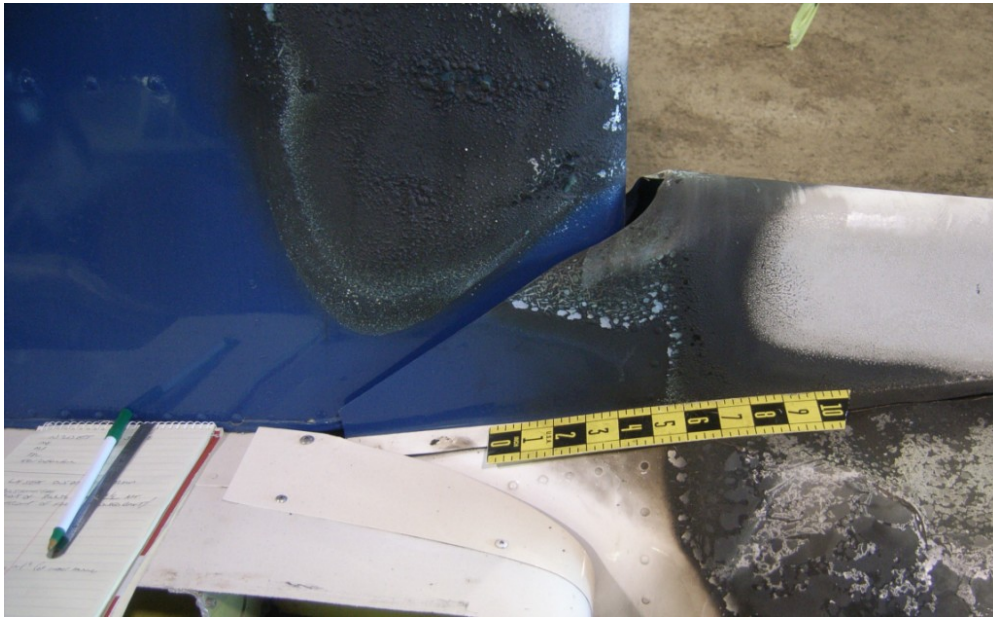
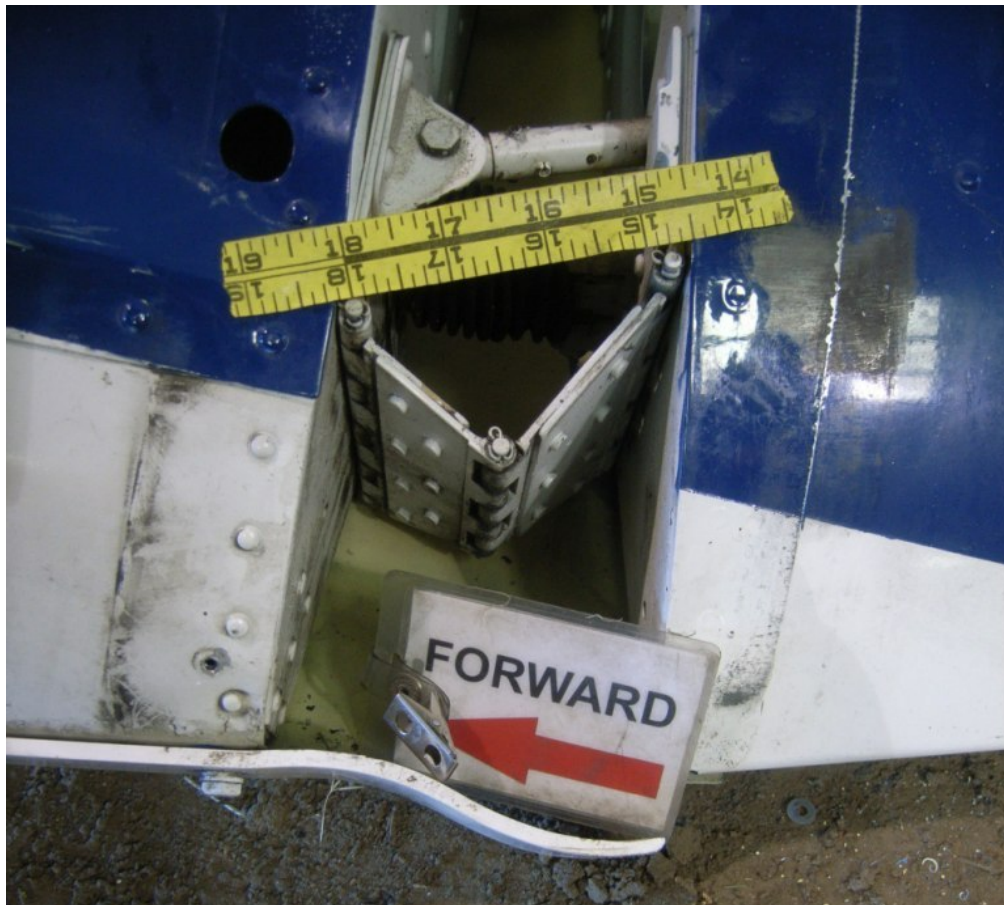
- The manually actuated pitch trim system integrity was confirmed
  - The airplane was not equipped with electric pitch trim
- Several different measurements to potentially determine the pitch trim setting were obtained. These included:
  - Distance between the LE of the vertical stabilizer and the TE of the fin fairing: 1"
  - Distance between the empennage hinge points at the fuselage and empennage: Left side 3 - 12/16" Right side 3 - 14/32"
  - Distances of under-cockpit trim jackscrew to stop block: 3/8" (~4 threads) from aft stop collar to aft face of stop block; 3/4" (~9 threads) from fwd face of stop block to collar at front of jackscrew
  - Aft jackscrew, threaded shaft exposure aft out of the mounting block: 1 - 4/32" or ~8 threads
- According to a Mooney representative, the measured values indicate that the longitudinal (pitch) trim is set at about the normal takeoff position

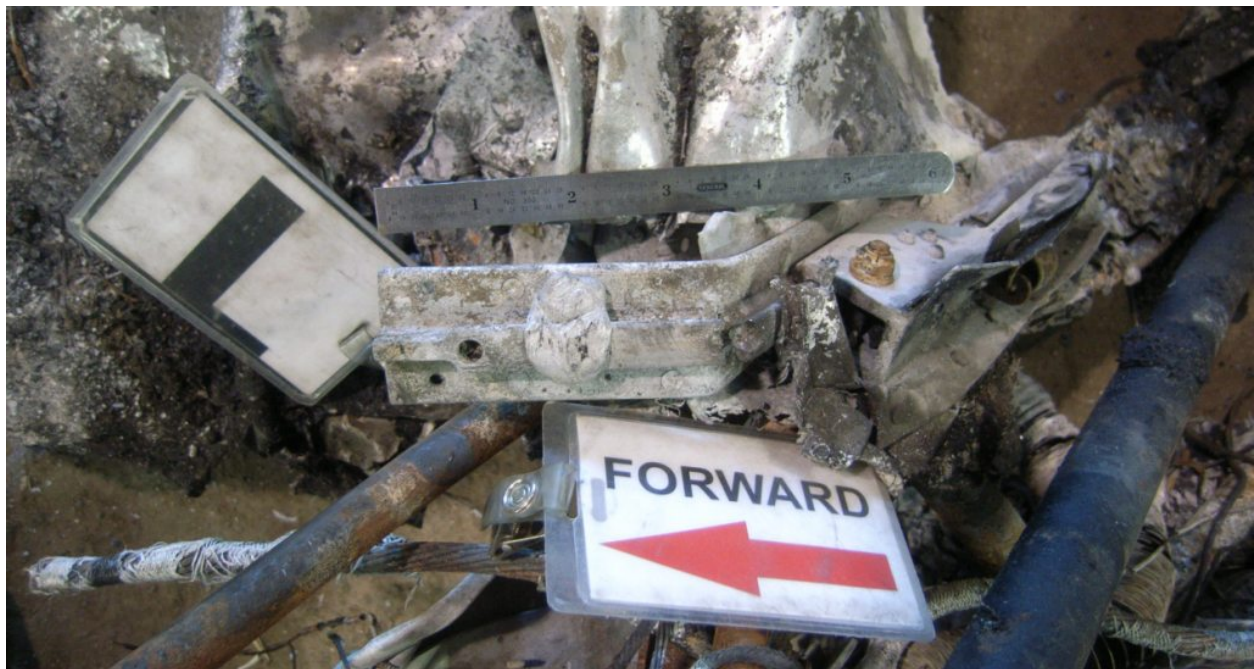
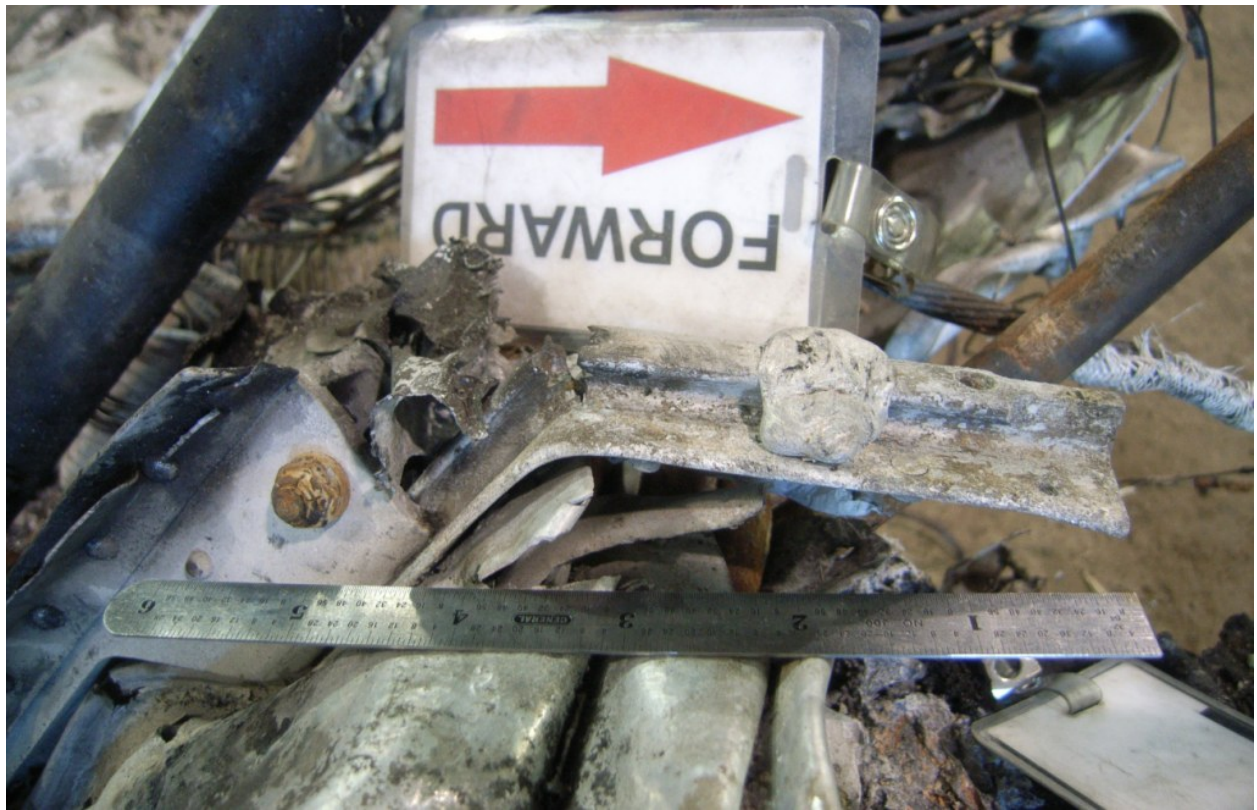
- The seat was longitudinally manually adjustable, and locked into place via a retractable pin on the seat assembly which fit into one of several holes in a longitudinal mounting rail/track
- The outboard seat track for the left (pilot's) forward seat remained partially intact, and was examined to determine the possible longitudinal position of the seat during the accident.
- The track contained seven holes
- The seat was found set with the pin in the 5<sup>th</sup> hole back from the front

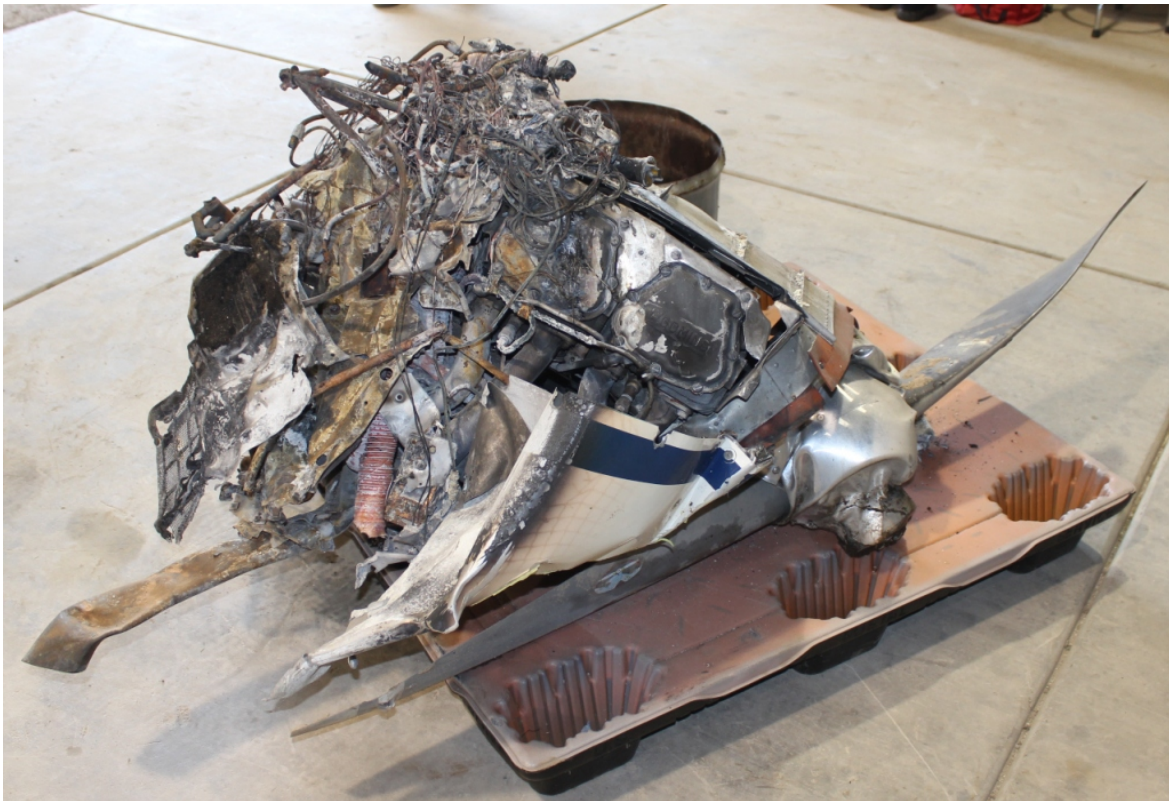
Figure 14 - Engine and Propeller

The engine remained attached to the airframe by the impact damaged engine mount. The engine had sustained significant impact damage that displaced the fuel injection servo and muffler. A post impact fire encompassed the rear of the engine, which resulted in the thermal destruction of the fuel pump, magnetos, vacuum pump and oil filter. Visual examination of the engine revealed no evidence of pre-impact catastrophic mechanical malfunction or fire.

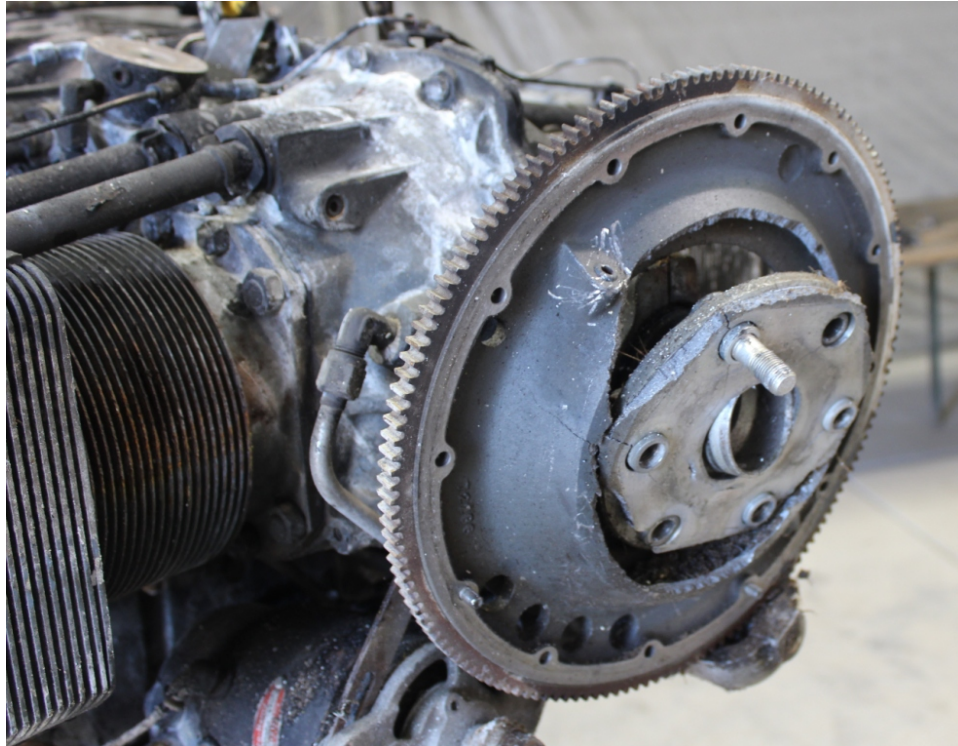
**Figure 17 - Starter Gear and Propeller Flange**

The propeller was removed to facilitate the examination. The top spark plugs were removed, examined. The crankshaft was rotated by hand at the flange utilizing a pry-bar. The crankshaft was free and easy to rotate in both directions. "Thumb" compression was observed in proper order on all four cylinders. The complete valve train was observed to operate in proper order, and appeared to be free of any pre-mishap mechanical malfunction. Normal "lift action" was observed at each rocker assembly. Clean, uncontaminated oil was observed at all four rockerbox areas. Mechanical continuity was established throughout the rotating group, valve train and accessory section during hand rotation of the crankshaft. The bottom spark plugs were not removed.

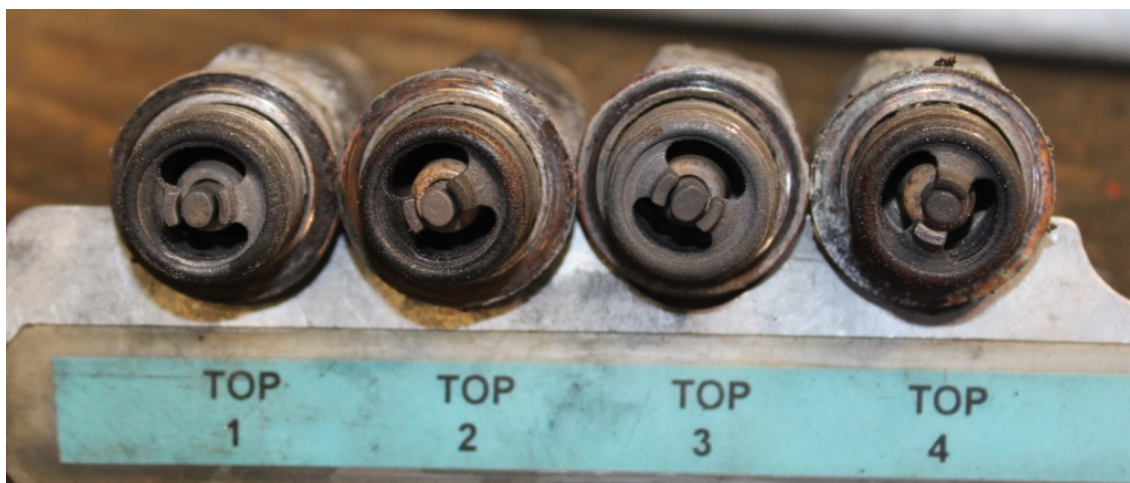
**Figure 18 - Spark Plugs**

The spark plugs were secure at each position with their respective spark plug lead attached. The top spark plugs were removed, examined and photographed. The spark plug electrodes remained

mechanically undamaged, and according to the Champion Spark Plugs Check-A-Plug chart AV-27, the spark plug electrodes displayed coloration consistent with normal operation.

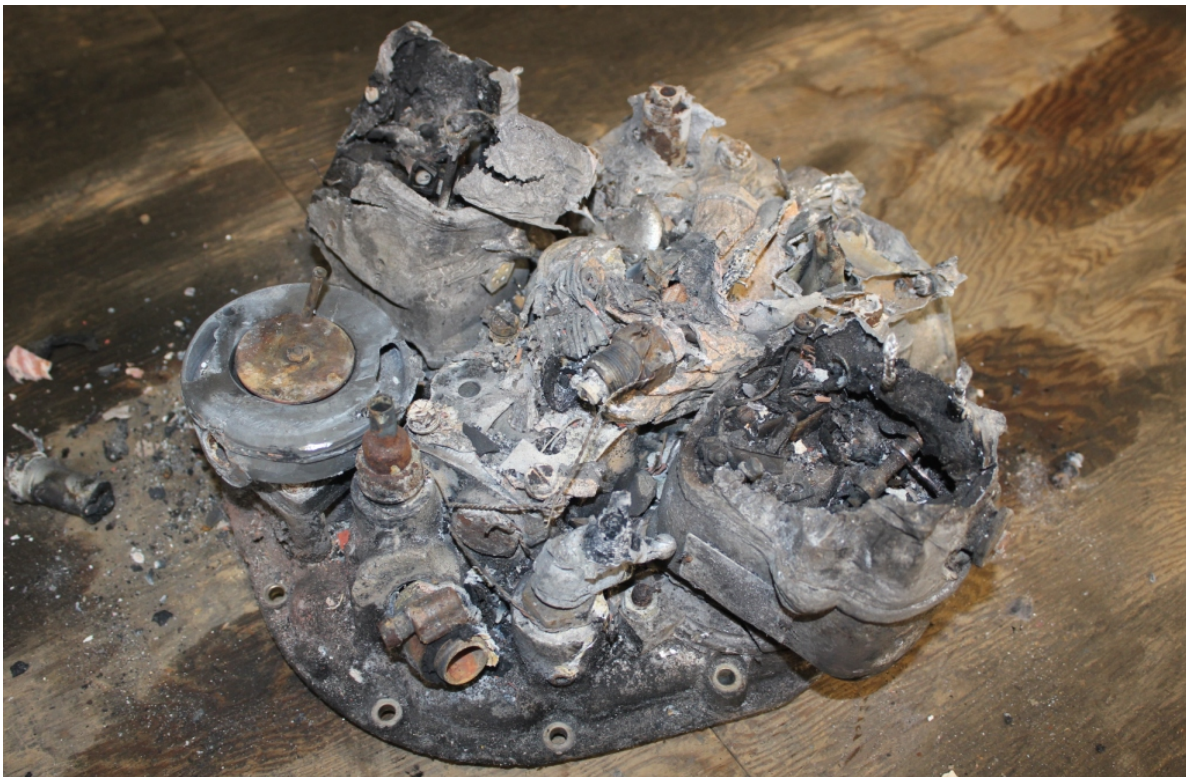
**Figure 21 - Accessory Face**

The accessory case was removed. The accessory gears including the crankshaft gear, bolt and dowel were intact and remained undamaged by any pre-impact malfunction.

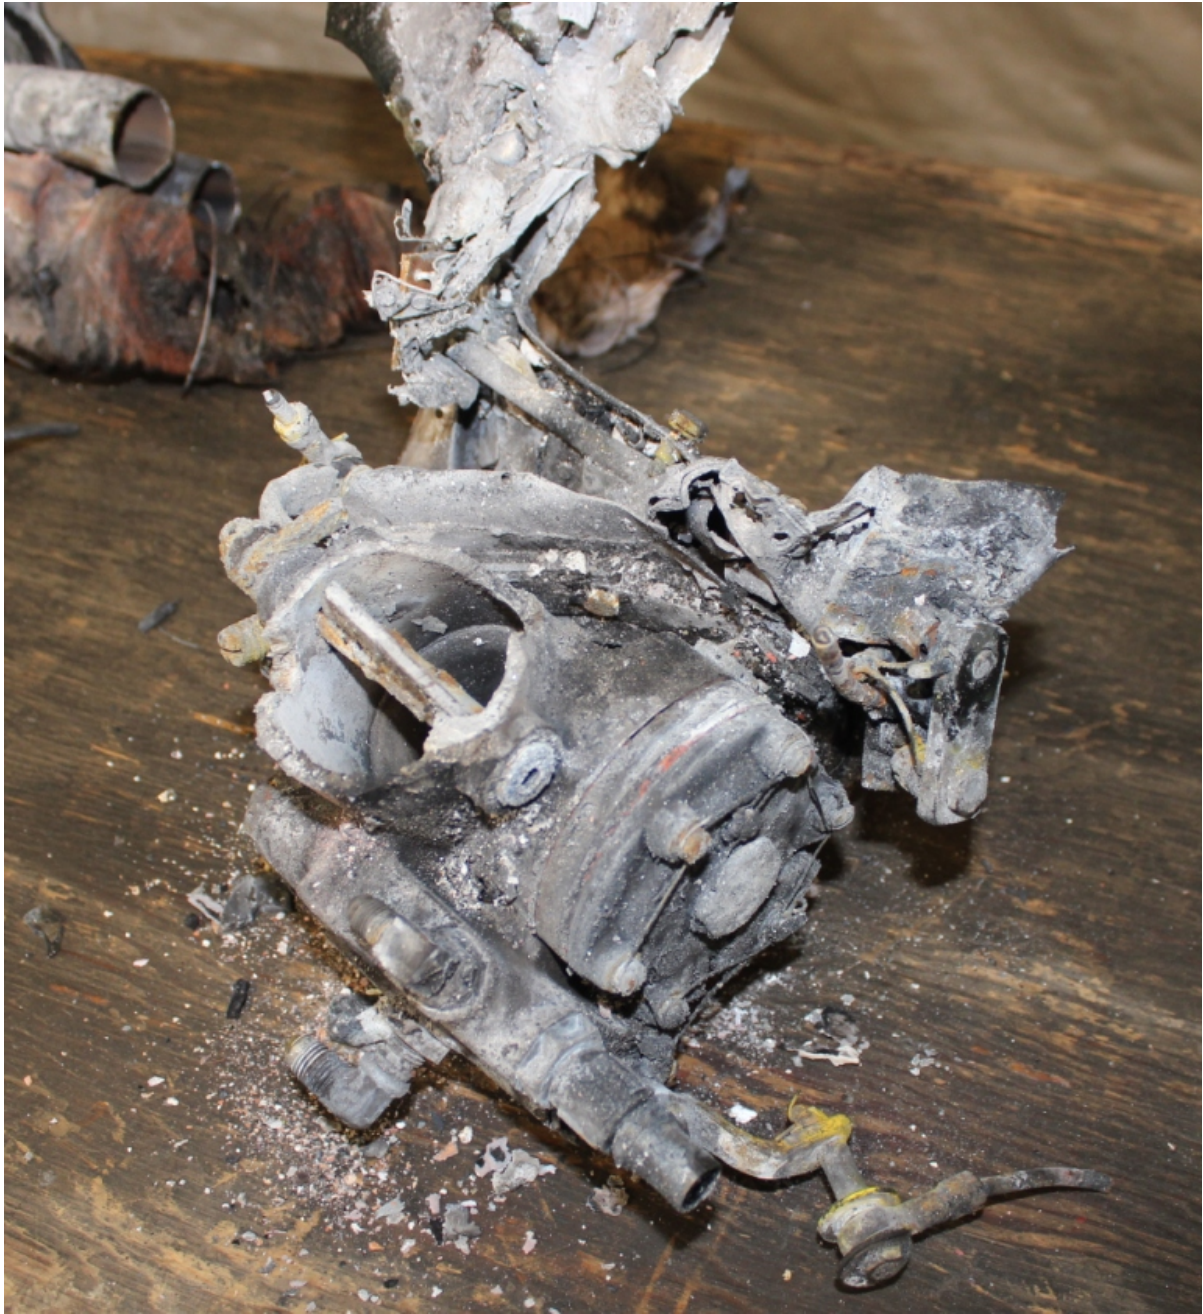
**Figure 23 - Fuel Servo**

The fuel injection servo was displaced from the engine and the portion that remained attached at the mounting pad was secure. The fracture surface signatures were consistent with overload. The throttle/mixture controls were found securely attached at their respective control arms of the servo. The castellated nut and cotter pin remained secure and the serrated interface at the throttle/mixture arm remained securely mated. The plug on the side of the injector body was secure with the safety wire in place. The servo fuel inlet screen was found properly installed and free of contamination. The fuel injection servo and induction system were examined and observed to be free of pre-impact obstruction. The fuel injection servo was disassembled, examined and photographed. The internal diaphragms were destroyed by fire.

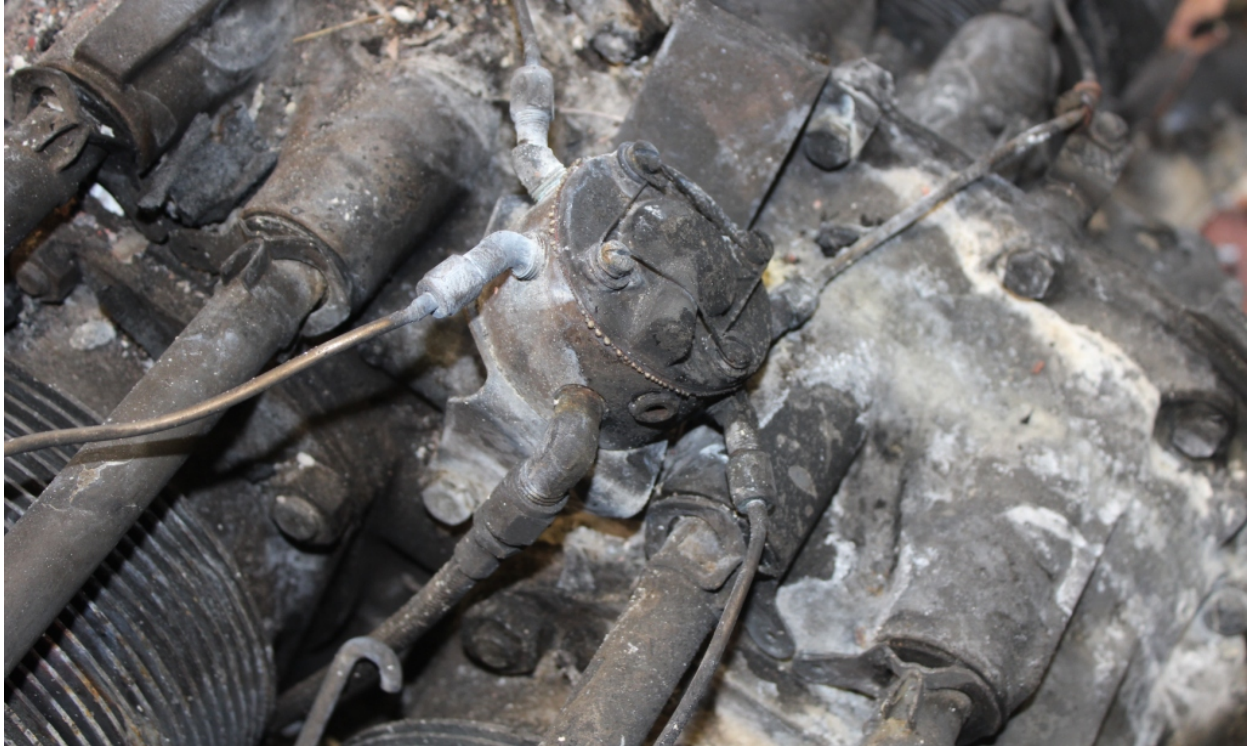
**Figure 24 - Fuel Distribution Manifold Valve**

The fuel flow divider (spider) remained secure at the mounting bracket situated at the top of the engine. The fuel lines remained secure at each flow divider fitting and fuel injector at each cylinder. The flow divider was disassembled. There was no evidence of internal mechanical malfunction or obstruction to fuel flow. The diaphragm remained intact and undamaged. The top of the diaphragm had been contaminated from the effects of fire suppression activities via the vent hole on the flow divider cover.

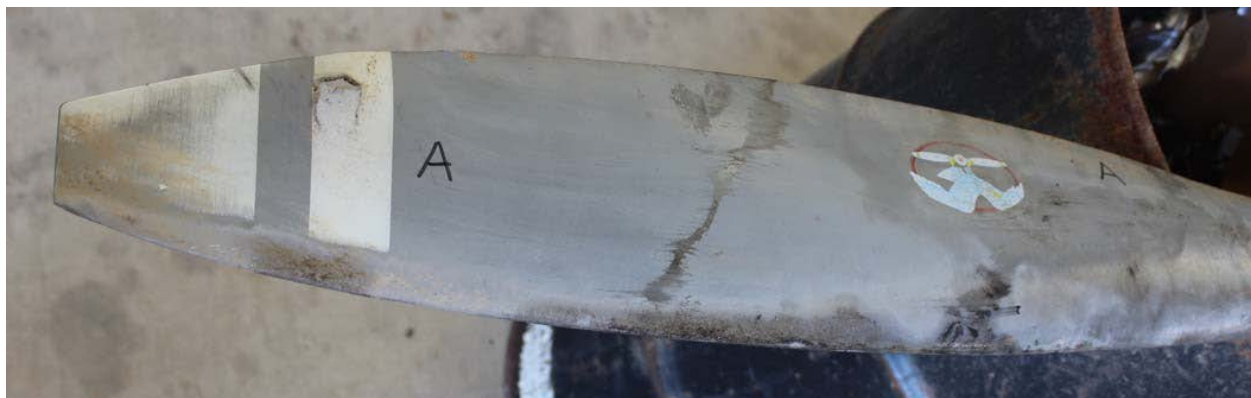
Figure 26 - Blade "A"

The propeller blades were marked “A” & “B” for narrative purposes. The propeller blade marked as “A” exhibited moderate leading edge and blade burnishing near the tip area. There was an impression and a circular through-hole about the size of a quarter on the face of the blade about 5 inches from the tip, near the blade trailing edge. The damage was consistent with a puncture in the aft to forward direction.

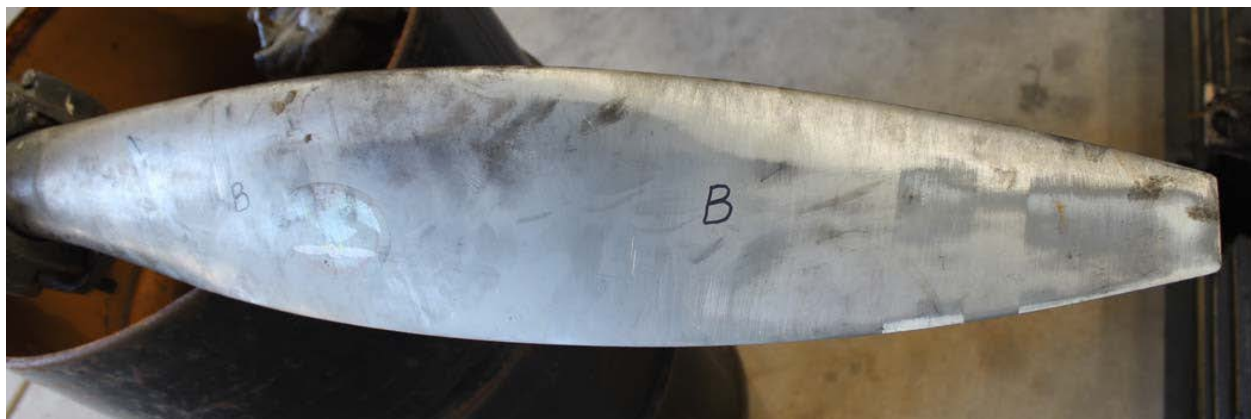
Figure 27 - Blade "B"

The propeller blade marked as “B” exhibited significant leading edge burnishing and chordwise burnishing across the cambered surface of the blade.
