NATIONAL TRANSPORTATION SAFETY BOARD

AIRFRAME AND ENGINE EXAMINATION

**NTSB Accident: WPR11GA115
Accident Date: January 31, 2011**

Location: Marana, AZ
Date: January 31, 2011
Aircraft: McDonnell Douglas 369FF, N530RL, Serial # 0602FF
NTSB IIC: Michael Huhn

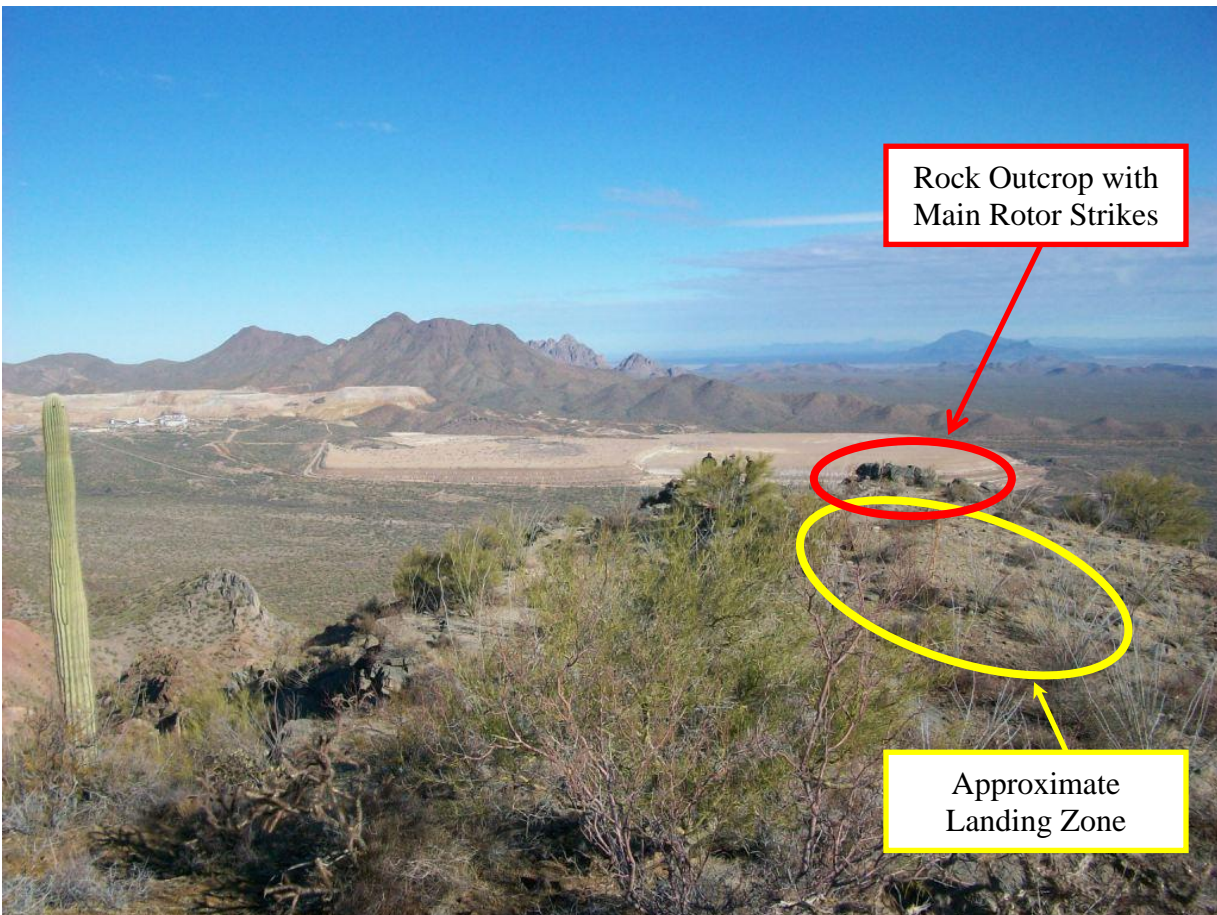
Figure 1- View of Landing Zone Looking Northwest (FAA photo)

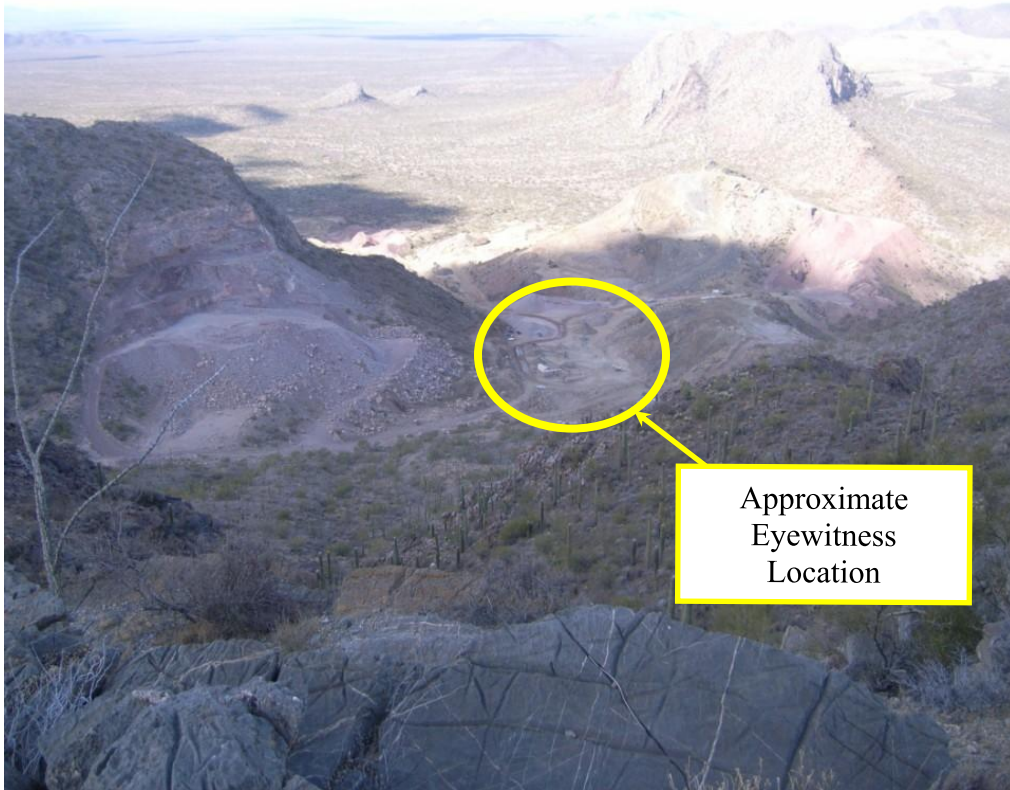
Figure 2 - View of Eyewitness' Location from Landing Zone

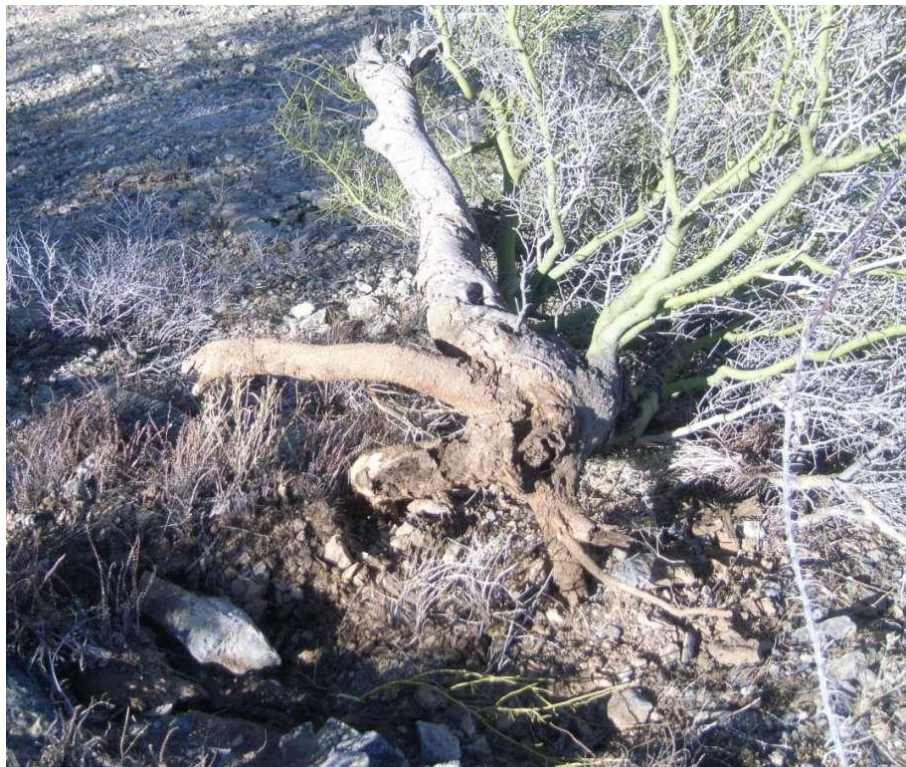
- 32° 21.027' N 111° 28.328' W (small)
 - 32° 21.025' N 111° 28.303' W (bigger, station ~124 - ~150)
 - Uprooted bush near south end (left rear quarter) of LZ

Figure 3 - Uprooted Bush Near South End of Landing Zone

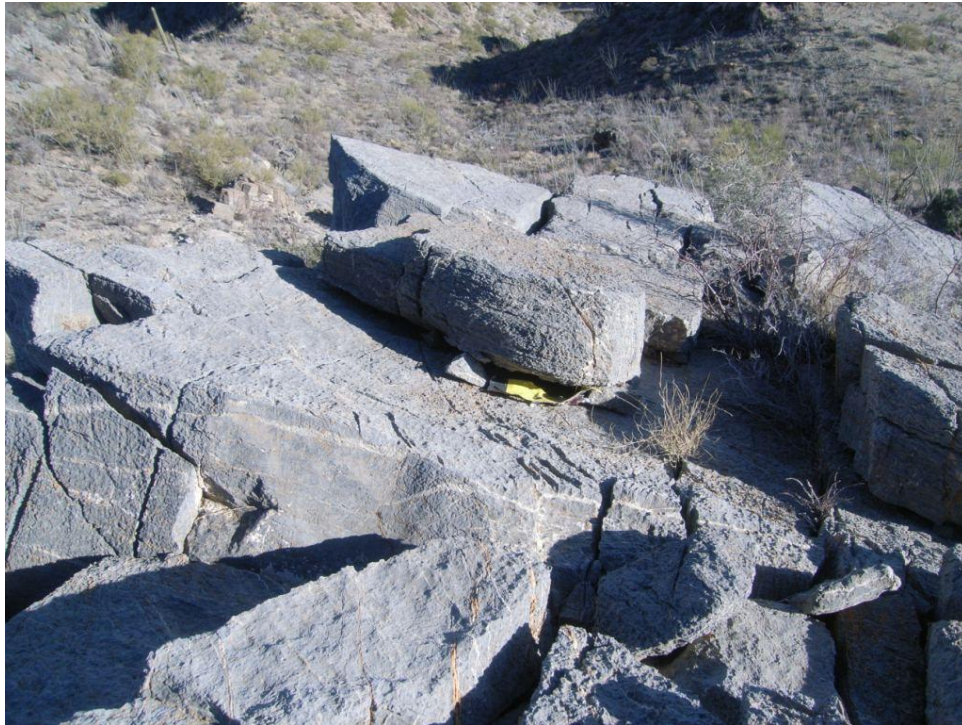
- 2-3 bushes w separated branches
 - Disturbed rock blocks (~2 ft in diameter)
 - These were at top/edge of canyon
 - Large MRB section wedged in these rocks

Figure 4 - Rock Outcrop and Main Rotor Blade Fragment

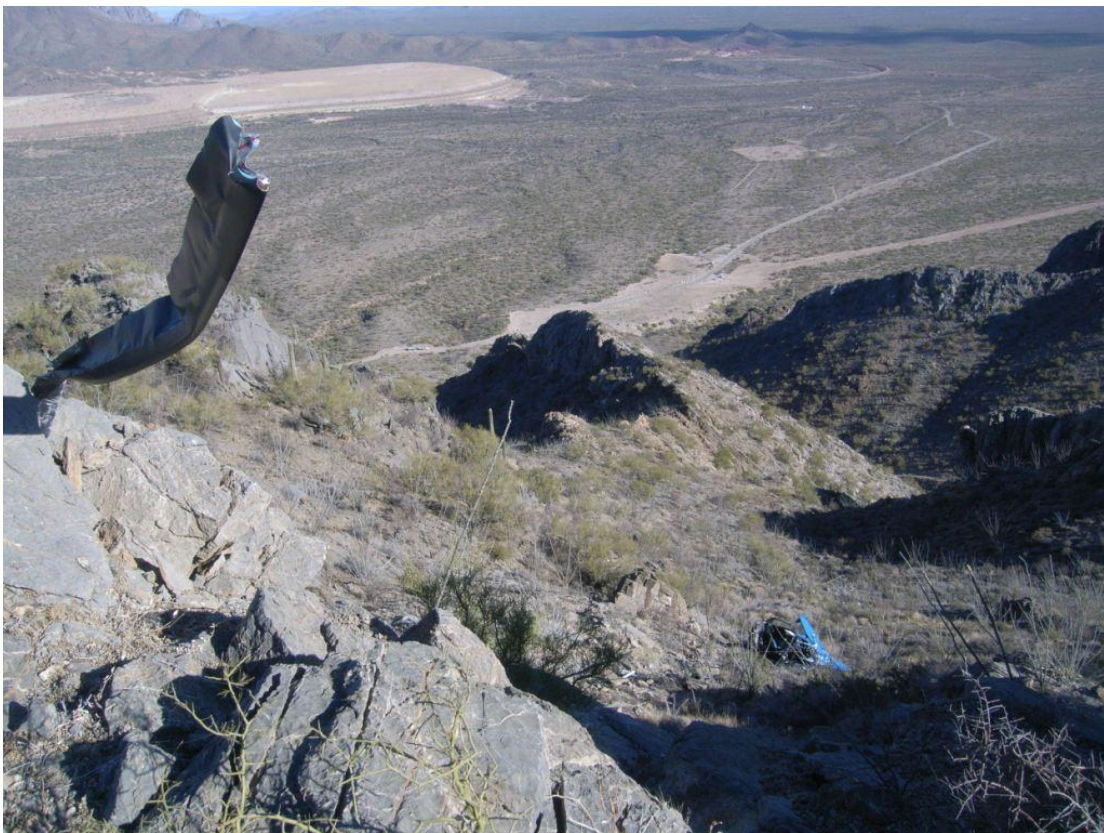
Figure 5 - View from Landing Zone Down to Wreckage (with Main Rotor Blade Fragment in Rock)

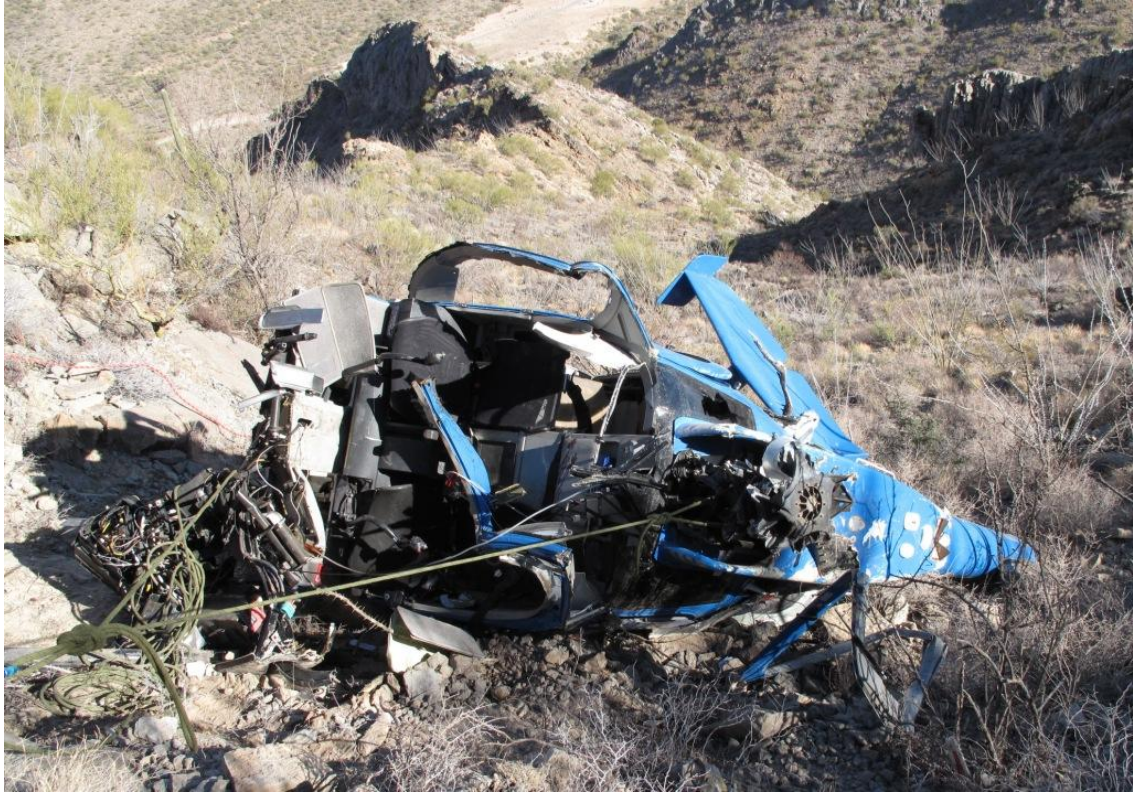
Figure 6 – Downslope View of Main Wreckage (note line securing wreckage)

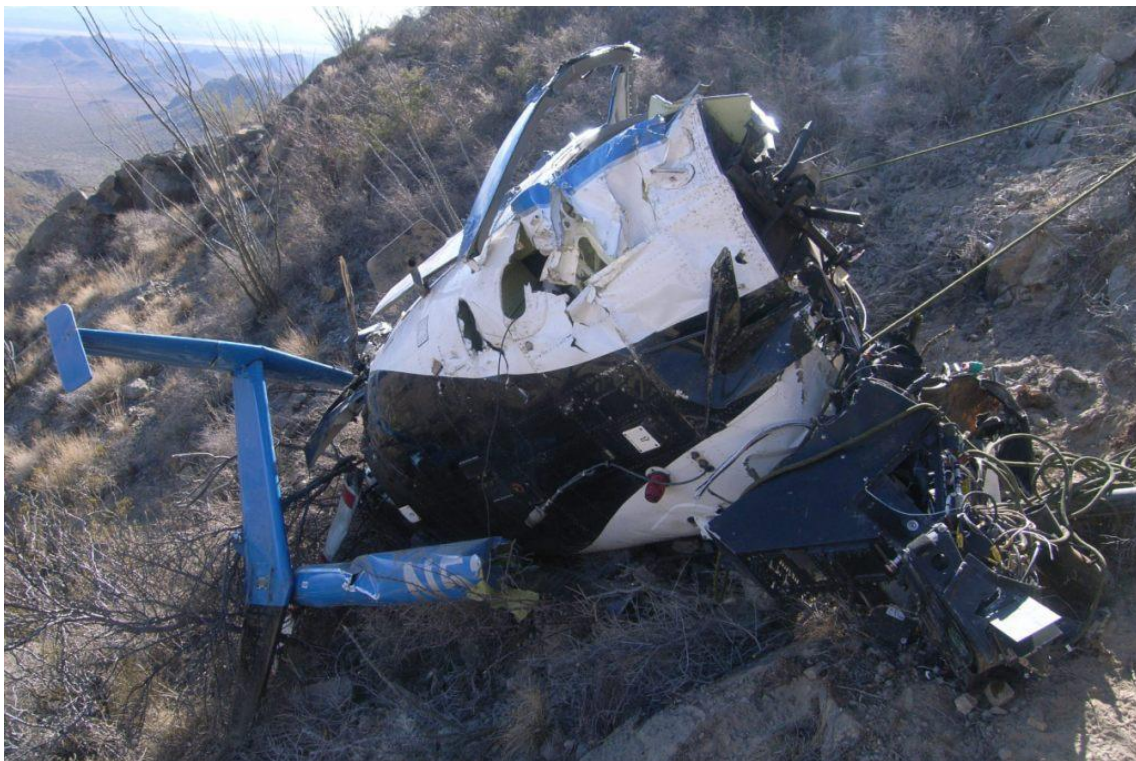
Figure 7 - Bottom View of Wreckage In Situ

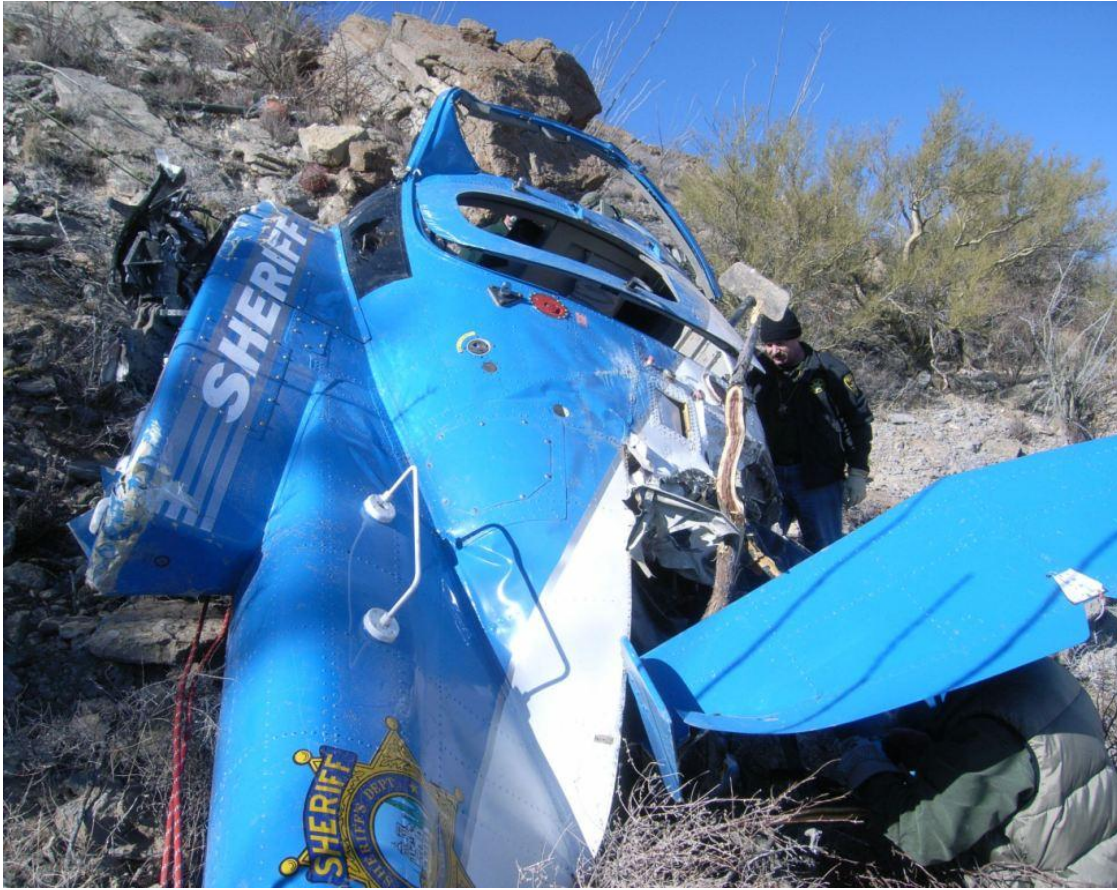
Figure 8 - Looking Upslope at Main Wreckage

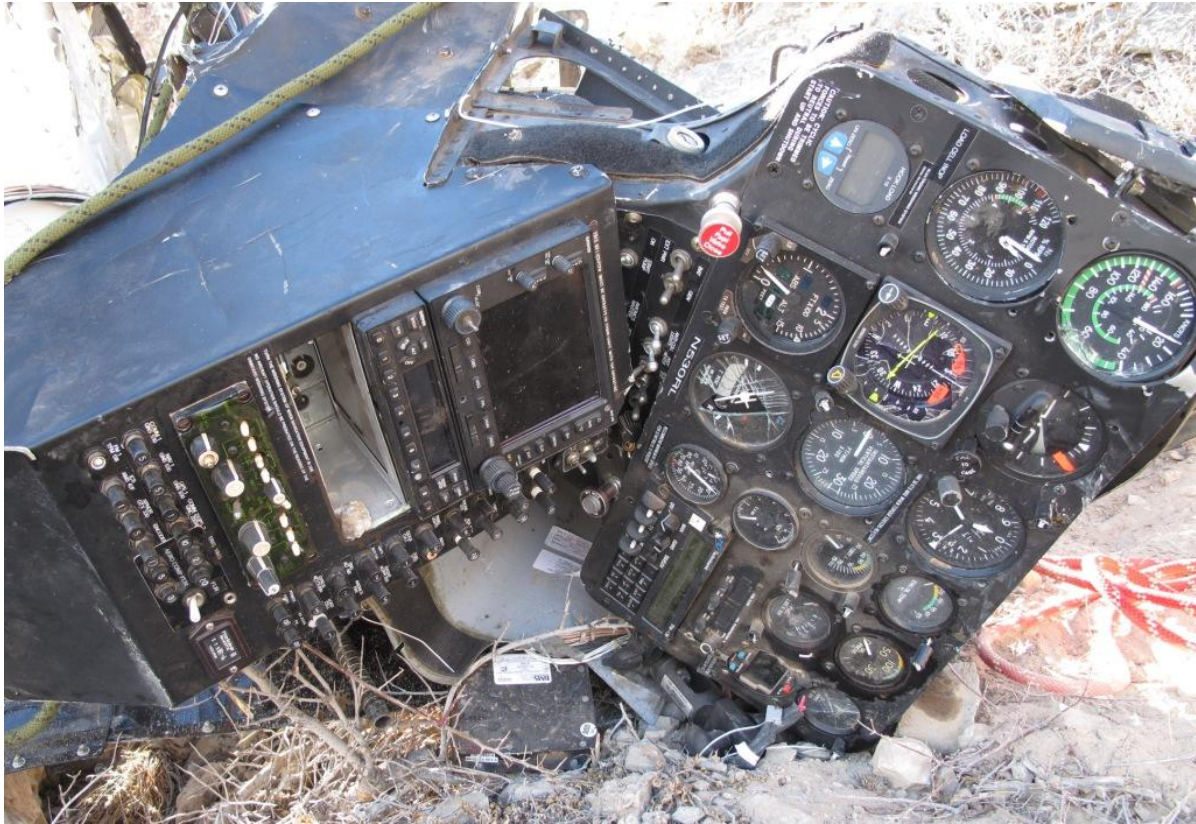
- The instrument panel was fracture-separated from its fuselage mounts.
- ELT (Ameriking AK-450, TSO-91a, 121.5Mhz) installed, connected, armed, red light blinking - NTSB shut off & disconnected antenna
- Hobbs 519.0
- GPS, Garmin 530
- No flight follow/tracking system installed
- No TAWS system installed
- Passenger video camera in use during flight

Figure 9 - Two-Segment Instrument Panel Outside Helicopter

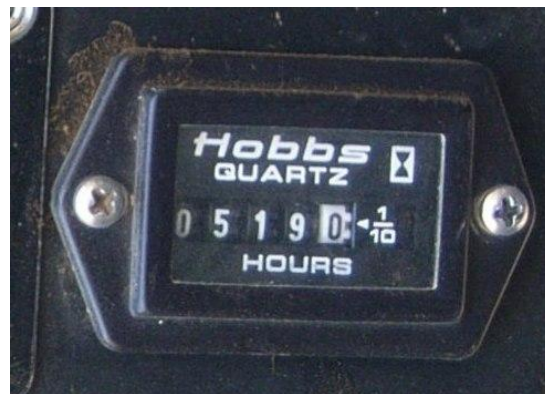
Figure 10 - Hobbs Hour Meter

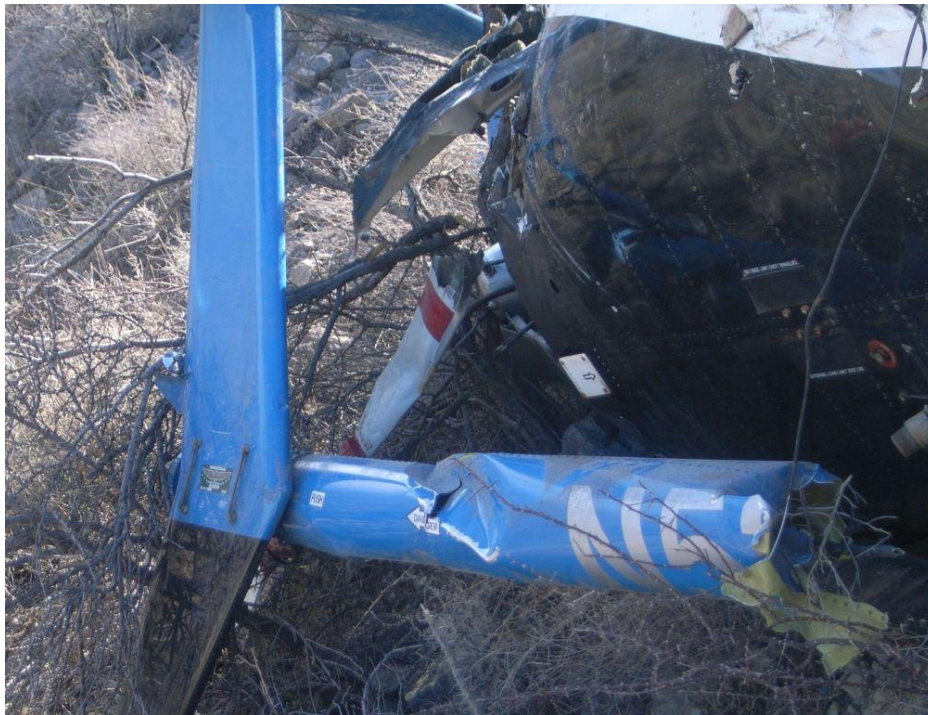
The tail boom was separated from the fuselage approximately 5 feet forward of the aft end of the boom, and was situated along the right side of the fuselage. The vertical and horizontal stabilizers remained attached to the tail boom. The tail stinger was not bent,

Figure 11 - Tail Boom and Tail Rotor In-Situ

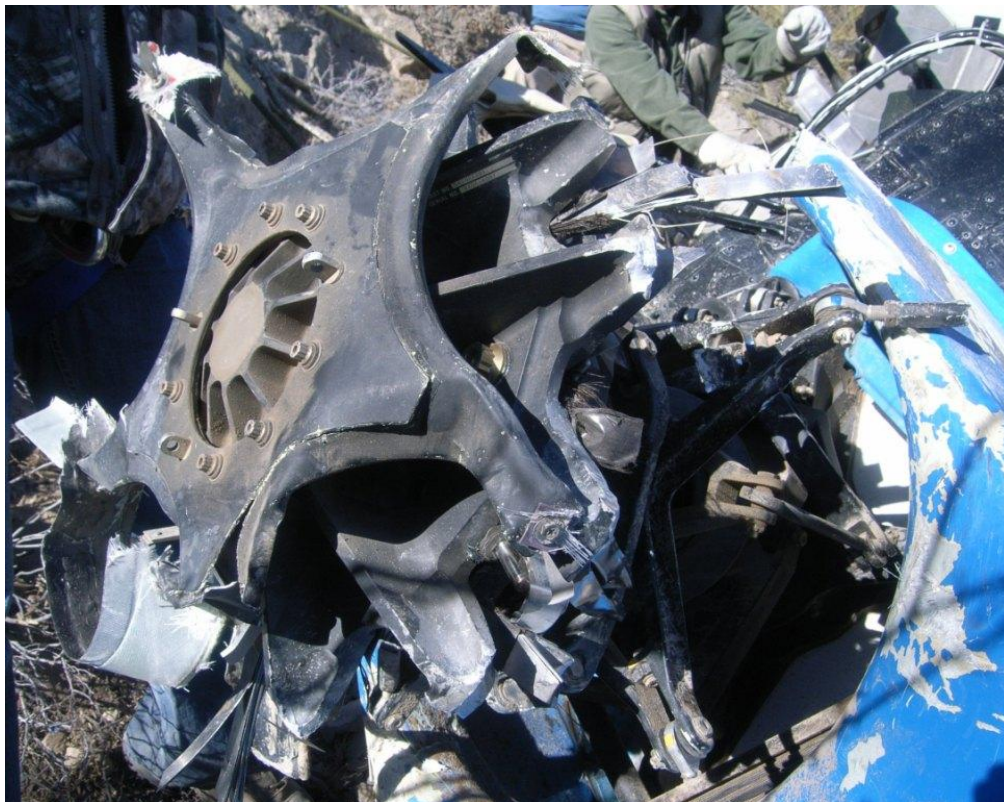
- All 5 MRBs fracture-separated from hub
 - 4 actuator/dampers separated from hub
 - 1 remained partially attached to hub
- Cyclic controls, continuity good

Figure 12 - Main Rotor Hub

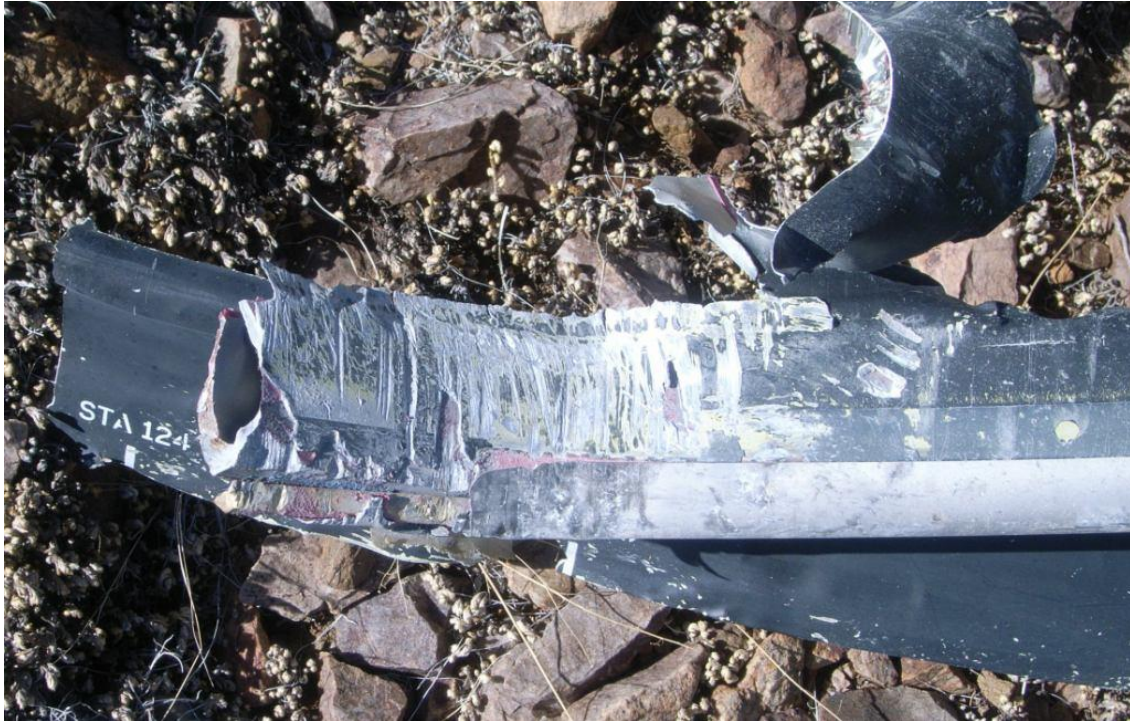
Figure 13 - Segment of Main Rotor Blade with Chordwise Scoring

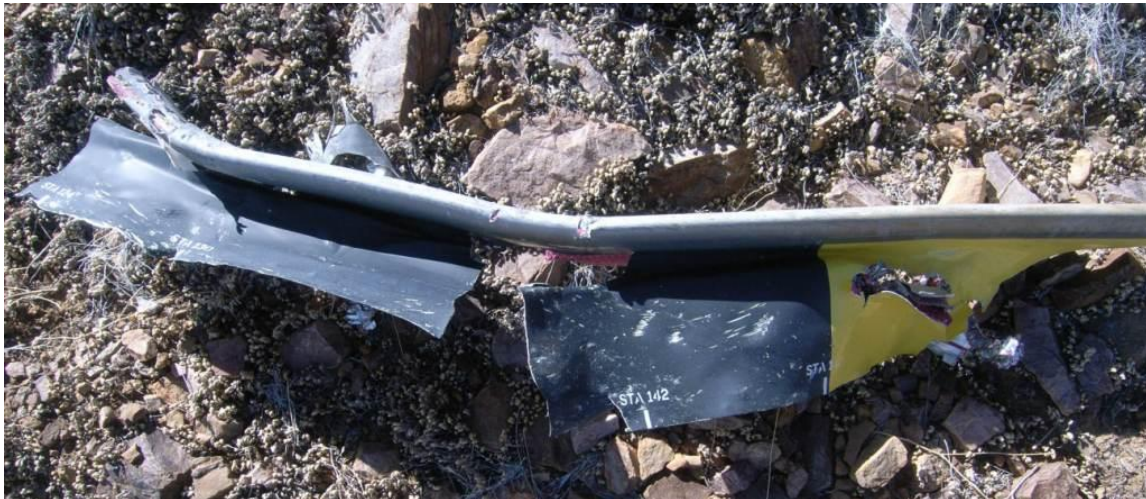
Figure 14 - Additional Main Rotor Blade Fragment

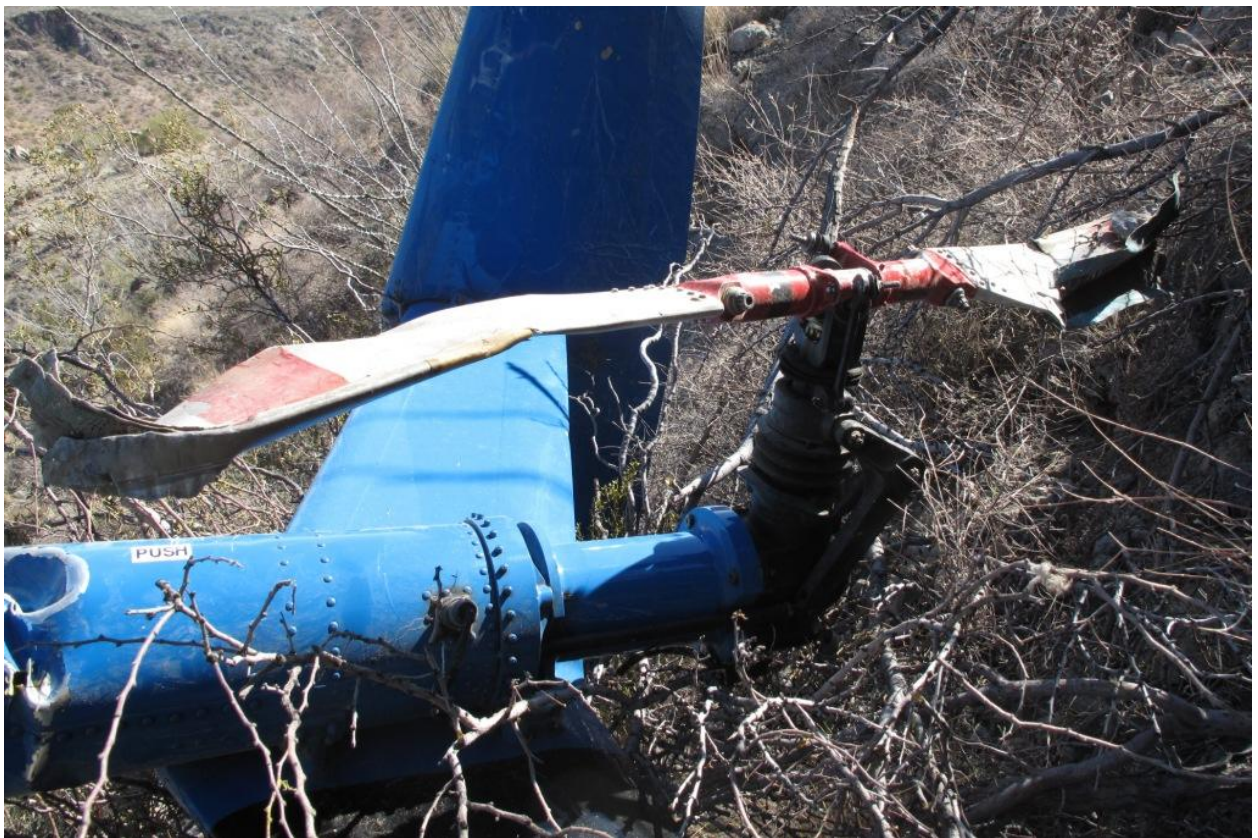
Both tail rotor blades were damaged. Several inches of each blade were fracture-separated, and the remaining blade segment ends had rotational abrasion damage. The tail rotor drive shaft was fractured into three sections. The tail rotor drive shaft and control rod fracture locations coincided with the tail boom fracture locations. The tail rotor gearbox, swash plate, pitch links, fork, and hub rotated freely, and had no visible damage. The pilot's tail rotor pedal bracket was fractured, consistent with the damage to the lower fuselage, instrument panel and front canopy damage. Pedal control continuity was verified from the right tail rotor pedals aft to the tail boom separation, and from that separation point to the tail rotor blades.

Figure 15 - Tail Rotor (Note missing ends)

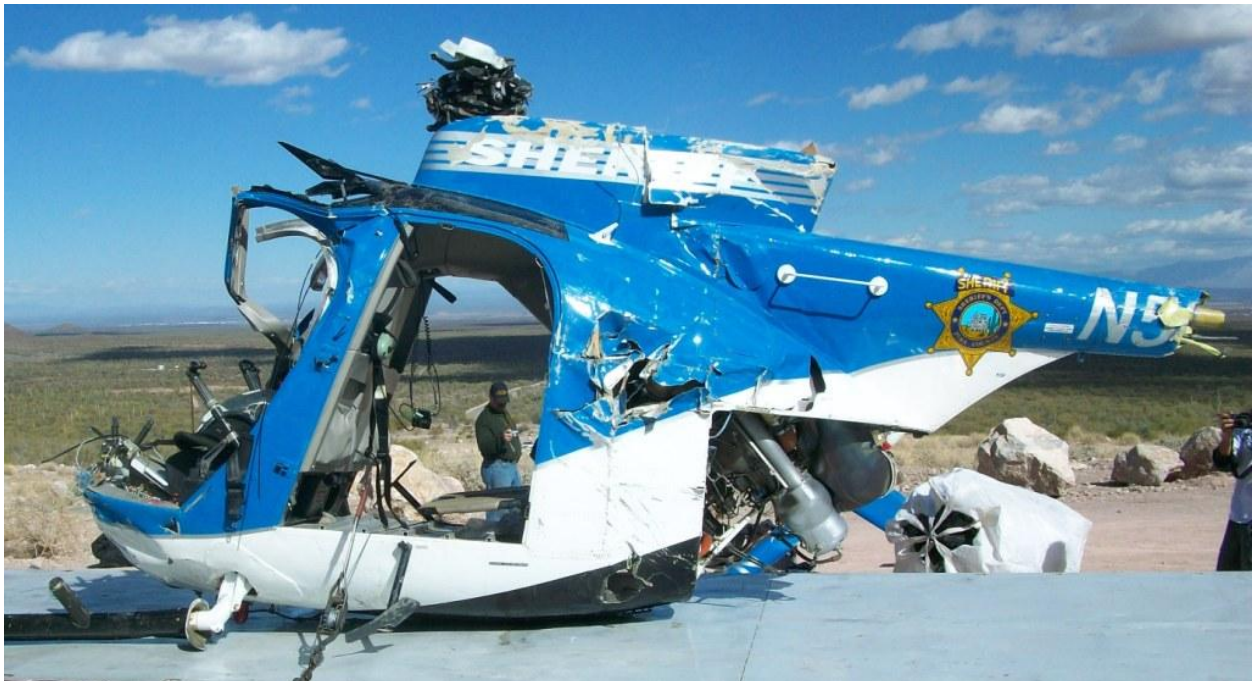
The front canopy frame and transparencies were extensively fractured. The instrument panel was fracture-separated from its pedestal mounts. The forward fuselage structure, cockpit floor, fuselage station (FS) 44.65 bulkhead and lower skins were severely crushed and deformed. The external fuselage skins and door frames were dented, crushed and deformed. The rear cabin A-frame structure and interior cabin appeared relatively undamaged.

Figure 16 - Fuselage Immediately After Recovery from Mountain (MDHI photo)

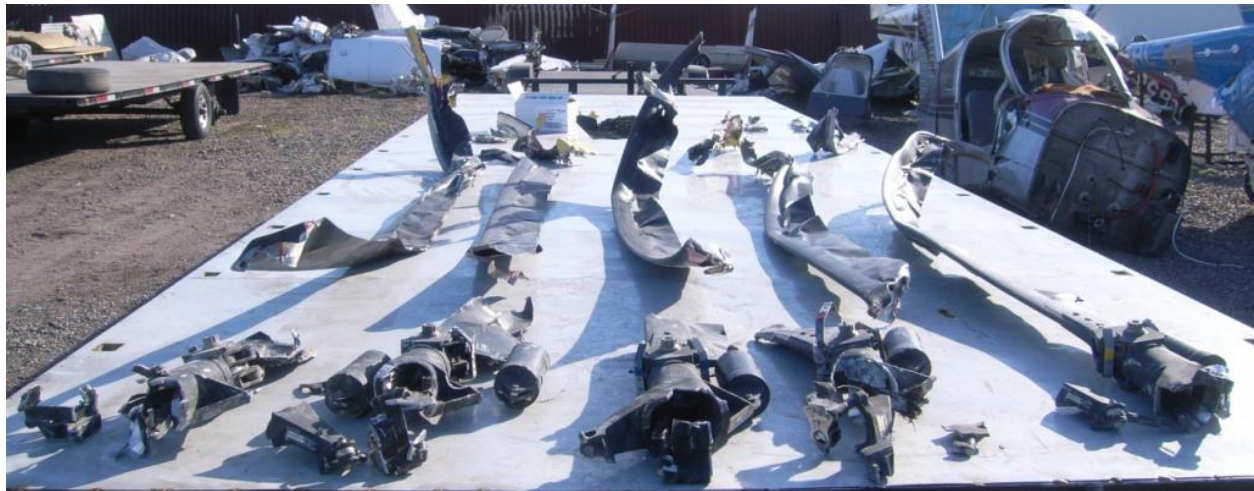
The five main rotor blades were separated from main rotor hub. The strap packs, main rotor dampers and main rotor blades exhibited multiple fractures consistent with impact while being rotationally driven. Two of the main rotor static mast legs were found fractured. The outboard sections of the main rotor blades were highly fragmented, with deep chordwise scratches. There were contact marks on the rock outcrop at the top of the canyon, and one main rotor blade remained lodged in the rock outcrop. Sections of the main rotor blades were found in the canyon, and above the canyon on the pinnacle.

- Only 2 tips located but 3 total tip weights recovered
- Heaviest blade scoring (consistent with rock impact) observed on Green and White blades at outboard fracture ends
- Also scoring on two small, free segments
- Dampers;
 - Partially attached to blade: Yellow, Blue
 - Completely fracture-separated from blade: Red, White, Green

Figure 17 – 2-D Layout of Main Rotor Blades (Green, White, Blue, Red, Yellow)

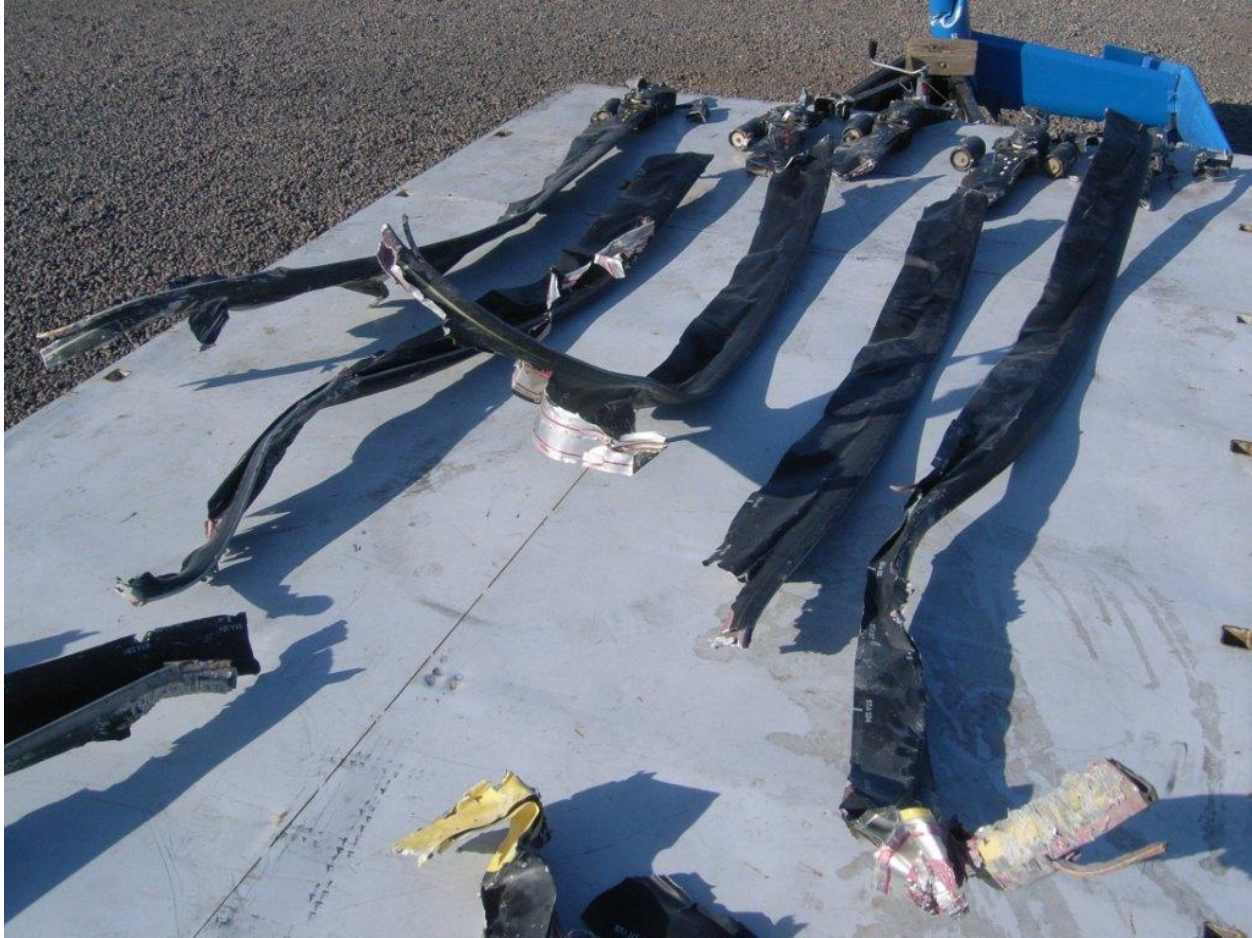
Figure 18 – 2-D Layout of Main Rotor Blades (Yellow, Red, Blue, White, Green)
