NTSB Identification: ERA16LA082
Accident occurred January 6, 2016 in Savannah, GA
Aircraft: Pilatus PC-12NG, Registration: N978AF

Introduction:

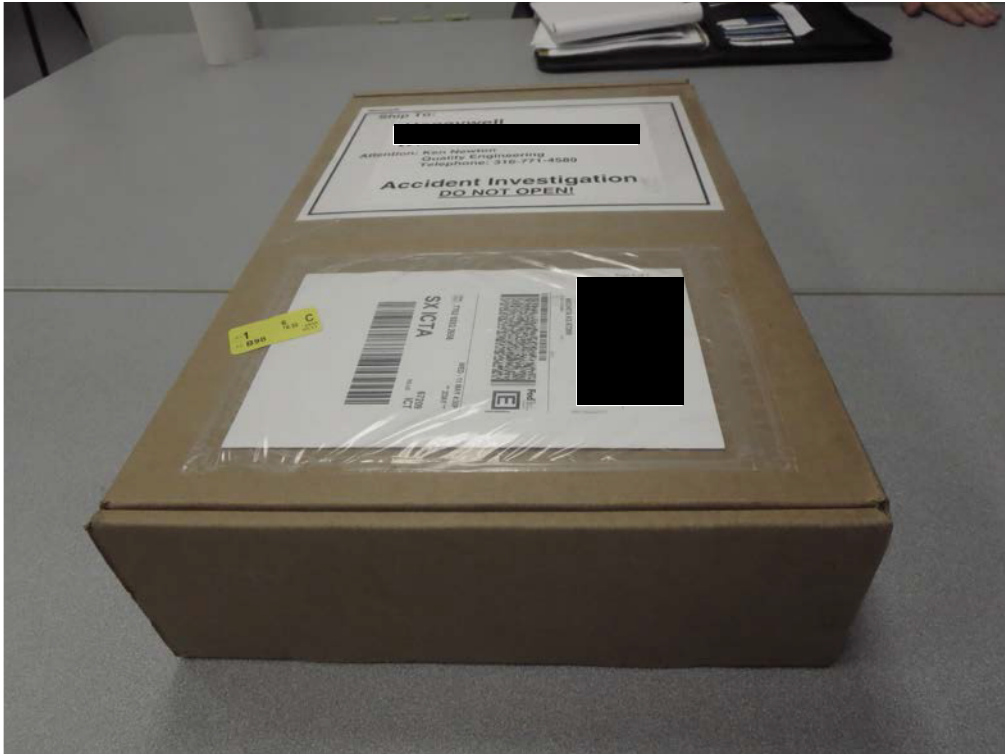
Figure 1. CSIO Module in Packaging as Received

1. The CSIO module was received in a standard Apex module shipping box. (Figure 1)
2. The CSIO module was removed from its protective Electro Static Discharge (ESD) bubble wrapped bag. (Figure 2)

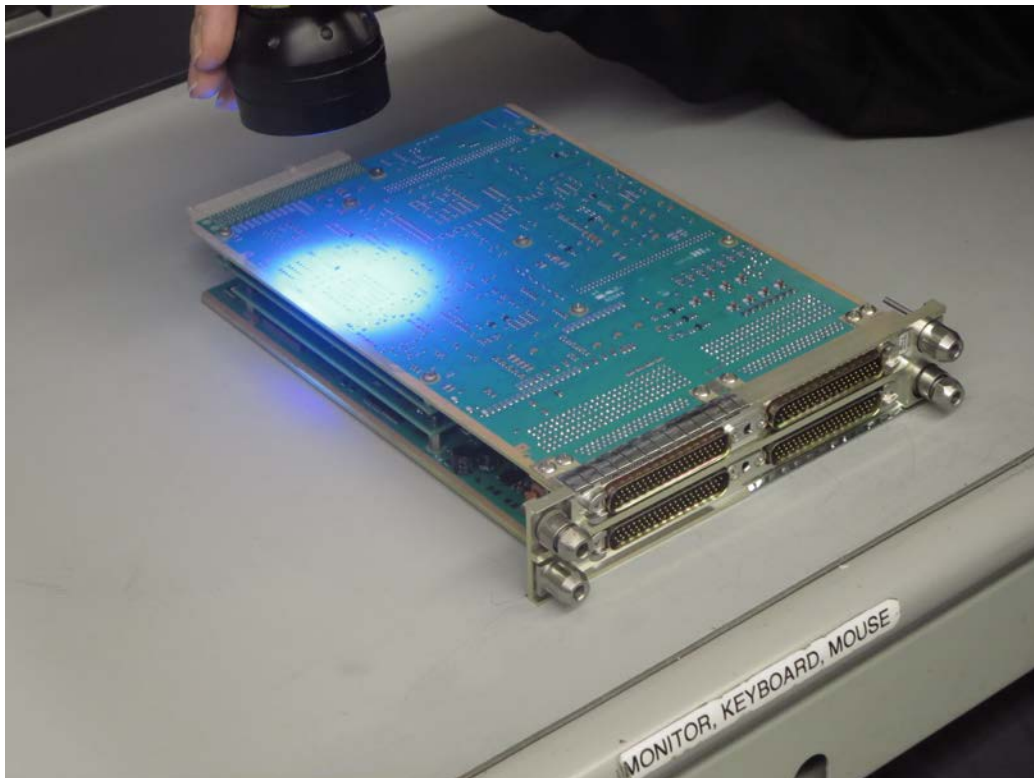
Figure 3. CSIO Module Being Inspected With A Black Light

3. A physical Inspection, including the use of a black light, was performed in order to look for any possible sheared components or damaged connectors (Figure 3).

- a. A burned smell, typical of burned electronics, was present with the unit. The source of the smell could not be determined.
 - b. The CSIO module appeared to be undamaged.

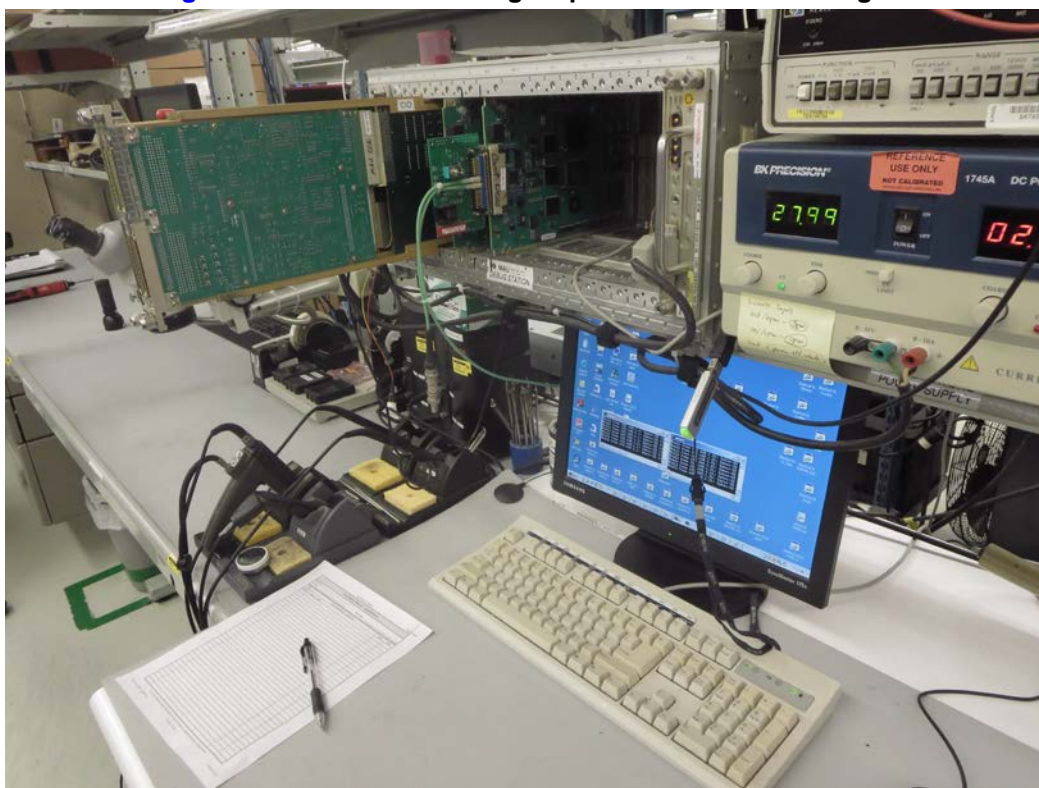
Figure 4. CSIO Module Installed Into Test Fixture for Downloading

4. The CSIO module was then installed into a test stand in order to download the stored Non-Volatile Memory (NVM) information out of the unit. (Figure 4). The following procedure was used for downloading as well as the data that was gathered.

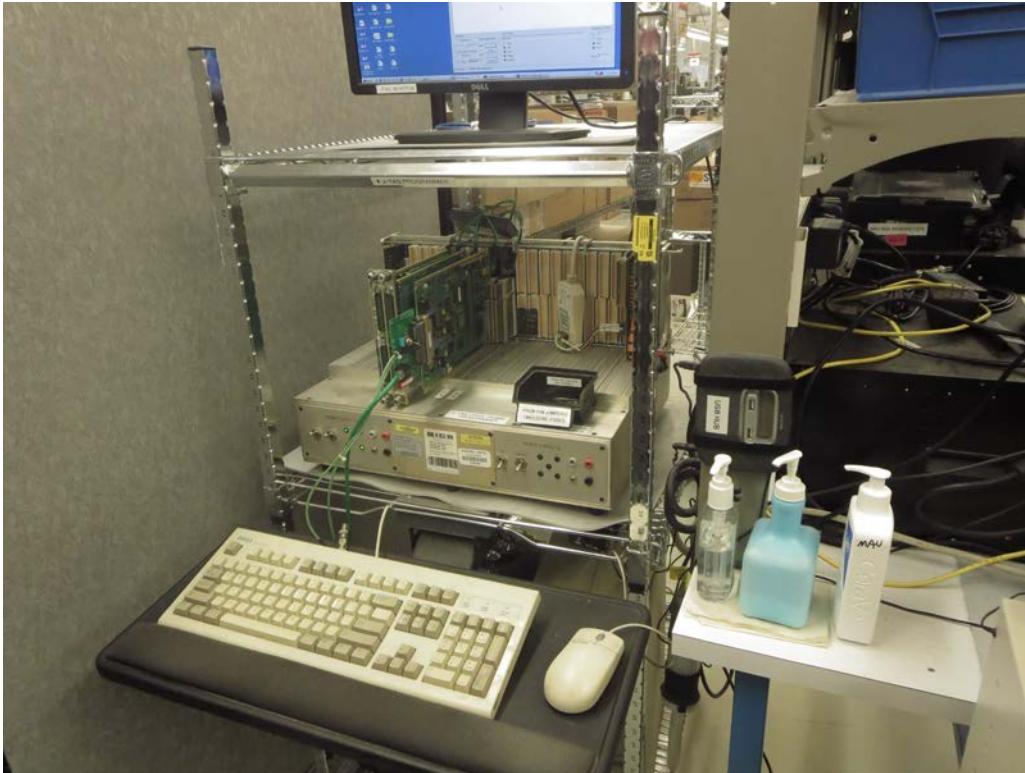
Figure 5. CSIO Placed in the JTAG Hbit Loading Fixture

5. After the NVM downloads were completed, the Hardware Built In Test (Hbit) operating system was loaded to both channels of the CSIO on the JTAG Hbit loading fixture using the respective JTAG port for each CSIO (Figure 5). The Hbit software is required for testing purposes which was to occur in the next steps.

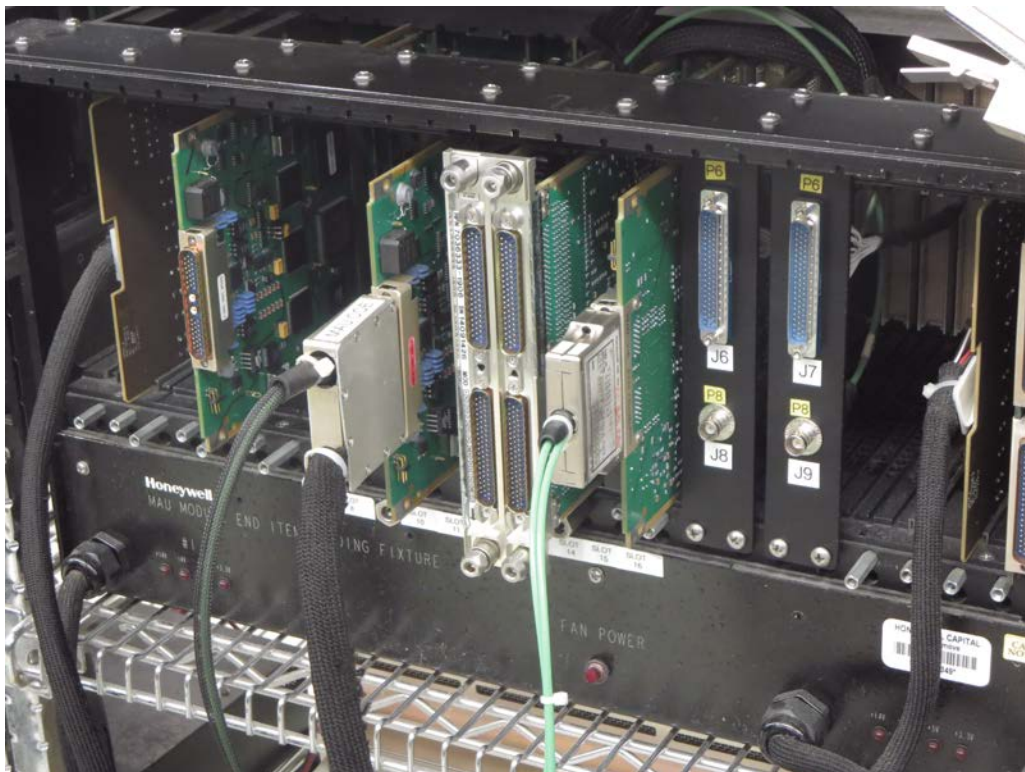
Figure 6. CSIO Placed in the Vector Test Platform

6. The CSIO was then placed into a Vector Test Platform for automated testing. (Figure 6)
7. The end item test (IT7036333-1902 Rev J) was run to the Apex test scenario (MT7036333-102, Rev F). (See data file "APEX Cust I_O in A13.txt" for test results).

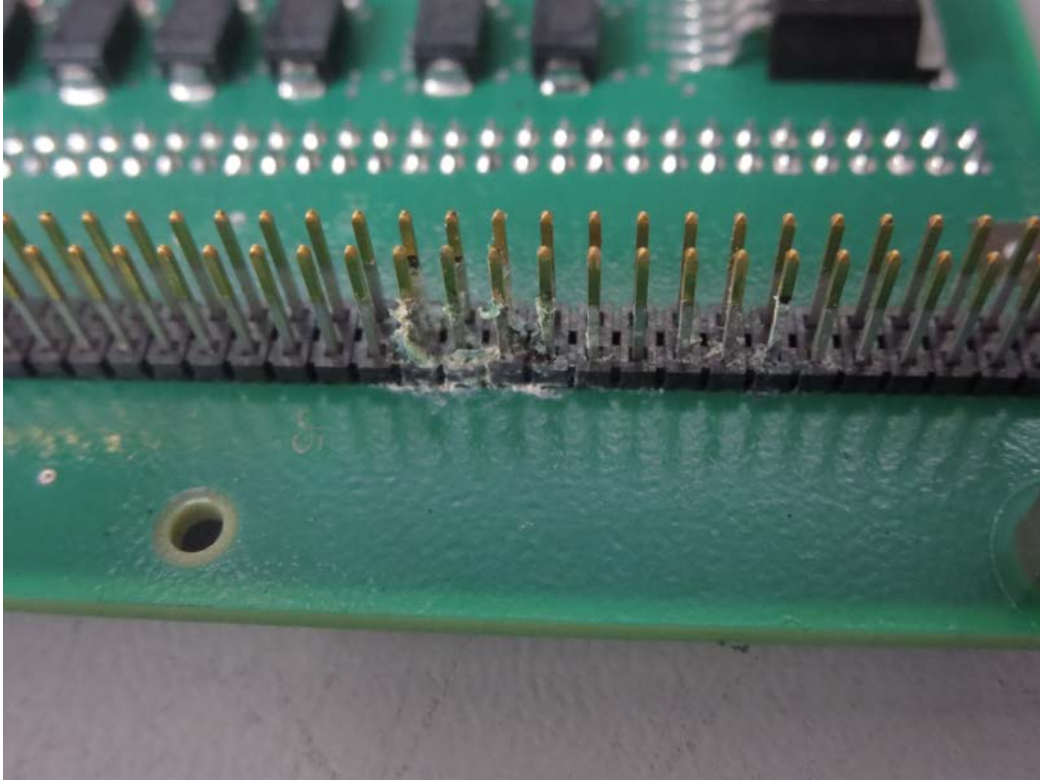
8. After the end item test was completed, the unit was disassembled for further inspection.
9. A small amount of debris was identified on a couple of pins of the unit, internal to the CSIO (Figure 7). The source of the debris was unable to be determined. Testing was not performed in order to determine the composition of the debris. The debris appeared to be indicative of a corrosion/mold growth.

Figure 7. "Growth" Identified Within CSIO Module
