**NATIONAL TRANSPORTATION SAFETY BOARD**

**LEFT & RIGHT ELEVATOR EXAMINATION**

**WPR12FA332**

# Airplane Examination Report

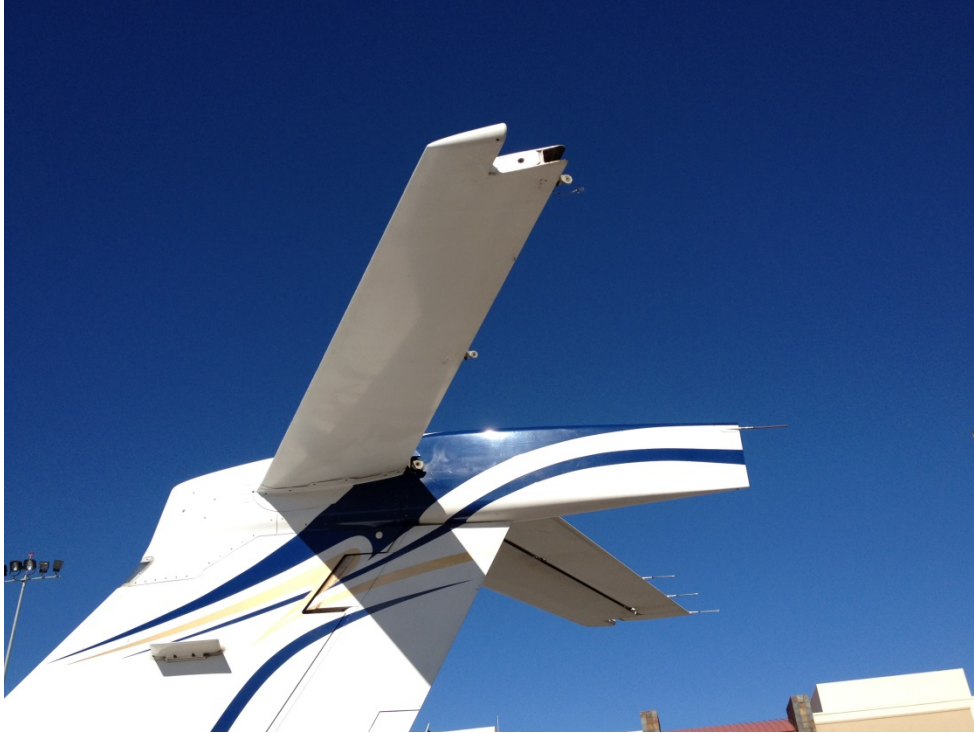
Photo taken Saturday, July 28, 2012, at Henderson Executive Airport.

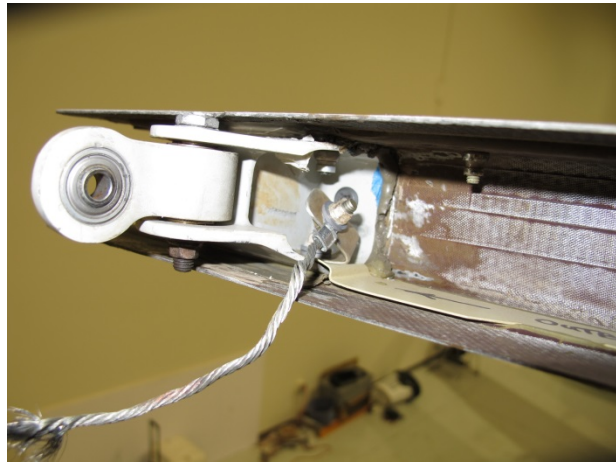
Left outboard elevator attachment fitting.

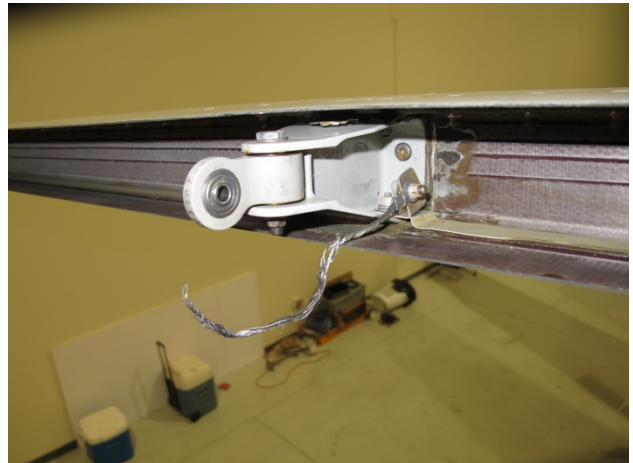
Left midspan elevator attachment fitting.

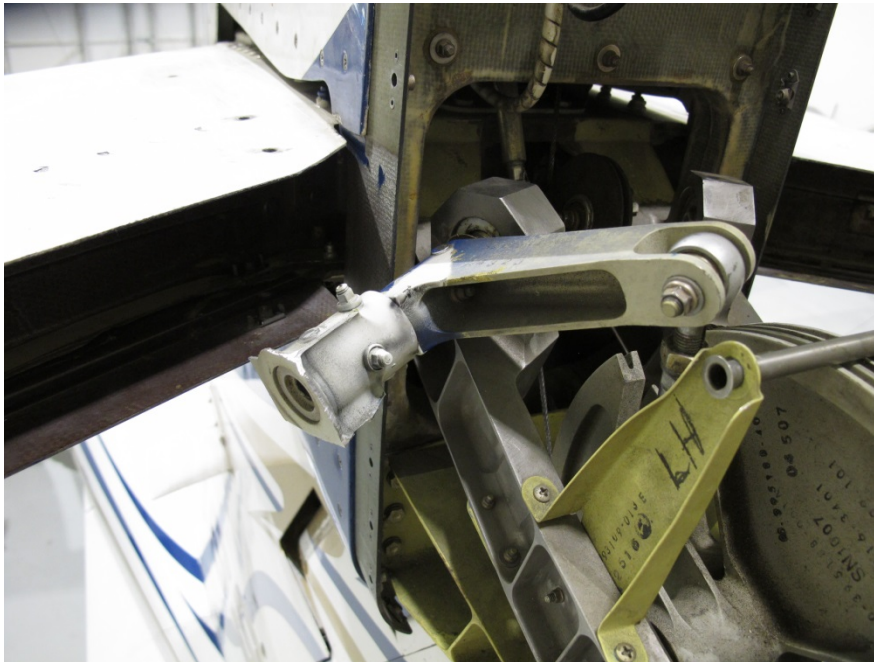
- Left elevator command lever separated from elevator torque tube. Fracture surfaces are bright, granular, with 45-degree shear lips.
- Elevator command lever bearing present with the command arm attach bolt secure. Outboard bearing seal had popped off.

Left elevator command lever with torque tube attached.

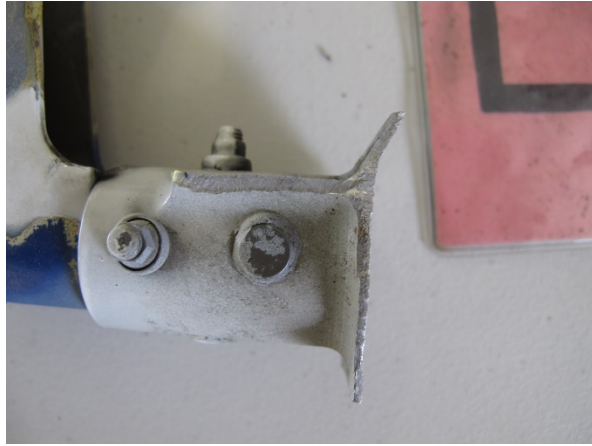
Left elevator command lever torque tube fracture.

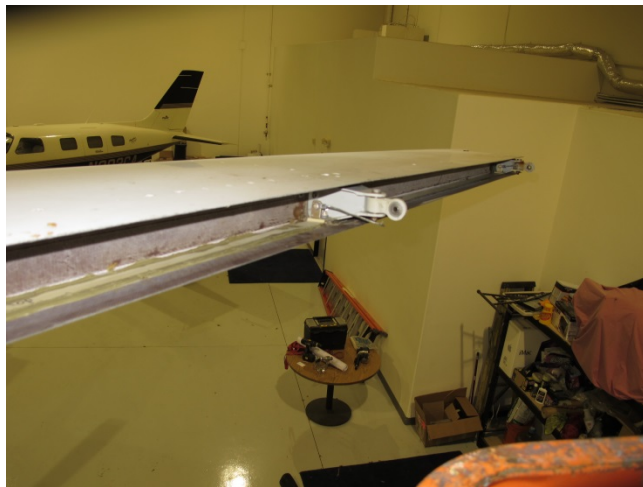
- Right elevator had been removed by an A&P Mechanic under the direction of Avantair on Sunday, July 29. The attaching hardware (bolts, bushings, & nuts) were removed and FedEx'd to Avantair's facility in Clearwater, FL.

Right horizontal stabilizer with elevator removed.

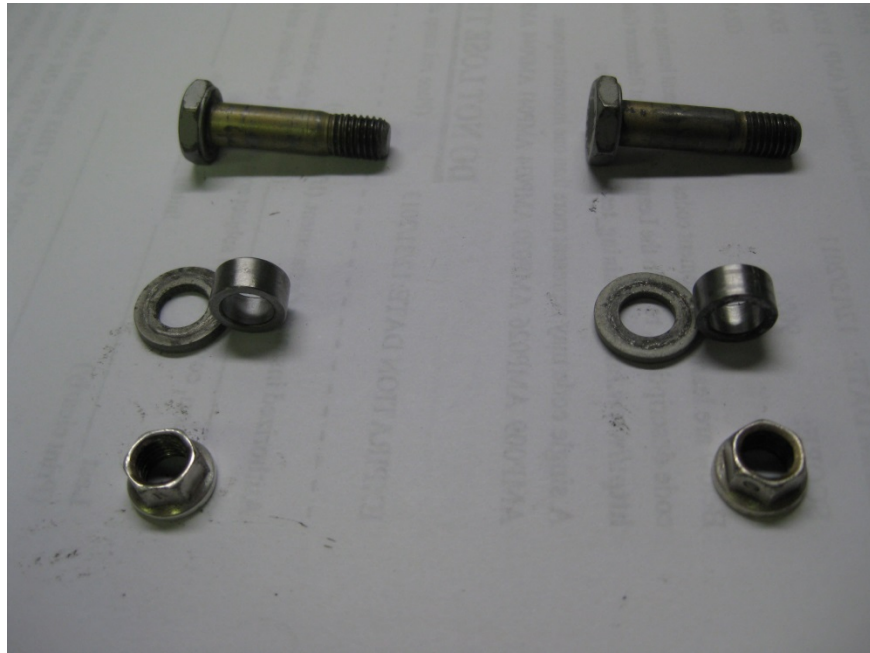
Right hand elevator attachment hardware. Hardware was removed by a A&P mechanic on 29 July, 2012, and sent to the Avantair facility in Florida. FAA Inspectors were present when the hardware package was opened by Avantair personnel. The photo is the hardware as received by Avantair and FAA personnel.

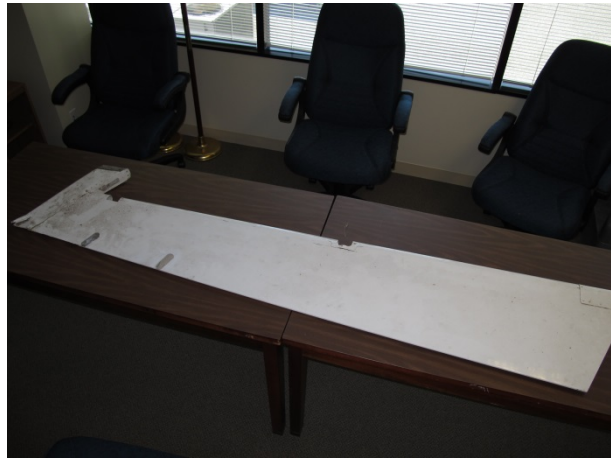
Left elevator - upper surface

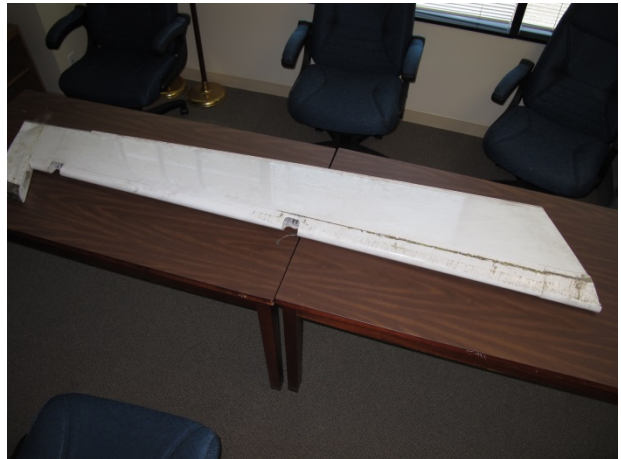
Left elevator - lower surface

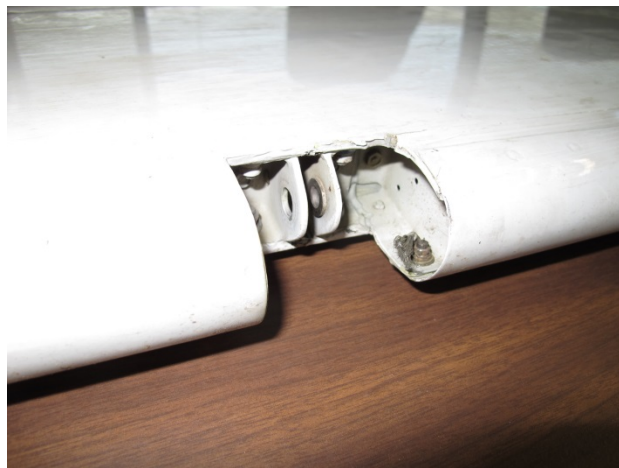
Left elevator - outboard hinge point.

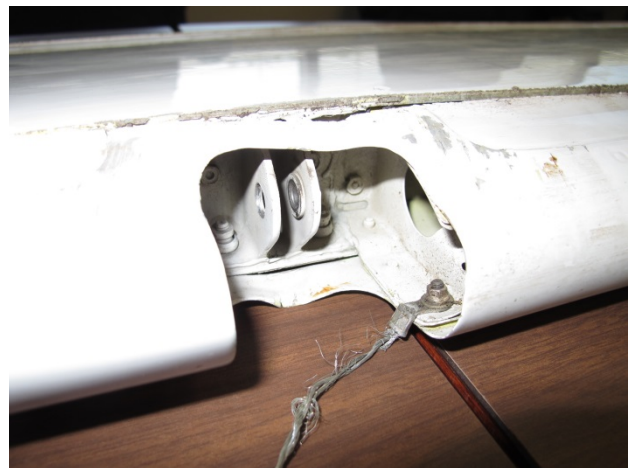
Left elevator - inboard hinge point.

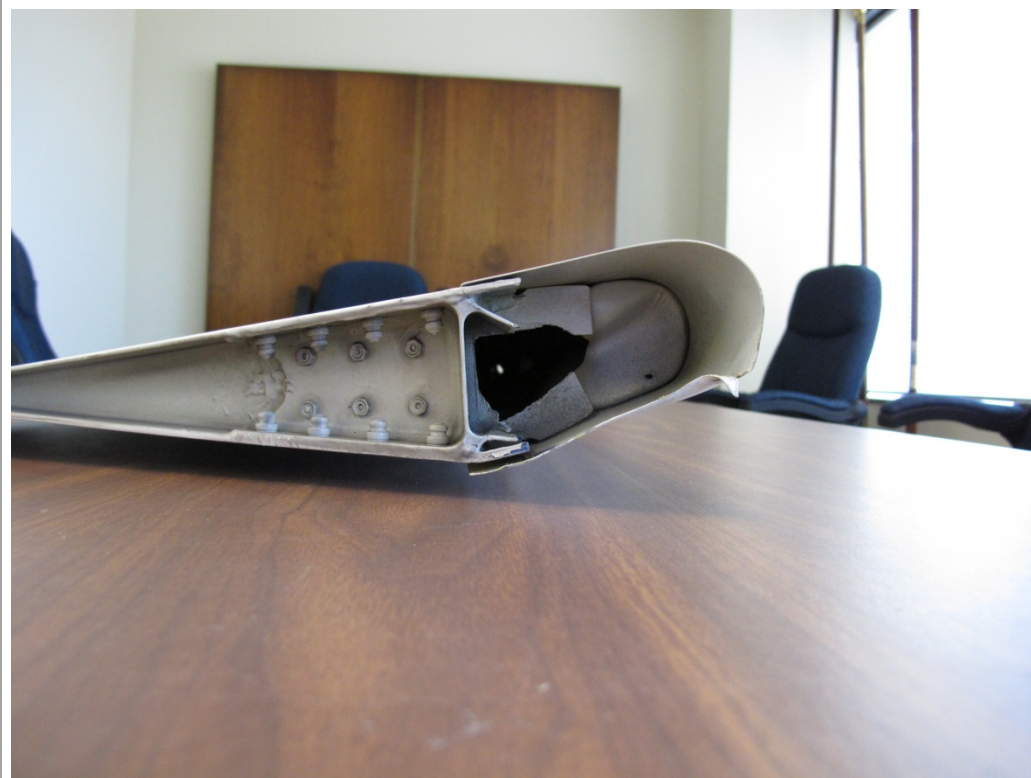
The elevator was placed on a table and photographed. The elevator attachment brackets were present on the elevator and did not exhibit unusual wear or deformation. The elevator command arm torque tube was not present and the structure where the torque tube normally is located exhibited bright and granular fracture surfaces.

Left elevator root - torque tube structure & separation fracture surfaces.
