NATIONAL TRANSPORTATION SAFETY BOARD

Colgan Air Flight 9446 Airplane Performance Study

A. Accident: NYC03MA183 (key 57787)

LOCATION:	Yarmouth, MA
DATE:	August 26, 2003
TIME:	Approximately 15:40 EST
AIRCRAFT:	Raytheon (Beech) 1900D, N240CJ
OPERATOR:	Colgan Air (d.b.a. US Airways Express)

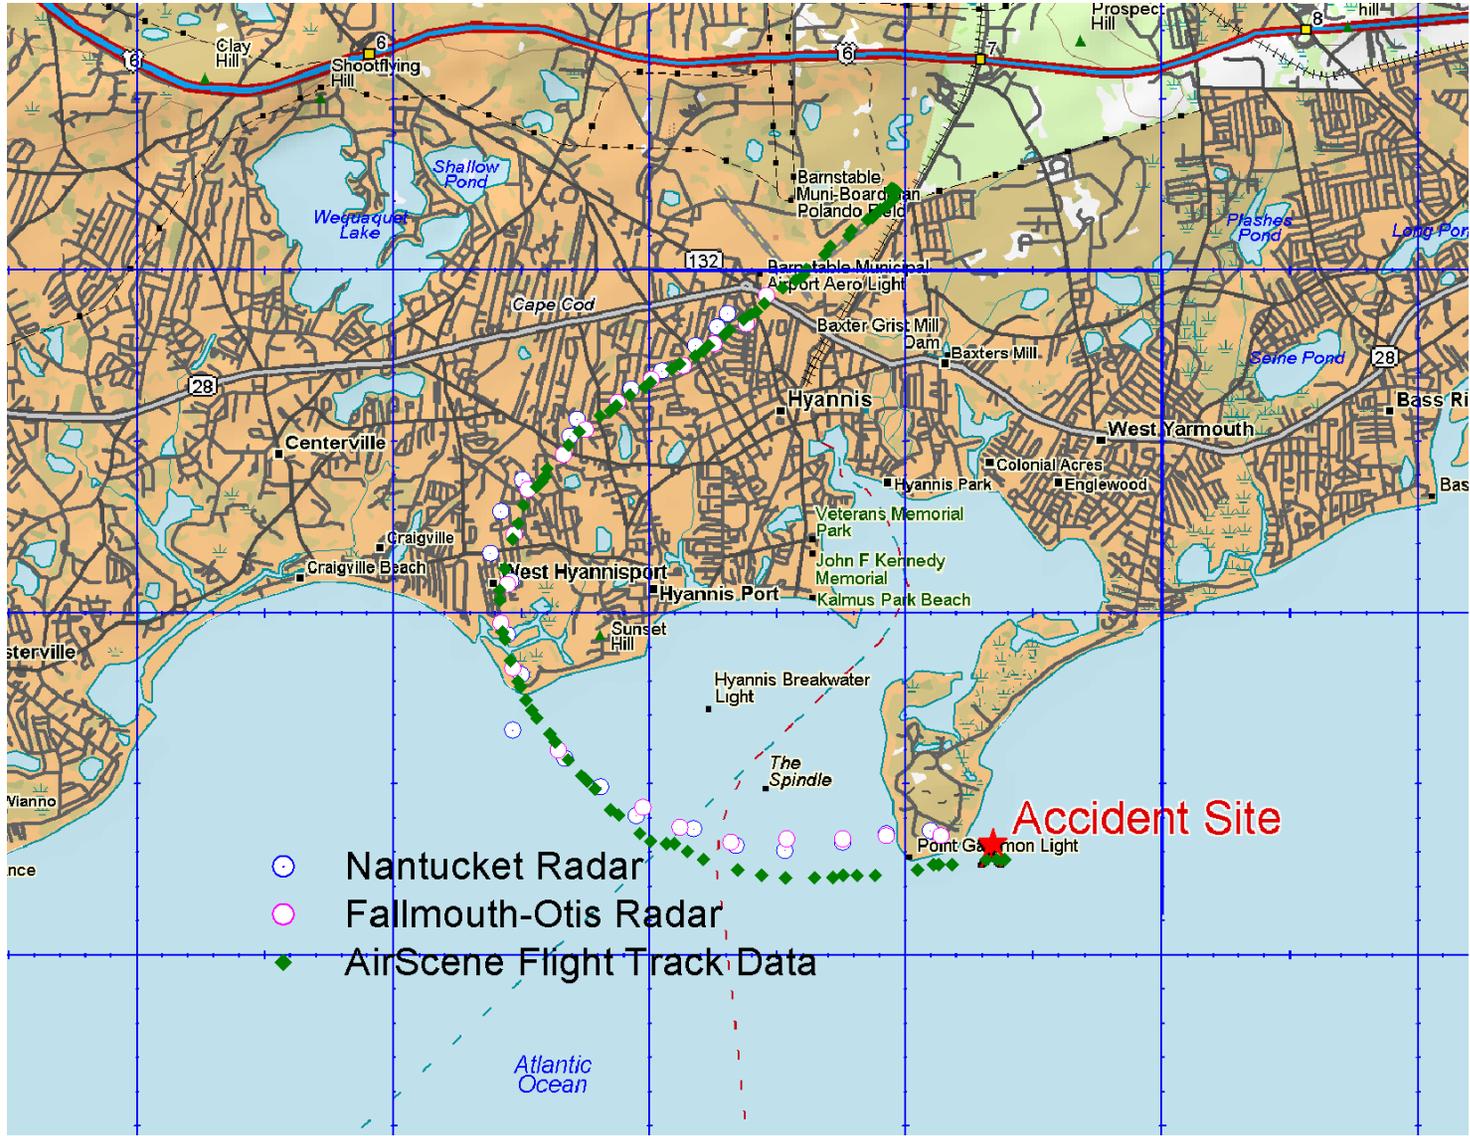
Figure 1: The accident flight track.

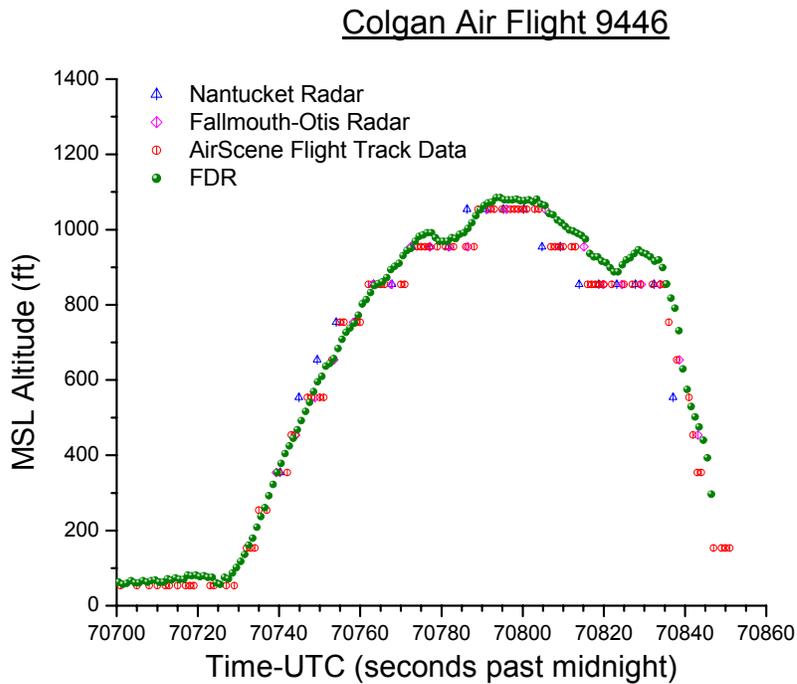
Pressure altitude is based on a standard altimeter setting of 29.92 (in. Hg.) Mean sea level altitude (MSL) can be derived from pressure altitude by adjusting the altitude to the accident altimeter setting of 29.87 (in. Hg.). After this barometric correction was applied, it was found that, while the radar altitudes were brought to field elevation when the aircraft was on the ground, the FDR recorded altitudes that were 100 ft higher. Accordingly, 100 ft was subtracted from the FDR altitude.

Figure 2: Radar/FDR altitude time synchronization.

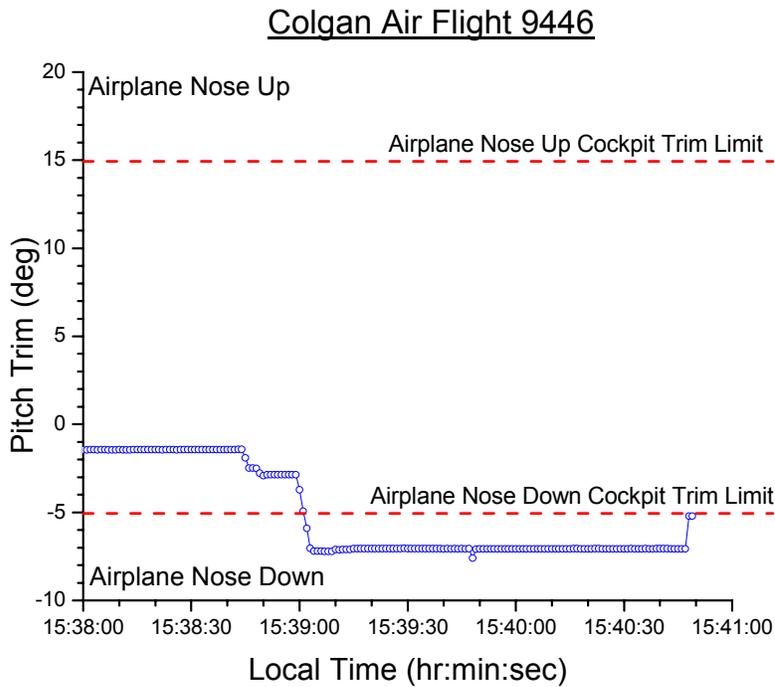
The accident flight was the first flight after maintenance. As a result of this maintenance, the elevator trim parameter on the FDR was listed as inoperative since it was not re-calibrated after work on the trim system that would have taken the elevator trim out of calibration³. The recorded trim is presented together with the trim limits in figure 11. Note that this recorded elevator trim represents degrees of trim commanded at the elevator trim tab but, since the measurement is actually on the cable, it does not include the gearing to the elevator. Since the FDR pitch trim was not calibrated after maintenance, the “zero point” for the trim was not known. The slope however should not have been affected by the maintenance.

Figure 11: Pitch trim command.

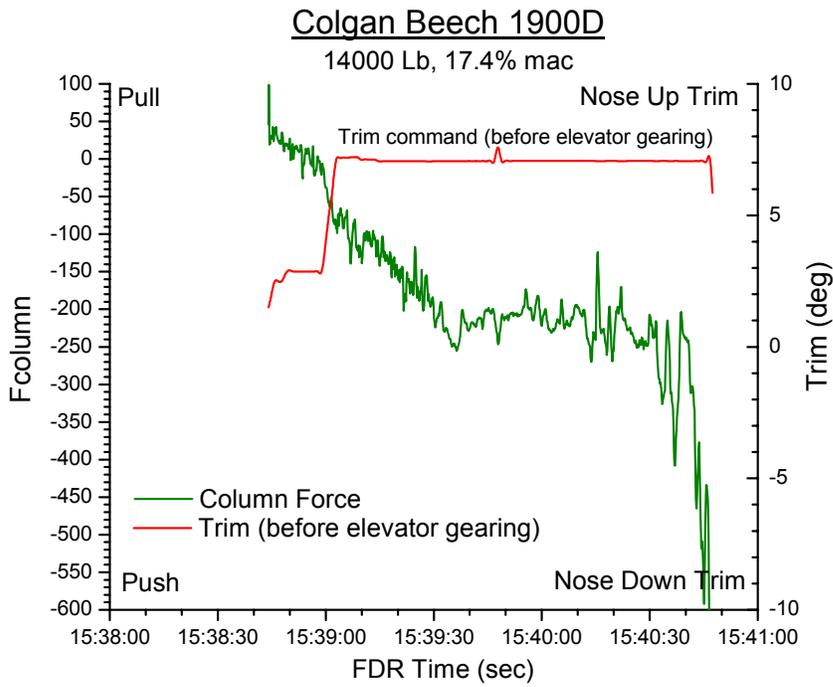
The possibility of a reversal in trim calibration, that is a nose up trim change, was explored. The input trim derived by reversing the sign of the FDR trim is shown together with the column force from a kinematics extraction in figure 12. The extracted elevator for this case is compared to the FDR elevator in figure 13. As previously discussed the FDR elevator is known to be calibrated incorrectly being shifted trailing edge up from the true elevator. The push force shown in figure 12 is inconsistent with CVR evidence and the pitch down to water impact shown in FDR and radar data. A shift of the trim command trace to the nose up stop would have resulted in even more extreme push forces.

Figure 12: Column force with reversed trim input.

A direction of tab motion opposite that recorded by the FDR would require a large push force to produce the recorded motion of the aircraft. This is inconsistent with CVR evidence and other data. The recorded direction of tab motion is consistent with the rest of the data.

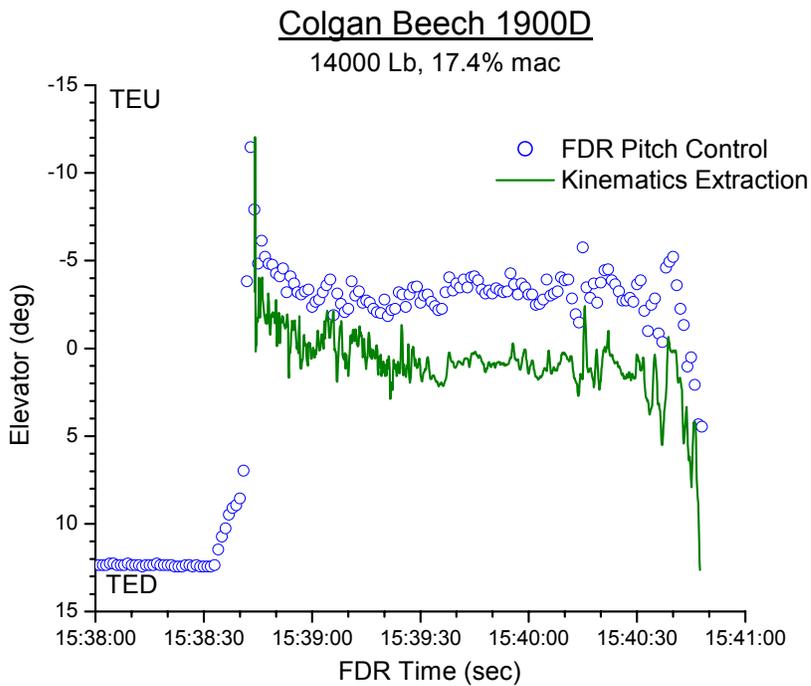
Figure 13: Extracted elevator with reversed trim input.

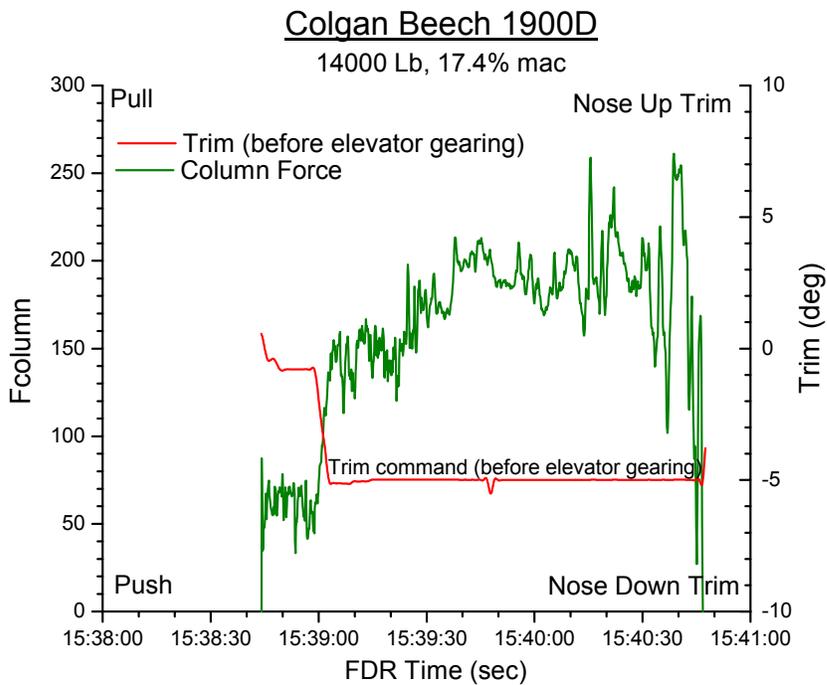
As discussed previously, since the FDR pitch trim was not calibrated after maintenance, the “zero point” for the trim was not known. However CVR evidence and the constant nature of the trim trace beginning about 14:39:02 indicate that trim was at its stop during this period providing a reference for establishing the “zero point”. Accordingly, the FDR pitch trim was shifted 2.07 degrees airplane nose up (tab trailing edge down) for input into the kinematics extraction. The shifted pitch trim is shown together with the column force from a kinematics extraction in figure 14. The extracted elevator for this case is compared to the FDR elevator in figure 15. The pull force shown in figure 14 is consistent with CVR evidence and the pitch down to water impact shown in FDR and radar data.

Figure 14: Column force with trim shifted to nose down stop.

The kinematics extraction (figure 14) shows approximately 60 lbs of column pull force were required until the tab movement to the airplane nose down stop. This tab movement increased the column force to 150 lbs pull. The required column force increased further to approximately 200 lbs as speed increased and remained at that level until reducing just prior to impact.

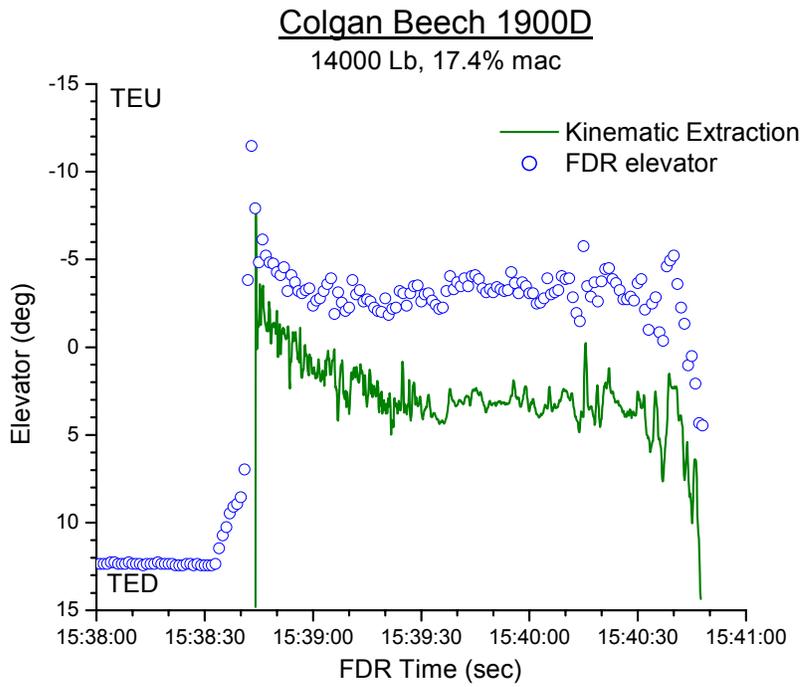
Figure 15: Extracted elevator with trim shifted to nose down stop.

The elevator extracted from the aircraft motion reflects the features (movements) of the offset FDR elevator. This indicates that the elevator was free to move and that the airplane responded properly to elevator movement.

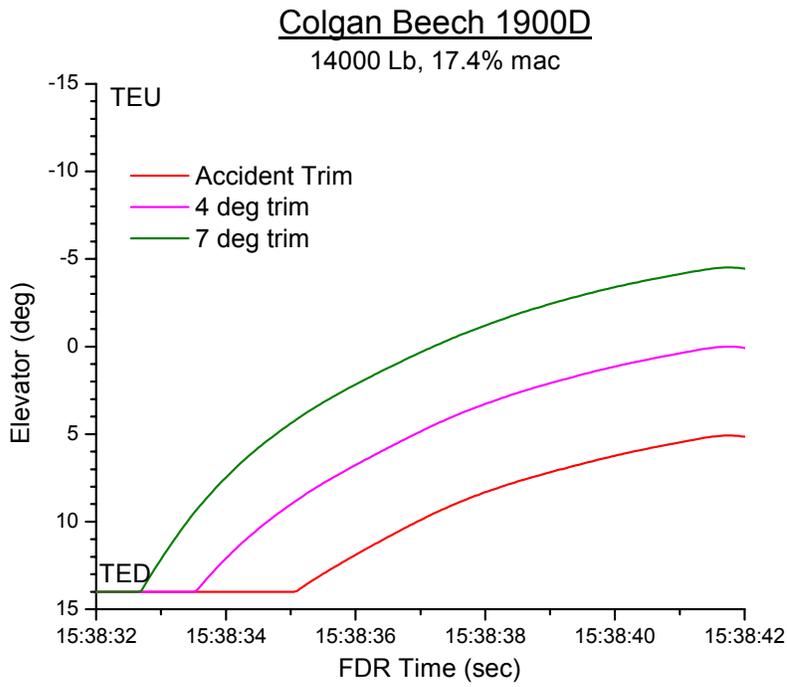
It is not possible to definitively match the accident profile with the pilot input forces unknown. However, trends can be examined for the zero column force case. The elevator angle with zero pilot input force is called the float angle. This angle was determined with the simulator for the accident takeoff. Figure 16 shows the float angle with the accident trim tab command, a 4 degree trim tab command (the average takeoff tab found in the Flight Data Recorder Study) and a more nose up trim tab command. As can be seen, the simulation with the accident trim begins to float later and moves less from the stop than the more representative 4-degree trim command. This is very consistent with the flight data in the Flight Data Recorder Study. The 4-degree trim command results in a more trailing edge down elevator tab than the accident trim command. The trailing edge down elevator tab lifts the elevator sooner than a less trailing edge down tab.

Figure 16: Elevator tab float.
