**National Transportation Safety Board**  
Office of Research and Engineering  
Washington, D.C. 20594

## Airplane Performance Study

Location: Springfield Township, New Jersey  
Date: June 13, 2018  
Time: 0907 EDT (1307 GMT)  
Airplane: Beechcraft B58 "Baron", Registration N218BL  
NTSB Number: ERA18FA167

ERA18FA167, Beechcraft B58 Baron, Registration N218BL, 6/13/2018

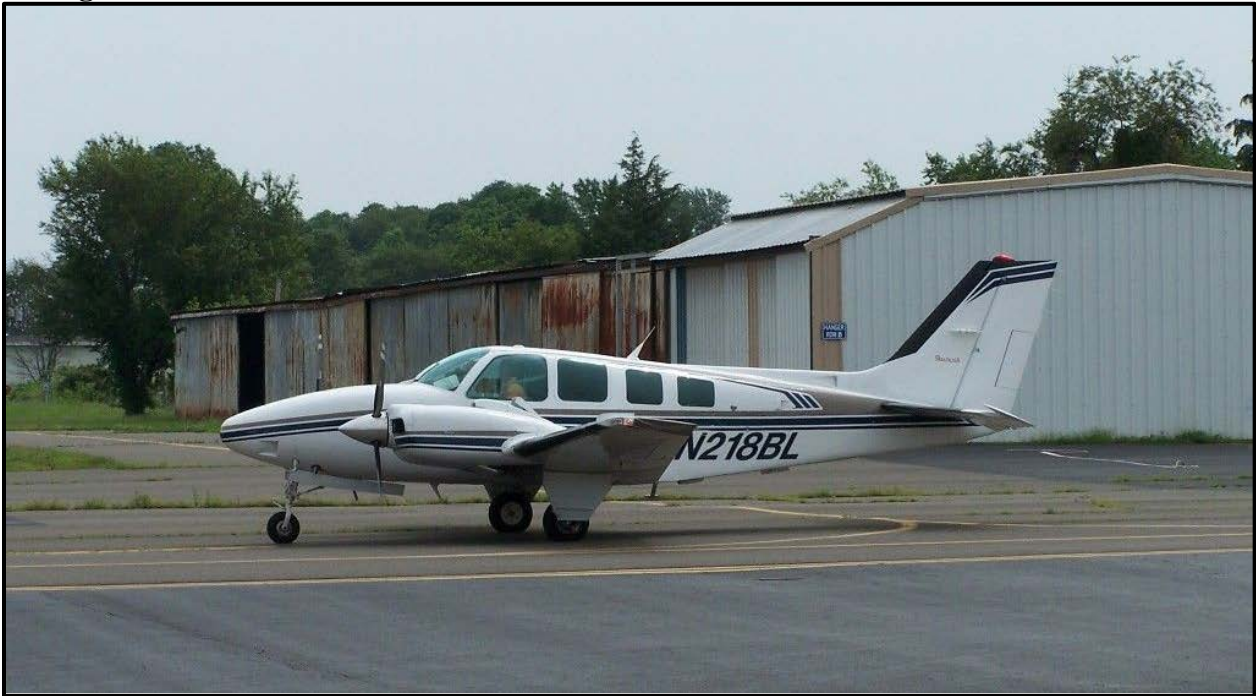
**Figure 1: Accident Airplane N218BL, a 1996 Beechcraft B58 Baron**

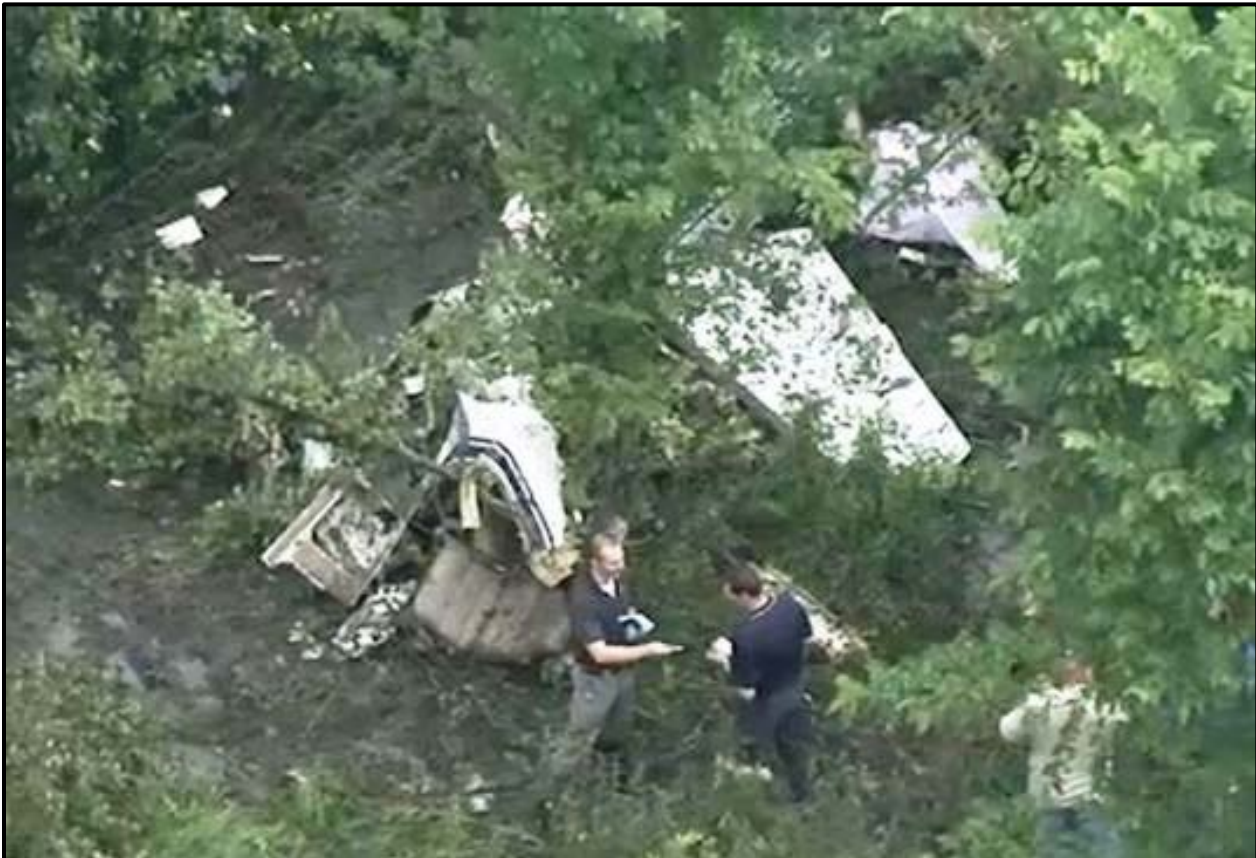
ADS-B as well as a witness statement suggest that N218BL stalled and came down at a high rate of descent approximately 6.4 NM from the departure end of VAY runway 8. A witness located about 1,450 ft south of the accident site reported that the weather conditions consisted of a low-cloud ceiling and a gentle breeze. The witness indicated that she heard an airplane flying “really low” to the ground, which she thought was “incredibly odd”. She heard revving engines, as if keeping the airplane airborne was difficult. It sounded as if the airplane made one pass over her location, consistent with turning around and similar to what other small airplanes had done before. She then ran to a nearby fence line, and, as she was running, she saw the airplane overhead. She reported that the airplane turned, flew over the tree line, and “came down at an awful angle like it was trying to land, but the angle was too steep.”

**Figure 2: Accident Site**

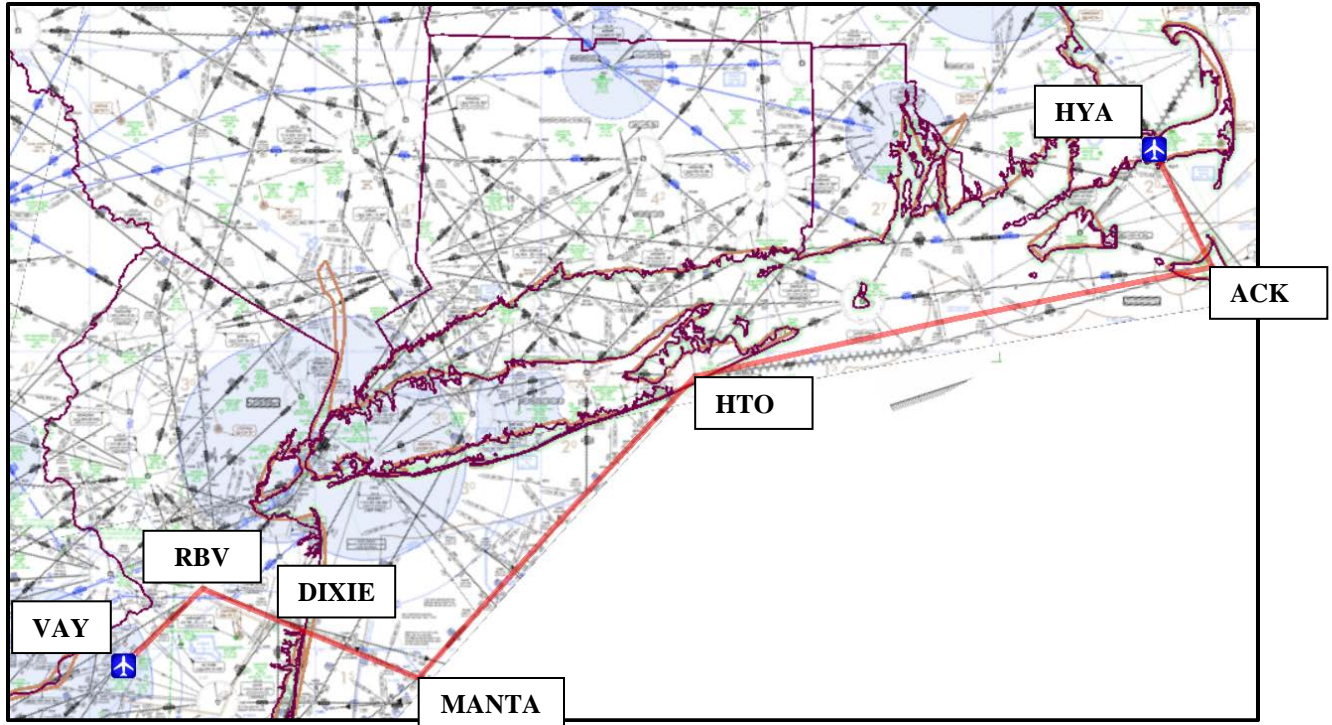
Figures 3 and 4 show the IFR route that N218BL received from ATC prior to take-off<sup>2</sup>. The pilot was given an amended clearance when he contacted clearance delivery and was cleared to HYA: upon entering controlled airspace, intercept the Robinsville 236 radial to Robinsville (RBV<sup>3</sup>), DIXIE, victor airway (V) 276 to MANTA, V139 to HTO, and then as filed. Climb and maintain 2,000 ft and expect 7,000 ft 10 minutes after departure. Departure frequency is 124.15 and squawk 2331. The airplane never made it to RBV or to 2,000 ft.

Figure 3: IFR Route: RBV, DIXIE, V276 MANTA, V139 HTO, ACK

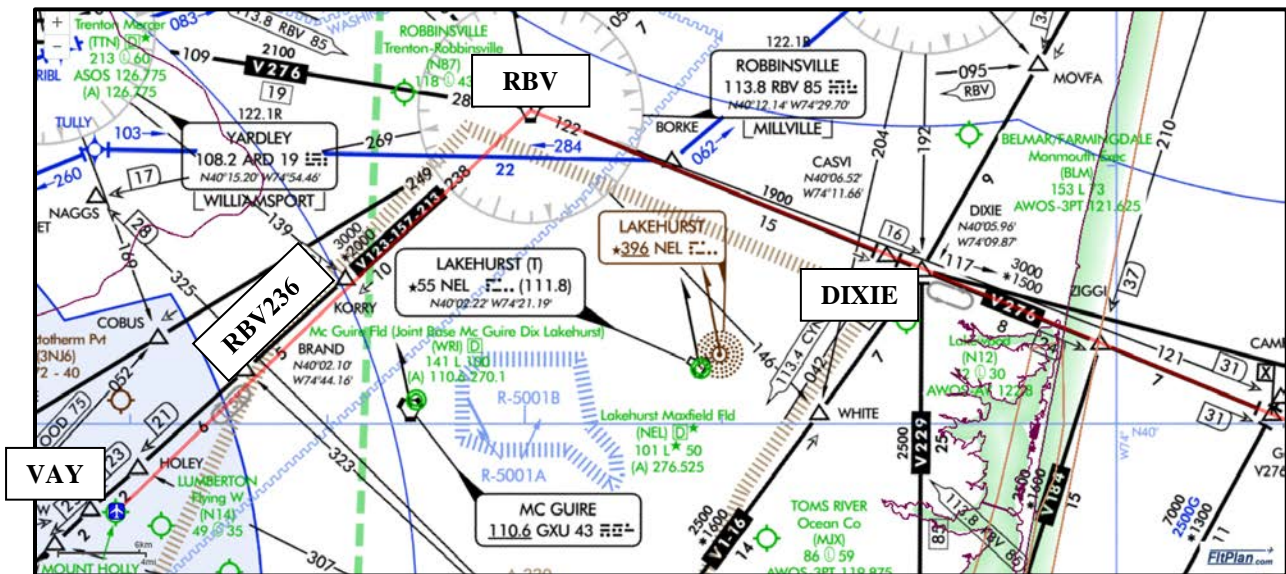
<sup>3</sup> RBV is a Very High Frequency (VHF) Omni-Directional Range or “VOR” approximately 22 NM northeast of VAY. The RBV 236 radial is the first leg shown in Figure 4.

Figure 4: Departure Instructions: "Intercept the RBV236 radial inbound to RBV"

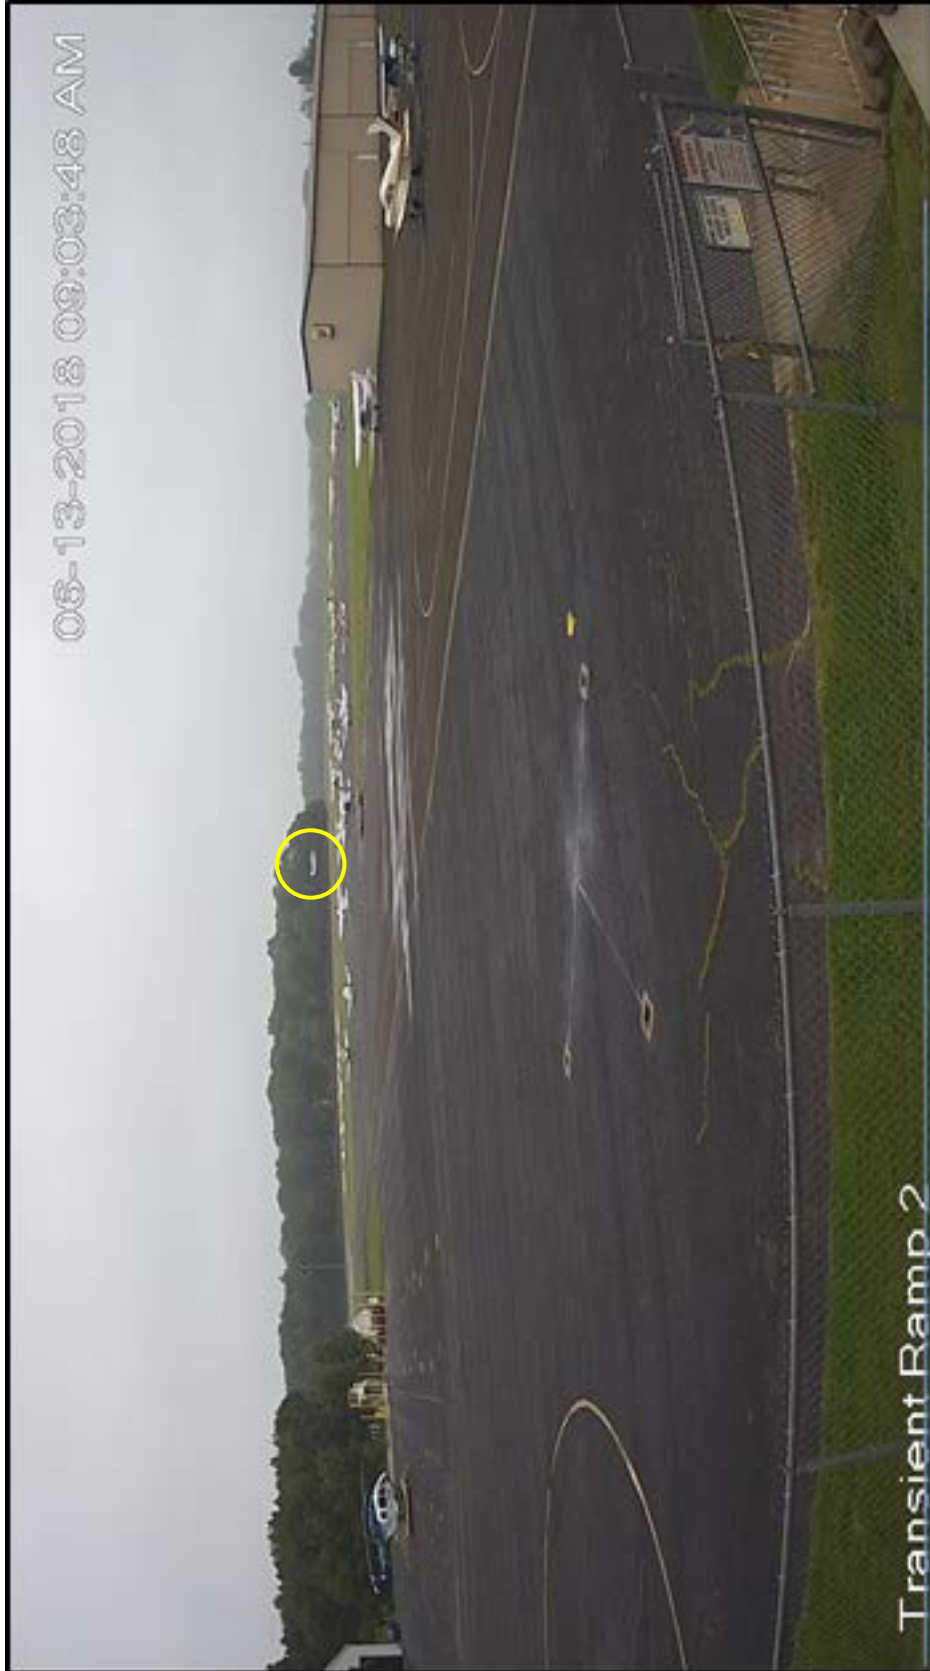
Security video captured N218BL just after lift-off from VAY runway 8 at 0903:48. Figure 5 is a snapshot from that video that shows the accident airplane over the runway and in a slight nose-high attitude<sup>4</sup>. The recorded ADS-B data for N218BL began at 0903:56 as the airplane was climbing through 150 ft msl. The pilot subsequently reported climbing through 500 ft for 2,000 ft at 0904:32 when checking in with departure control; ADS-B data had the airplane at 465 ft. The ADS-B ground track for the entire flight is shown in Figure 6.

<sup>4</sup> The airplane had a slight right quartering tailwind taking off on runway 8 according to both the windsock captured in the security video and the WRI weather observation.

**Figure 5: Security Video of N218BL Take-off**

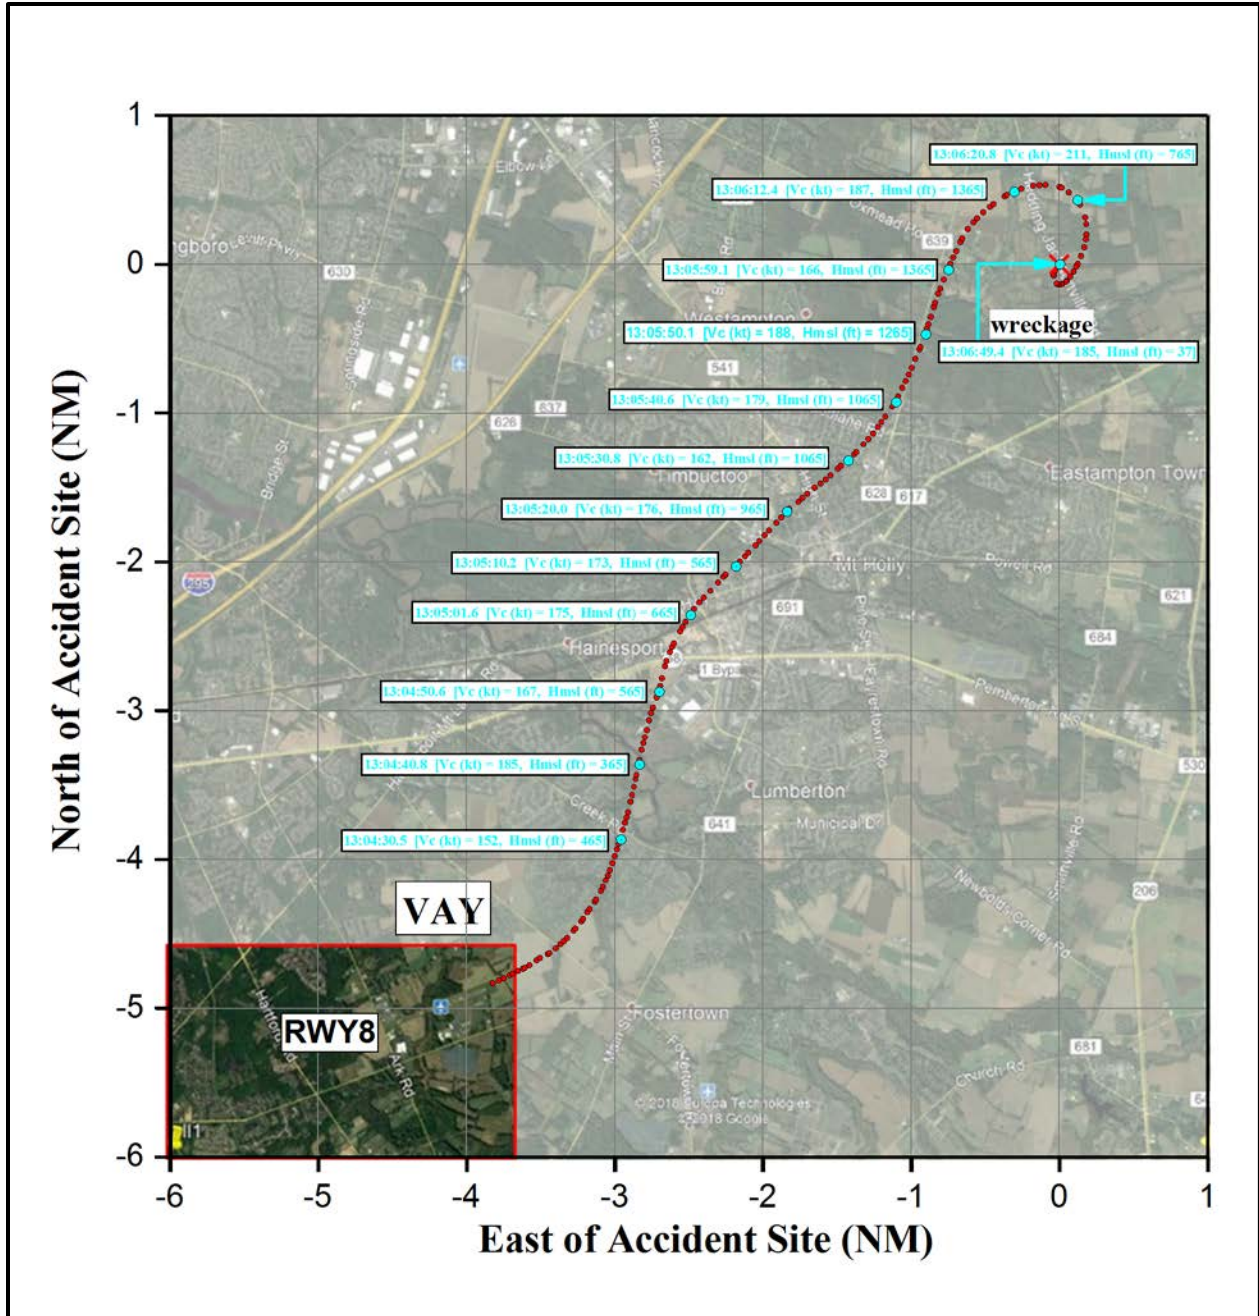
The departure instructions to intercept and track the RBV 236 radial could explain the early ADS-B ground path for N218BL shown in Figure 6, i.e., a left turn after take-off and a right turn shortly afterwards. Intercepting the 236° radial after take-off from runway 8 would require a slight left turn. Once intercepted, tracking the RBV 236 radial inbound would require a right turn to a magnetic heading of approximately 056° (236° - 180°), assuming no wind. This is the ground path depicted in Figure 6 until the end of the flight when the airplane made a 180° right turn.

**Figure 6: Ground Track based on ADS-B Data**

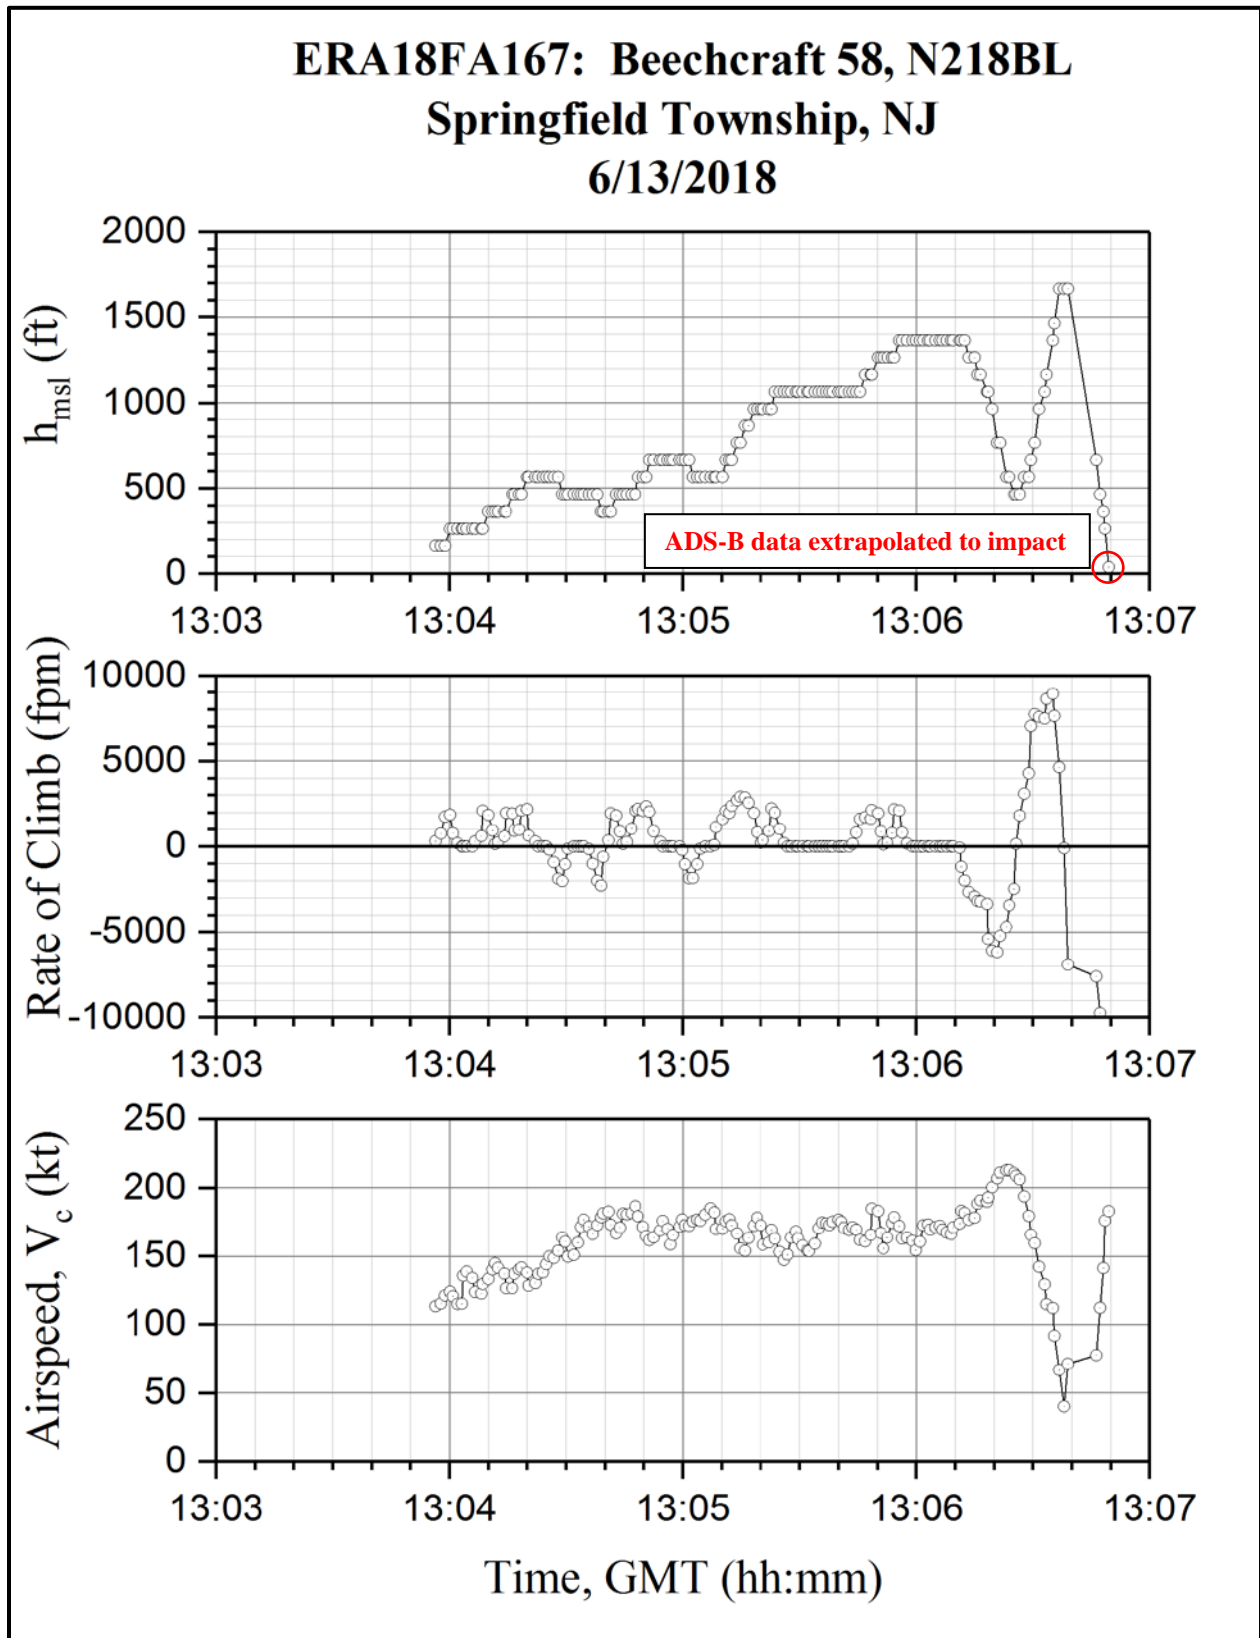
The altitude profile for the accident flight shown in Figure 7 is less understandable. The initial climb appeared normal with the airplane climbing at the best-rate-of-climb speed for the Beechcraft B58 or 105 kt indicated airspeed. However, about 30 sec into the climb at 0904:20 and after accelerating to an airspeed<sup>5</sup> of 160-170 kt, the airplane leveled off at approximately 500 ft msl. The airplane was now in IMC and just above the reported 500 ft overcast ceiling (lower at WRI). It is unclear why the pilot delayed the climb or why he reported climbing “through” 500 ft to ATC at 0904:32 when, in fact, the airplane had leveled off at 500 ft 12 seconds earlier<sup>6</sup>.

At 0905:10, N218BL initiated a second climb and ultimately leveled at 1,400 ft at approximately 0905:55. The airspeed remained at 160-170 kt. The airplane never made it to the 2,000 ft altitude assigned by ATC. Instead, at 0906:11, approximately 16 sec after leveling

off at 1,400 ft, the airplane began descending at over 5,000 ft/min<sup>7</sup> in a right-banked turn<sup>8</sup> as shown in Figures 7 and 8. The descent reversed direction at 0906:27 just below the reported overcast ceiling of 500 ft agl, and the airplane began a “zoom climb”<sup>9</sup> back up to a maximum altitude of 1,700 ft at 0906:35.

Figure 7: Altitude and Calibrated Airspeed Based on ADS-B Data

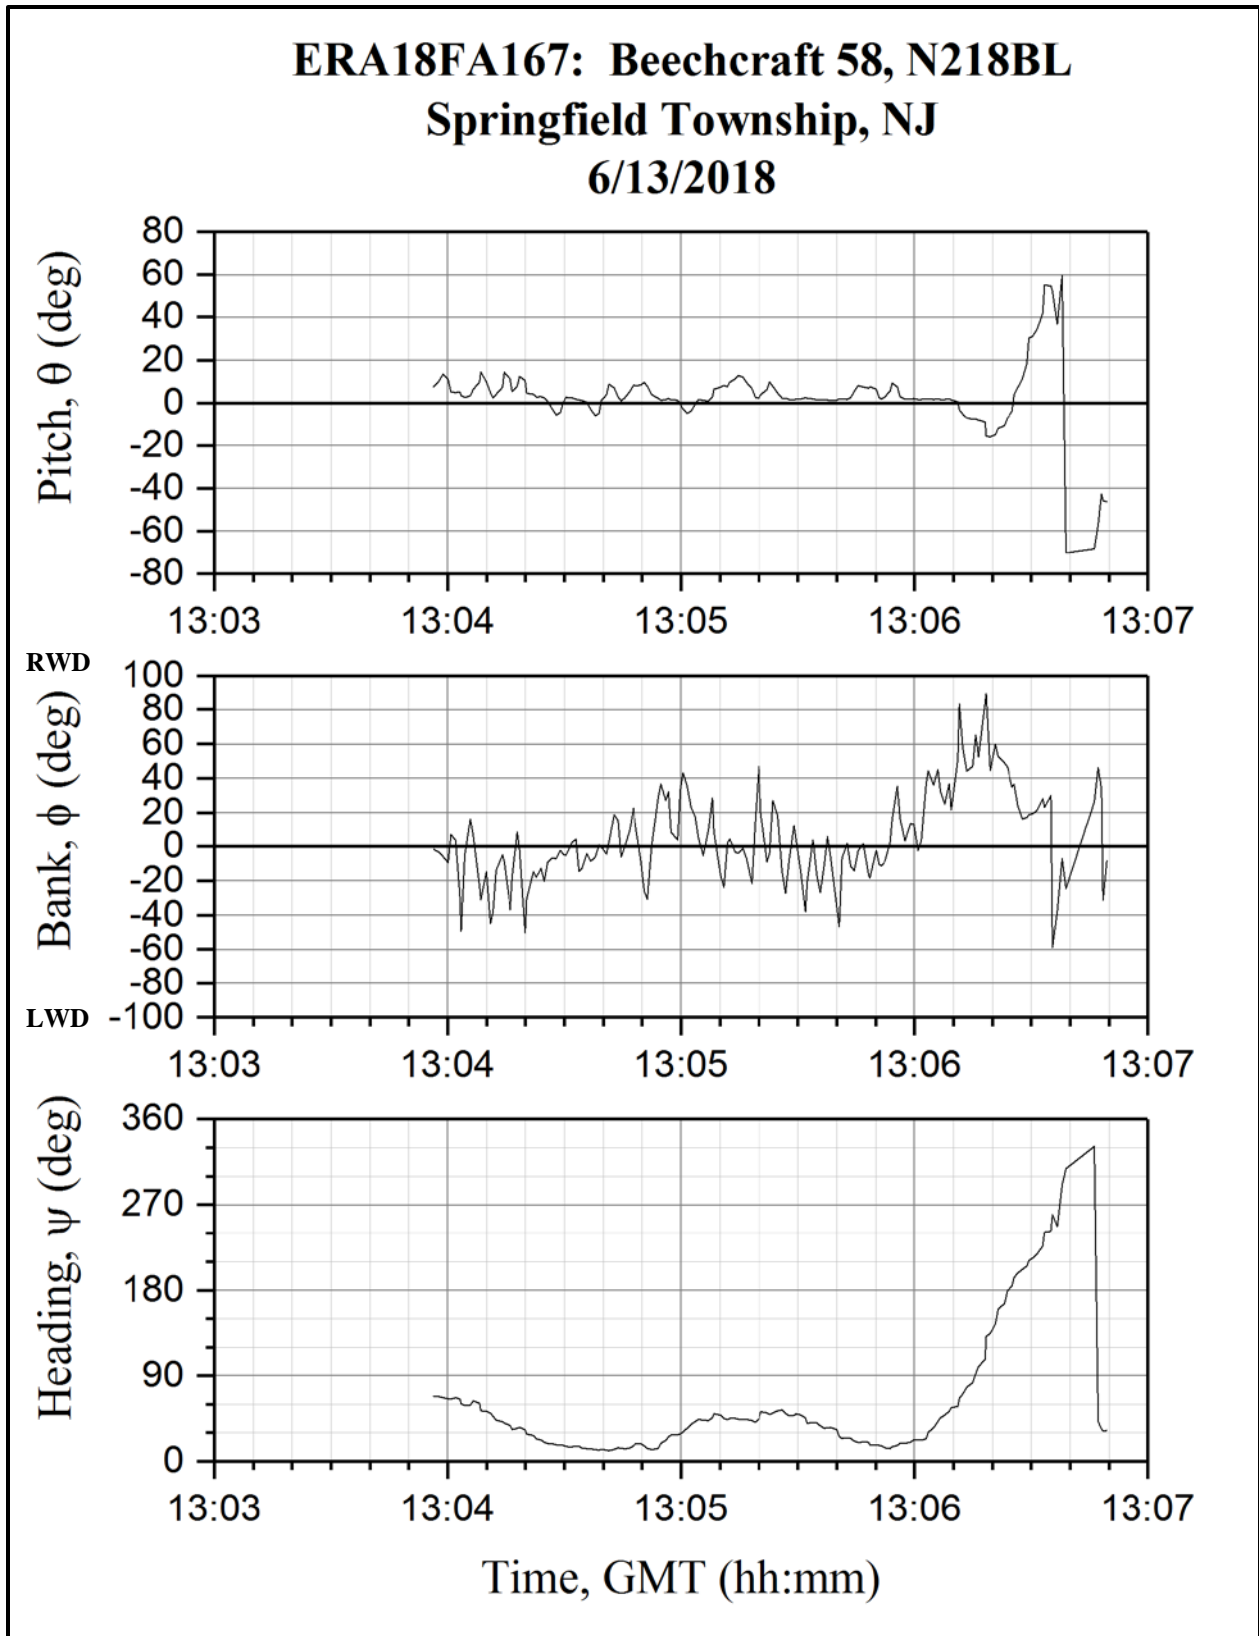
<sup>8</sup> Figure 8 shows the airplane entering a right bank of 60°-80° around 0905:55, about the same time the airplane leveled at 1,400 ft. The 180° right turn and the descent could indicate the pilot was attempting to return to the airport. However, the last intelligible communication with N218BL was at 0906:04, and the pilot did not mention returning to the airport.

Figure 8: Pitch, Bank, and Heading Based on ADS-B Data

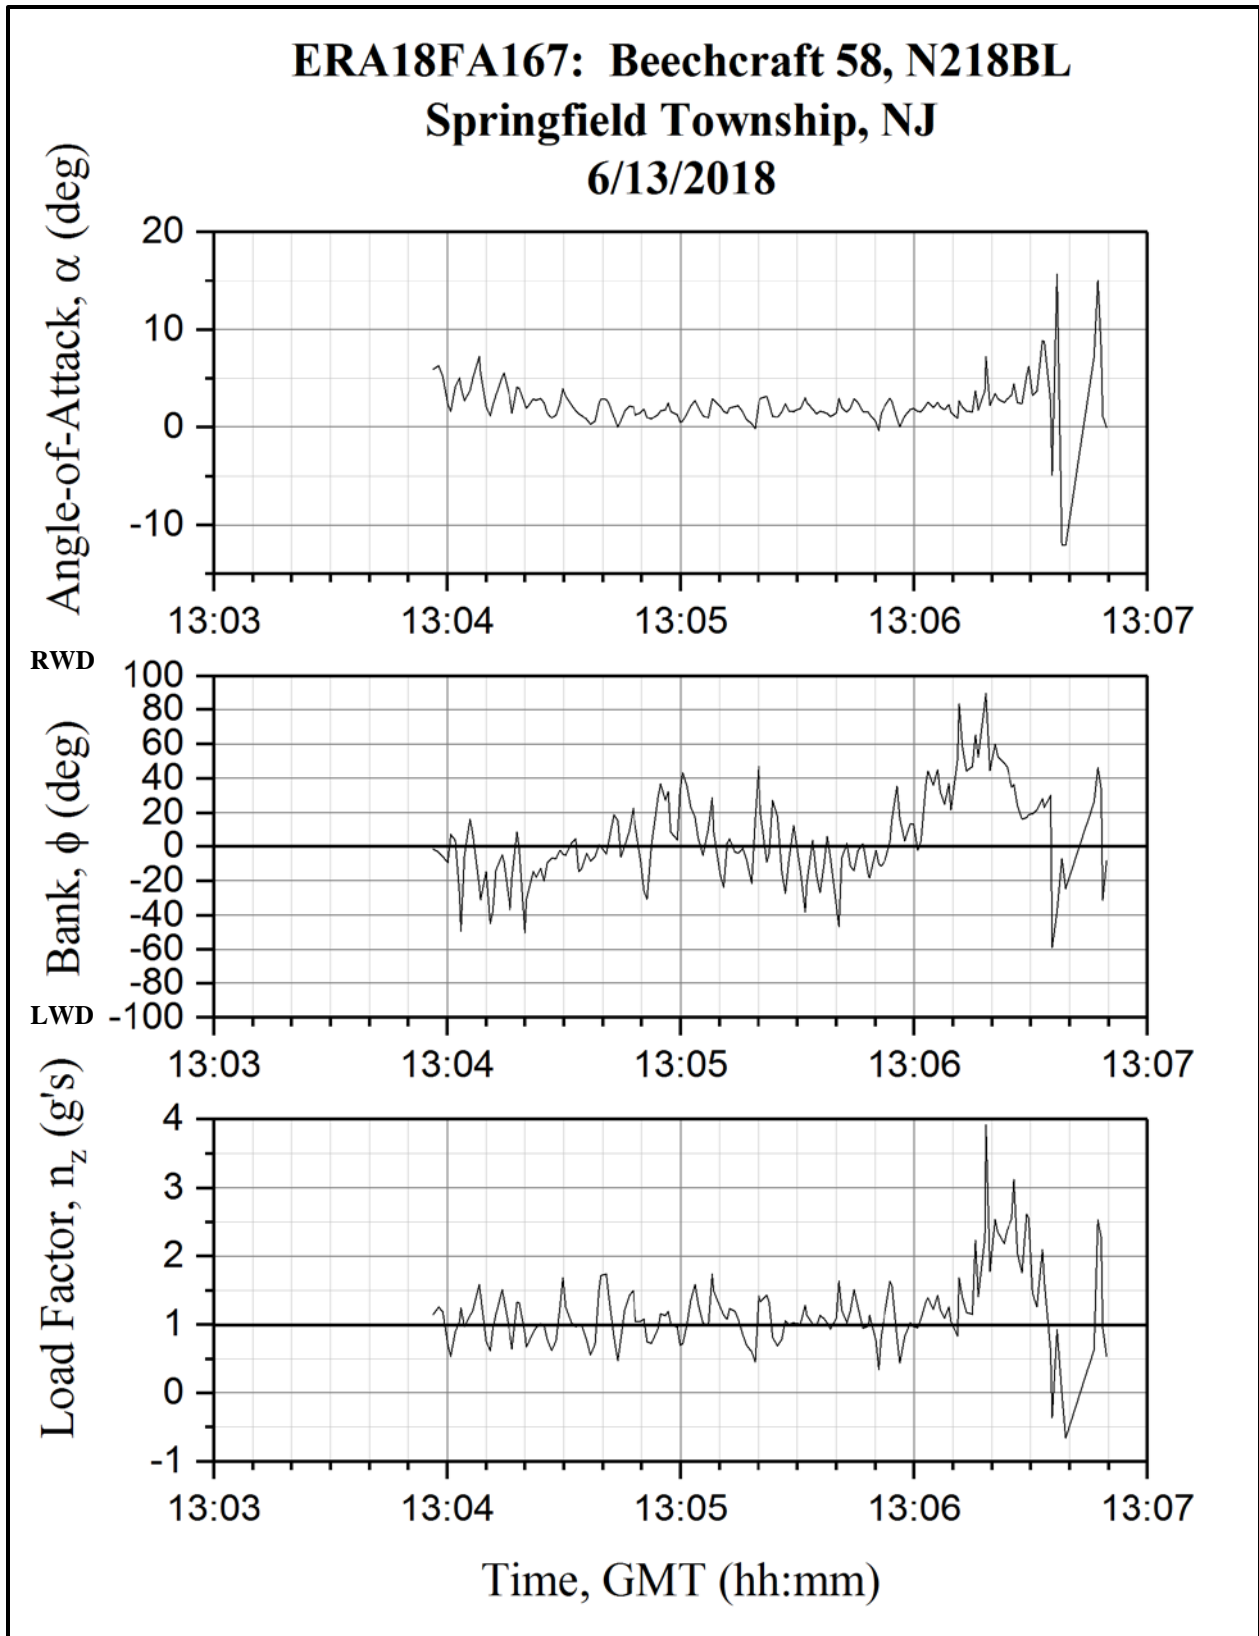
There appears to be a stall break in the estimated normal load factor and angle-of-attack shown in Figure 9 at about 0906:35. The airspeed was decelerating and quickly approaching the published wings-level, 1g, stall speed of 84 kt at this point. The airplane was initially banked 30° to the right before the break and snapped left to a bank angle of 60° after the break. The pitch attitude dropped abruptly, and the airplane impacted the ground approximately 14 sec after the apparent stall break, at 0906:49.

According to ADS-B, wind, and airplane manufacturer data, the pilot of N218BL likely stalled the airplane while turning less than three minutes after take-off from South Jersey Regional Airport. The airplane was in approximately a 30° right-banked turn when it abruptly rolled left, pitched down and, ultimately, impacted terrain. The normal load factor went from 1g to -0.5g as the nose dropped.

Figure 9: Estimated Angle-of-Attack, Bank Angle, and Normal Load Factor Based on ADS-B Data
