Radar Performance Study

Specialist Report
Timothy Burtch

Location: Akron, OH
Date: November 10, 2015
Time: 1952 GMT (2:52 pm EST)
Airplane: Hawker 125B-700A, N237WR
NTSB Number: CEN16MA036

**Radar Study, Airplane Performance
CEN16FA036, N237WR, Hawker 125B-700A, 11/10/2015**

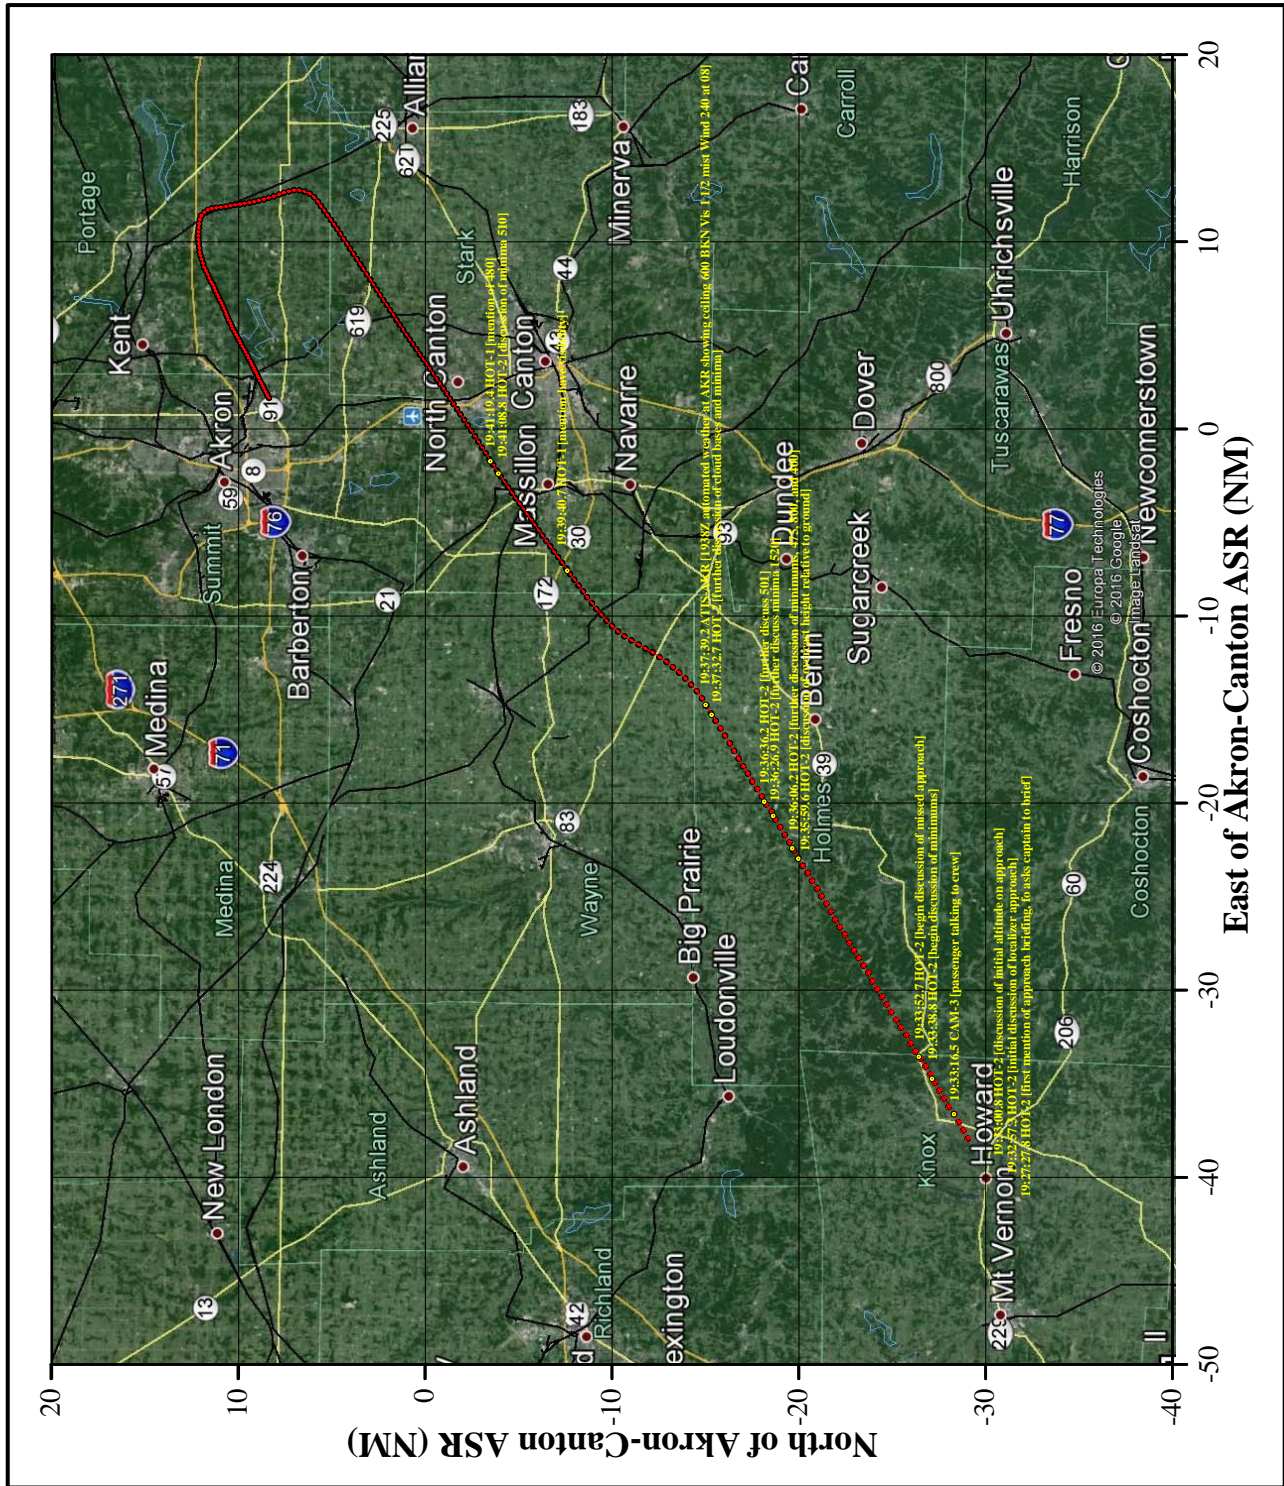
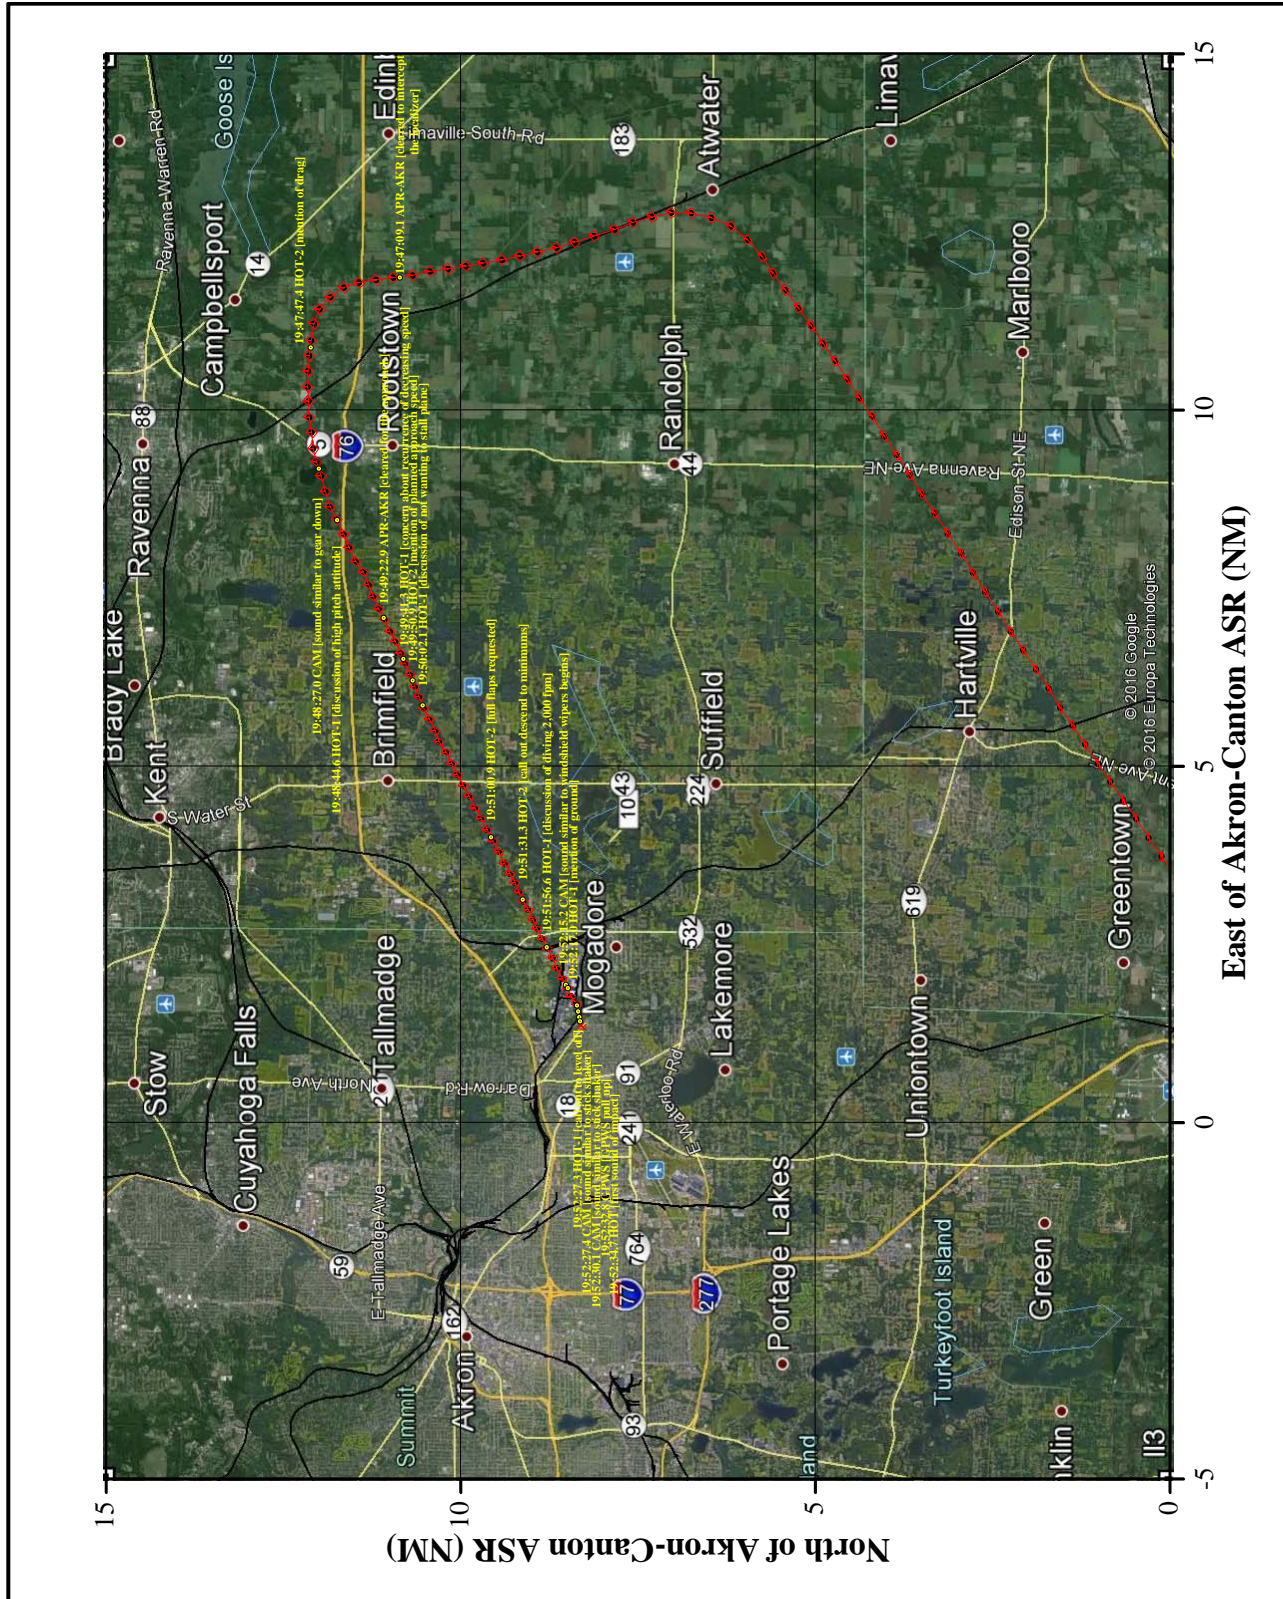
Figure 2 highlights the radar ground track along with paraphrased communications from the CVR. The accident flight approached the airport from the southwest and received vectors to turn the airplane for the AKR localizer approach to runway 25. The airplane checked in with Cincinnati Approach over HOVER intersection at 9,000 ft. The flight crew was instructed to maintain 5,000 ft, then 4,000 ft, and finally 3,000 ft at a speed of 170 kt. Vectors to fly heading 350°, then 360° (because of traffic ahead on the same approach), and finally 280° were also provided with final instructions to maintain 3,000 ft until established on the approach and to intercept the runway 25 localizer along 249°.

Air Traffic Control (ATC) instructed the flight crew to switch to (the airport) advisory frequency and to cancel their IFR flight plan on the current frequency or remotely on the ground¹. The crew acknowledged. That was the last radio transmission between the accident flight and ATC.

Figure 2a: Radar Ground Track with Paraphrased CVR Communications

Figure 2b: Radar Ground Track with Paraphrased CVR Communications

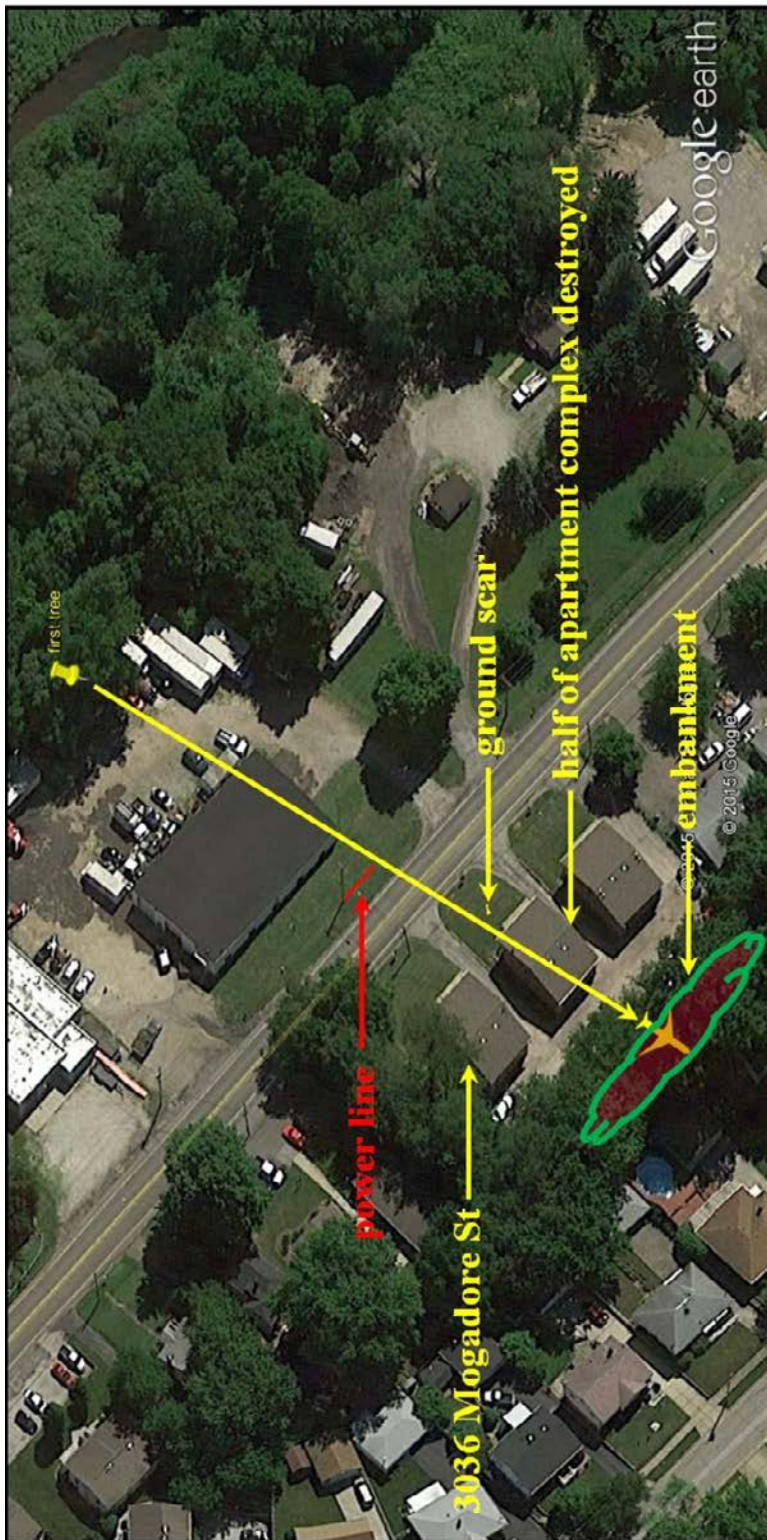
Figure 3 shows a more detailed overview of the accident site with select landmarks and features. After striking the tree branches, the airplane hit power lines adjacent Mogadore Street before banking sharply to the left and traveling through the middle of three apartment 4-plex buildings. The airplane finally came to rest on an embankment that was located behind the middle apartment building. While most of the wreckage was consumed by fire, all “four corners” of the airplane were located on or near the embankment.

Figure 3: Overview of Accident Site

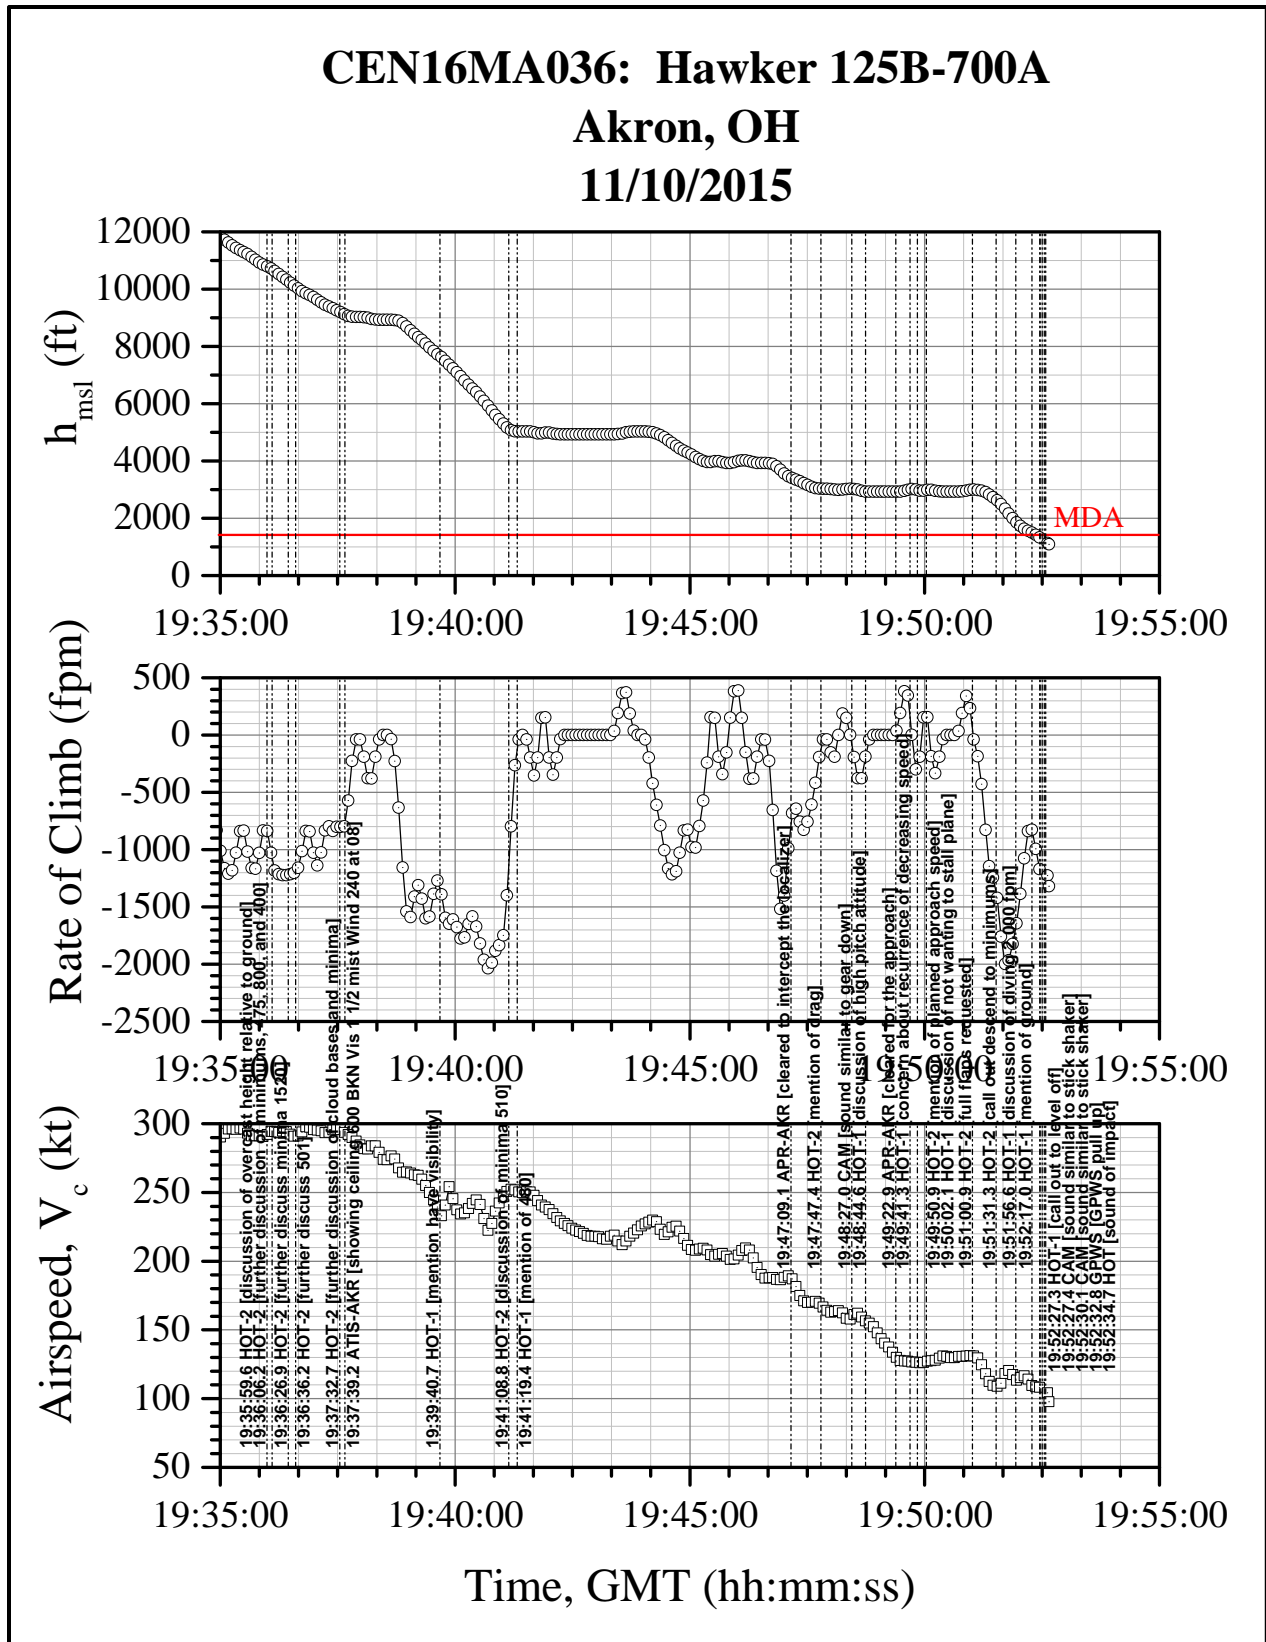
Figure 4 shows the altitude and airspeed derived from radar and meteorological data. Paraphrased CVR communications are also included. The minimum descent altitude (MDA) for the localizer runway 25 approach is 1,540 ft above mean sea level (msl) and is marked in

Figure 4: Altitude and Speed for Final Minutes of Flight Based on Radar Data with Paraphrased CVR Communications

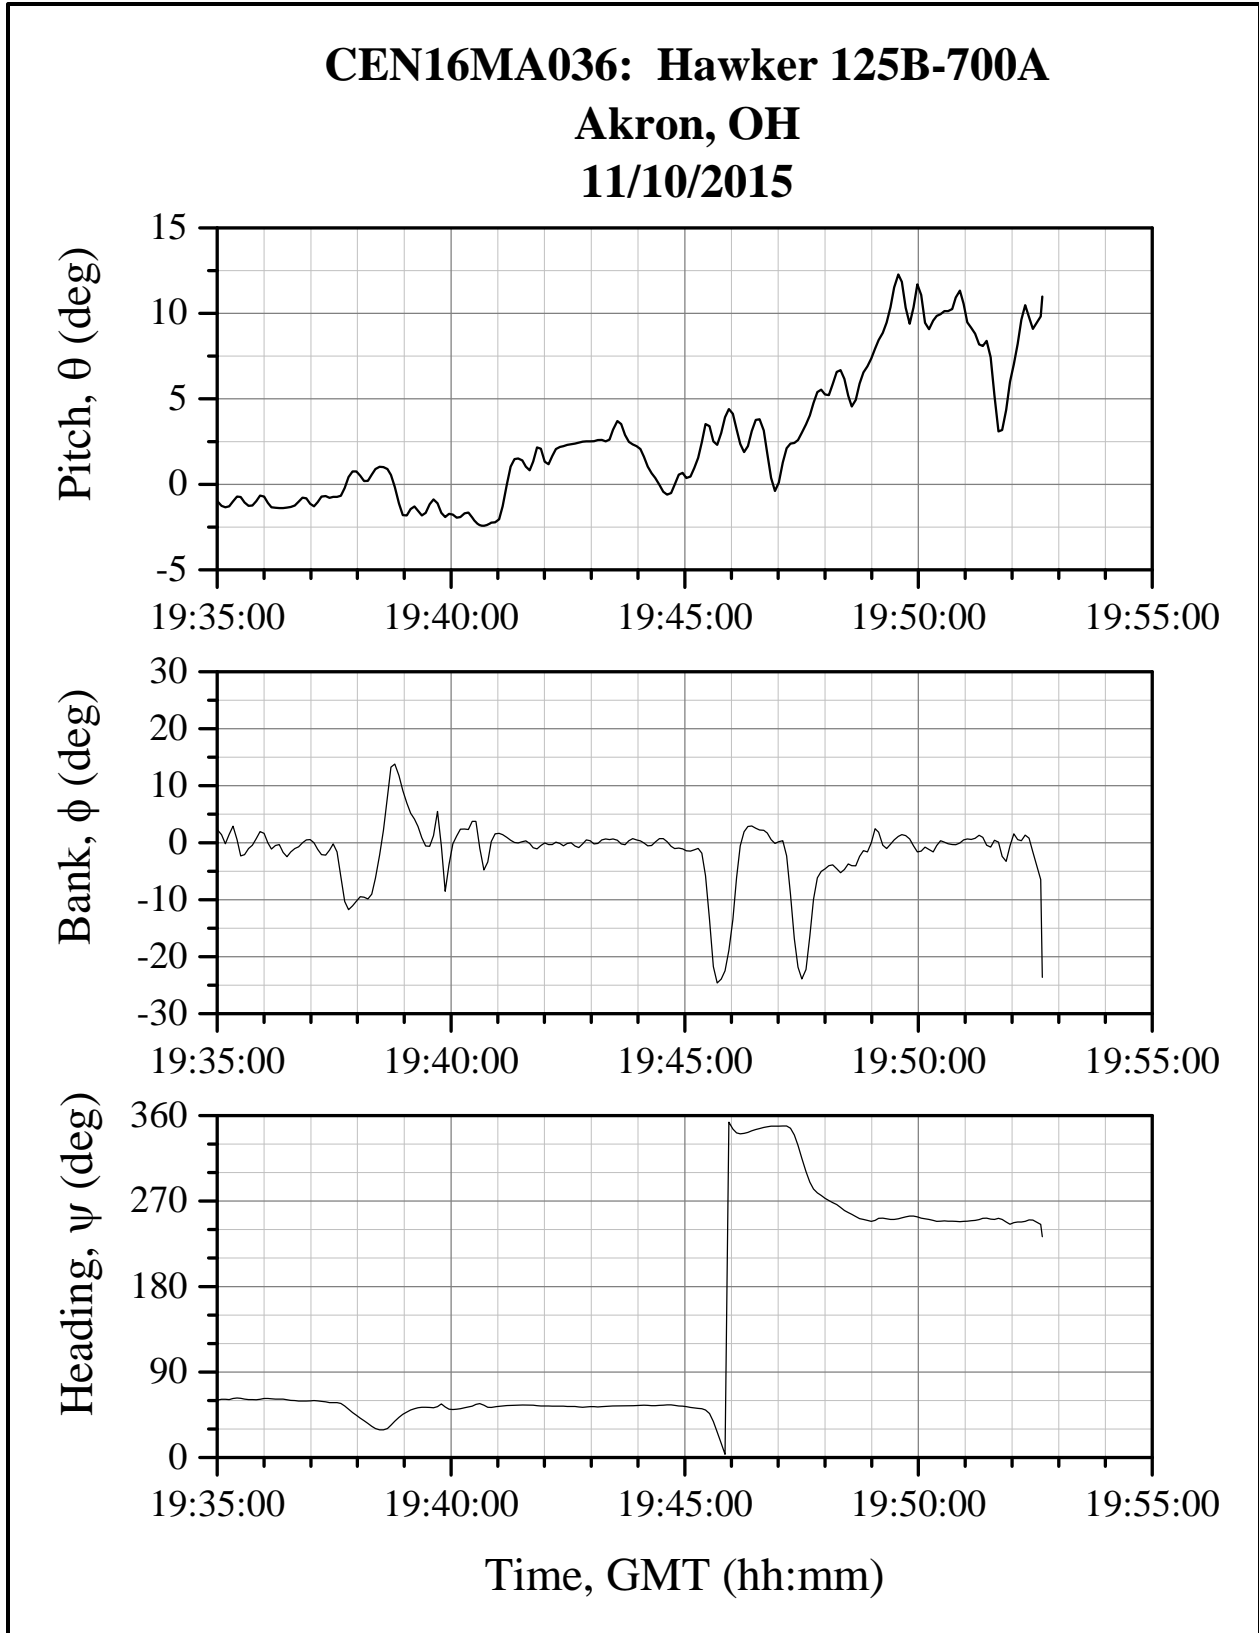
Figure 6 includes the pitch, roll, and heading angles derived from radar data from the final minutes of the flight. Figure 7 shows an estimate of angle-of-attack and load factor also based on radar.

Figure 6: Pitch, Bank, and Heading Based on Radar Data

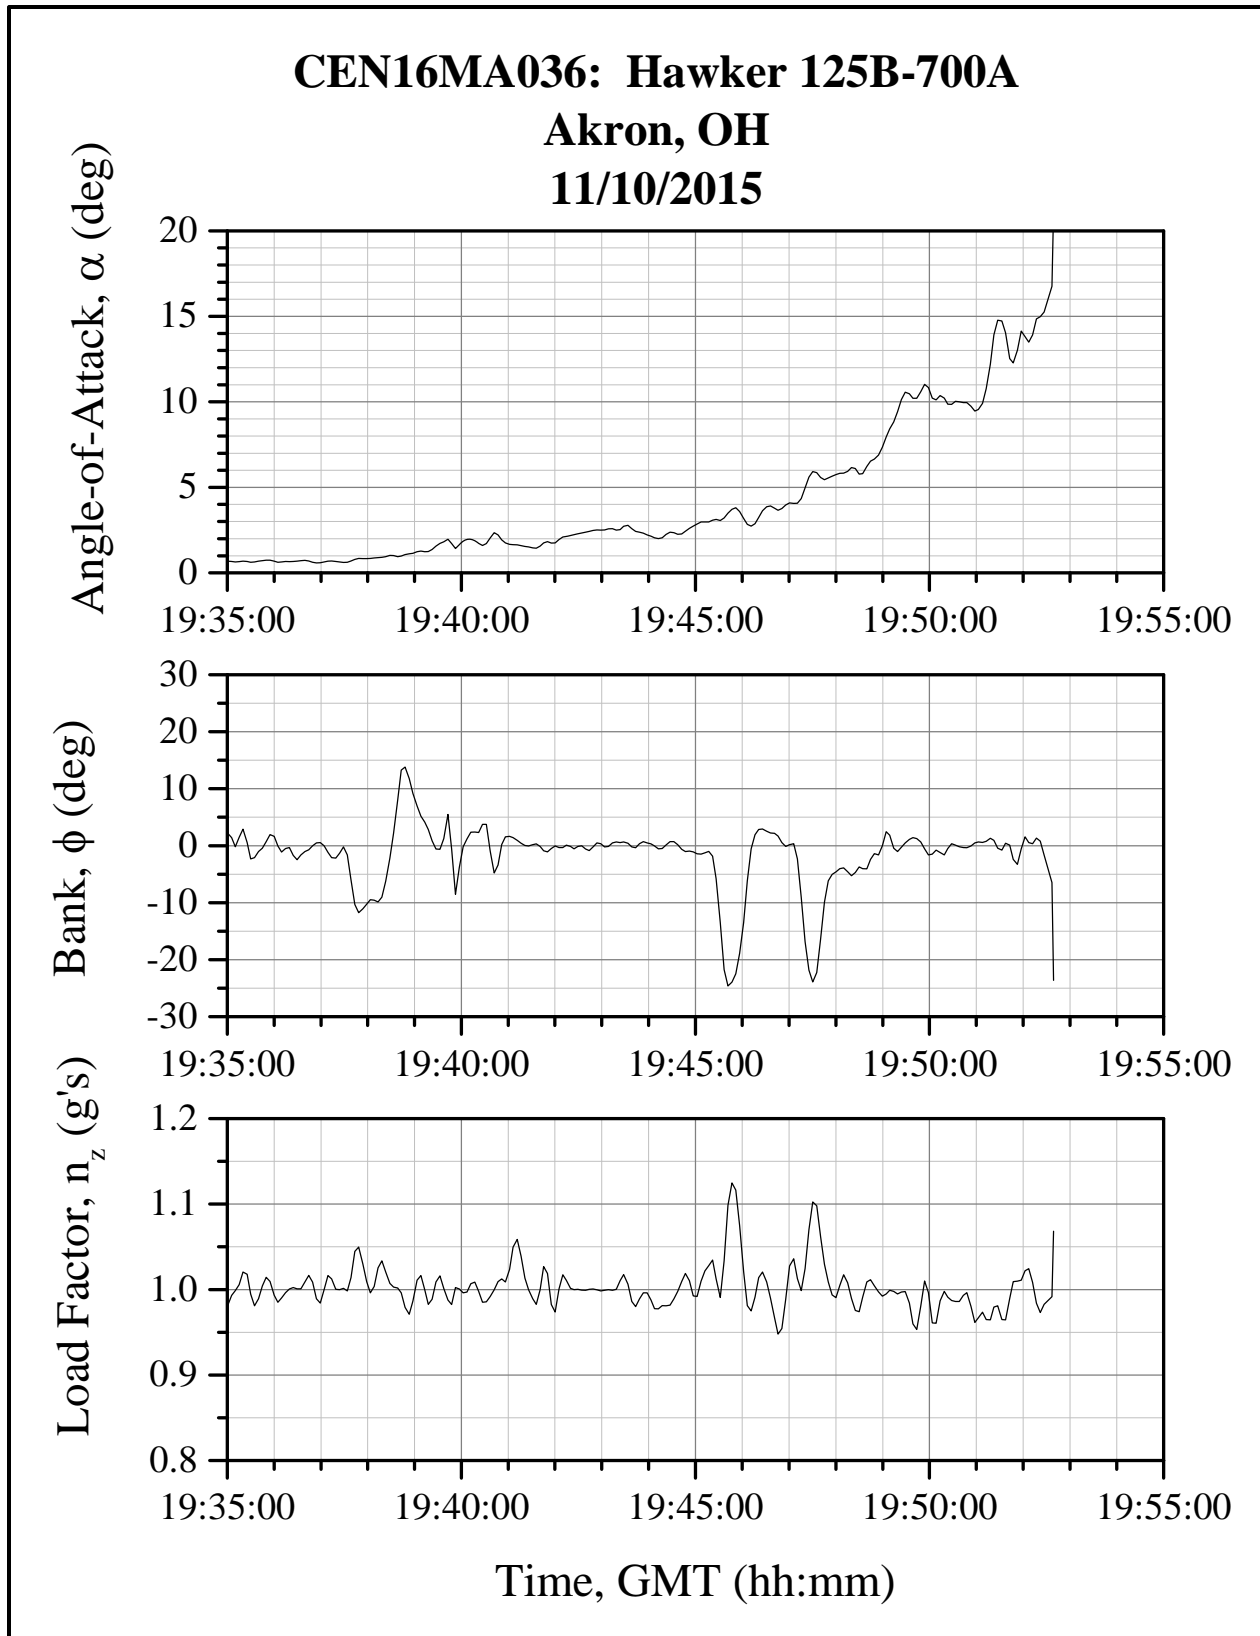
Figure 7: Estimated Angle-of-Attack and Load Factor Based on Radar Data

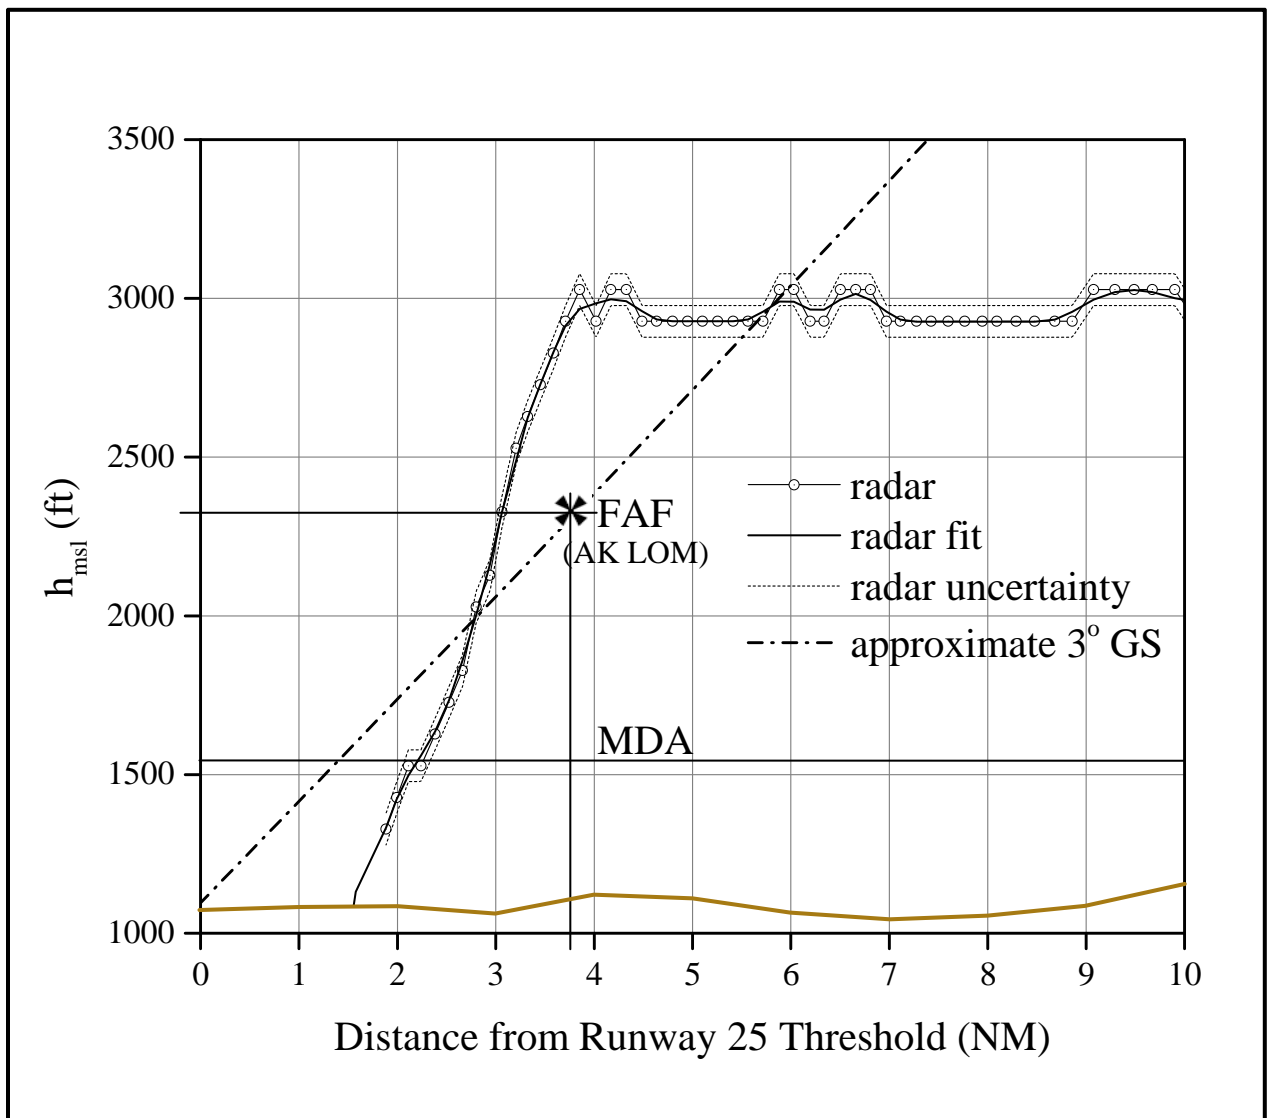
Finally, Figure 8 shows a profile view of the accident approach as described by radar. A localizer approach is a Non-Precision approach and does not include vertical guidance: the 3° glide slope depicted in the figure is provided only for reference.

The radar data in Figure 8 show that N237WR was approximately 700 ft above the minimum 2,300 ft final approach fix (FAF) altitude in the approach procedure. Shortly after crossing over the FAF, the airplane descended at rates of up to 2,000 ft/min before impacting trees and a power line.

Figure 8: Profile View of Accident Approach to AKR Runway 25 Based on Radar Data

(note: The localizer approach to runway 25 does not include vertical guidance. The 3° glide slope and terrain depicted are approximate and for reference only.)
