DCA01MA034 March 29, 2001 Aspen, CO

NATIONAL TRANSPORTATION SAFETY BOARD Washington, D.C.

REIL Documentation

FLIGHT INSPECTION REPORT--NONDIRECTIONAL BEACON,

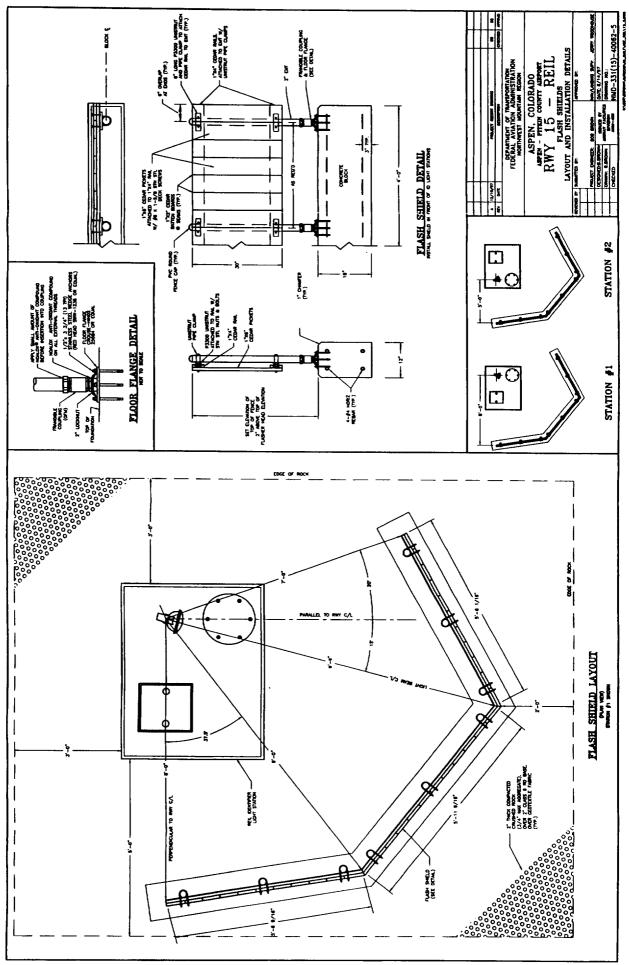
Attached is a copy of a REIL flight inspection dated 2/8-9/99. This inspection was result of a user complaint the left light was somewhat obscured.

13. REMARKS: O-1 ound to be obscured by skistherory. ATCT and FACILITY STATUS	y small baffli maintenance	ng fenc 1 advise	è install	ed in	a front of light	Maintena	iL ilght w nce mede	ras obșcui : two helg	ed when hi adjust	01 no mi 10 no mi	al 3.00 REIL I	degrec glider ight installeti	path. Left ion and re	REIL II	UNSAT
A REMARKS: O-I ound to be obscured by substancory. ATCT and FACILITY STATUS INRESTRICTED INUSABLE	y smell baffi maintenance NOTAN	ng fenc advise fs:	e install d of the	ed is resu	n front af light. Nes of the inspe	Malatena ection.	nce mede	: two helg	, .	nents to	REIL	dogree glidey ight installati	on and <i>r</i> e	REIL II	UNSAT ght
	y smell baffi maintenance NOTAN	ng fenc advise fs:	e install d of the	ed is resu	a front of light	Malatena ection.	nce mede	ns obșcu : two helg :HNICIAJ	, .	nents to	REIL	dogree glidey ight installati	on and <i>r</i> e	REIL II	UNSAT ght
