NATIONAL TRANSPORTATION SAFETY BOARD

AIRWORTHINESS AND MAINTENANCE GROUP CHAIRMAN'S FACTUAL REPORT

A. ACCIDENT: DCA08MA098
LOCATIONS: Columbia, South Carolina
DATE/TIME: September 19, 2008
AIRCRAFT: Learjet Model 60, N999LJ, S/N 60-314

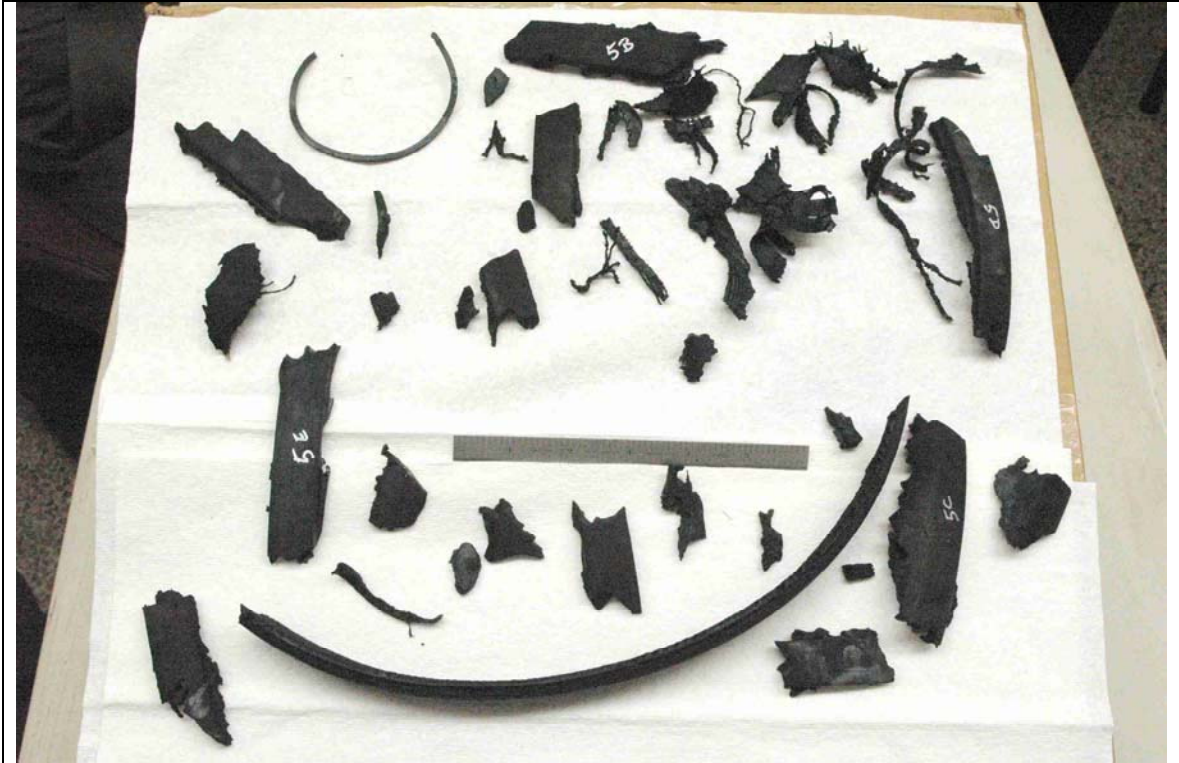
Figure 1. Example of tire and glass fragments in an evidence bag. This group was in bag #5 and a six-inch scale is shown in the middle of the group for proportion.

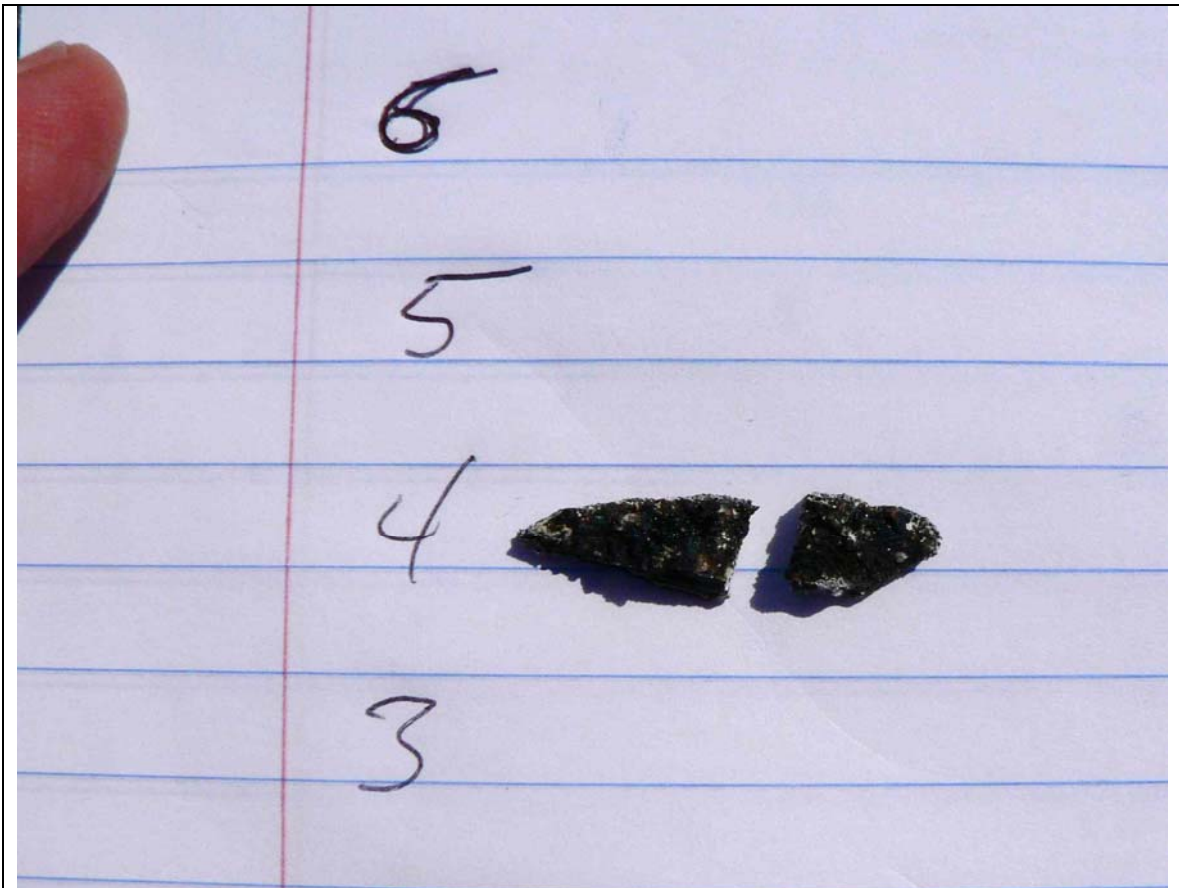
Pieces B5 through B1 were the only foreign material found on the portion of the runway that included the initial tire debris and were found in a rough line that led to the first piece of tire debris from the accident airplane. The pieces visually matched fragments of hardened epoxy, but electron dispersive spectroscopy showed that the fragments did not match either the material from a recovered broken runway reflector,² or any markings on the tires. The longest fragment (about 1.5 inches long) was broken by hand. (Ref. Figure 2)

Figure 2. Piece B4 was about 1.5 inches long when found and was broken by finger pressure while determining how hard the material was.

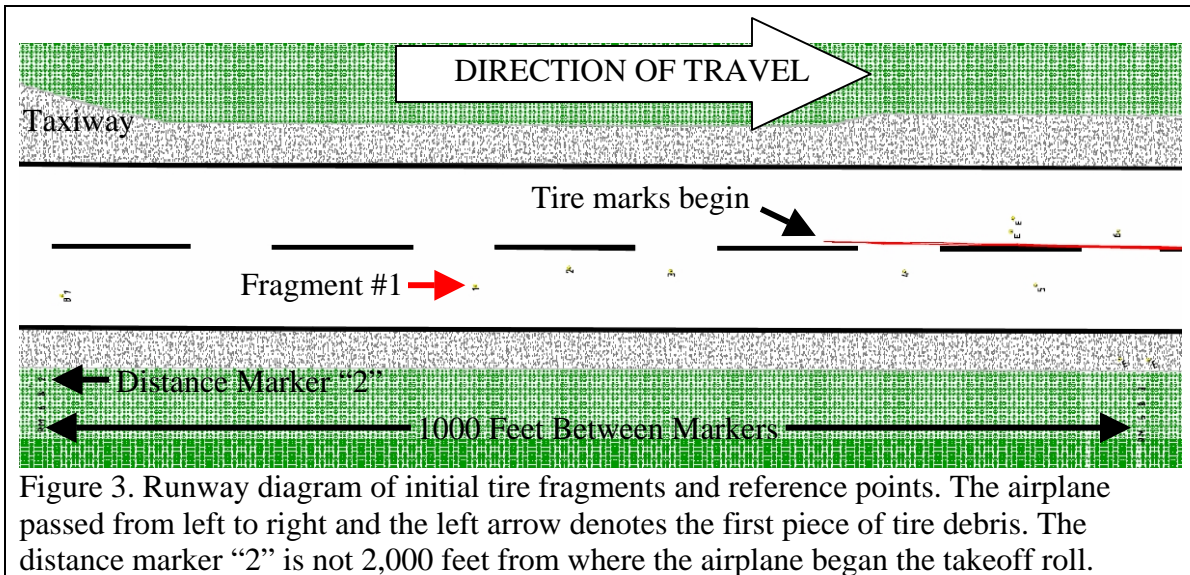
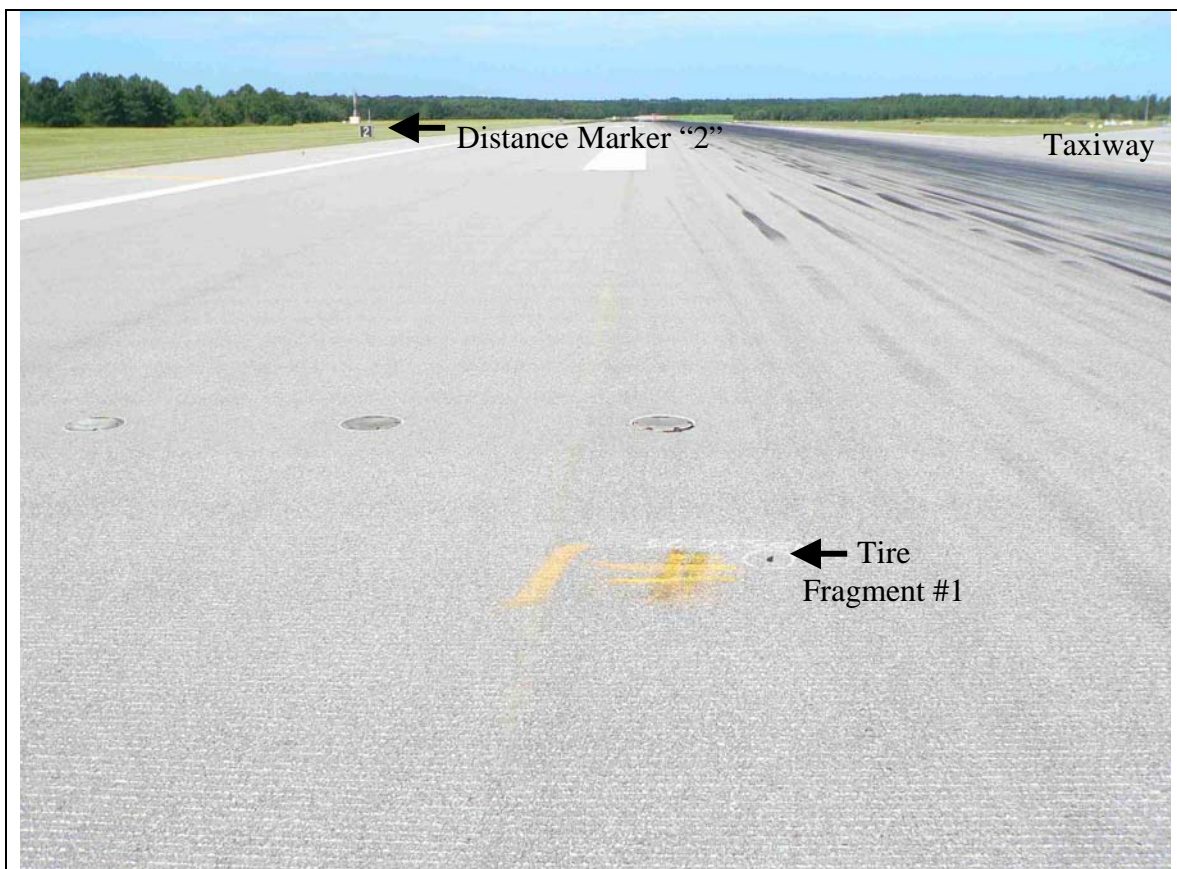
Tire and skid marks could be followed on the runway and were spaced 100 inches apart (8' 4") which was the spacing between the centers of the inboard left and outboard right wheels.³ (Ref. Figures 3 through 6)

Figure 4. Facing west, toward the first tire fragment from the accident airplane and where the airplane started from. Note runway distance marker “2” at upper left of photo and taxiway at upper right, as shown in the runway illustration. The white paint in the background is known as “Fixed Distance Marking,” is visible in the next photo, and is not the runway centerline. The runway centerline is in the black area to the right.

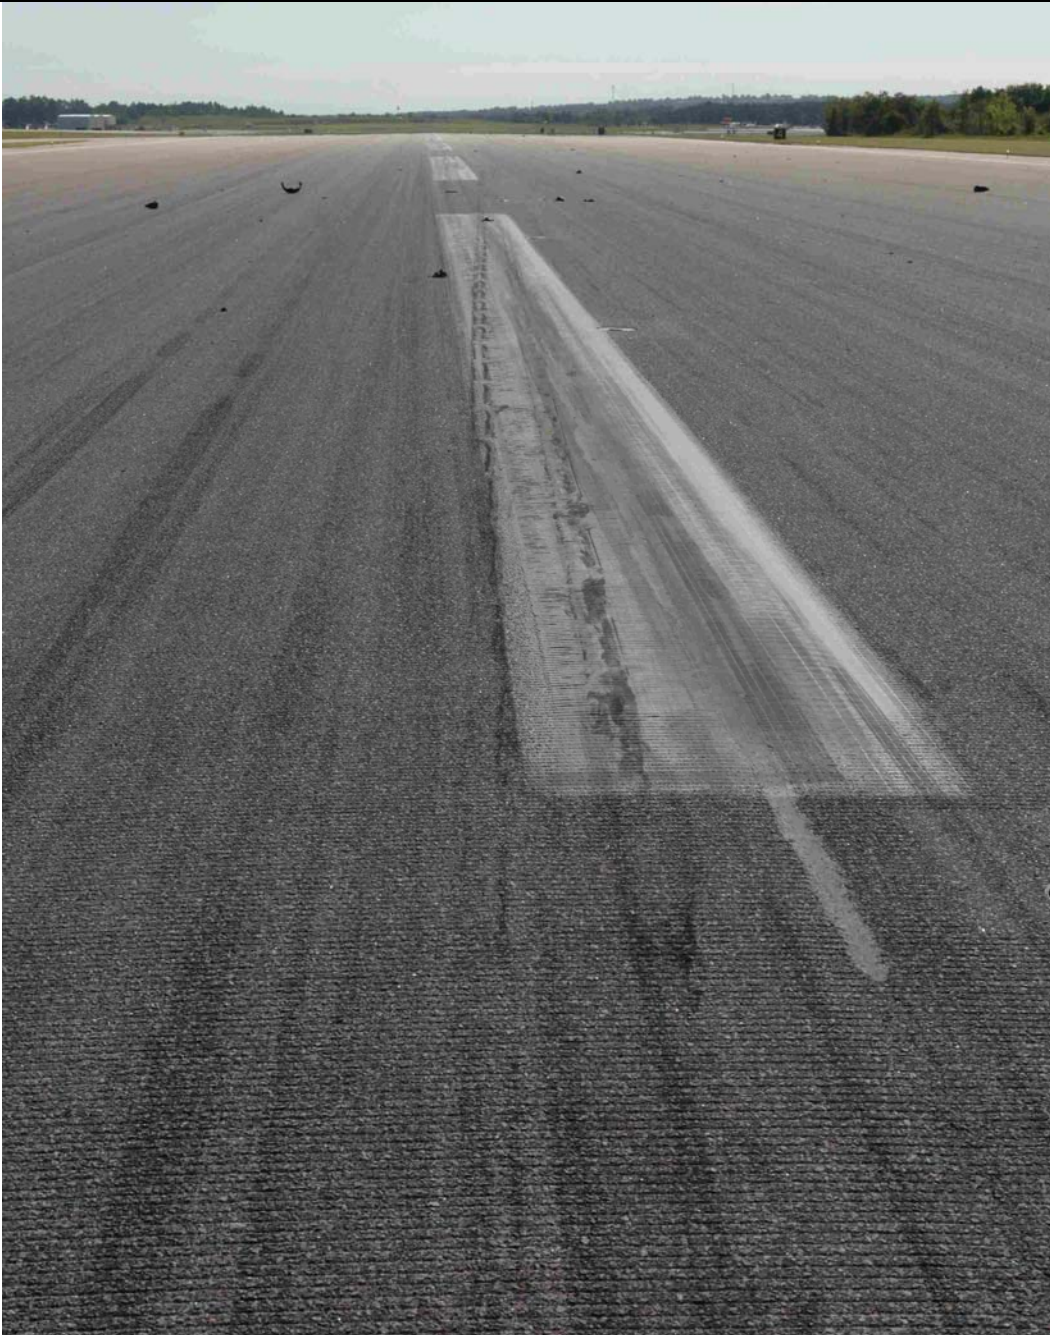
Figure 5. Facing east, the direction that the airplane traveled, this photo shows the initial tire marks crossing the runway centerline. Tire debris is visible.

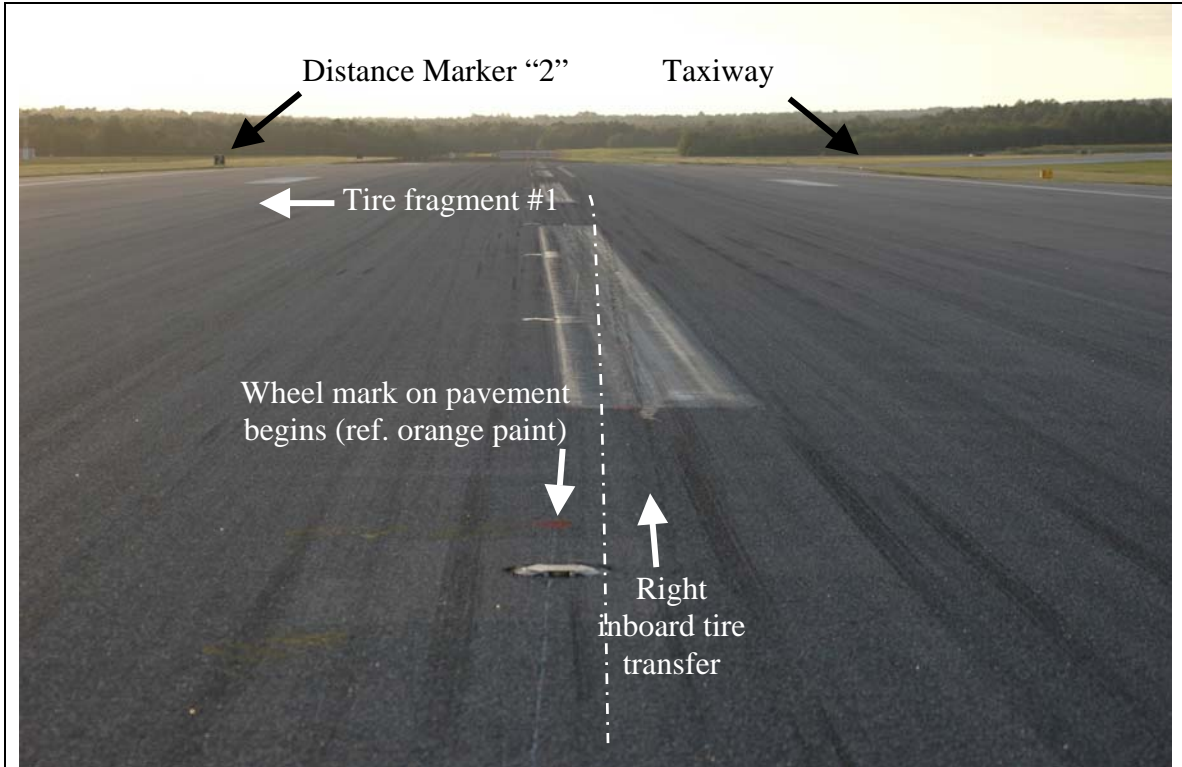
Figure 6. The same skid marks, facing west, toward where the airplane started from. A white aluminum wheel-mark is visible on the pavement and none of the debris from the left set of tires was found this close to the beginning of the runway. Reference points have been added for clarity. The dashed line is drawn between the right inboard and outboard tire marks and shows the angle at which the marks cross the centerline. Note

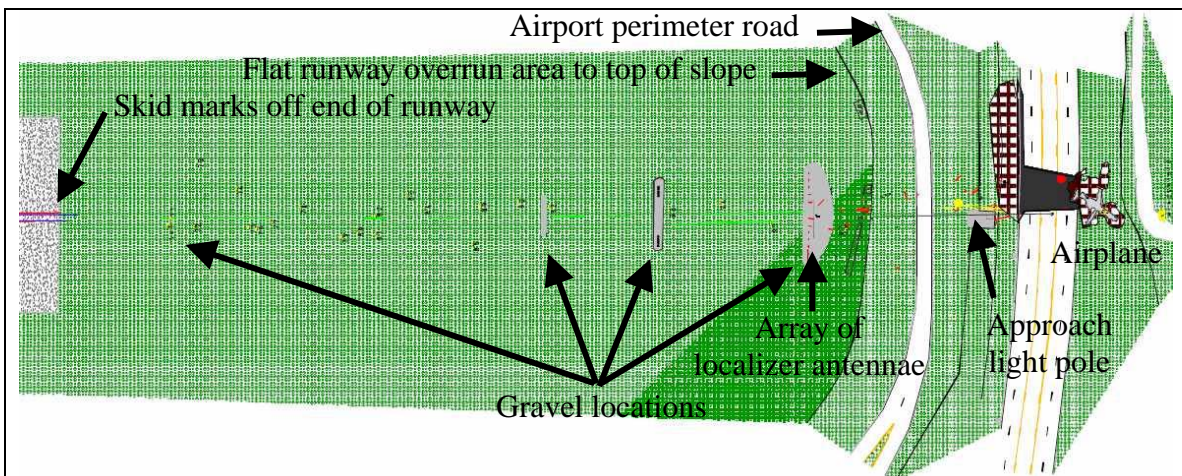
The tire/wheel marks and debris path led past the runway and through four rows of gravel at the bases of the runway end lighting and instrument landing system components. A trail of displaced dirt and gravel at about the width of the fuselage ran from near the first bed of gravel to the end of the flat runway safety area area. (Ref. Figure 7)

Figure 7. Illustrated locations of debris in the runway safety area and across the roadway.

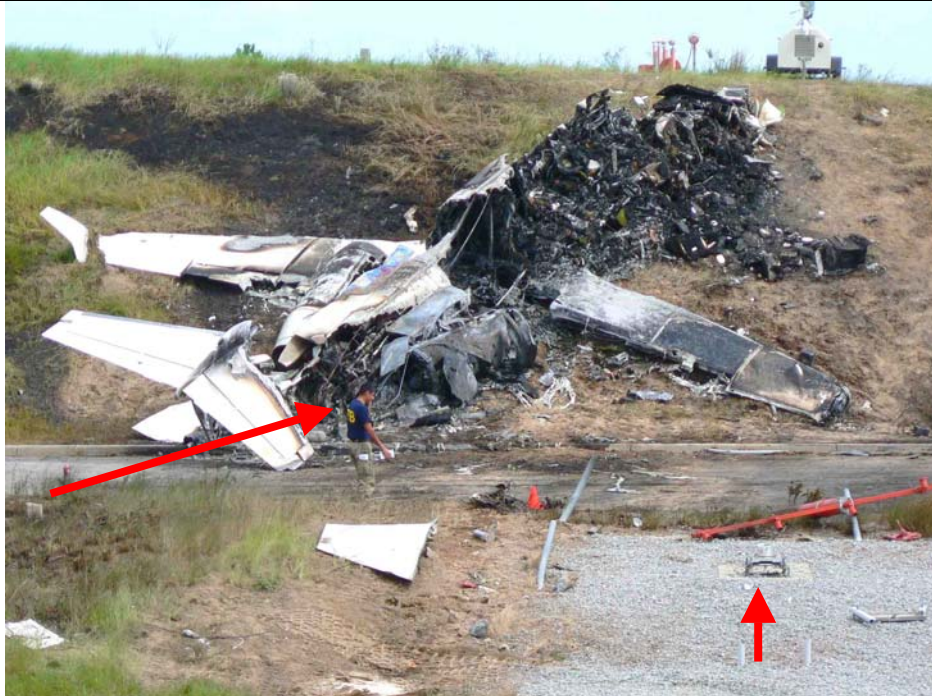
Figure 8. Airplane wreckage as viewed from mid-way down the slope, between the runway safety area and the approach light pole. The base of the broken light pole is at the lower right arrow. The arrow at the lower left points to the base of the broken concrete roadway right-of-way (R/W) marker and where the top was found (See also Figure 18). The fuel-burned area begins at the post.

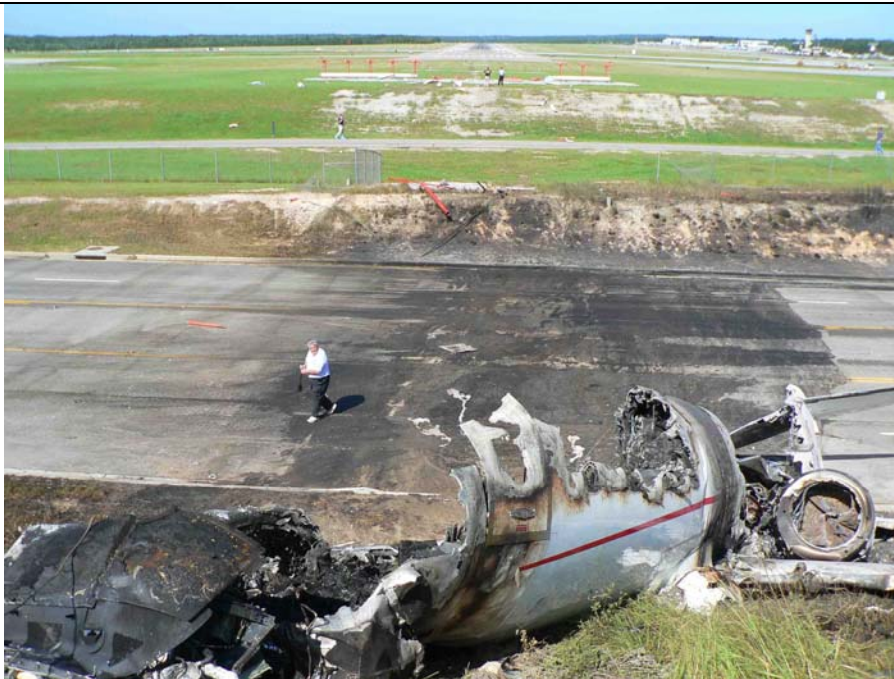
Figure 9. Airplane wreckage on hill, viewed back to the runway and crossing South Carolina Highway 302.

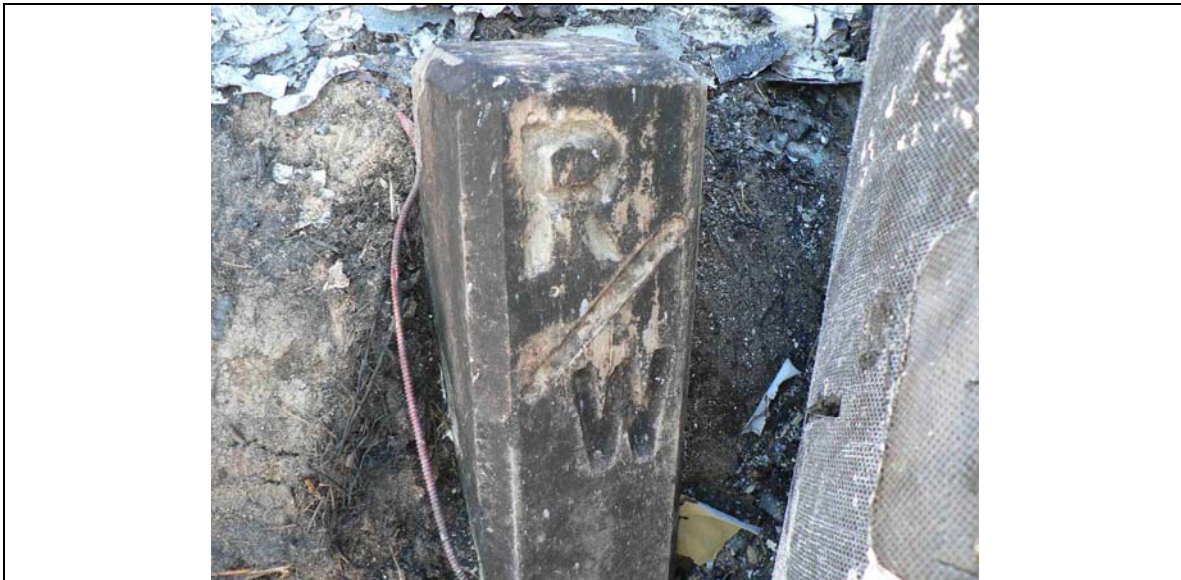
Immediately outside of the airport fence was a square concrete post marked "R/W" to denote highway right of way. A second similarly marked concrete post was on the east side of the road and both had been struck by the airplane. The markers were not on airport property according to both airport personnel and maps. Each concrete post was six inches square, with the complete post standing 14 inches tall. The post closest to the runway had been fractured seven inches above the ground, exposing rebar reinforcement inside and the top portion was found inboard of the right engine thrust reverser. The eastern marker post was found protruding from beneath the left engine. (See Figure 10)

Figure 10. Concrete post found beneath left engine. The post was six inches square and was internally reinforced with steel rebar.

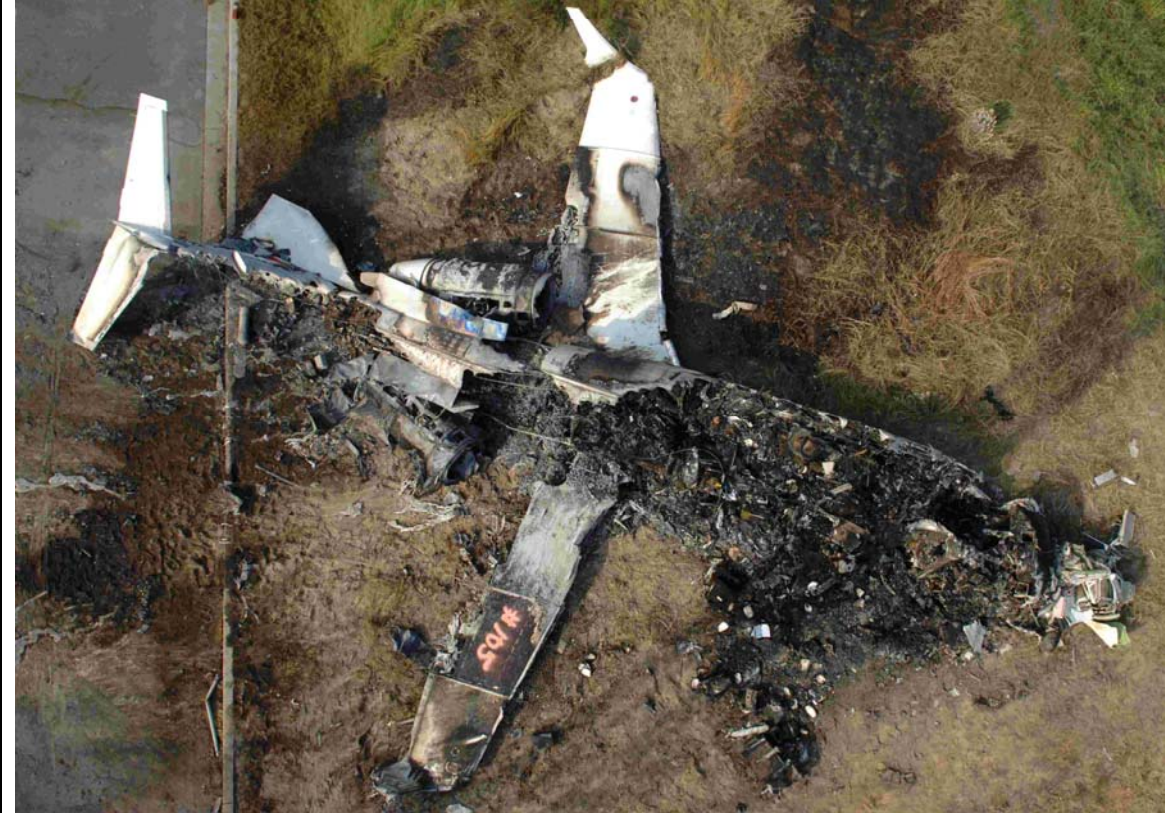
The airplane was generally on a magnetic heading of 134 degrees and resting nose-up on the side of a hill of approximately 25-30 degree slope.⁴ With the exception of all three landing gear, the right delta fin, and the right wing flap, all major airplane assemblies were found in the appropriate orientations or beneath where they would have been prior to the fire. The thrust reversers were found in the closed positions. (See Figure 11)

Figure 11. Aerial view of the airplane.

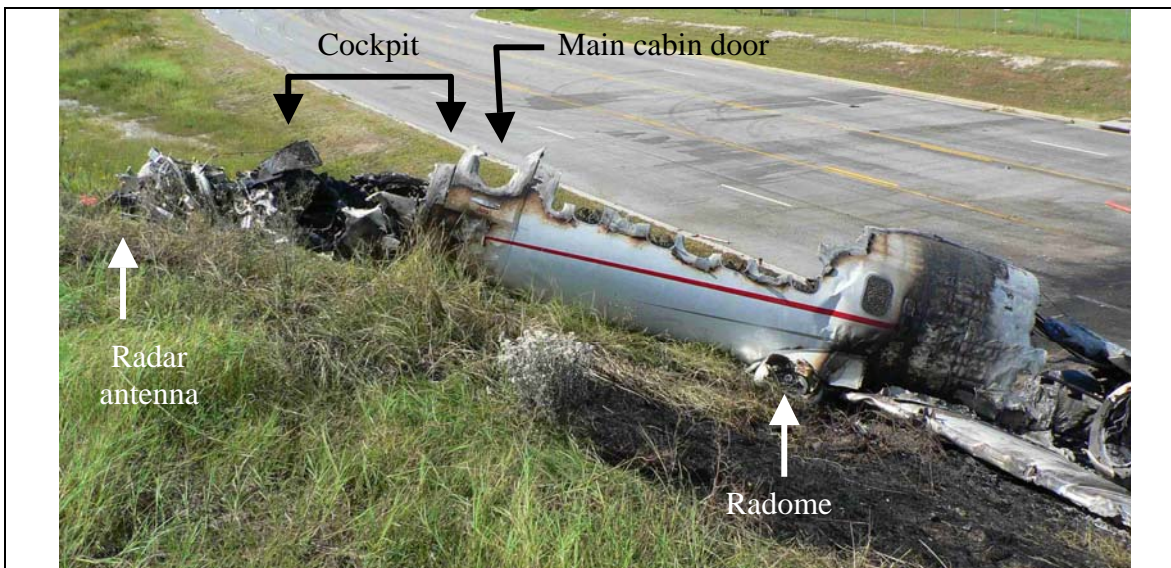
The radome cover was found in front of the left wing root and the radar antenna was not crushed aft, as from striking an object in front of the airplane. The bottom portion of the forward pressure bulkhead was crushed upward without aft displacement. (See Figure 12)

Figure 12. The forward portion of the airplane conformed to the hill. The nose is not crushed aft and the radome cover is resting ahead of the wing root.

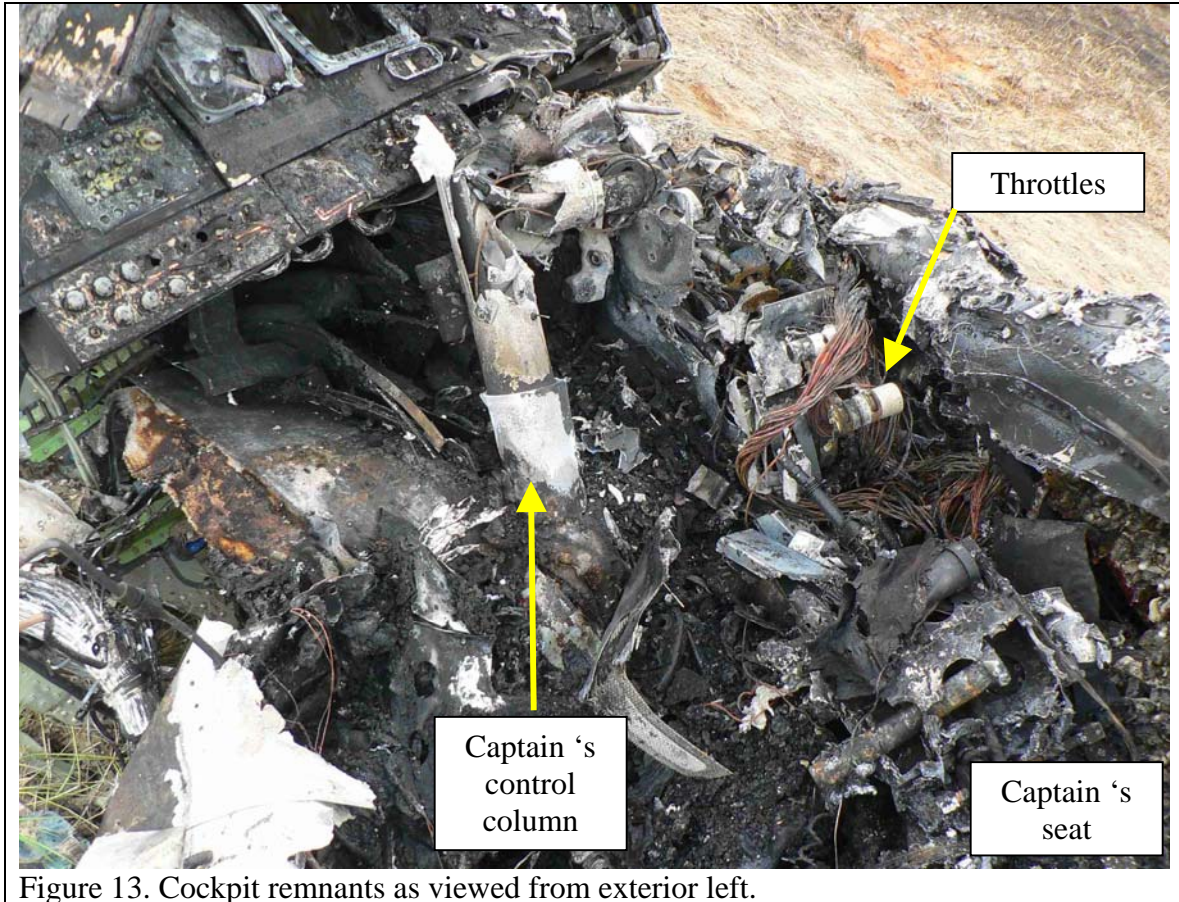
The cockpit had been burned to about the level of the seat pans, although components from above that level were found on top of the debris pile. The two fire handles were found in the stowed positions. The instrument panels had been displaced relatively forward from the pilot seats, consistent with a downward impact. The instrument panels had extensive fire damage that obliterated most of the surface features. The Captain's control column had impacted the area of switches that had been in front of it, flattening their features. The left and right starter/generator switches were found bent past the GEN positions. The 2-position lift-latch toggles from above the left generator switch were found in the up positions. (See Figure 13)

Figure 13. Cockpit remnants as viewed from exterior left.

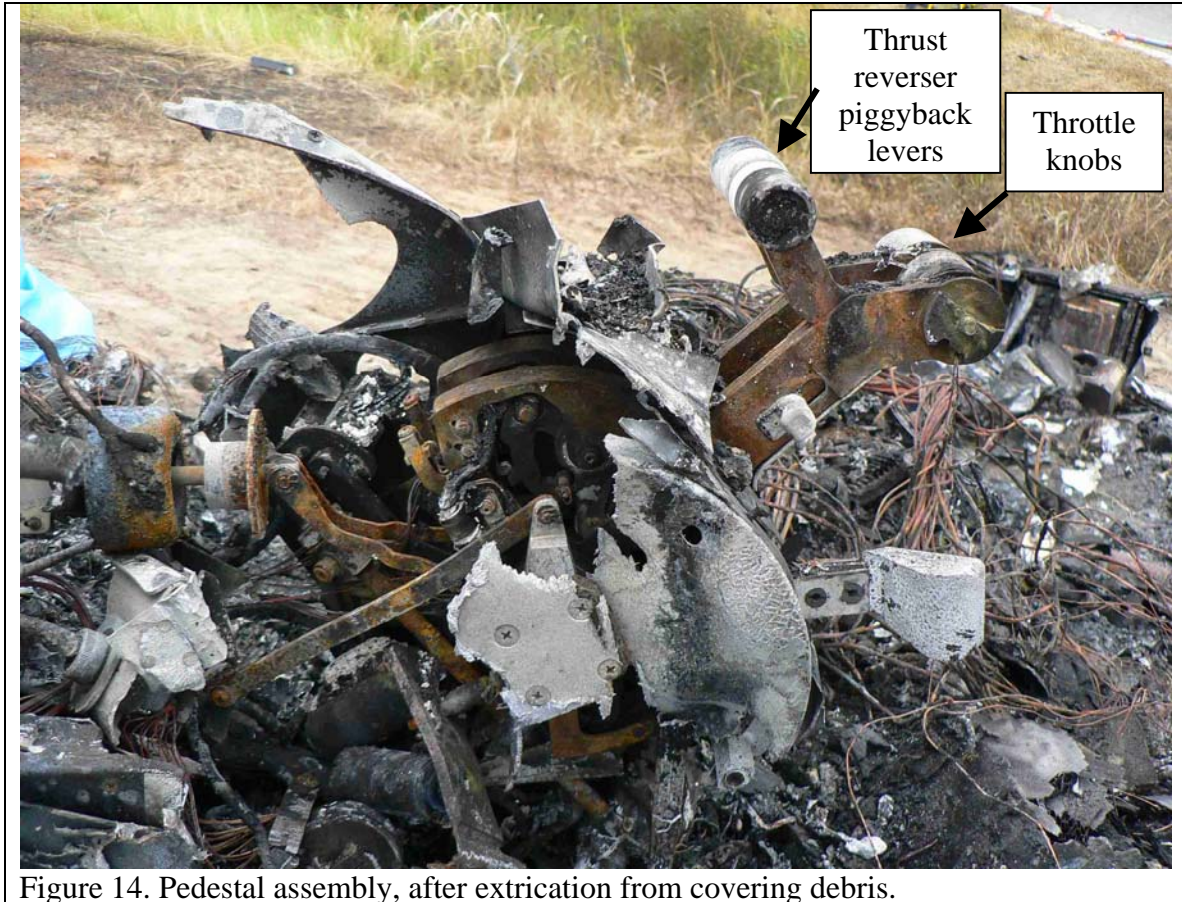
The cockpit center pedestal had broken aft of the throttles and had been displaced to the right. (See Figures 13 and 14) The pedestal exhibited extensive impact and fire damage. The two throttle levers were found at the forward end of the travel limits and the sheetmetal from forward of each was cut forward. The reverser levers were in the stowed positions and the spring-loaded cut-off toggles were in the stowed positions. The cut-off switch track was examined and nothing was found to indicate whether or not the toggles had been pulled up at any time. The center of the flap handle was found at 2.25 inches from the bottom of the 3.25 inch slot. The spoiler handle was found in a mid-position in the slot but was loose and free to move. The landing gear freefall and blow-down controls were found in their normal positions. The automatic power reserve (APR) switch was found in the armed position. (See Figure 14)

Figure 14. Pedestal assembly, after extrication from covering debris.

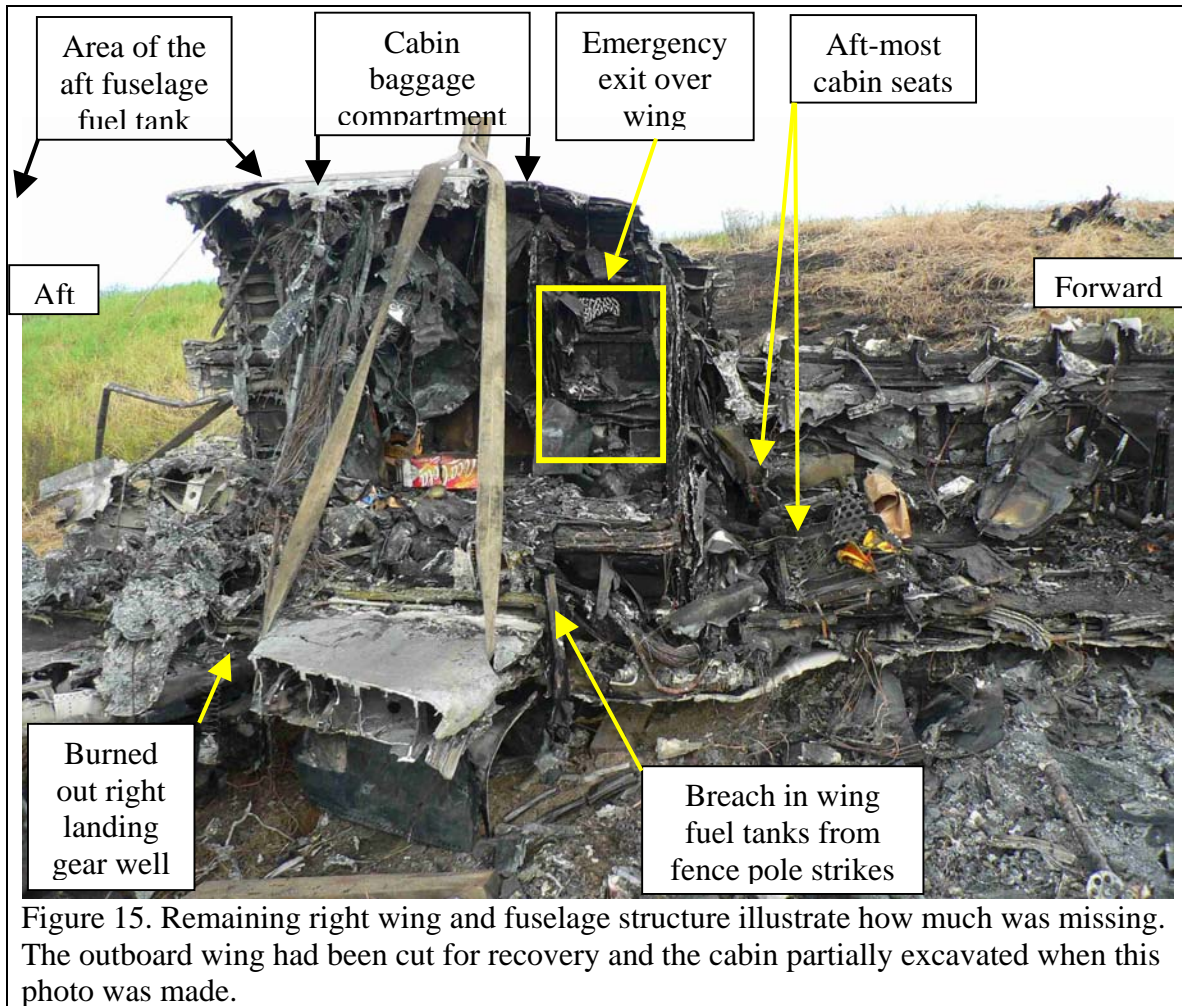
There was no right cabin wall or roof from the forward pressure bulkhead to the right engine inlet. The structure from around the emergency exit had been consumed by fire. (See Figure 15)

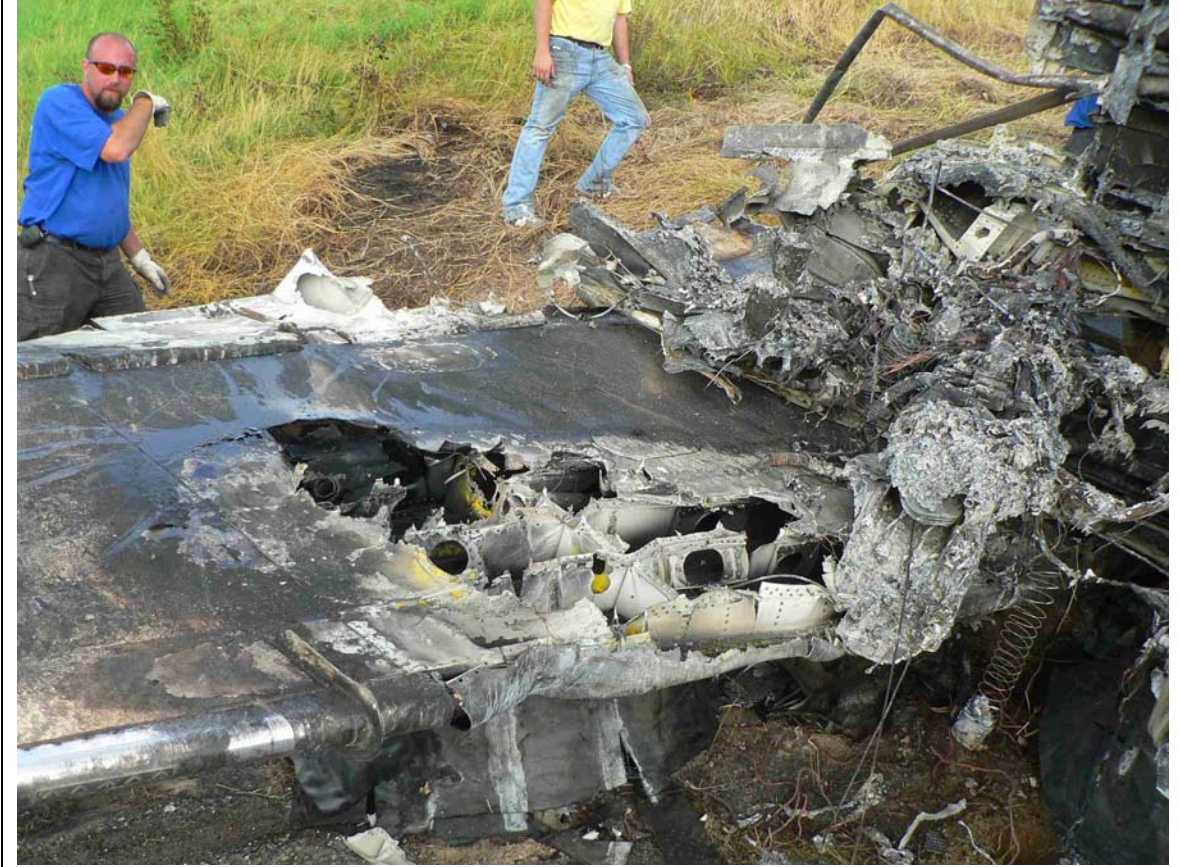
The left wing had a rip in line with the concrete highway right of way marker and the distance between the leading edge of the puncture and the rear was 64 inches. (See Figure 16) On the east side of Highway 302, a belly-mounted antenna left a line in the dirt of about the same length, where the airplane struck the ground and came to a stop.

Figure 16. Bottom of the left wing, shown during recovery, exposing the leading edge opening into the fuel tank that aligned with the path past the concrete post on the west side of the roadway.

The left wing had an assortment of dents and crushed locations to the outboard aerodynamic fence. The bottom surface of the wing and integral fuel tank had been completely opened and crushed aft. The location of this matched the distance from the fuselage imprint in the ground to the fragment of concrete right of way marker that had been near the frangible light assembly on the west side of the roadway. Other wing leading edge damage was matched to the airport perimeter fence posts and none of the fence post strikes had the depth or damage that was found where the concrete post had been struck.

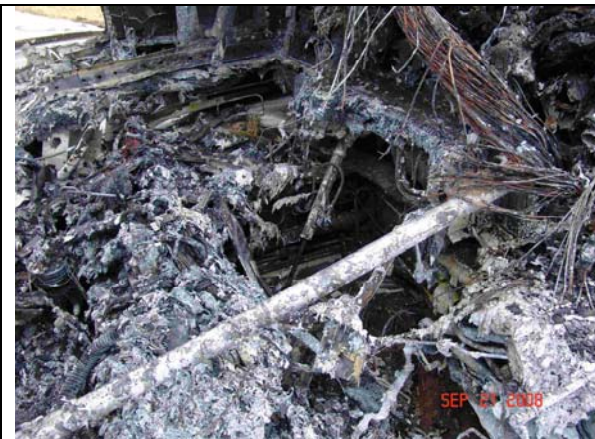
The right wing was downhill from the breached fuselage fuel tank. The right wing had more extensive fire damage than the left wing and bent downward at the outer edge of the landing gear well, which was in line with the deepest area of leading edge damage. The right main landing gear well had been under the fuel tank and was extensively fire damaged, so that the rear and the wing structure from over the well no longer existed. Components within the well had burned, melted, or been encased in aluminum slag that pooled from other melted parts of the airplane. (See Figures 17 and 18)

Figure 17. The right main landing gear well from above right, as exposed by the post-crash fire.

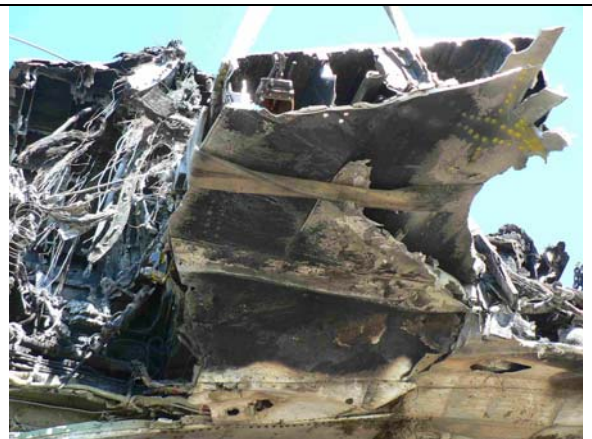
Figure 18. The right main landing gear well from below. The indented leading edge along the right edge of the photo better shows where the succession of three airport perimeter fence posts struck.

The right wing leading edge damage that opened into the right wing fuel tank was within two feet of the fuselage. This opening in the right wing fuel tank was also immediately outside of the emergency exit that had been located at the aft of the passenger cabin, above the toilet. The spacing between the leading edge impacts was compared with the airport features and the chain link fence that the airplane dragged to the resting place. The opening in the leading edge aligned where the three fence posts had been in line with the path of airplane travel, between the south side of the frangible light support and the concrete highway marker that had opened the left wing.

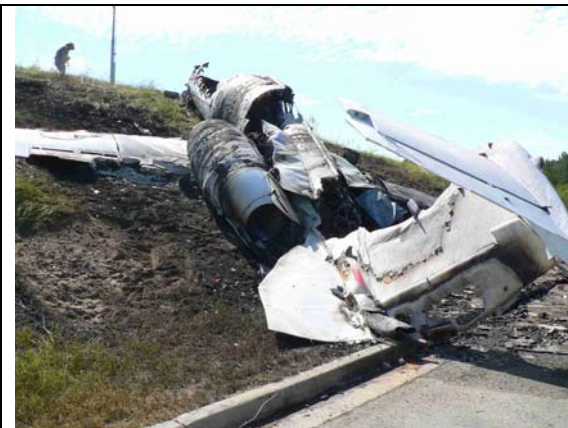
The aft fuselage had been consumed by fire between the engines and the aft cabin baggage compartment, with the right engine suffering more fire damage than the left engine. (See Figures 19 and 20)

Figure 19. Left aft fuselage, engine, and tail assembly.

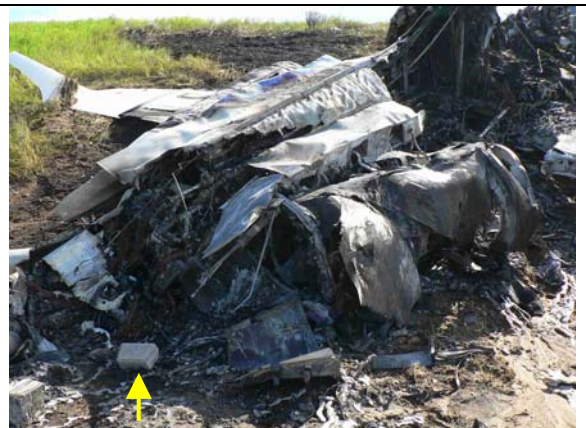
Figure 20. Right aft fuselage and engine. Note: The arrow points to the top of the concrete marker post from the west side of the road.

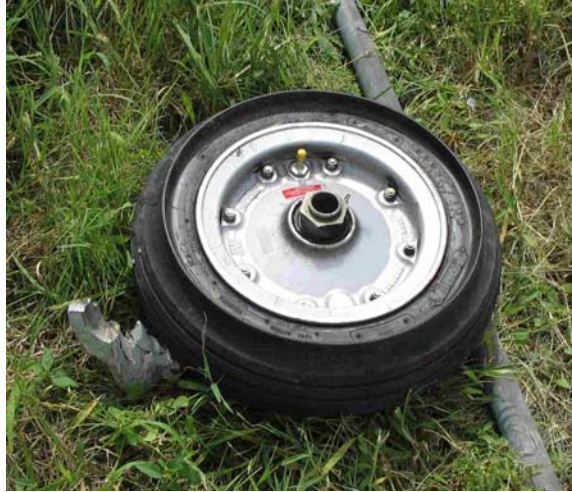
The upper portion of the nose landing gear was found forced back and up into the fuselage. The lower yoke and wheel assembly was found on grass at the east side of Highway 302, with the nose tire inflated. (See Figure 21)

Figure 21. Nose landing gear tire and yoke assembly, resting on the east side of Highway 302. The pole is a fence post from the west side of the highway.

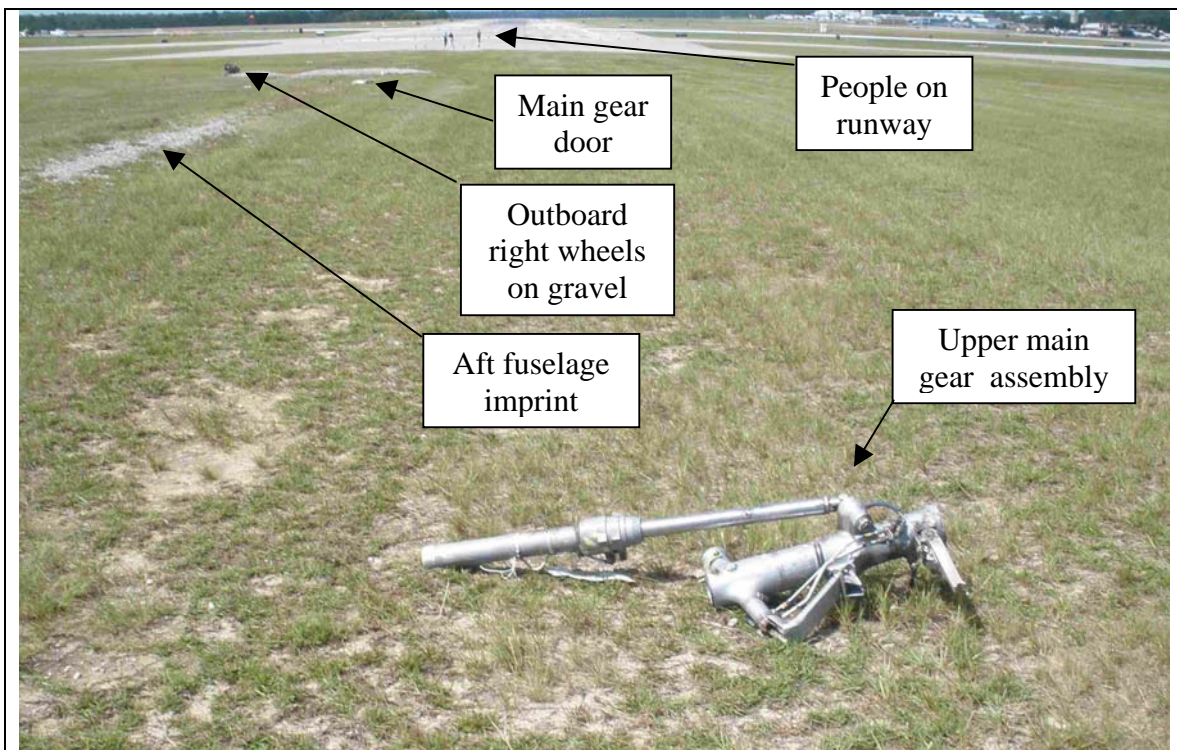
The main landing gear pieces were collected for a partial reconstruction. The aft fuselage imprint on the ground was close to the center of through the runway safety area and the main gear parts were found to the left and right of that path. (See Figure 22)

Figure 22. View toward the runway from the runway safety area shows the initial gravel, where the main landing gear was found.

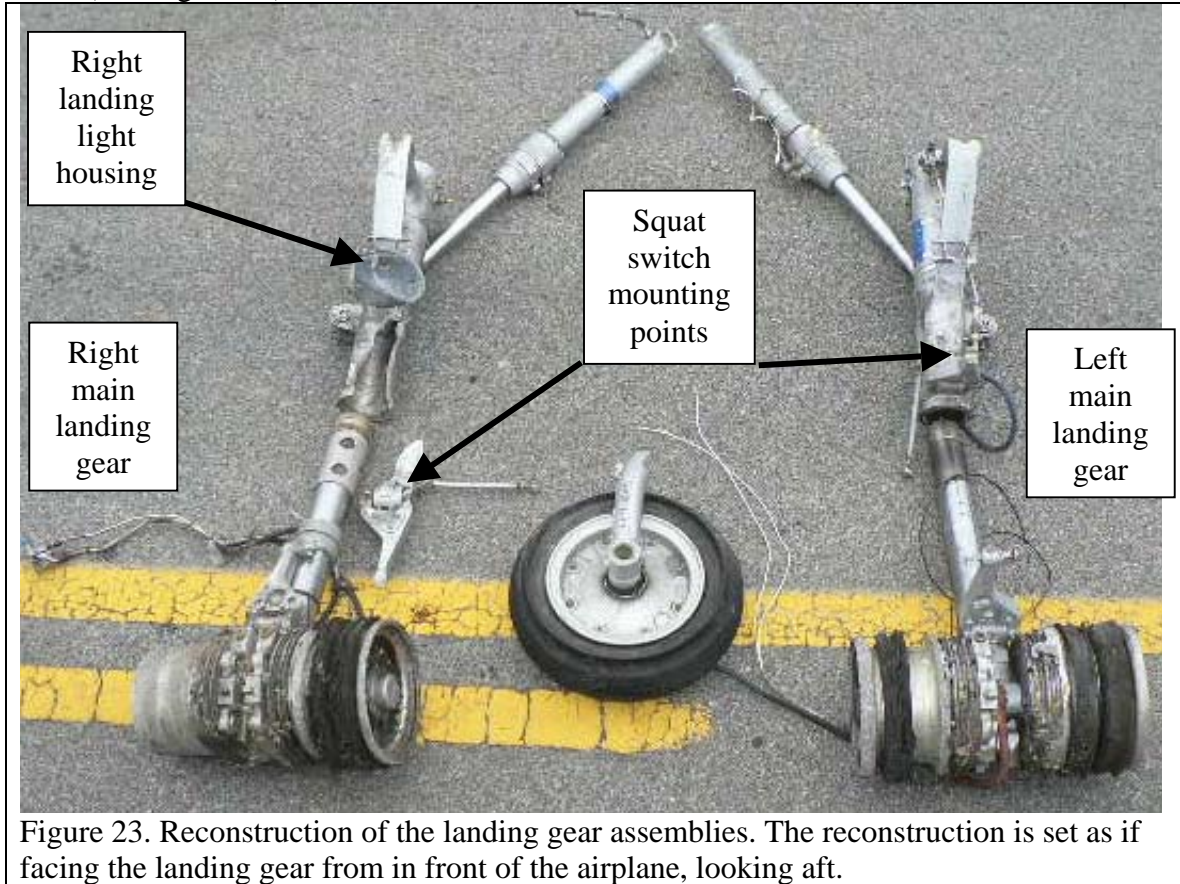
The right wheel on each landing gear strut was conspicuously more worn than the left was. (See Figure 23)

Figure 23. Reconstruction of the landing gear assemblies. The reconstruction is set as if facing the landing gear from in front of the airplane, looking aft.

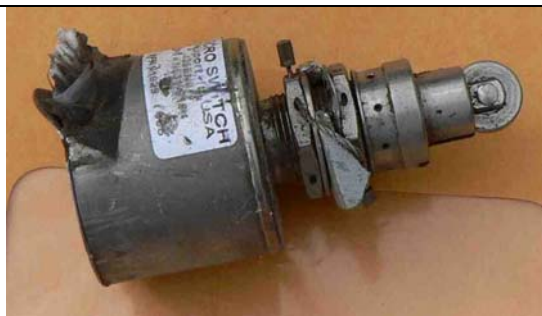
Figure 24. Left squat switch.

The left and right squat switches were each found separate from the main landing gear struts. (See Figure 24 and 25)

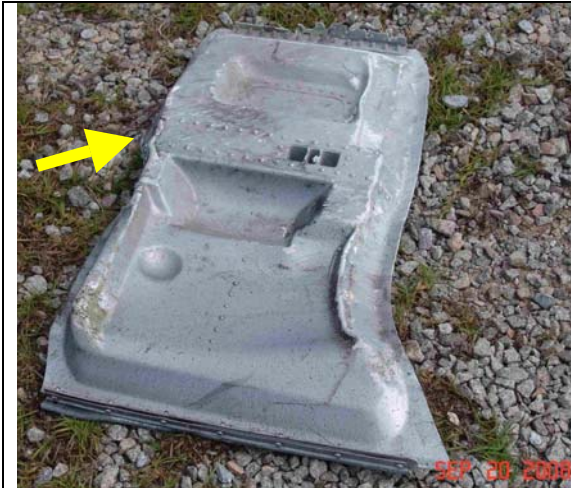
The outboard main landing gear doors from each wing were found in the grassy area near the gravel at the runway safety area. Each door had numerous specks of rubber adhered. The right door had black tire marks and indentations along the aft edge, but substantially less than the impact damage that edge of the left door exhibited. (See Figures 26 and 27)

Figure 26. Left main landing gear door with impacts along the trailing edge (arrow) and black rubber transfers near the hinge.

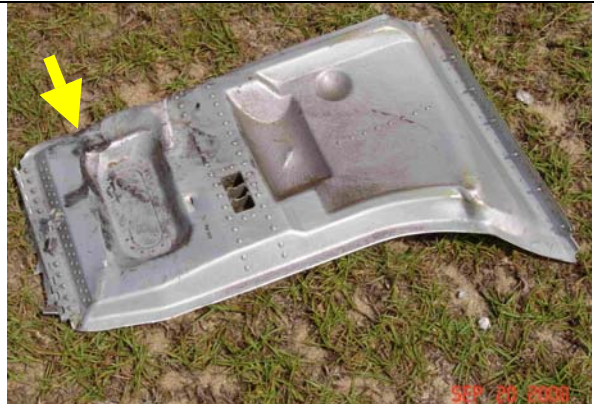
Figure 27. Right main landing gear door with impacts along the trailing edge (arrow) and black rubber transfers near the hinge.
