NATIONAL TRANSPORTATION SAFETY BOARD

AIRWORTHINESS GROUP CHAIRMAN'S FACTUAL REPORT

ERA14MA271

Location: Hanscom Field, Bedford, MA
Date: May 31, 2014
Aircraft: Gulfstream G-IV, N121JM, S/N 1399

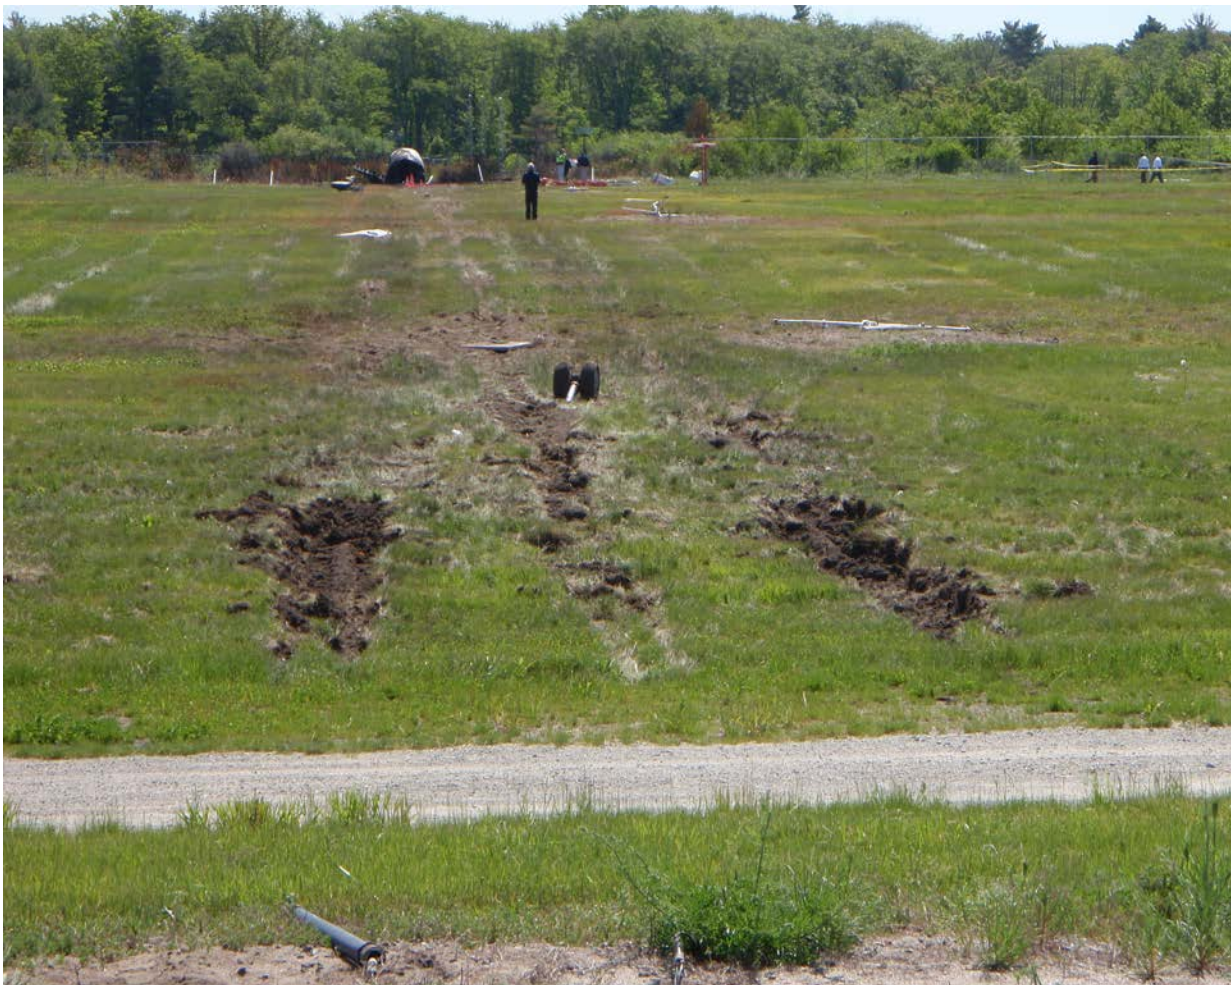
Figure 1: Accident Scene from End of Overrun Pavement

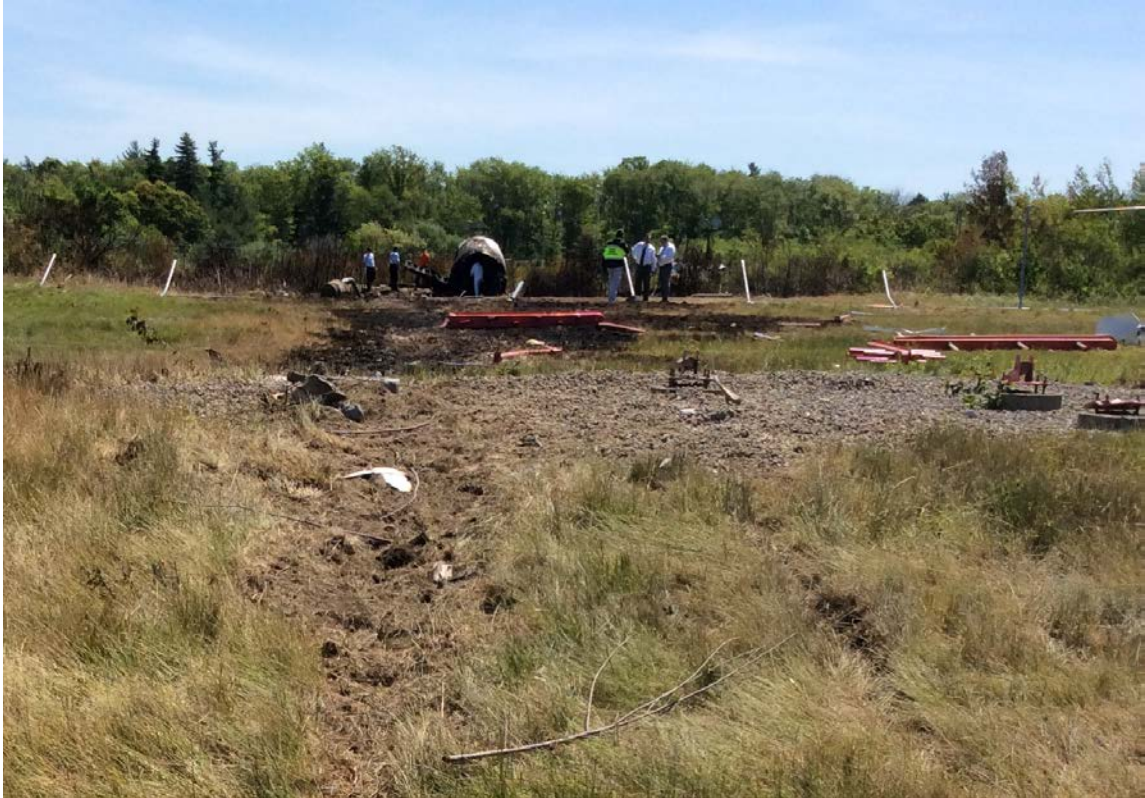
Figure 2: Accident Scene from Just Prior to ILS Fixture

The localizer antennas were in the airplane path and were broken and knocked down. Multiple localizer antenna poles were severed approximately 17 to 18 inches above their base. The grass between the localizer antennas and the ravine was blackened and charred (see Figure 2). Just prior to the ravine was a large perimeter fence that was partially knocked down. The airplane was found spanning the width of the ravine with the tail on the airport side, the engines, wings, and fuselage down in the ravine, and the cockpit on the far side of the ravine (see Figure 3). The majority of the airplane was destroyed by fire, with the greatest fire damage occurring near the wing root area of the fuselage. All major portions of the airplane were accounted for at the accident site.

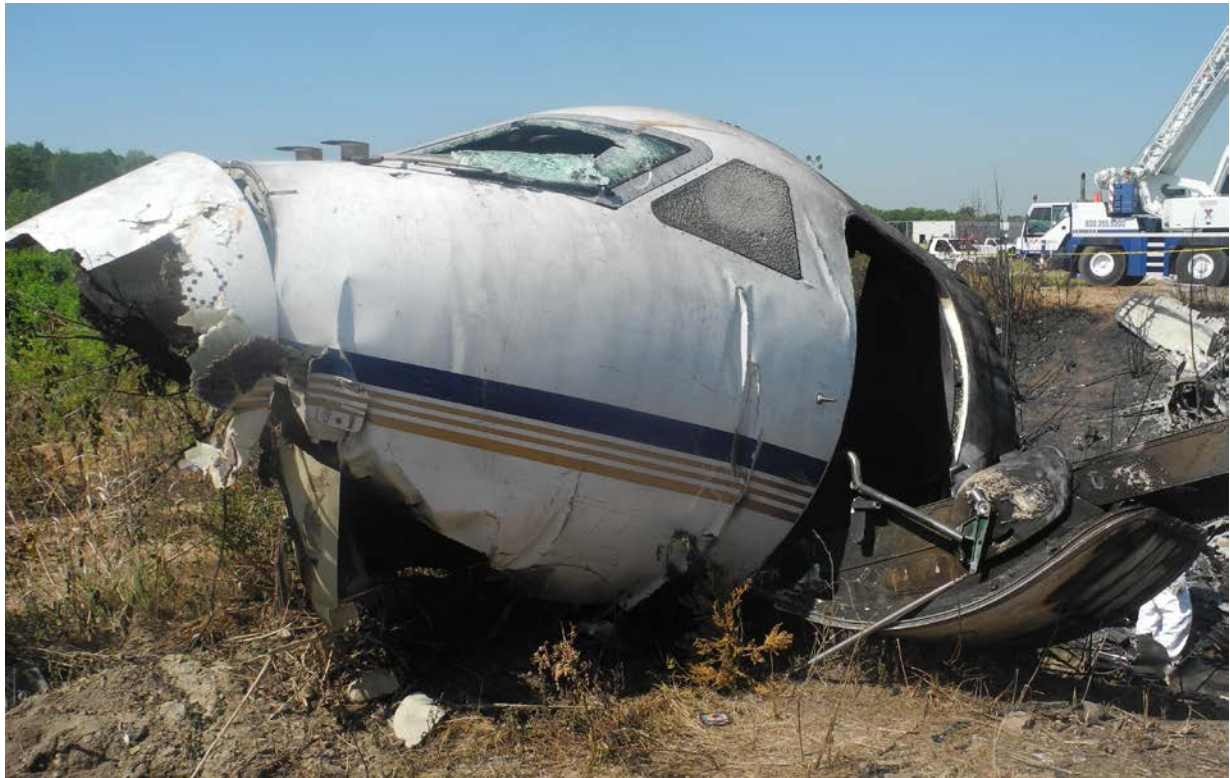
Figure 4: Forward Fuselage Structure

The fuselage structure remained mostly intact from the fractured nose cone aft approximately 14 feet (see Figure 4). Aft of this point the fuselage structure was destroyed by fire. The exterior paint forward of the forward entry door remained intact, and around the door and aft of the door the paint was discolored or burned away. The cockpit windows were cracked and discolored, and the left side forward windscreen was cut out by rescuers. The nose cone was broken and partially missing. The bottom of the forward fuselage was deformed at approximately a 45° angle from the nose cone attachment frame extending down and aft approximately 3 feet. Circumferential buckling around the fuselage was noted approximately 6 feet aft of the nose cone attachment frame. The main entry door was partially opened by rescuers by operation of the external door handle prior to the arrival of investigators.

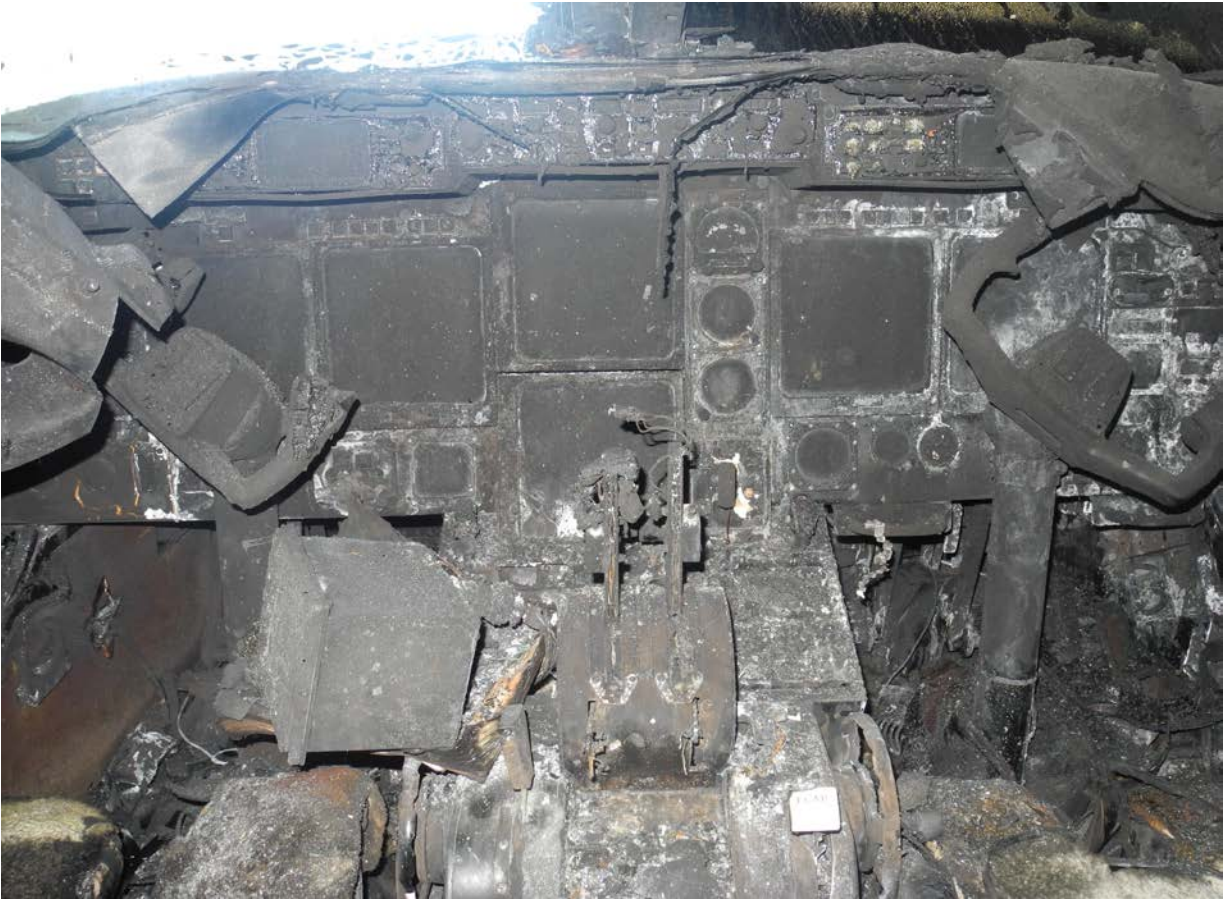
Figure 5: Flight Deck

The interior of the cockpit and door entry way was heavily sooted, melted, or destroyed by fire (see Figure 5). Prior to the occupant recovery efforts, inspection of the cockpit revealed that the throttle levers were in a position between full forward and half throttle. The thrust reverser handles were down (stowed) and the gust lock handle was in the full forward position (gust locks not engaged). The left Control Display Unit (CDU) was out of its slot and laying on top of the pedestal assembly. Later analysis of the CDU found that the screws were not in the secured position.

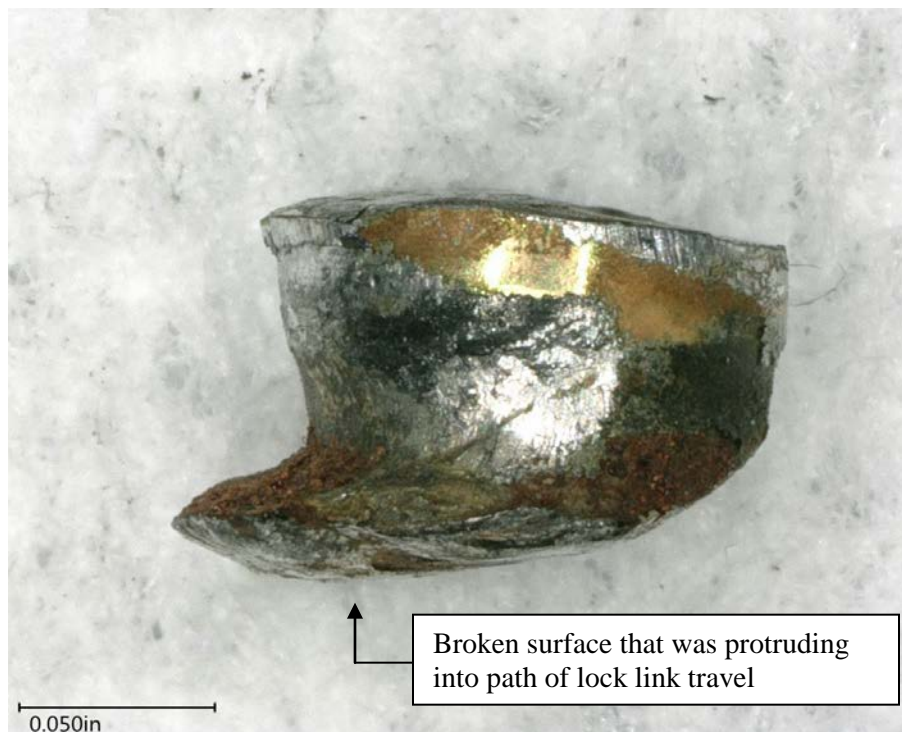
The gust lock handle was initially found in the down position. The handle was sooted and the primer was charred. The spring action of the latch was not smooth and the spring was not consistently returning the latch mechanism to the lock position when the lever knob was released. X-ray analysis later showed that the latch spring was intact.

Figure 8: Lock Pin Stub from Right Side of Slider Assembly

Following wreckage recovery, the gust lock handle was moved full up and then manually moved down until a resistance was met (the forces normally provided by the return springs were absent due to the severed control cables). This resistance was thought to be the lock pin slot engaging with the lock pin. It was noted that with increased force the handle could be pushed past the lock pin, and it was later discovered that the pin was severed and only stubs remained on both sides of the slider assembly. NTSB lab analysis revealed that the pin material remaining on the right side of the slider assembly as installed on the aircraft was significantly deformed with smearing damage having pushed the pin material in the direction consistent with the lever going from the up position to the down position (see Figure 8). The material remaining on the left side of the slider assembly was small enough to be inside the pin hole. The middle section of the pin was never found. By design, the pin will either free float in the restraint holes in the slider assembly or have a slight interference fit. During lab analysis, the stub from the left side fell out of the slider assembly.

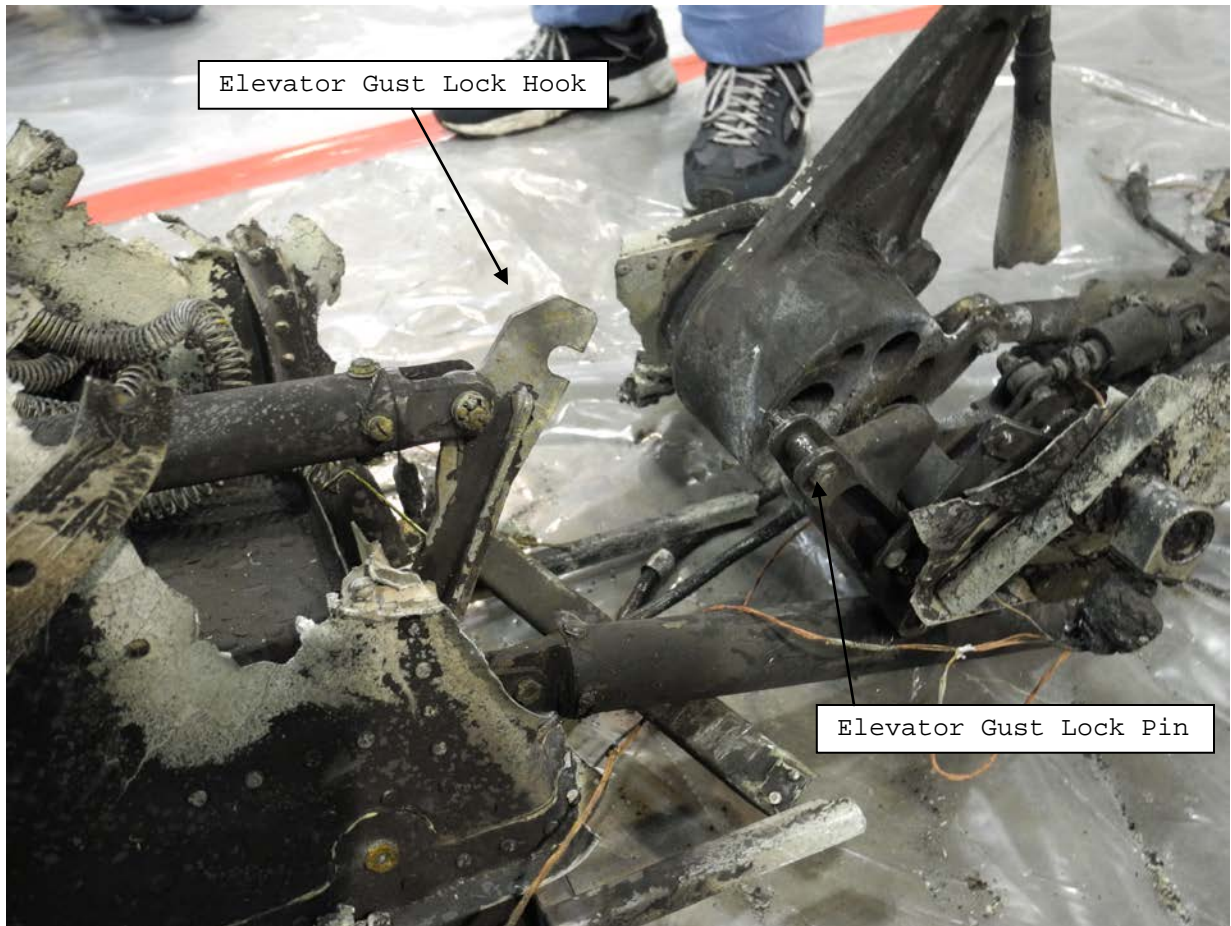
Figure 11: Elevator Gust Lock Mechanism Showing Gust Lock Hook and Gust Lock Pin

All observations regarding the gust lock components in the FS 775 area were made after the structure was removed from the ravine. The rudder and elevator gust lock hooks were not engaged with the gust lock pins when found. The two rudder/ elevator gust lock return springs were intact and provided return force to the torque tube in the direction to disengage the gust lock hooks. The cable input crank was fractured at both cable attachment lugs and both fracture surfaces contained soot. The elevator gust lock hook bungee moved freely back and forth but without any resistance from the internal spring. The elevator hook remained attached to the bungee and was straight. The inside surface of the elevator lock hook capture slot appeared sooty and/or corroded. The elevator gust lock locking pin attach bracket was intact. The locking pin was mostly sooted but had a small shiny area that spanned the length of the roller on one side. The shape could not be correlated to the shape of the gust lock hook, and it could not be determined if the area was caused by shielding during the fire or by contact after the fire. The soot could be removed easily from the roller.

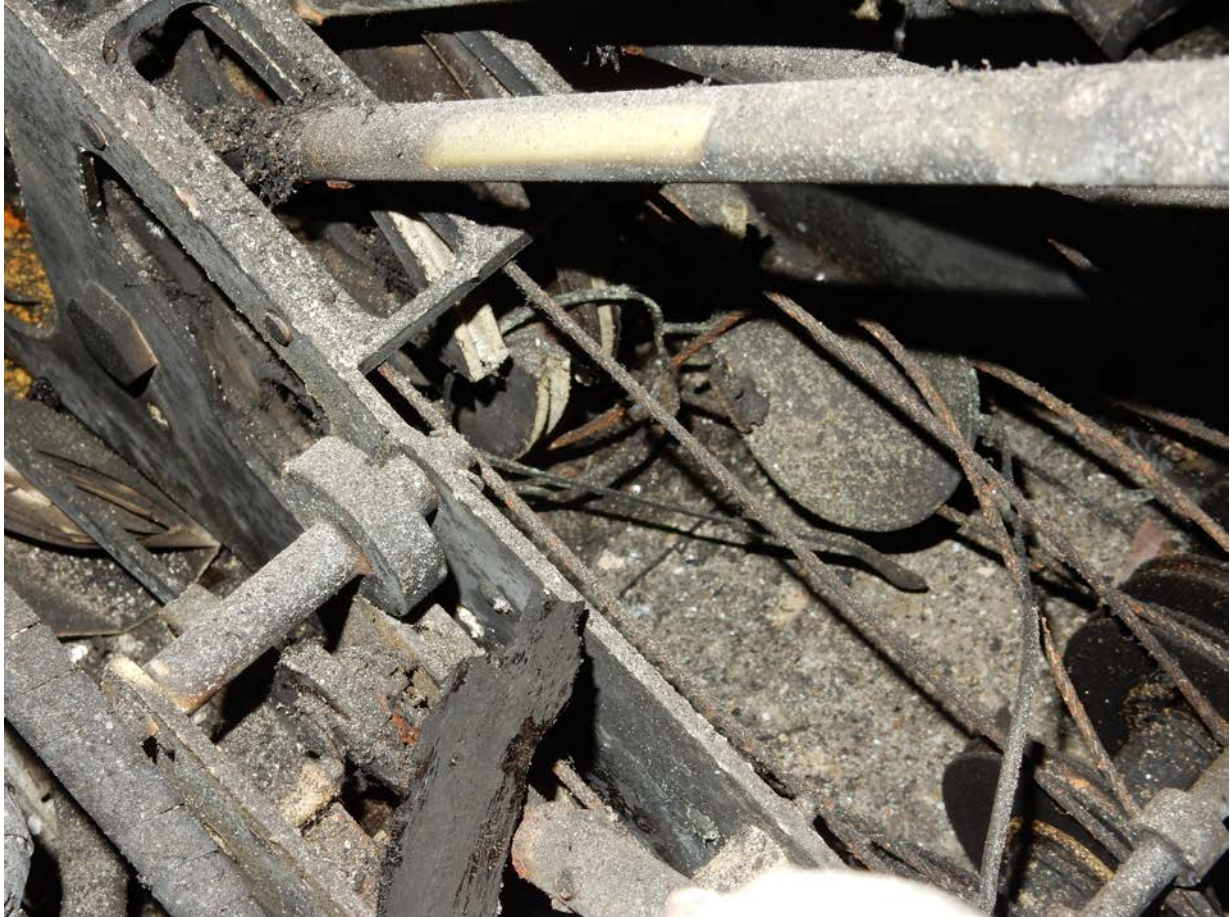
During initial pedestal rigging tests at the wreckage storage facility, a pair of sunglasses was found inside the accident airplane's pedestal. The sunglasses impeded the gust lock sheave movement, and the gust lock handle travel was stopped before reaching the full down position. The glasses were charred. The left lens was found separated from the frame and broken prior to rigging tests at the storage facility being performed. Pieces of the lens were found in various parts of the pedestal floor and the edges of the broken pieces were sooted.

Figure 13: Sunglasses as Found on the Pedestal Assembly Floor

Additional testing using the sunglasses that were found and a new pair of similar sunglasses was performed to determine the effects of the sunglasses in that area. The accident sunglasses were placed in a similar position as initially found in the wreckage (see Figure 13). The left throttle lever was moved to idle and the gust lock handle was in the up and latched position. The left lens of the glasses was missing, and the lens frame was around the left throttle sheave with the frame extending towards the adjacent gust lock sheave. When the gust lock lever was moved down the gust lock sheave would be impeded by the frame of the glasses. Following multiple tests, the greatest restriction observed with this configuration allowed the gust lock handle to move down approximately 15° from the up and latched position. Any forward movement of the left throttle lever rotated the throttle sheave such that the glasses were moved to a lower position. This allowed the gust lock sheave to have more range of travel before contacting the glasses. With the left throttle lever moved 25° forward of idle, the most restrictive test case observed allowed for the gust lock handle to have 62° of downward movement from the up and latched position.

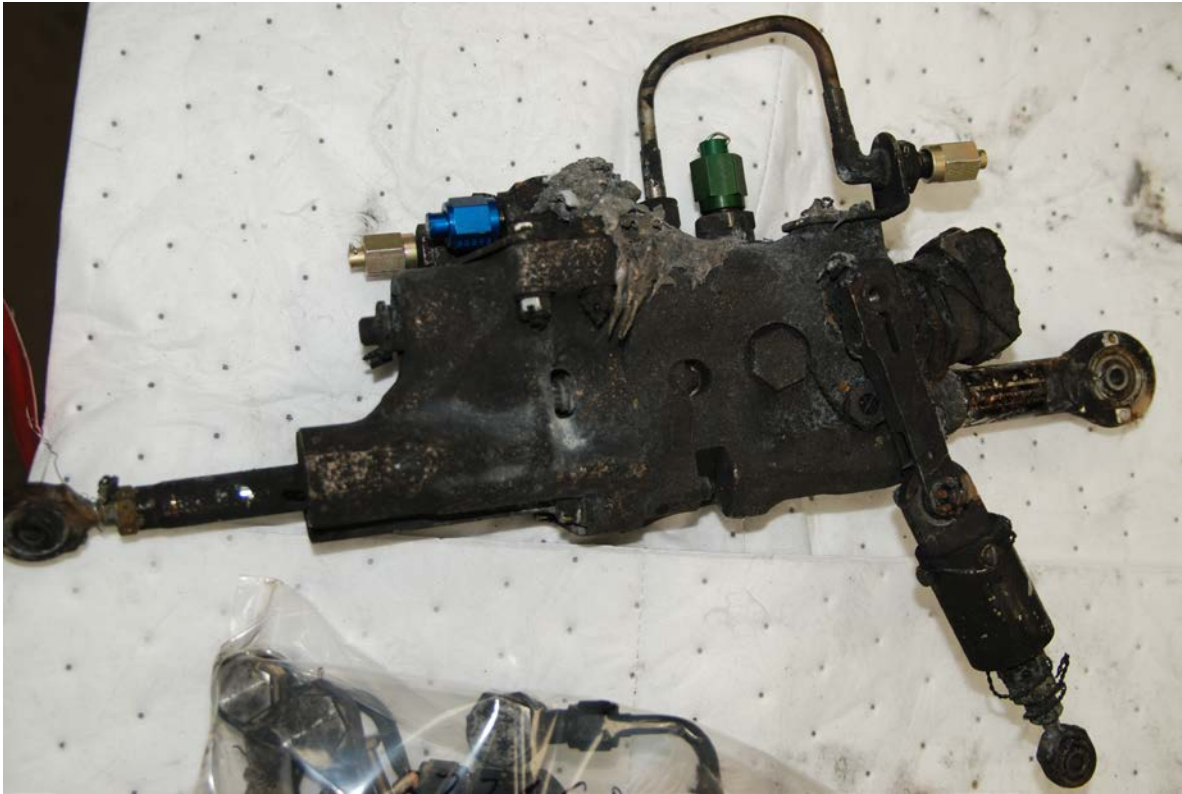
Figure 14: Elevator Actuator

The box containing the actuator was removed from a secure locker. The unit was sooted and melted aluminum was adhered to the surface in some locations. The unit measured 15.75 inches from rod end bearing center to tail stock bearing center. A more exact measurement was taken from the face of the body to the end of the piston rod (before the rod end nut) which measured 2.072 inches. According to Parker Aerospace, the latter measurement corresponds to an elevator position on the G-IV of approximately 7° TE down.

The molten aluminum was chipped away and the tubes were removed from the body. The inside of the system 2 pressure and return plugs revealed a substance similar to a solidified fluid. The actuator was put on a test stand. The input lever was stuck in the retract position and 15 lbs of force could not move it. The center of the rig pin hole on the input lever was 0.161 inches from the center of the rig pin hole in the body. The piston would not move with 80 lbs force applied. The control valve cap assembly was removed and the bearing underneath the cap was dry, seized, and corroded. A substance resembling tar was noted on internal components. The system 1 filter assembly was opened and contamination similar to solidified fluid was found inside the housing. This filter also had a black melted substance adhered to a portion of the outer diameter of the mesh. The system 2 filter assembly appeared much cleaner.

Hydraulic pressure was slowly applied to the pressure ports. The piston would not move with both systems pressurized to 500psi. The system 2 bypass valve cap leaked externally with 100 psi of pressure applied. System 1 had no leakage to return while system 2 appeared to be free flowing to return. The actuator was allowed to sit overnight with hydraulic fluid contained within.

The system 1 and 2 bypass valves were removed. The system 2 bypass valve cap seals were deformed. Both bypass valves appeared to have a substance similar to solidified fluid inside the housing. All valve components including the springs were intact. The damper shaft was removed and both sides of the damper piston assembly were stuck together and could not be separated. Light was visible when looking through the main orifice of the two halves. All damper components appeared intact including the damper shaft. The piston was also removed with no anomalies noted other than the presence of a substance similar to solidified fluid. The manifold body was scoped and the control valve and piston scallop cuts contained a black residue in them. The system 1 bypass valve bore was also heavily contaminated with a solidified fluid and a white residue was present.

The control valve (slide and sleeve together) was cut in half longitudinally using wire EDM. Considerable corrosion and solidified fluid buildup was present on the system 1 side of both components. The system 2 side of both components appeared less contaminated but corrosion was still present. The slide lap left a mirrored image of the slide location on the sleeve inner diameter revealing that it was in a piston retract position. There was a 0.035 inch slide opening in the retract direction by measuring the system 2 return port. The elevator trailing edge moves up as the piston retracts. Many of the flow passage edges in the sleeve were corroded/pitted/or built up with solidified fluid material making inspection difficult. No evidence of chip shear was found on either the spool or slide metering edges.
