**NATIONAL TRANSPORTATION SAFETY BOARD**  
**Office of Aviation Safety**  
**Washington, D.C. 20594**

**Airworthiness Group Chairman's Factual Report**

**NTSB No: CEN13FA192**

Operator: Era Helicopters LLC  
Aircraft: Sikorsky S-76A++, Registration N574EH  
Location: Grand Lake, Louisiana  
Date: March 15, 2013  
Time: 1147 central daylight time

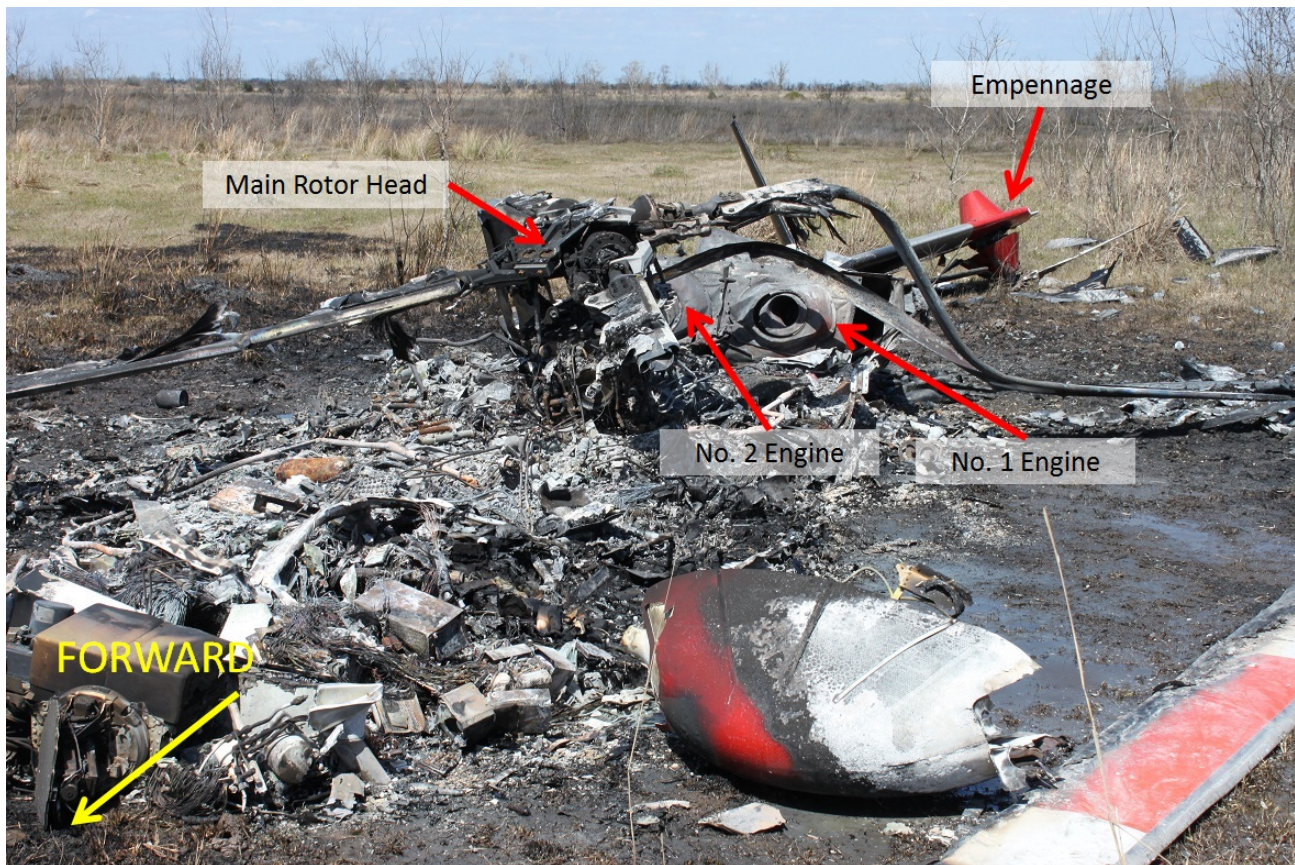
The helicopter came to rest upright on a southerly heading. The main wreckage exhibited damage consistent with exposure to a post-crash fire. The majority of the airframe, including the cockpit, main cabin, and forward portion of the tailboom, was either consumed or heavily heat distressed by the post-crash fire (**Photo 1**). The aft-right and forward wheeled landing gears were partially consumed by the post-crash fire. The aft-left landing gear was found buried about 1 foot into the ground underneath the main wreckage.

**Photo 1. N574EH at the accident site exhibiting heavy damage from the post-crash fire.**

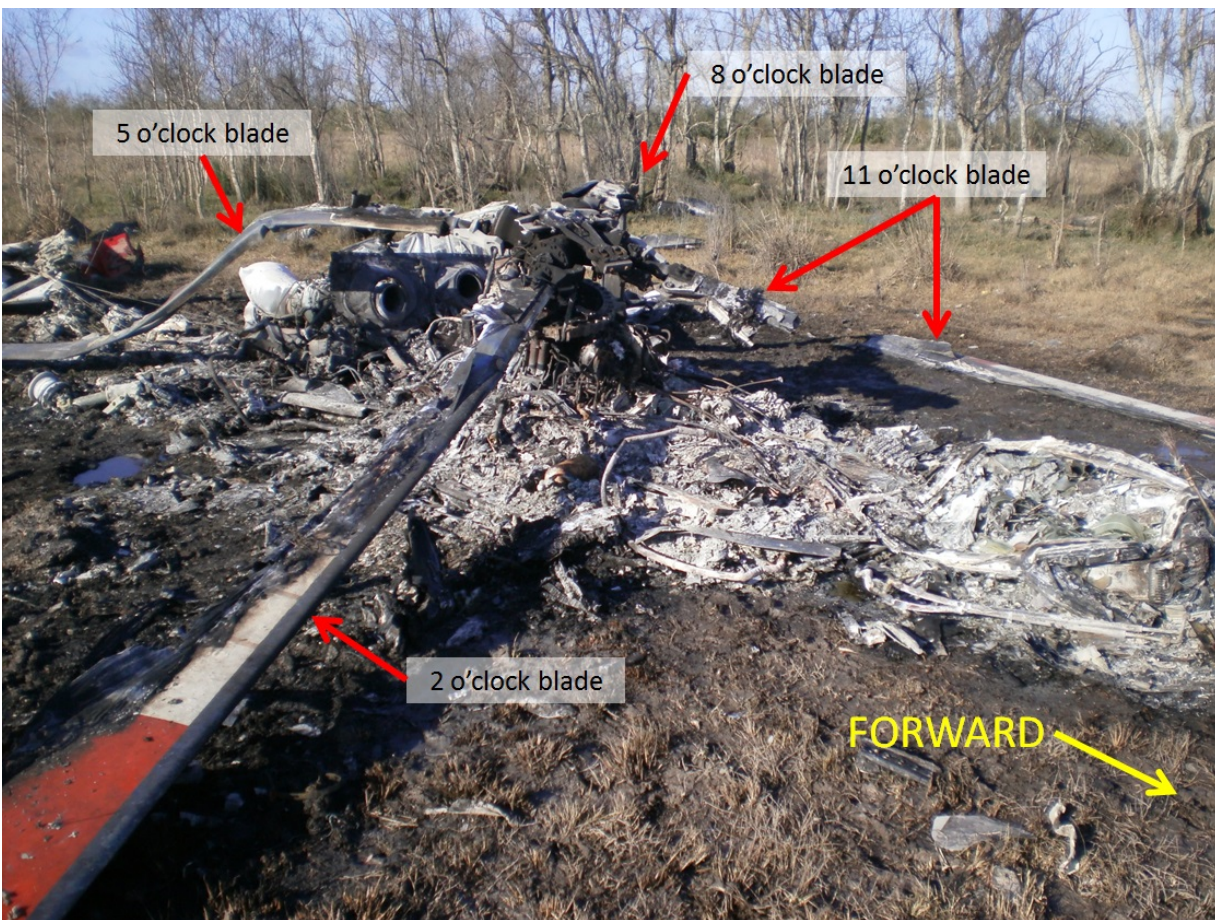
Three of the four main rotor blades remained connected to the main rotor hub and the main rotor blade spindles were oriented at about 11 o'clock, 2 o'clock, 5 o'clock, and 8 o'clock positions when viewed from above (**Photo 2**). The 11 o'clock blade had fractured chordwise outboard of its pitch horn but was found adjacent to the main wreckage about 6 feet away. All four main rotor blades exhibited evidence consistent with low rotational energy at ground impact. The 5 o'clock and 11 o'clock blades exhibited severe chordwise deformation of the spar consistent with exposure to extreme heat. The tip cap for the 5 o'clock blade was found separated from the blade and was found about 12 feet to the east of the main wreckage.

**Photo 2. Main rotor blades.** [photo courtesy of Turbomeca]

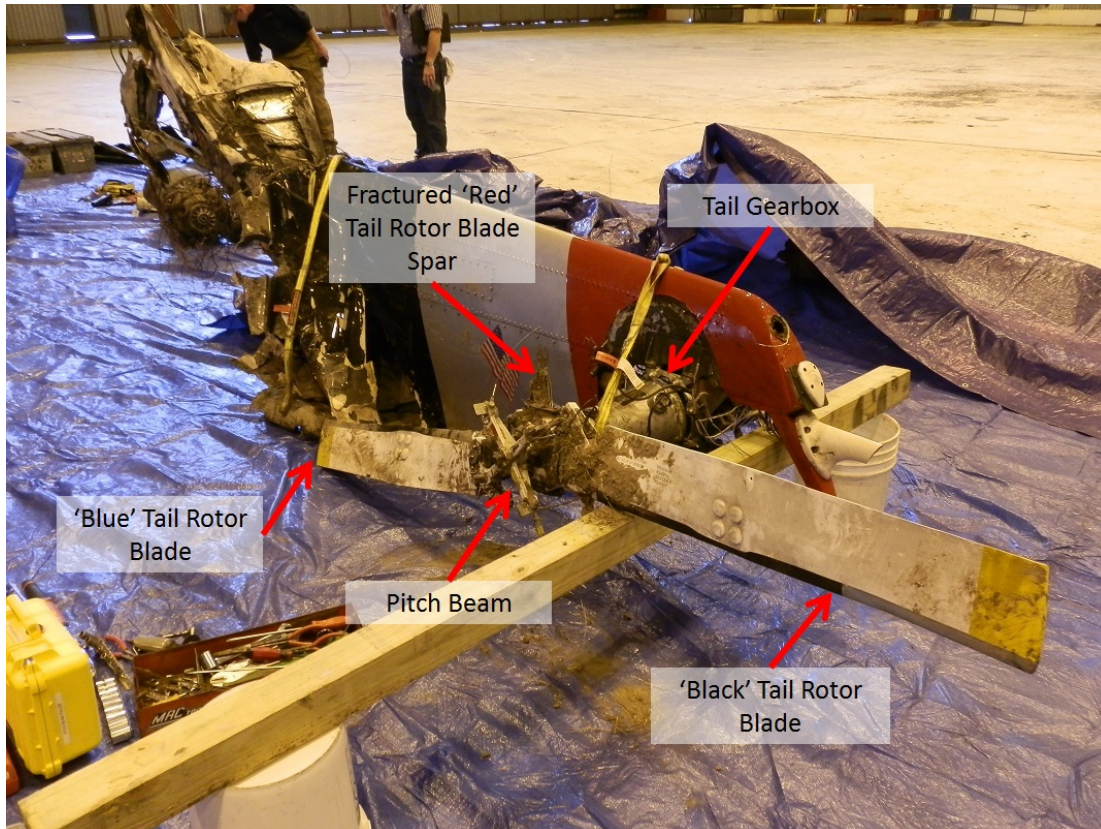
Only two of the four tail rotor blades (the 'black' and 'blue' blades) were recovered at the accident site. The 'black' blade had fractured from the 'black'/'blue' tail rotor spar while the 'blue' blade remained attached to the spar. The 'blue' and 'black' blade surfaces were mostly intact and did not exhibit damage associated with high rotational energy. The 'black' and 'blue'

PCLs remained attached on both ends to the pitch beam and their respective blade pitch horns. The 'red' PCL had fractured at the pitch beam-side threads and the remainder of the 'red' PCL was not recovered. The remnant 'red' PCL remained attached to the pitch beam. The 'yellow' PCL remained whole and attached on its outboard end to the pitch beam, but the inboard rod end was observed to be free. The bolt and nut connecting the 'yellow' PCL to its respective blade pitch horn were not recovered. Disassembly of the pitch beam and outboard retention plate revealed the 'red'/'yellow' tail rotor spar had shifted toward the 'yellow' blade side by evidence of the shifted spar nylon wraps. The elliptical plug of the 'red'/'yellow' spar exhibited crushing damage on the 'red' blade side, with the direction of crushing going toward the 'yellow' blade side.

**Photo 3. The recovered empennage with the installed TGB and remaining tail rotor blades.**  
[photo courtesy of SAC]

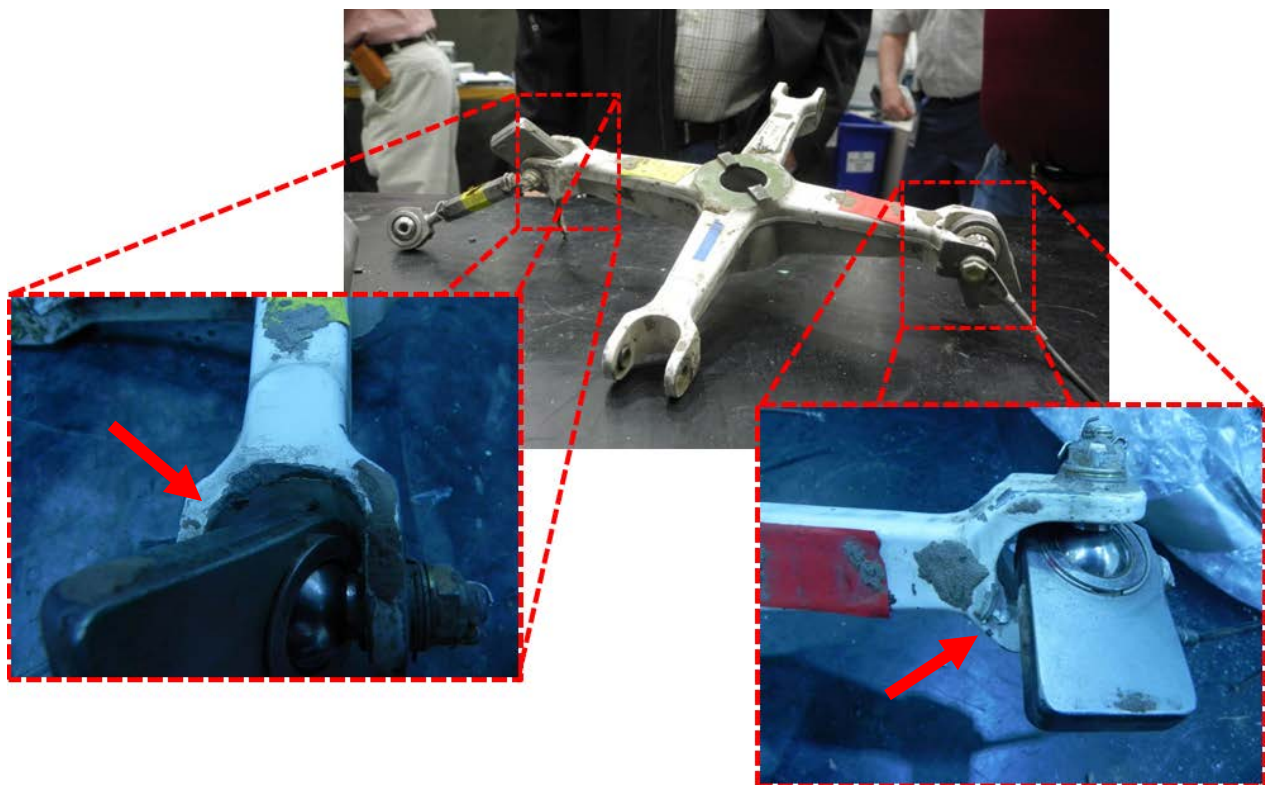
The pitch beam was received separate from the tail rotor head assembly. The PCL for the ‘yellow’ tail rotor blade and the remnant upper end of the PCL for the ‘red’ tail rotor blade remained attached to the pitch beam (**Photo 4**). The attaching hardware between the pitch beam and both the ‘red’ and ‘yellow’ PCLs remained installed with their cotter pins intact. The inboard edge of the pitch beam fork connected to the ‘red’ PCL exhibited a large impact mark matched to that of the remnant ‘red’ PCL that was still installed. The inboard edge of the pitch beam fork connected to the ‘yellow’ PCL exhibited multiple impact marks matched to that of the ‘yellow’ PCL. The PCLs from the ‘black’ and ‘blue’ tail rotor blades had been previously disconnected from the pitch beam by investigators after the wreckage was salvaged from the accident site. No evidence of cracks or fractures was observed on the pitch beam.

**Photo 4. Tail rotor pitch beam with the ‘yellow’ and remnant ‘red’ PCLs attached. The unlabeled arrows point to the impact marks observed on the pitch beam fork of the ‘yellow’ and ‘red’ PCL.**

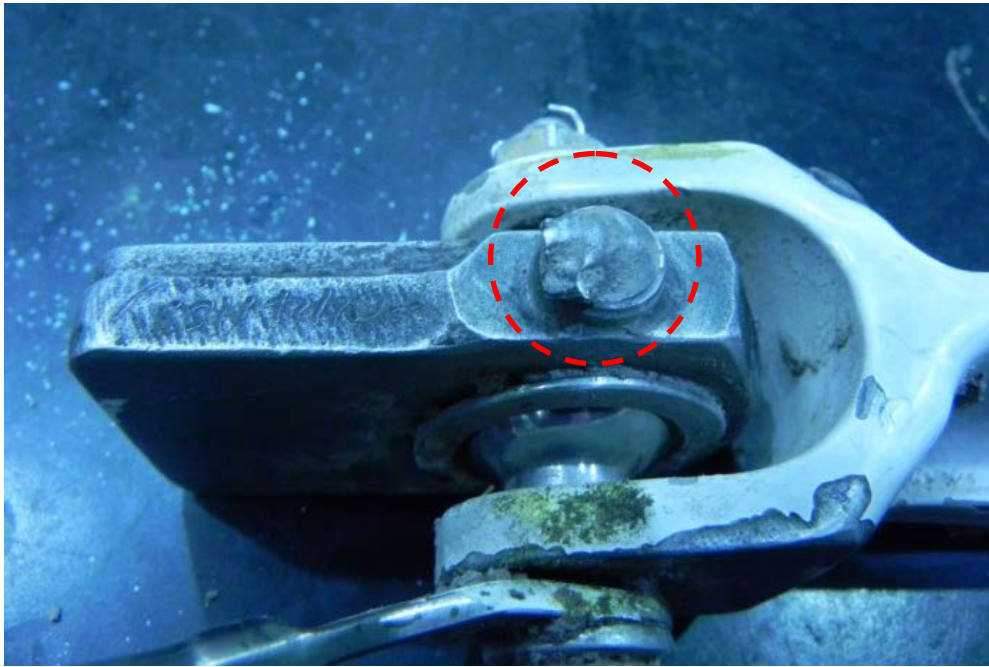
The ‘red’ PCL had fractured at the start of the threaded shank adjacent to the PCL tab (**Photos 5**). The fracture surfaces exhibited signatures consistent with overload. A run-on torque check of the ‘red’ PCL measured 107 inch-pounds.<sup>5</sup> The ‘yellow’ PCL exhibited a slight bend deformation at the blade-side rod end. A run-on torque check of the ‘yellow’ PCL was performed but an error made during the measurement process resulted in an inaccurate torque reading. The bolt connecting the ‘yellow’ PCL to the

**Photo 5. Fracture surface of the threaded shank of the 'red' PCL.** [photo courtesy of SAC]

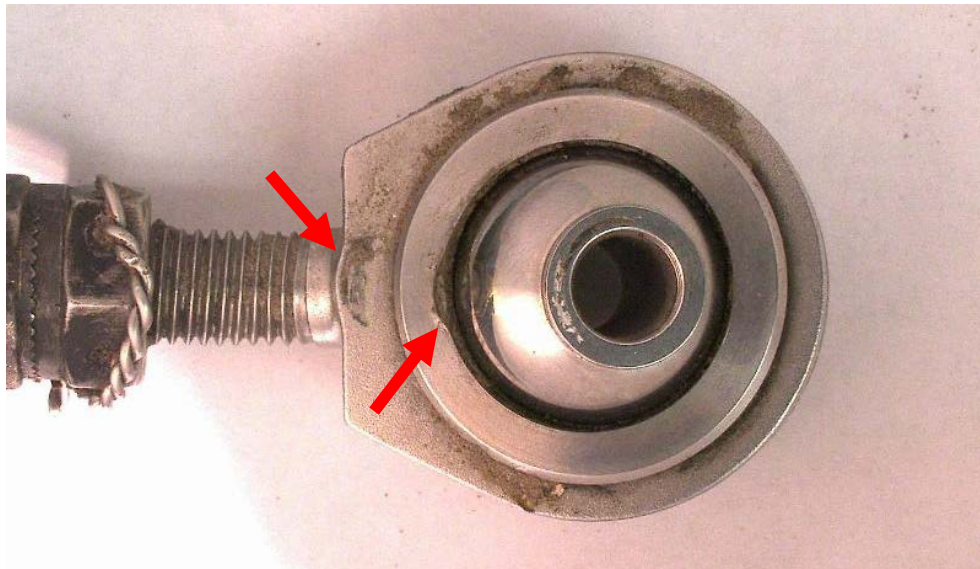
pitch beam had to be tapped out with a mallet during removal of the bolt; a slight bend in the bolt was observed after removal. The blade-side rod end ball joint contained two impact marks, one on each side of the ball joint and 180° apart, consistent with ball trunnion impact (**Photos 6 and 7**). Another impact mark, aligned with one of the trunnion impact marks, was found on the ball housing adjacent to the threaded shank (**Photo 6**).

**Photo 6. The trunnion impact mark and the second impact mark adjacent to the threaded shank of the 'yellow' PCL blade-side rod end.** [photo courtesy of SAC]

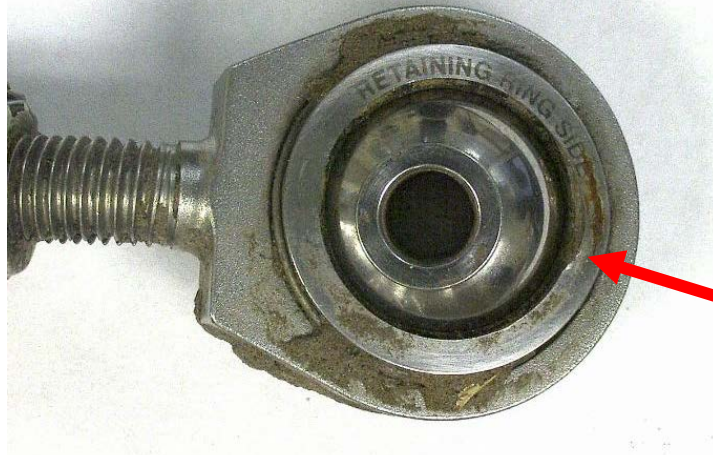
**Photo 7. Trunnion impact mark 180° opposite of the trunnion impact mark seen on opposing side of the ‘yellow’ PCL blade-side rod end. [photo courtesy of SAC]**

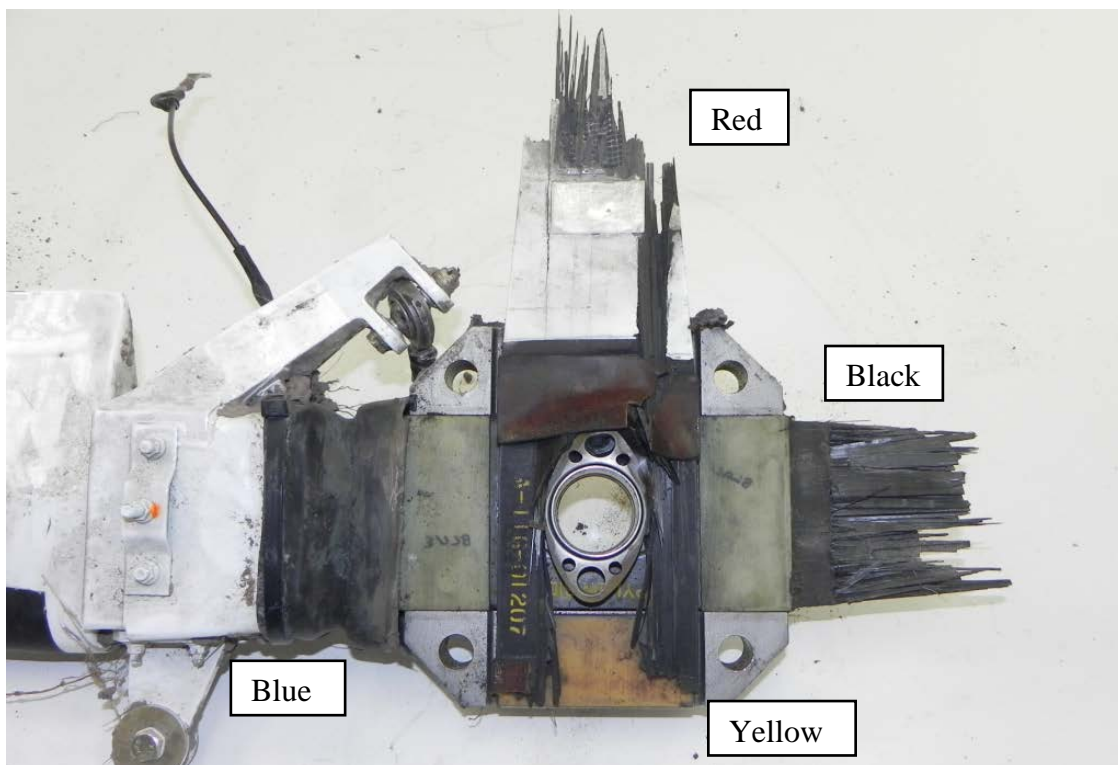
The outboard retention plate was received separated from the inboard retention plate. Sections of spar for the ‘red’/‘yellow’ tail rotor blade and the ‘black’/‘blue’ tail rotor blade remained attached to the outboard retention plate (**Photo 8**). No cracks or fractures were observed on the outboard retention plate. There was no evidence of fretting or galling on the surfaces which mates the outboard retention plate to the inboard retention plate. The nylon shims on both spar channels remained installed with no evidence of major discoloration. The center bushing for the pitch change shaft did not exhibit any abnormal contact between the bushing and the shaft.

**Photo 8. Outboard retention plate containing the ‘red’/‘yellow’ spar and the ‘black’/‘blue’ spar. [photo courtesy of SAC]**

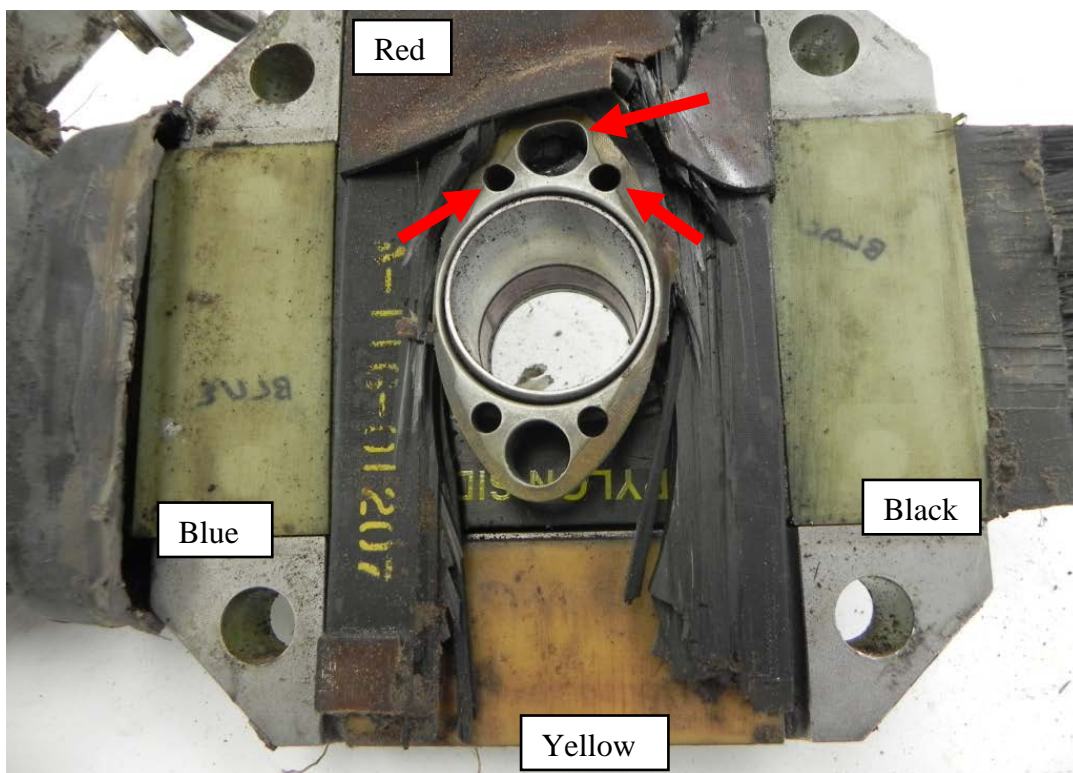
The center section of the 'red'/'yellow' tail rotor spar<sup>6</sup> remained attached to the outboard retention plate. The spar was fractured in two locations and had shifted in the direction of the 'yellow' tail rotor blade, while the elliptical centering plug remained in its normally installed location. Crush deformation of the three holes of the elliptical centering plug on the 'red' side of the spar was observed, consistent with the spar being pulled by force in the direction of the 'yellow' side of the spar (**Photo 9**). A small section of the spar was observed to have punctured the center hole (of the three deformed holes). Severe splintering of the spar was observed adjacent to the crushed side of the elliptical plug. The remnant spar was also fractured in the spanwise direction, about 0.5 inches inboard from the trailing edge side when measured at the nylon wrap.

**Photo 9. The three deformed holes of the elliptical centering plug.** [photo courtesy of SAC]

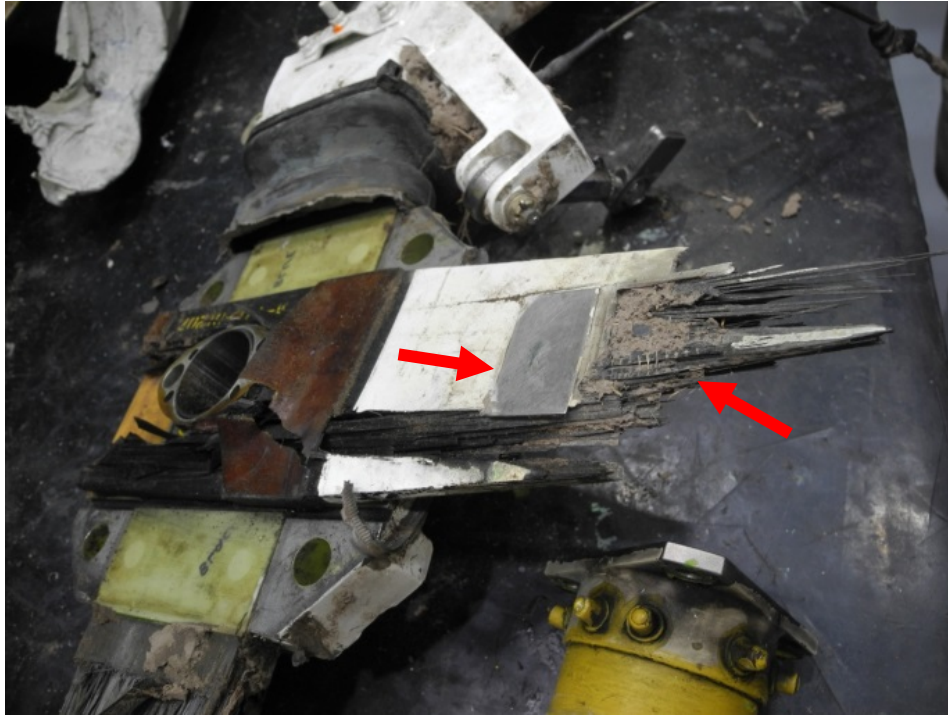
One of the spar fractures was located near the root end of the 'red' tail rotor spar, adjacent to the 'red' blade's bumper plate (**Photo 10**). The area of the 'red' side bumper plate exhibited a slight bowing in the outboard direction (when looking outboard from the pylon-side of the spar). The remnant adhesive layout for the 'red' blade's pivot bearing retainer was observed on the spar fracture. Examination of the remnant adhesive layout

under a scanning electron microscope (SEM) revealed no definitive direction that the layout fibers were pulled. The fracture had a broomstraw appearance, with the broomstraw appearance more prevalent near the central width of the spar. Examination of the fracture under a SEM revealed no evidence consistent with composite matrix rubbing. The spar's nylon wrapping on the 'red' side had a dark maroon discoloration.

**Photo 10. The spar fracture for the 'red' tail rotor blade. The left arrow points to the bumper plate and the right arrow points to the remnant adhesive layout for the pivot bearing retainer.**

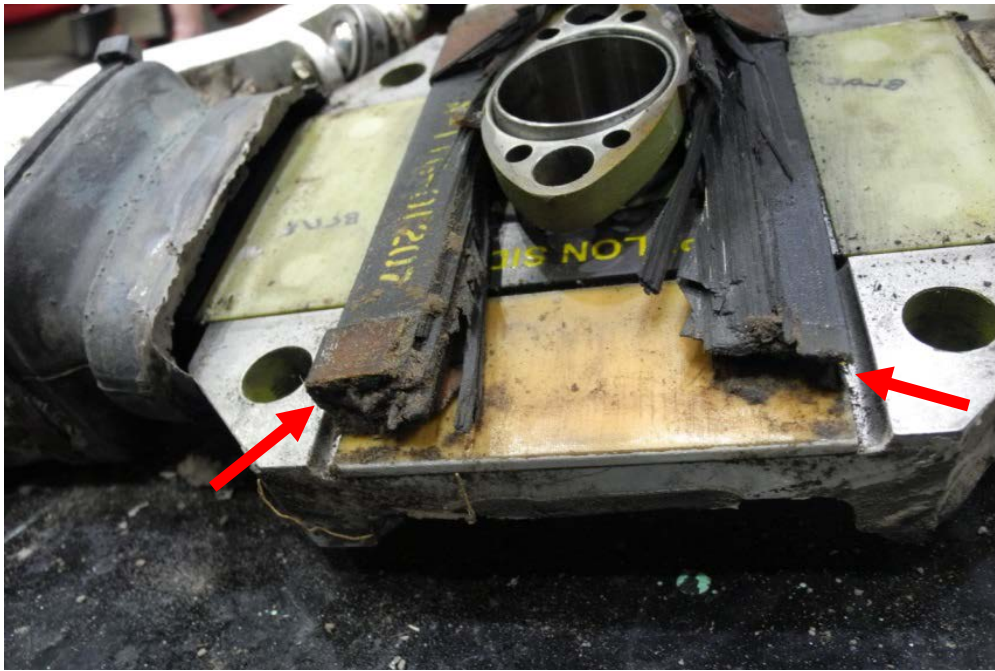
The opposing spar fracture, located on the 'yellow' side of the spar, occurred near the edge of the retention plate (**Photo 11**); the remnant nylon wrapping also exhibited a dark maroon discoloration. The 'red'/'yellow' spar had S/N "A-116-01207" stenciled on the surface of the spar. The spar fracture had an overall blunt and flat appearance.

**Photo 11. The fracture observed at the ‘yellow’ tail rotor blade spar.**

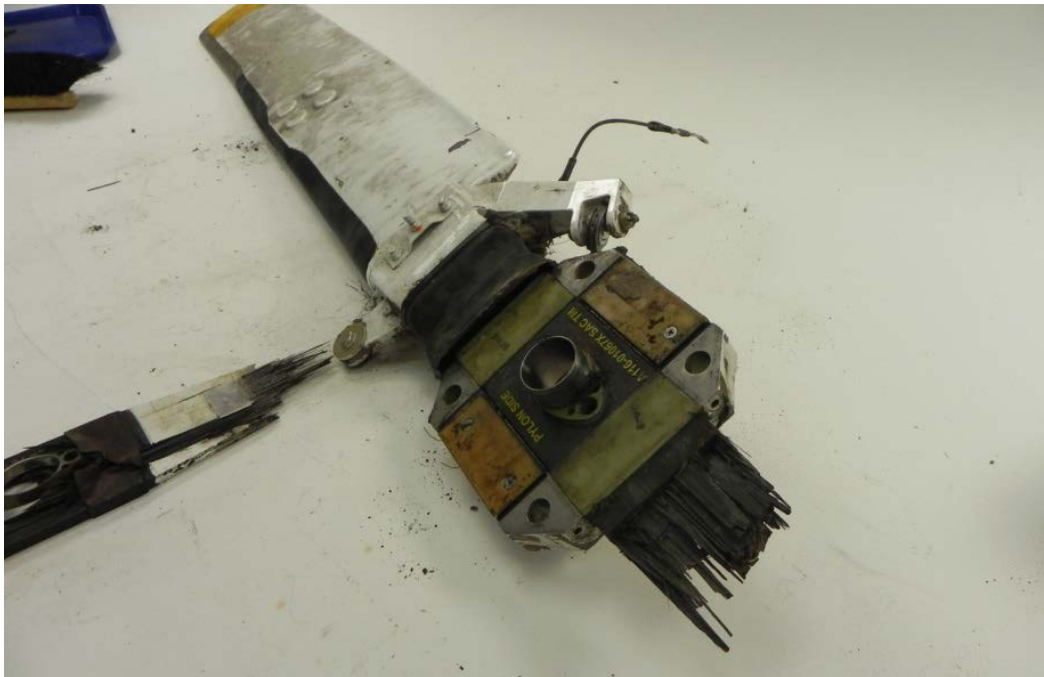
The spar for the ‘black’/‘blue’ tail rotor blade<sup>8</sup> was fractured adjacent to the ‘black’ tail rotor blade rubber boot, but remained continuous through outboard retention plate and the ‘blue’ tail rotor blade (**Photo 12**). The ‘black’ blade spar fracture had a broom straw appearance across the entire width of the spar, the length of the broom straws relatively uniform across the fracture. The ‘black’/‘blue’ spar had S/N “A116-01067X” stenciled on the surface of the spar. The spar was removed from the outboard retention plate and the ‘blue’ blade was disassembled from the spar. Minor cracks and fractures were seen in several areas on the leading and trailing edge surfaces of both ‘black’ and ‘blue’ blades. There was no evidence of heat damage on the blade surfaces. The pitch horns remained attached to both blades with their respective PCLs and associated attaching hardware and cotter pins still installed. A run-on torque check of the attaching hardware for the PCL measured 26 inch-pounds for the ‘black’ PCL and 34 inch-pounds for the ‘blue’ PCL.

**Photo 12. The 'black'/'blue' spar attached to the outboard retention plate. The fracture of the 'black' tail rotor spar is seen on the lower-right.** [photo courtesy of SAC]

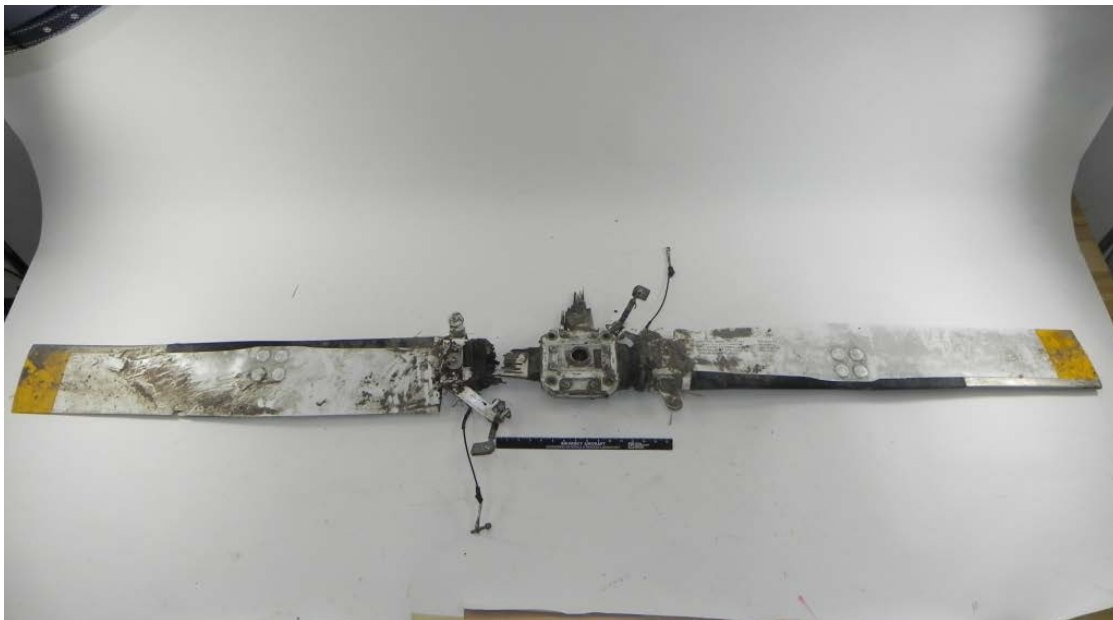
X-ray examination of the 'black'/'blue' spar, in accordance with Sikorsky Quality Assurance Technical Instruction No. 3210 Revision D showed no evidence of "waviness" of the composite filaments in the undamaged areas.<sup>9</sup> Both the 'black' and the 'blue' tail rotor blades exhibited no evidence of damage consistent with high rotational energy (**Photo 13**).

**Photo 13. Overall view of the 'black' (left) and 'blue' (right) tail rotor blade. The outboard retention plate and the remnant 'red'/'yellow' spar is seen in the center.** [photo courtesy of SAC]

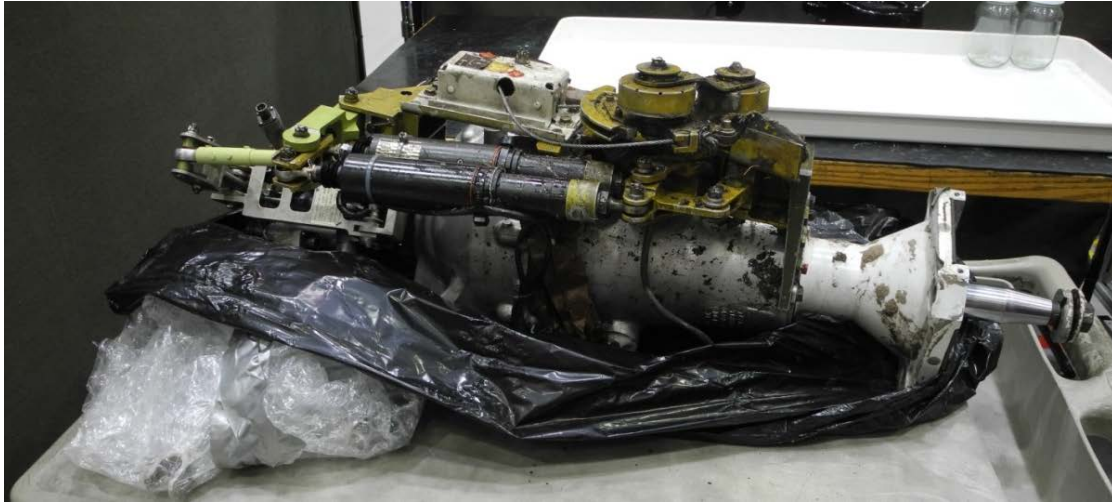
The TGB was received as a complete assembly with tail rotor servo and associated pulleys and spring capsules; the tail rotor quadrant; the pitch change shaft; and the inboard retention plate installed (**Photo 14**). The TGB contained only traces of oil and no oil sample was submitted with the TGB; the TGB was not drained of oil when it was recovered at the accident site.

**Photo 14. The TGB assembly as received.**

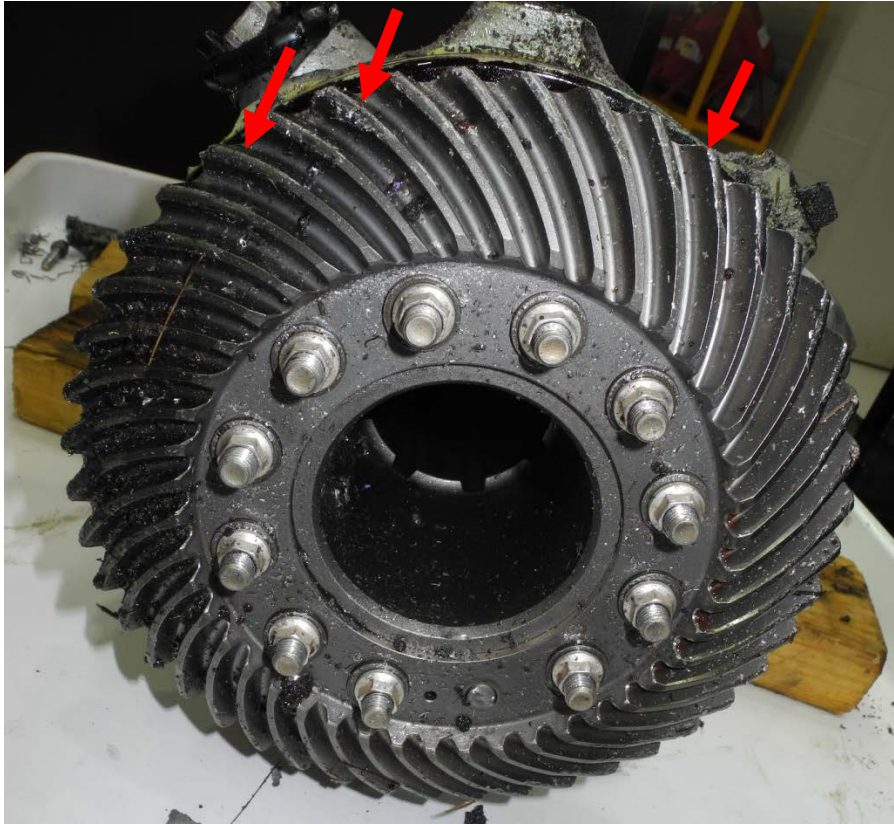
The output bevel gear and output housing were removed from the TGB center housing as a single assembly. The splines and threads on the outboard end of the bevel gear exhibited no damage. The lock washer, large nut, and tapered split cone exhibited no damage. The top land of the output bevel gear teeth exhibited damage from the tooth heel to about 1/3 of the length of the top land (**Photo 15**). One of the twelve bolts securing the output bevel gear to the output gear shaft was fractured; the fracture surface exhibited signatures of overload. Small metallic flakes were found throughout the output bevel gear surfaces and the inner diameter of the output gear shaft. The flanges of the output housing that attaches to the center housing were fractured (**Photo 16**). The flanges remained attached to the center housing with their respective attaching nuts. All observed fracture surfaces of the output housing exhibited signatures consistent with overload.

**Photo 15. Damage seen on the top lands of the output bevel gear teeth.**

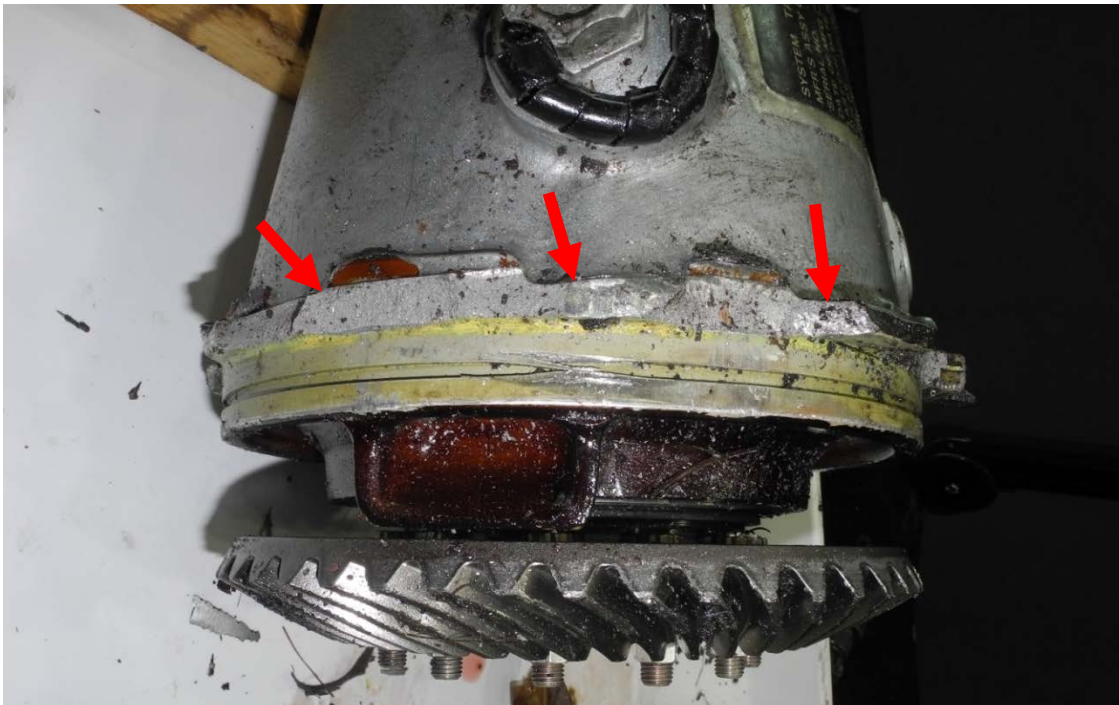
The output housing, containing the output bevel gear, was separated from the center housing; the mounting hardware for the tail rotor quadrant, spring capsules, and pulleys were holding the output housing to the center housing. Rotation of the input pinion by hand did not engage the output bevel gear. There was no evidence of binding when the input pinion was rotated. Rotation of the output bevel gear by hand revealed no evidence of binding. The pitch change shaft rotated in unison with the output bevel gear. The TGB exhibited no damage to its internal bearings and no discoloration of its external paint or internal coatings. Discoloration of paint and coatings are consistent with heat distress.

**Photo 16. Fractures of the output housing flanges that attach to the center housing.**

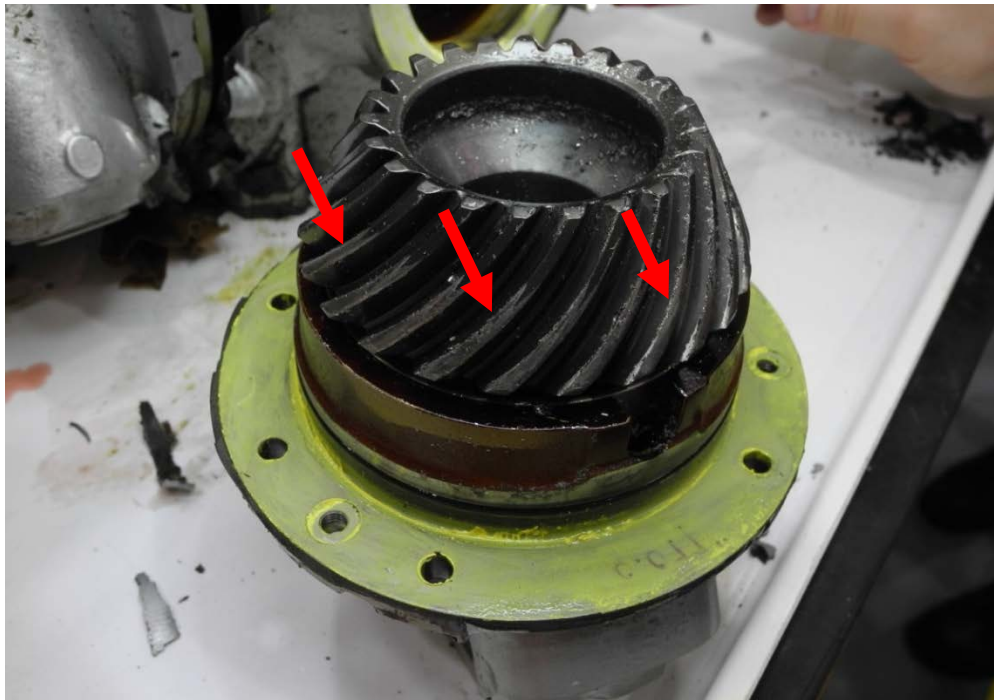
teeth exhibited damage from the tooth heel to about ½ of the length of the top land (**Photo 17**). The driving and coasting surfaces of the input pinion gear teeth did not exhibit signatures of abnormal operation or of FOD ingestion through the gear mesh. Small metallic flakes were found throughout the surfaces of the input pinion.

**Photo 17. Damage seen on the top lands of the input pinion gear teeth.**

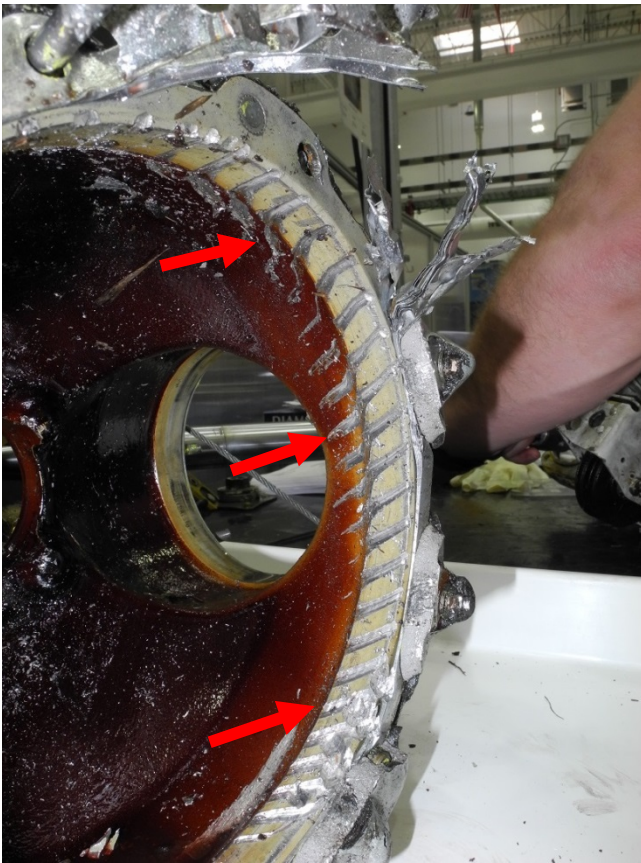
The exterior of the center housing exhibited no signatures of cracks or fractures aside from those associated with the fracture of the output housing. Small metallic flakes were found throughout the interior surfaces of the center housing and a trace amount of oil was found inside the housing. On the center housing, static impressions of output bevel gear teeth impacting the sealing surface (the inner diameter mating surface) to the output housing were seen from about the 3 o'clock to the 8 o'clock position<sup>10</sup> (**Photo 18**); the impressions were consistent with impact from a non-rotating output bevel gear. Damage to the center housing with a shiny, machined appearance was found adjacent to the sealing surface from about the 7 o'clock to the 12 o'clock position (**Photo 19**); this damage was consistent with impact from a rotating output bevel gear. Additional static gear tooth impressions were found in the damaged area with the machined appearance.

**Photo 18. Gear teeth impressions found on the output housing sealing surface of the TGB center housing.**

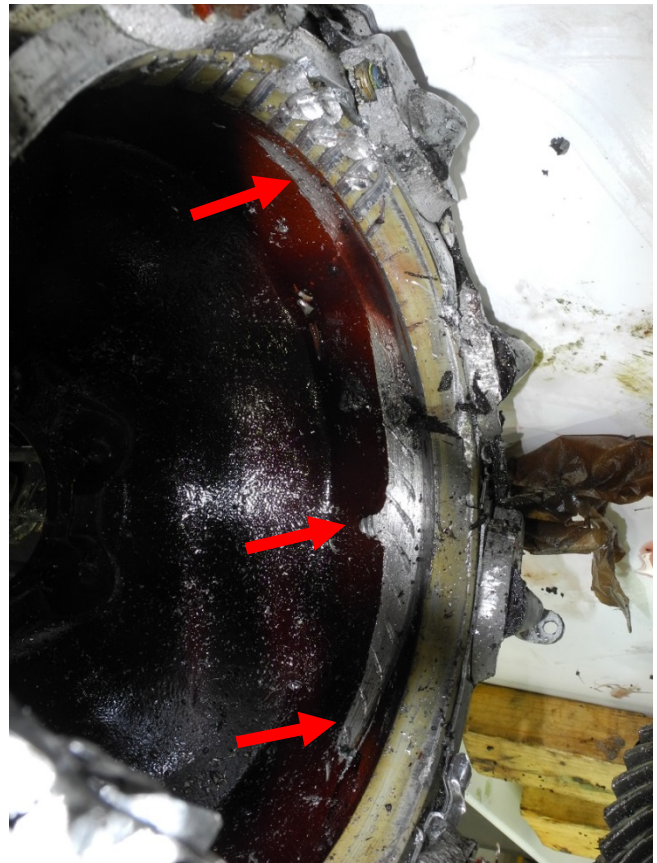
**Photo 19. Damage with a machined-like appearance found adjacent to the output housing sealing surface of the TGB center housing.**

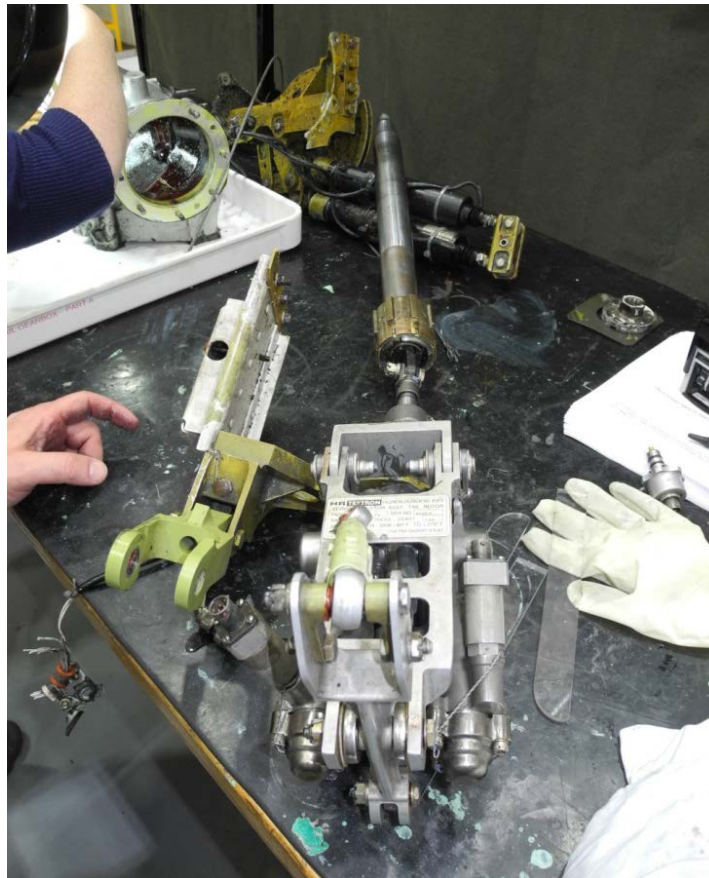
The tail rotor servo remained attached to the TGB center housing. The pitch change shaft remained attached to the tail rotor servo with its attaching hardware installed and intact (**Photo 20**). Impact damage on the inner diameter of the inboard end of the pitch change shaft was observed; the damage was consistent with impact by the link connecting the pitch change shaft to the tail rotor servo.

**Photo 20. The tail rotor servo and pitch change shaft after removal from the TGB.**

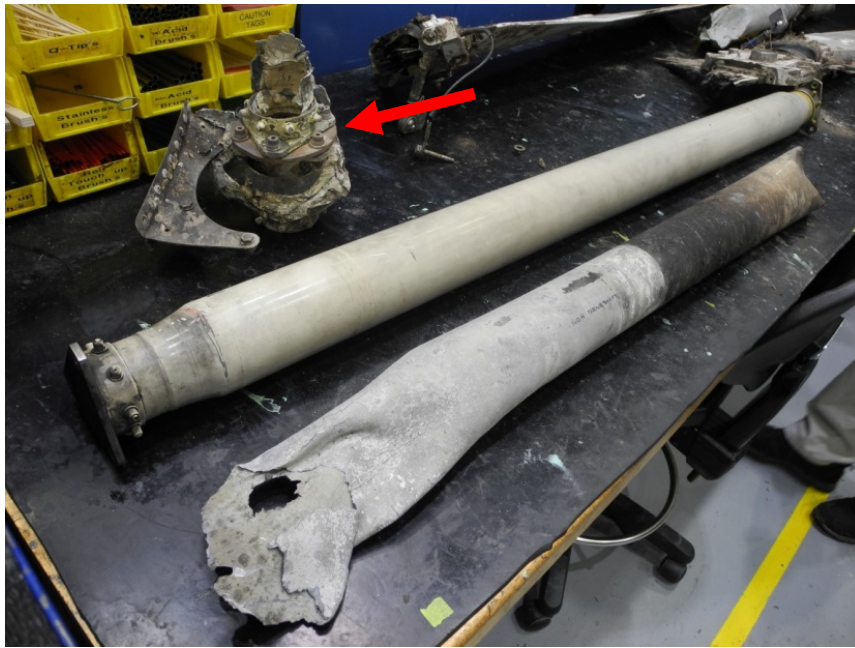
The No. 5 TRDS was received as a single assembly that was disassembled from the IGB and TGB (**Photo 21**). There were no signatures of cracks or fractures in the No. 5 TRDS.

An unlabeled TRDS airframe mount was also recovered from the accident site (**Photo 21**). The mount contained two flange ends connected to each other via flexible coupling and a hangar bearing sleeve. The entire assembly exhibited significant heat distress.

**Photo 21. The No. 4 TRDS (bottom shaft), No. 5 TRDS (top shaft), and unlabeled TRDS airframe mount (red arrow).**

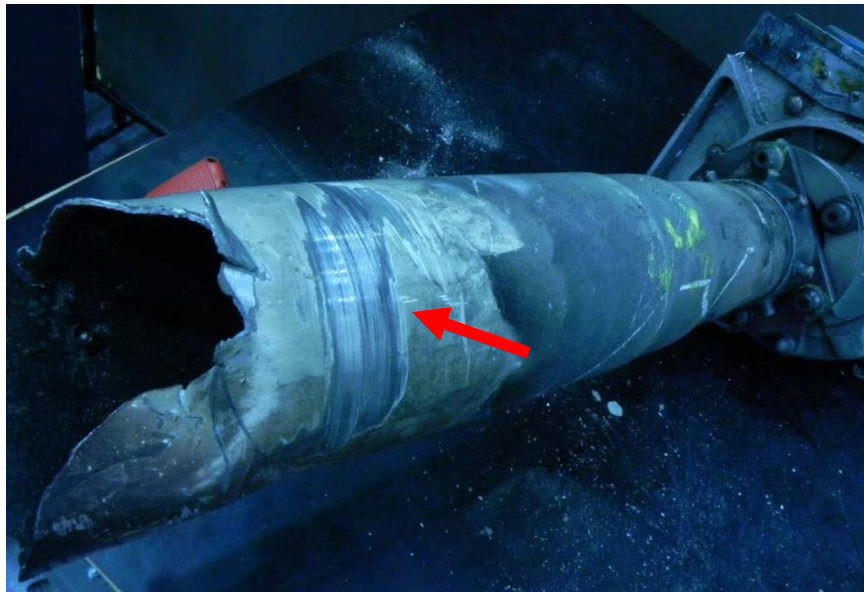
The No. 4 TRDS was received in three sections: the forward section (attached to the No. 3 TRDS), the center section, and the aft section (attached to the IGB). The entirety of the center section exhibited heat distress, with the forward end of the center section exhibiting a flattened appearance with a hole of missing material (**Photo 21**). Heavy soot deposits were observed from the midpoint to the aft end of the center section. The forward end of the aft section of the No. 4 TRDS also exhibited heavy sooting. Rotational smear marks were observed near the fracture of the aft section (**Photo 22**). The aft section of the No. 4 TRDS remained attached to the IGB input flange via flexible coupling.

**Photo 22. The No. 4 TRDS with the rotational smear marks near the fracture. [photo courtesy of SAC]**

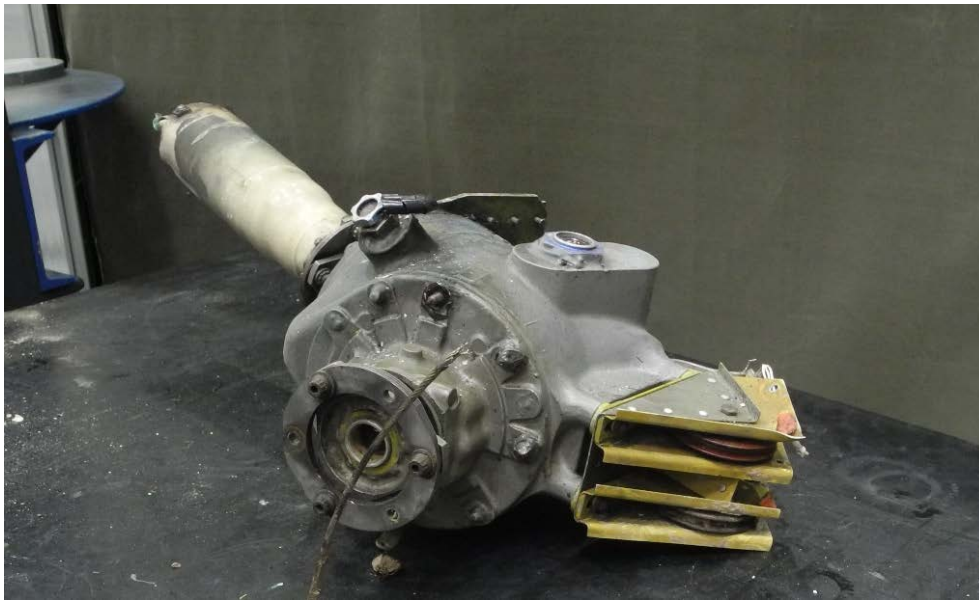
The IGB was received as a single assembly (**Photo 23**). Examination of the exterior of the IGB revealed no evidence of cracks or fractures. Rotation of the input pinion by hand resulted in the corresponding rotation of the output gear, exhibiting continuity of drive. The IGB exhibited no significant signatures of heat distress.

**Photo 23. The recovered IGB as received. The No. 4 TRDS remains attached to the input flange.**

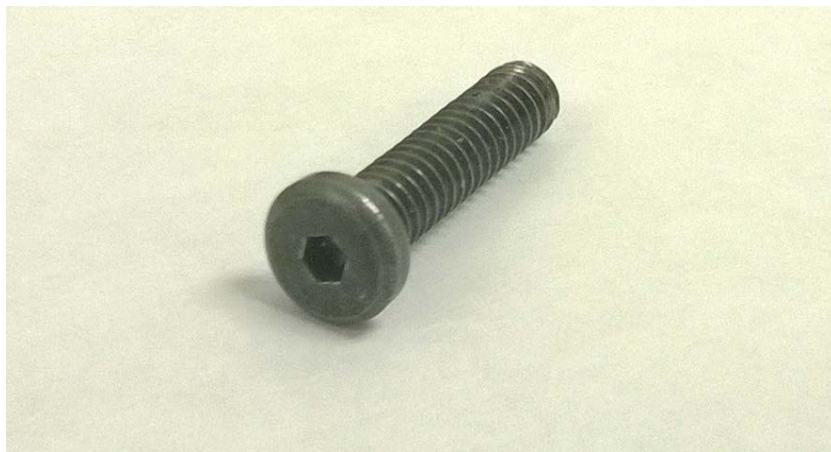
The pivot bearing replacement procedures, found in chapter 65-21-01 of Sikorsky S-76 Maintenance Manual No. SA 4047-76AA-2, requires the use of a compression screw, CR Industries P/N B40-926377 with a 7/8 inch long grip, for compressing the pivot bearing in order to facilitate removal or installation of the pivot bearing from the tail rotor blade assembly (**Photo 24**). A compression screw is included with each new pivot bearing; the screw is partially installed within the screw slot of the new bearing.

**Photo 24. Exemplar compression screw, P/N B40-926377.**

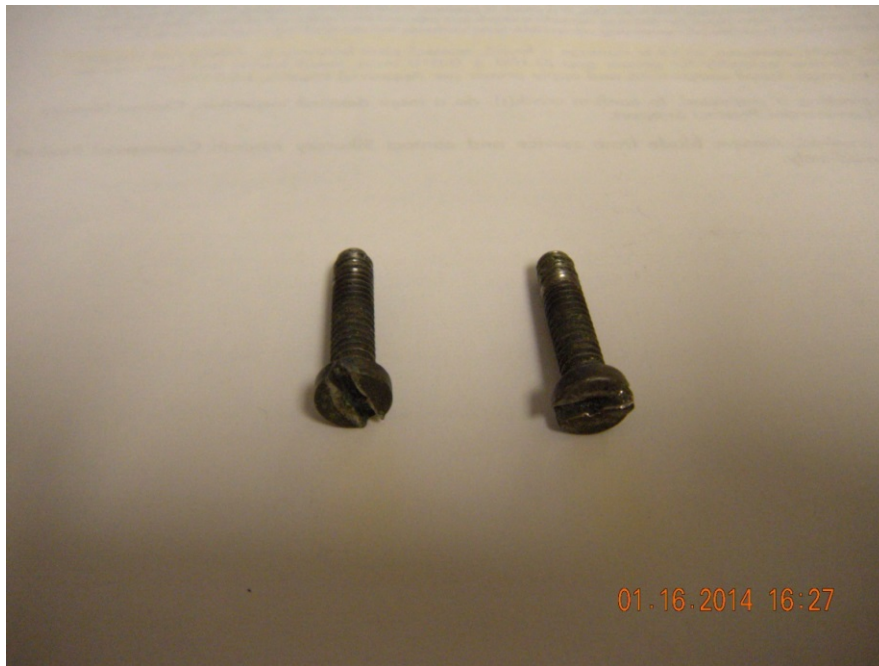
According to BHTI, the Bell Helicopter Broussard facility had modified the compression screw by cutting a slot in the compression screw head in order to facilitate a flathead screwdriver. Bell Helicopter Broussard stated they modified the compression screws “about 10 years ago” in order to allow for increased torque when compressing the pivot bearings. When asked about the tooling control processes in place to prevent a compression screw from being inadvertently left within the pivot bearings, the facility stated the same two modified compression screws had been used for about the last 10 years for “all S-76 tail rotor [pivot] bearing removals and replacements”, and provided a photo dated January 16, 2014 of the “same modified screws” (**Photo 25**). The compression screws were discarded by Bell Helicopter Broussard in late-January 2014; the NTSB was not informed of this action until June 18, 2014, at which time the NTSB requested Bell Helicopter Broussard replicate the modified compression screws for the purposes of testing (**Photo 26**). The grip length of the modified compression screw set was measured to be about 7/8 inches.

**Photo 25. Modified compression screws used at Bell Helicopter Broussard.** [photo courtesy of BHTI]
