**NATIONAL TRANSPORTATION SAFETY BOARD**  
**Office of Aviation Safety**  
**Washington, D.C. 20594**

**Airworthiness Group Chairman's Factual Report**

**NTSB No: CEN13FA192**

Operator: Era Helicopters LLC  
Aircraft: Sikorsky S-76A++, Registration N574EH  
Location: Grand Lake, Louisiana  
Date: March 15, 2013  
Time: 1147 central daylight time

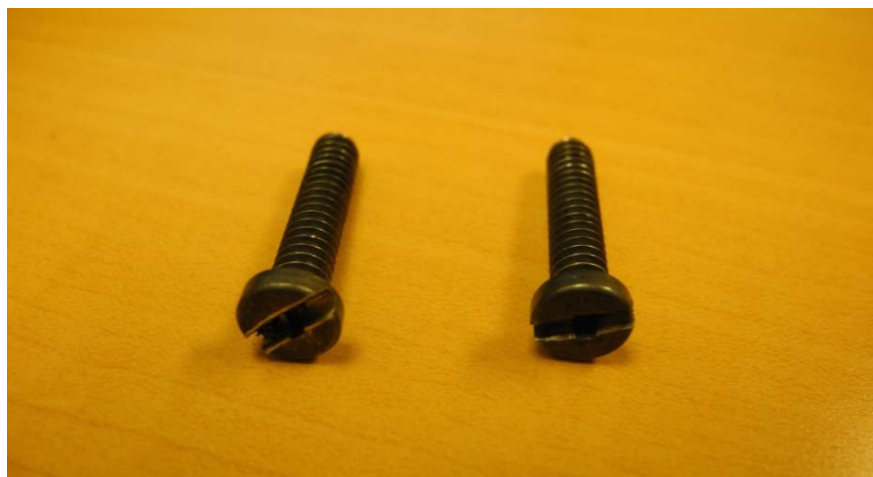
**Photo 26. Replicated modified compression screws used for testing at Bell Helicopter Broussard.**

The NTSB requested Bell Helicopter Broussard to utilize the same tooling that would have been used for tail rotor blade assembly S/N A137-00708X. A modified compression screw set was used to remove the pivot bearings from the test blade set. In order to document the condition of the spar from the test blade set, the pivot bearing and associated hardware were removed from the test blade set. The spar was visually examined for evidence of cracks and delamination and the pivot bearing retainer was tap tested for evidence of disbonds; no evidence of anomalies were found on the spar and pivot bearings. A test was performed to determine if the compression screw was able to be turned enough to cause the screw to protrude through the spar-side of the pivot bearing (through the pivot bearing plate which inserts into the retainer bonded to the spar). Turning the screwdriver by hand, it was observed to be extremely difficult to torque the screw enough to result in the screw protruding through the spar-side of the pivot bearing plate.

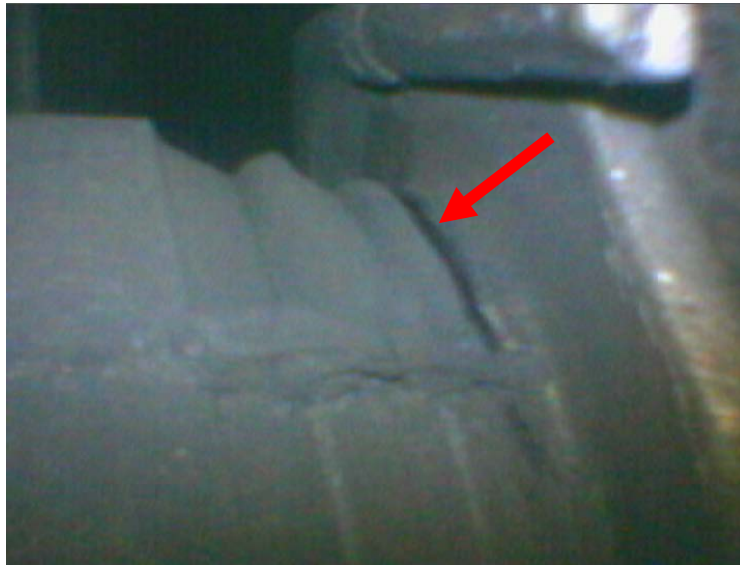
the pivot bearing, observed via video borescope (**Photo 27**). No defects were noted in the remainder of Era Helicopters' S-76 fleet. The suspect blade assembly was removed and shipped to SAC for further inspection. Representatives from the NTSB, FAA, SAC, and Era Helicopters examined the suspect blade assembly and pivot bearing. Examination of the pivot bearing under a video microscope found a seam of adhesive in the area of the suspected crack, but did not find evidence of cracks, disbonding, or excessive wear within the elastomers of the pivot bearing.

**Photo 27. Suspected crack observed on the pivot bearing via video borescope.** [photo courtesy of Era Helicopters]
