NATIONAL TRANSPORTATION SAFETY BOARD
Office of Aviation Safety
Washington, D.C. 20594

Airworthiness Group Chairman's Factual Report – Addendum 1

NTSB No: DCA12FA024

Operator: AAR Airlift Corporation
Aircraft: Bell 214ST, Registration Number N5748M
Location: 7 miles south of Camp Bastion, Helmund Province, Afghanistan
Date: January 16, 2012
Time: 1045 local time¹ (0615 coordinated universal time)

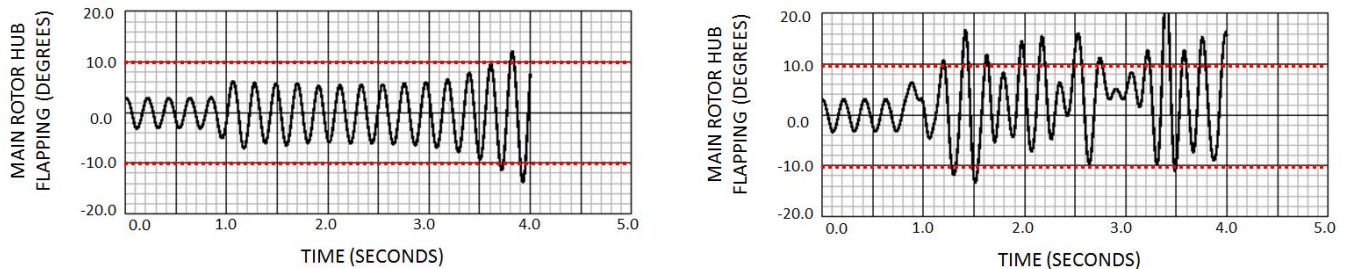
Figure 1. The predicted main rotor hub flapping from the “healthy” collective control simulation (left) and the severed collective control simulation (right). The red dotted lines indicate the location of the hub stops.

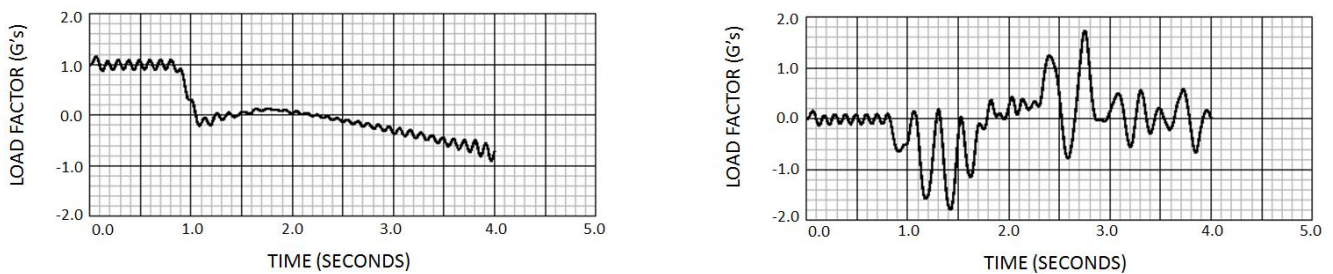
Figure 2. The predicted load factor experienced by the helicopter from the “healthy” collective control simulation (left) and the severed collective control simulation (right).

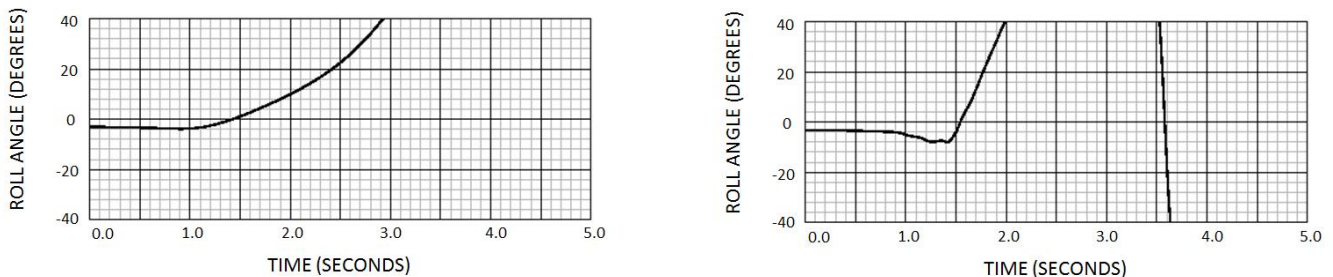
Figure 3. The predicted helicopter roll reaction from the “healthy” collective control simulation (left) and the severed collective control simulation (right). Positive values on the y-axis indicate a right roll.

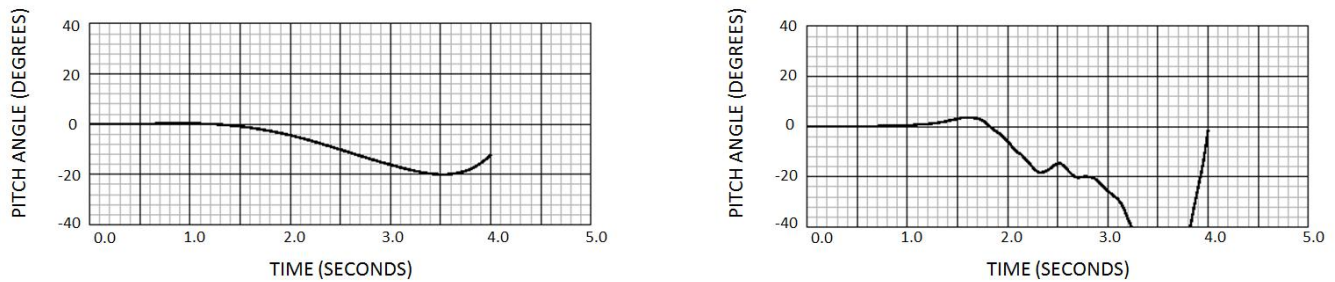
Figure 4. The predicted helicopter pitch reaction from the “healthy” collective control simulation (left) and the severed collective control simulation (right). Negative values on the y-axis indicate a nose-down pitch.

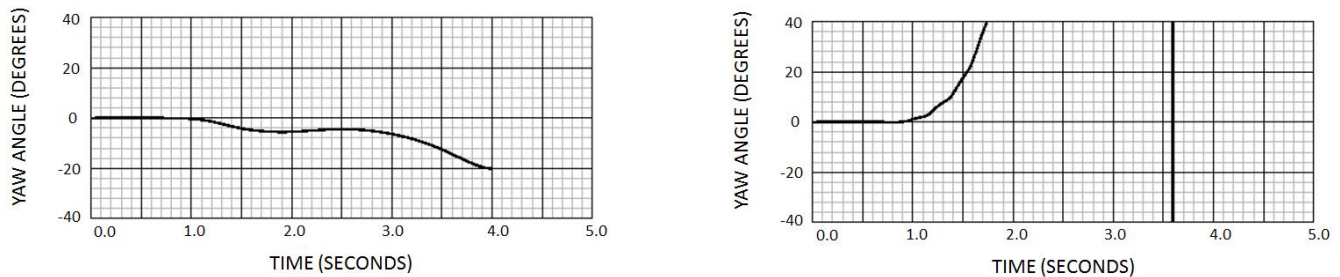
Figure 5. The predicted helicopter yaw reaction from the “healthy” collective control simulation (left) and the severed collective control simulation (right). Positive values in the y-axis indicate a right yaw.

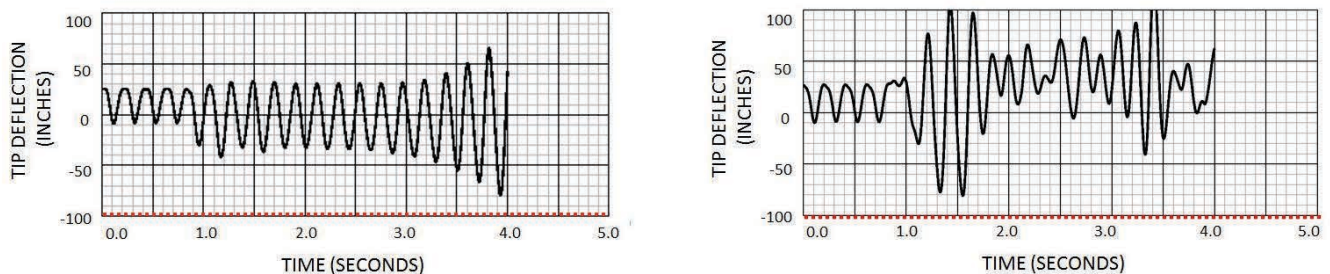
Figure 6. The predicted main rotor blade tip deflection from the “healthy” collective control simulation (left) and the severed collective control simulation (right). The red line at the bottom of the graph indicates the nominal clearance of 100 inches between the main rotor blade tip and the tailboom.

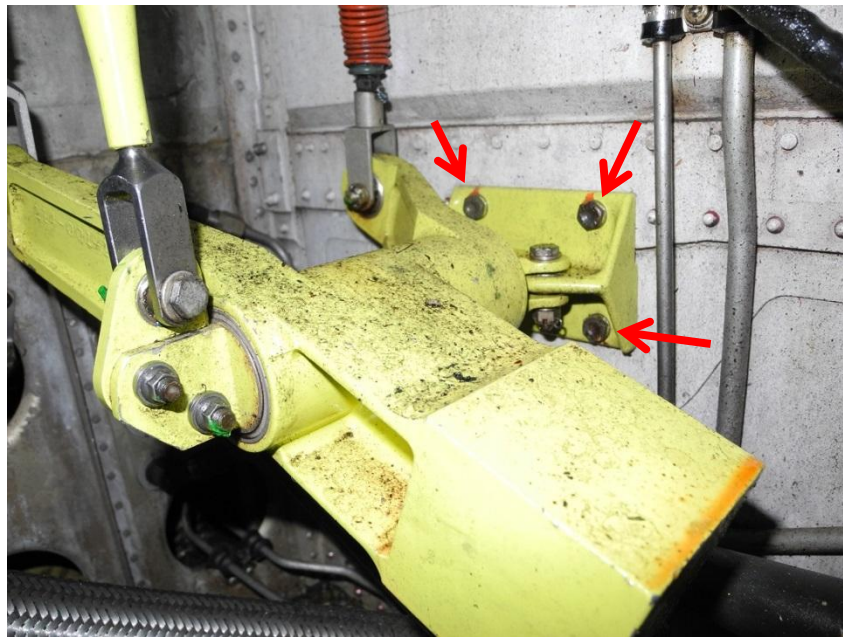
On March 5, 2014, representatives from the NTSB and AAR Airlift convened at AAR Airlift facilities in Melbourne, FL to witness a collective torque shaft support bracket removal from an exemplar Bell 214ST. The collective torque shaft support bracket is attached to the airframe by four bolts (**Photo 1**) while the torque shaft and torque tube are attached to four clevis connections (**Photo 2**). An attempt was made to try and remove the support bracket without disconnecting any of the clevis connections. In order to do this, the two bolts securing the torque shaft to the support bracket would need to be removed (**Photo 3**). However, due to the working space constraints within the open access port on the underside of the helicopter, directly underneath the main transmission, the wrench could not be practicably used to remove the two bolts securing the collective torque shaft to the support bracket; the method of first disconnecting the torque shaft from the support bracket without removing the four clevis connections was determined to be impractical. The second method attempted to remove the support bracket from the airframe involved: 1) disconnecting all clevis connections from the collective torque tube, 2) removing the four bolts securing the support bracket to the airframe, and 3) removing the collective torque tube assembly in its entirety (with the torque shaft and support bracket still installed) from the helicopter. This was found to be the most practical and logical sequence for removing the support bracket from the airframe. The reverse of the aforementioned procedures could be performed for the reinstallation of the collective torque tube assembly with the support bracket attached.

Photo 1. An overall view of the collective torque tube assembly. The red arrows point at three of the four bolts securing the support bracket to the airframe (fourth bolt is not visible in this photo).

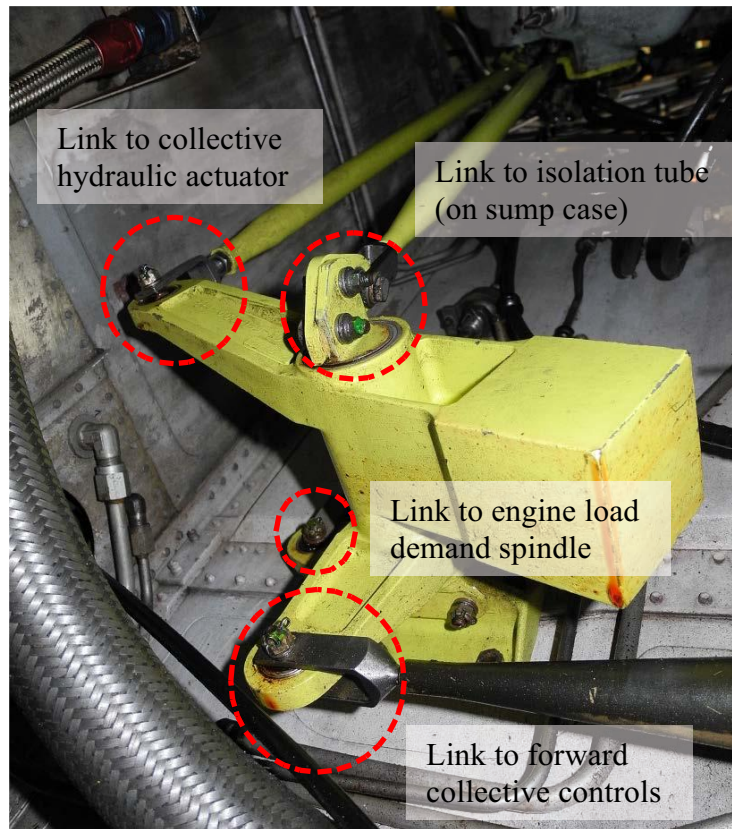
Photo 2. The four clevis connections on collective torque tube assembly (circled).

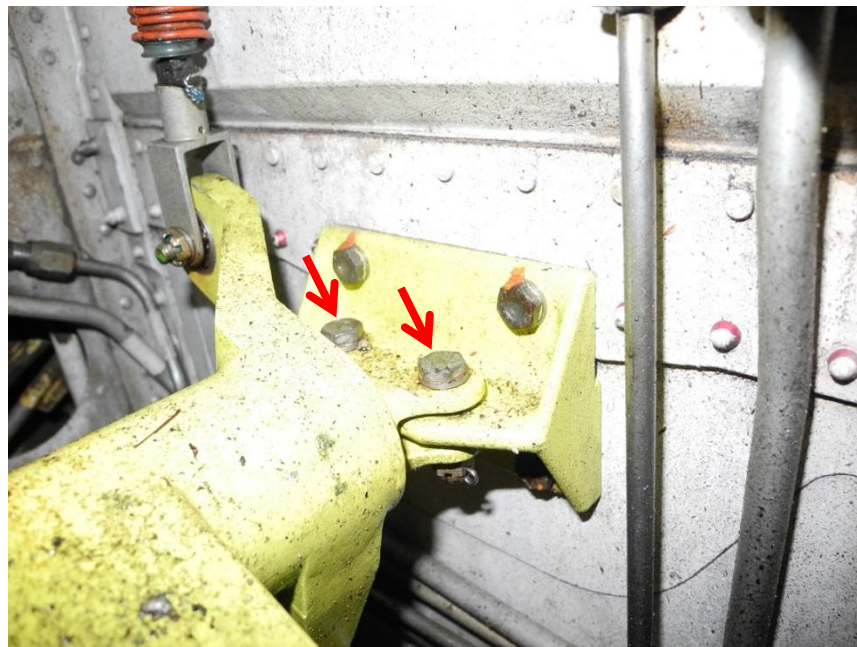
Photo 3. A view of the bolted connection between the support bracket and the torque shaft. The red arrows point to the two bolts securing the torque shaft to the support bracket.
