**NATIONAL TRANSPORTATION SAFETY BOARD**

**Group Chairman's Factual Report**

**DCA11FA004**

**Appendix A - Figures**

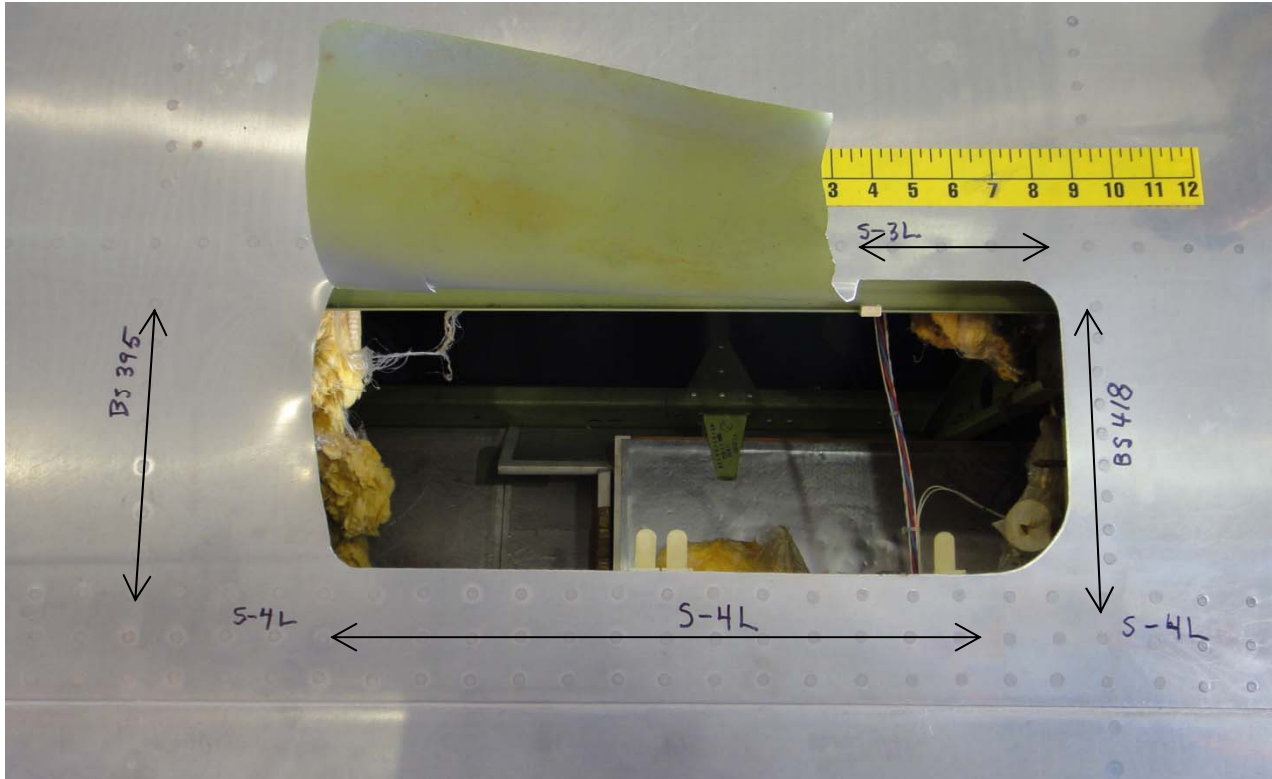
**Figure 1 – Fuselage Hole, N626AA**

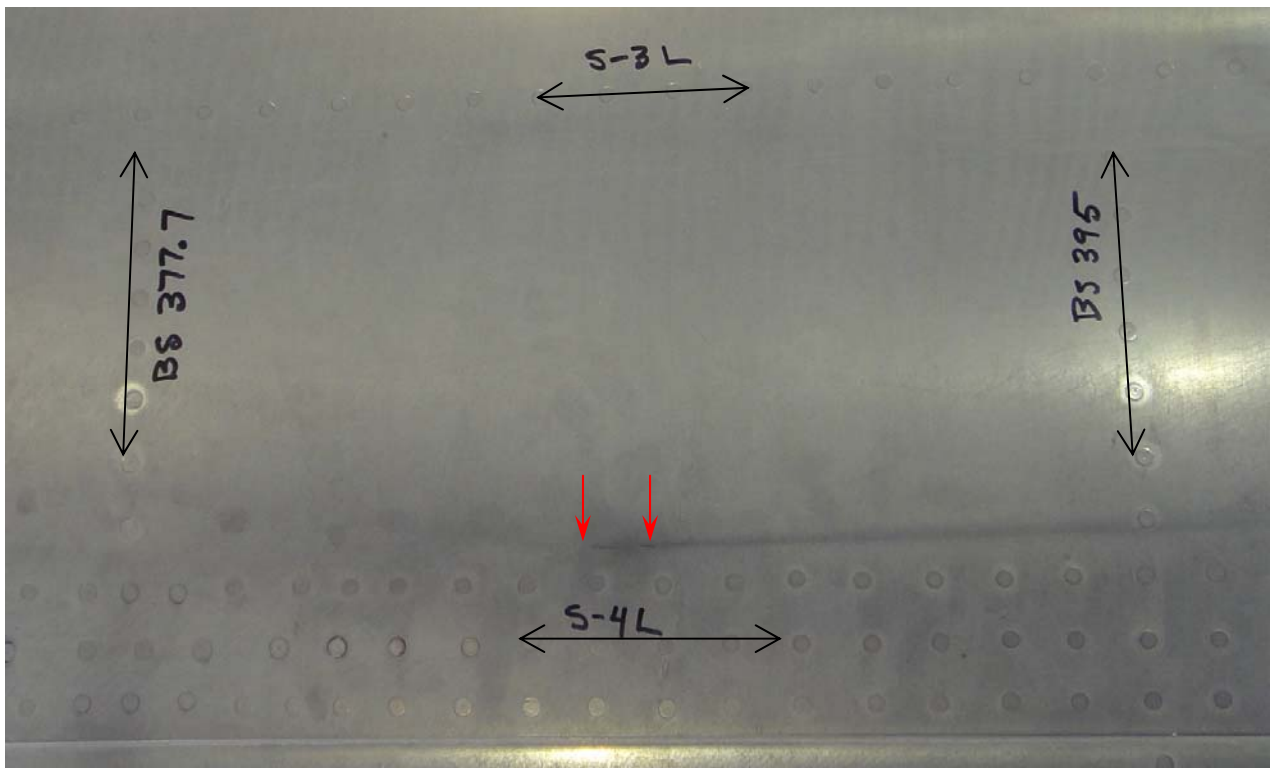
**Figure 2 – Crack Indication, N626AA**

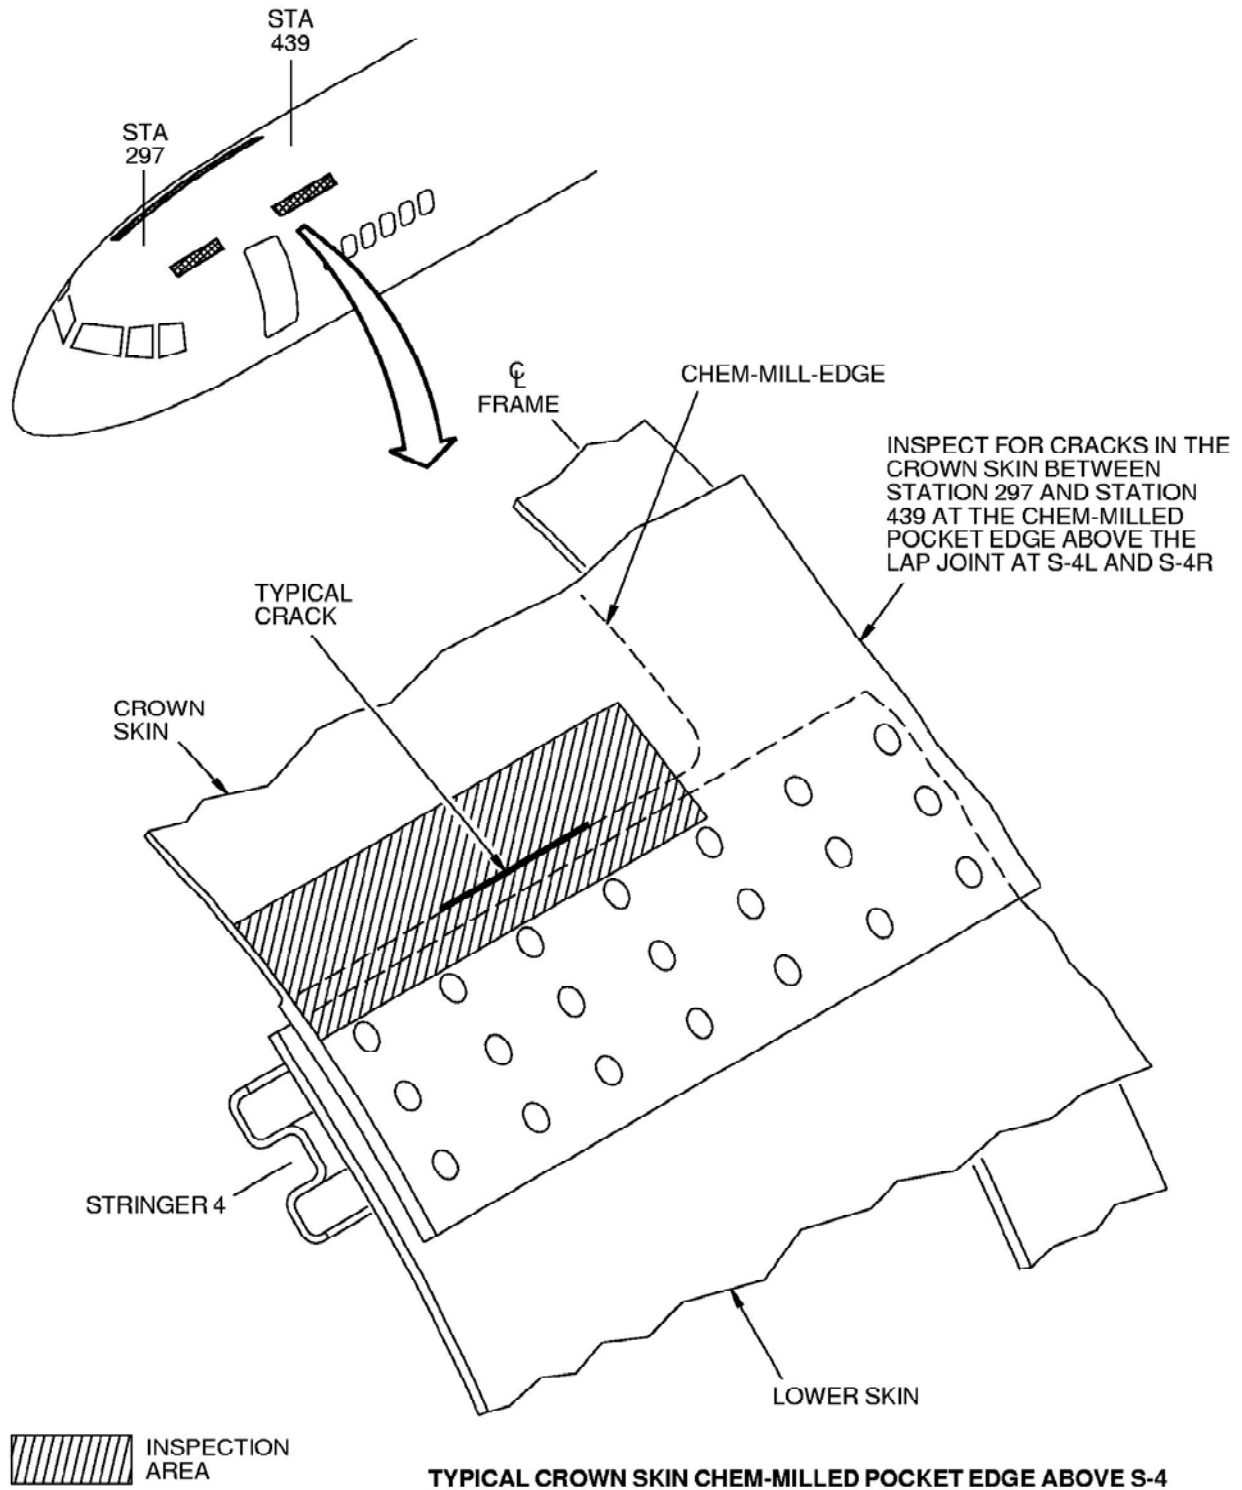
**Figure 3 – Sliding Probe eddy current inspection area details**

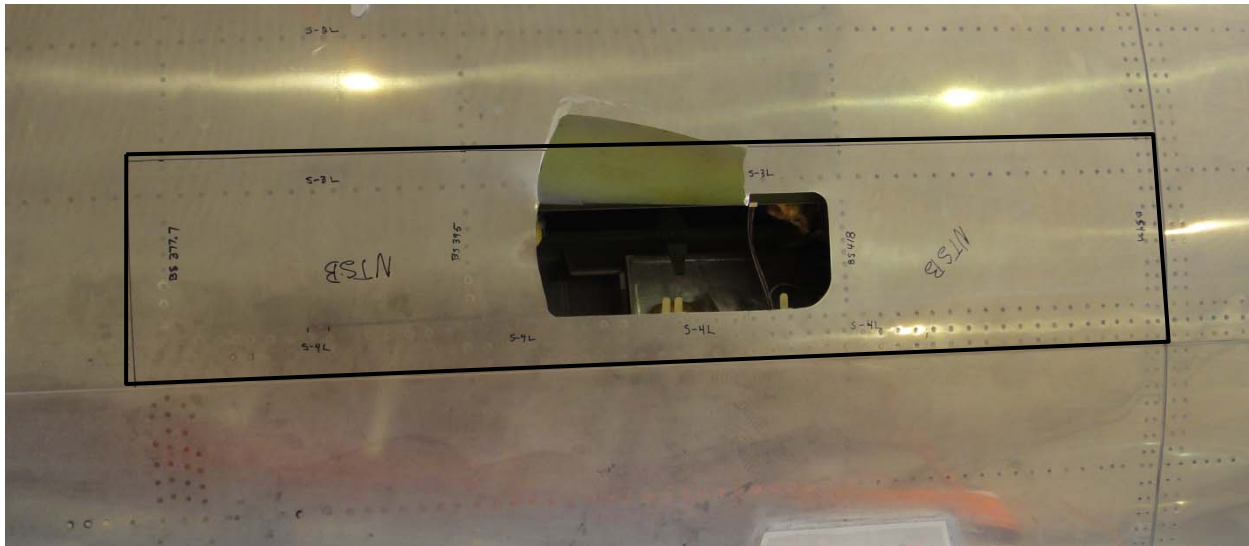
**Figure 4 – Approximate area removed for laboratory examination**

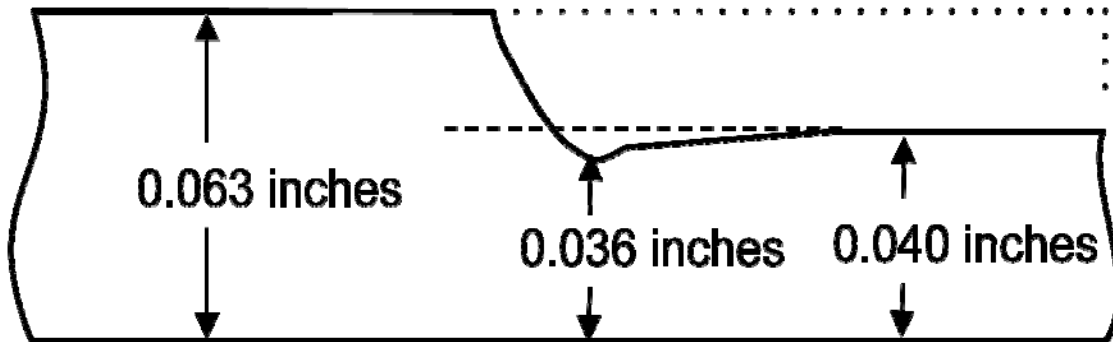
Figure 7 – Channeling defect in a chem-mill panel

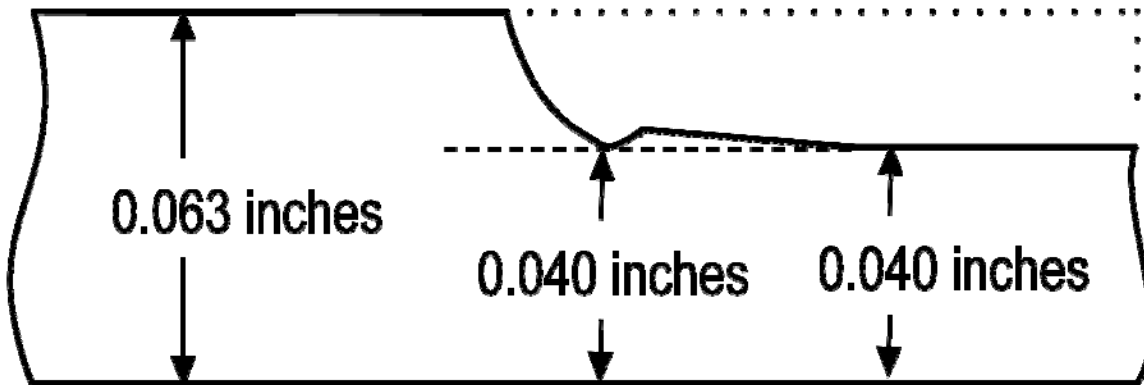
Figure 8 – Ridging defect in a chem-mill panel

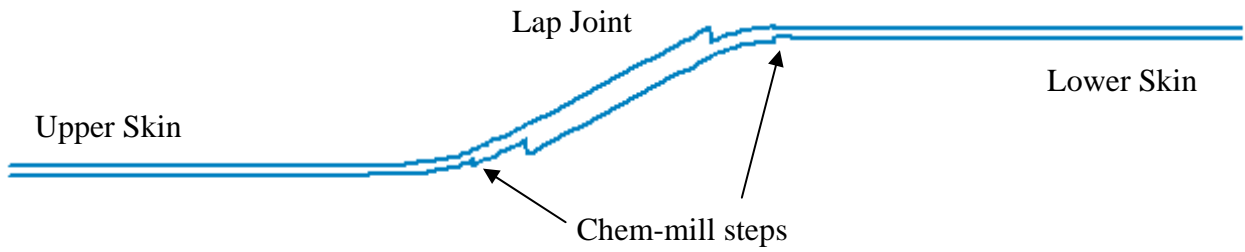
**Figure 9 – Exaggerated lap joint eccentricity due to pressurization**
