**NATIONAL TRANSPORTATION SAFETY BOARD**

**Group Chairman's Factual Report**

**CEN11IA341**

**Appendix A – Figures  
(5 pages)**

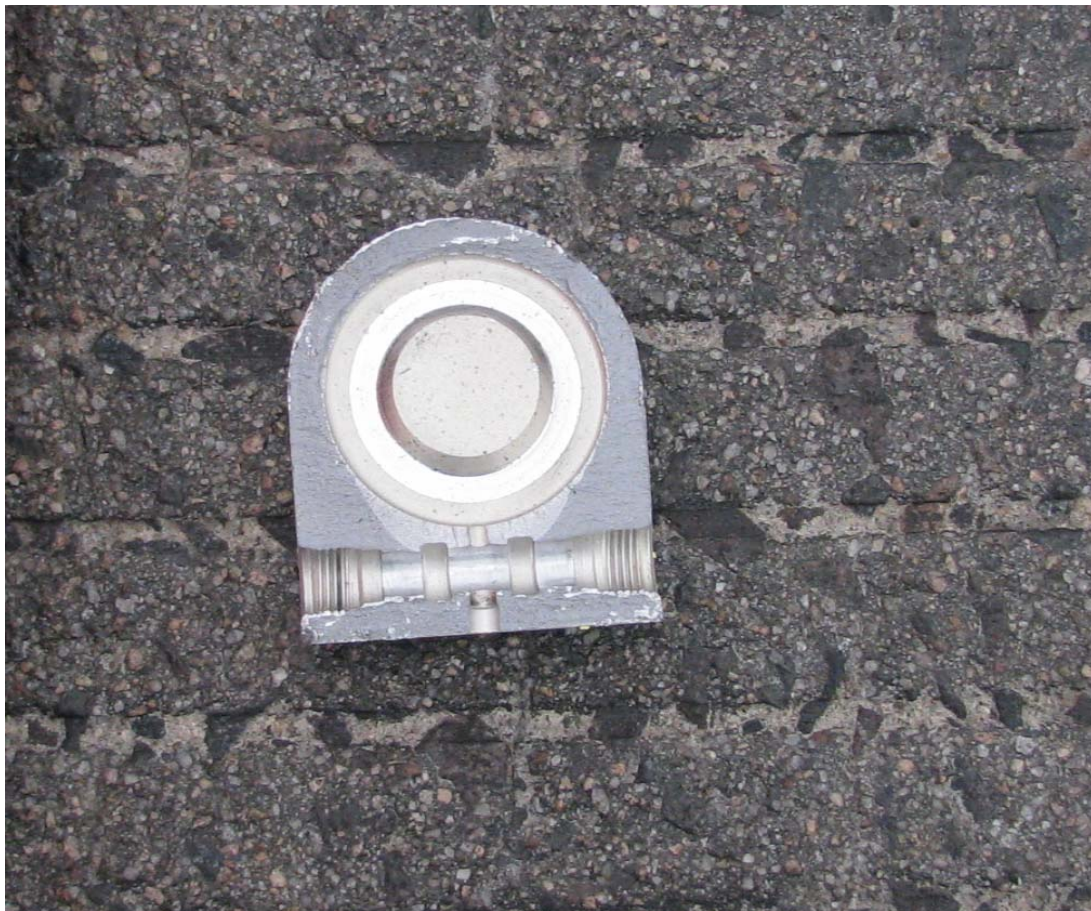
**Figure 2 – NLG End Cap piece found on runway**

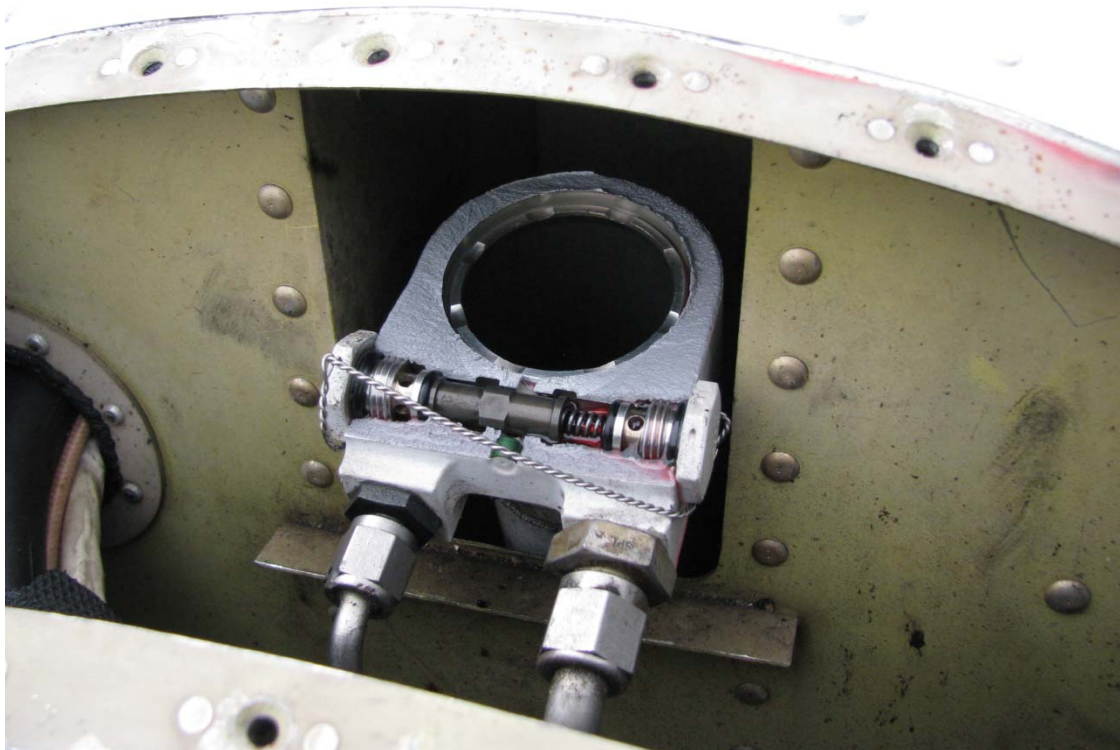
**Figure 3 – NLG actuator, top end with fractured end cap**

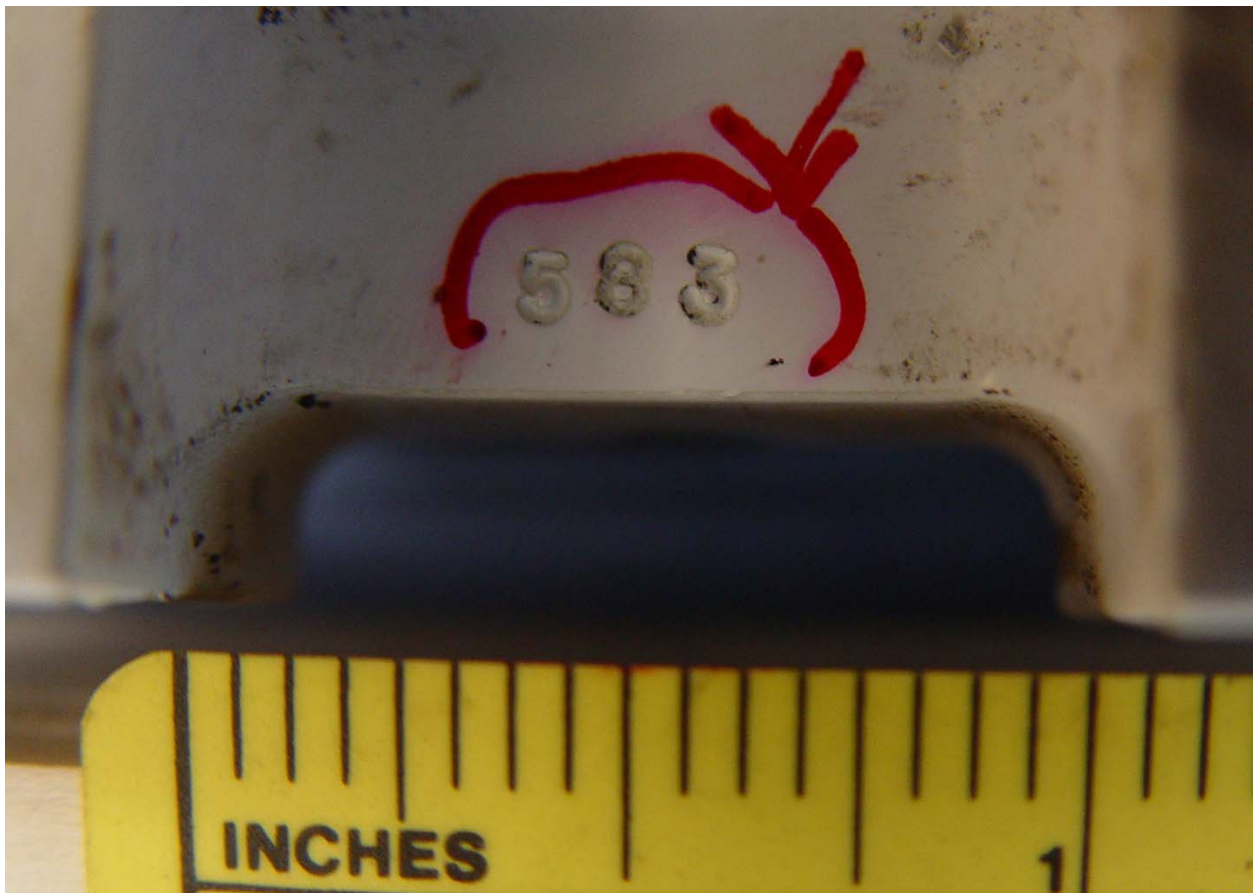
Figure 10 – Incident NLG End Cap serial number stamp
