## NATIONAL TRANSPORTATION SAFETY BOARD

## AIRWORTHINESS

Group Chairman's Factual Report
DCA13FA148

Appendix A – Figures (4 pages)

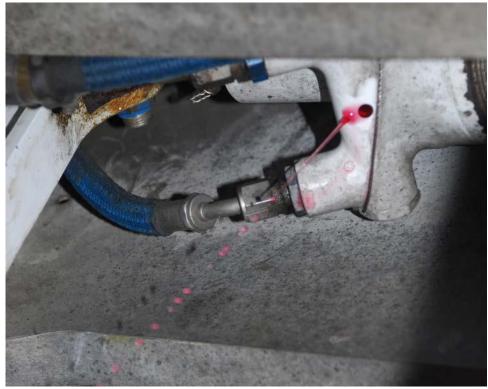
Figure 5 – LMLG Actuator Leak

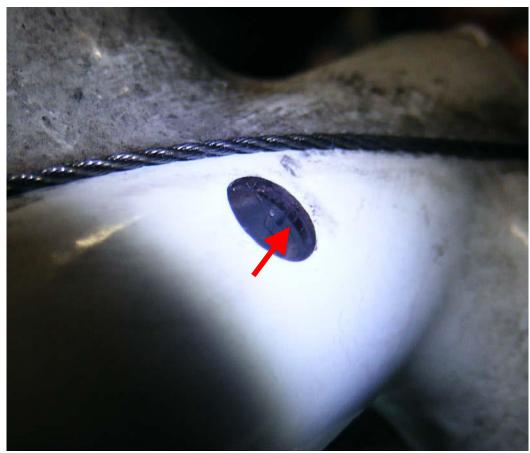
Figure 6 – Damage noted in Lee plug hole
