**AIRWORTHINESS GROUP CHAIRMAN'S FACTUAL REPORT**

**CEN13FA121**

**Turbomeca Engine Investigation Report No. A-2013-001  
(6 pages)**

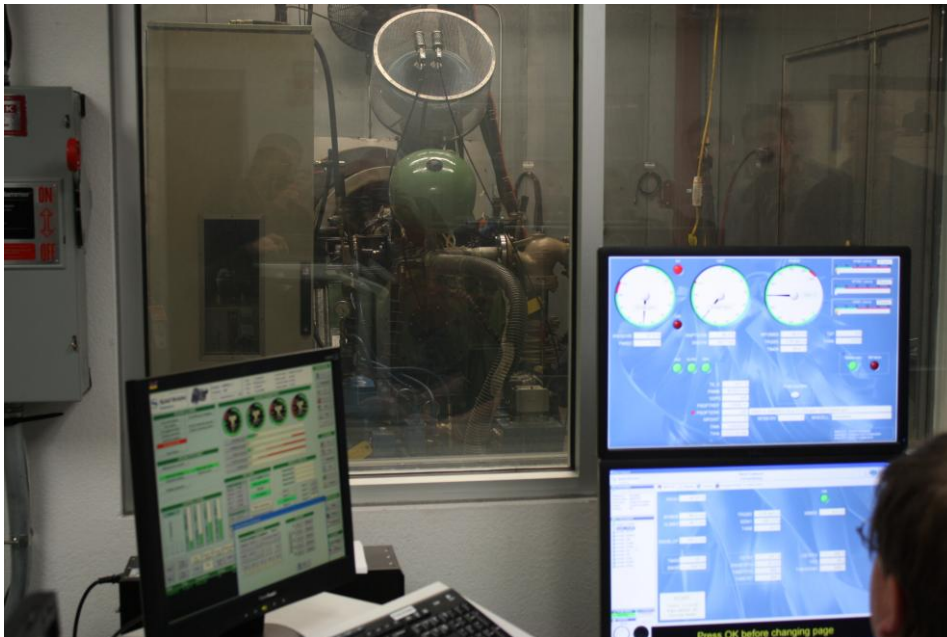
Engine was installed on Arriel 2B1 test cradle then installed on TEC02 TurboCat test cell. The first start was attempted in speed mode and a flame was observed coming from the exhaust and an emergency stop was performed by the test cell operator. The maximum T4.5 reached was 892°K (619°C). The over temp automatic safety limit on the test cell and the max starting T4.5 limit is set at 785°C. The test DECU was reset and a second start was attempted with the same results. The HMU s/n 1036 was removed and a shuttle test HMU was installed. The engine then started normally. Vibrations were within limits so the engine was accelerated to flight idle. A unusual noise could be heard most likely caused by the disruption in airflow caused by the bent axial blades. All indications appeared normal so an oil pressure check was performed at 85% Ng. The engine was then brought to ground idle and the operator shutdown the engine after a two minute cool down. The gas generator rundown time was 43 seconds. The engine was then started in position mode. The operator gradually accelerated the engine up to the point the N2 began to droop. N1 = 99.3% and torque was 89.66 daN.m (100% = 85.3 daN.m). All indications were normal other than the unusual noise. The engine was then brought back to ground idle, 2 minute cool down, shutdown, and removed from the test cell.

Engine on Test Bench
