From: Larimore, Bryan [REDACTED]
Sent: Monday, March 26, 2012 10:05 AM
To: McKenny Van
Subject: FW: Turbmomeca reports - Tucson accident
Attachments: 471040.pdf; 471039.pdf

Arriel 2B1

Fuel main manifold supply pipe test

September 2010

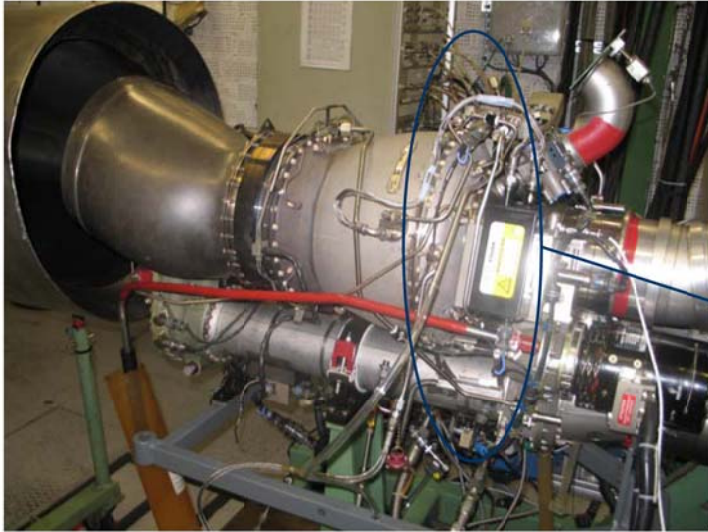
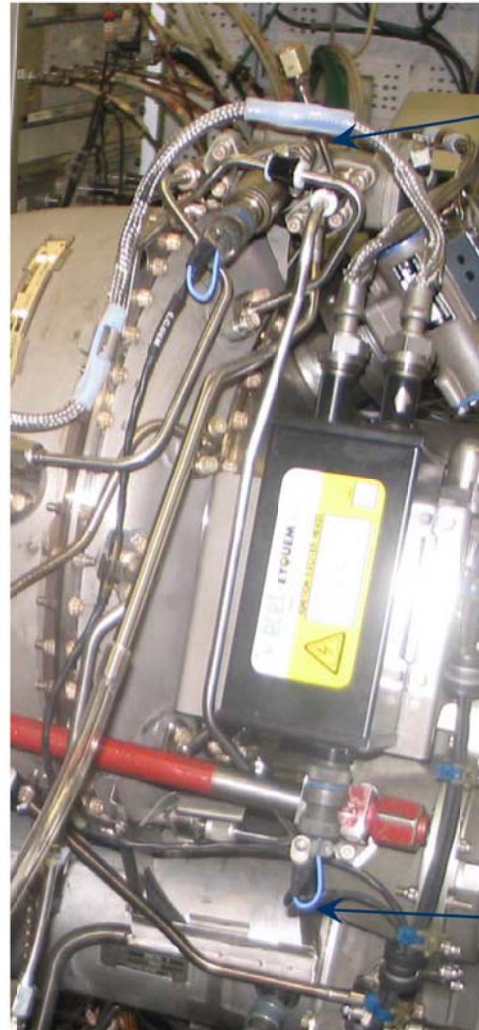
Bench installation

Fuel inlet pressure tapping point

Protection box

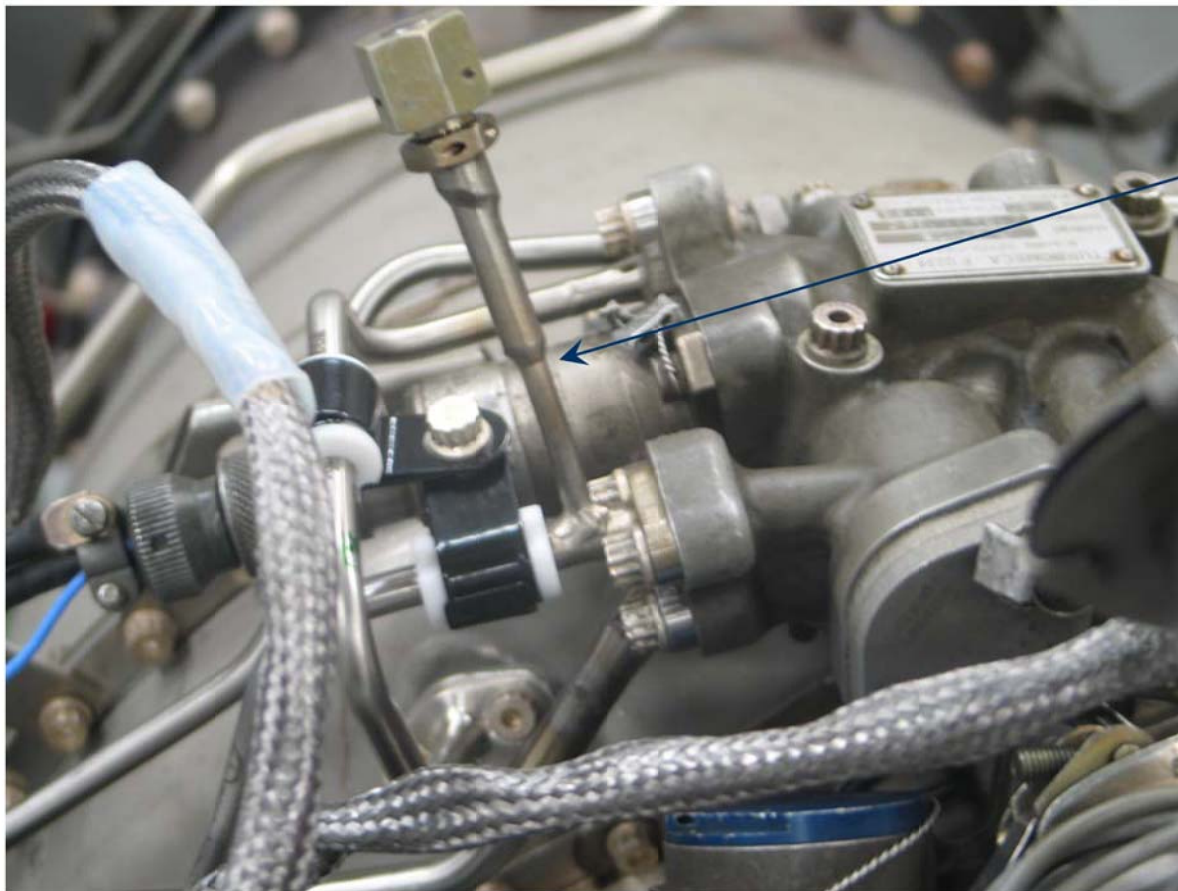
Bench installation

Fuel inlet
pressure
tapping point

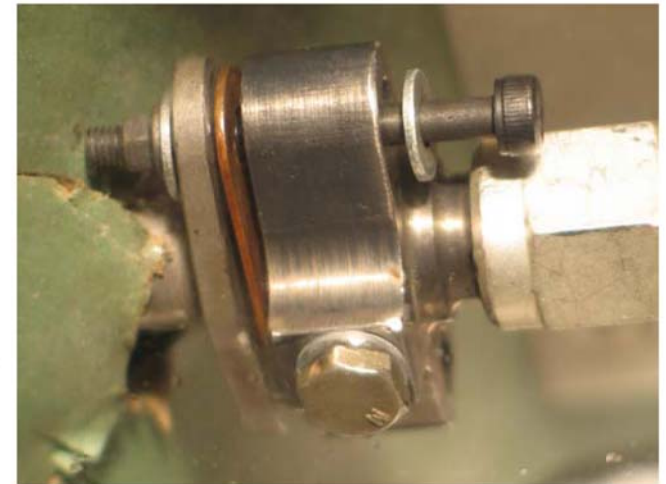
Test #1

➤ Configuration : representative of an assembly without screws

- ✓ Seals installed with grease (as specified).
- ✓ 1 Screw (located on the upper position) diameter 3mm and length which allowed a free axial displacement of the union up to 9 mm
- ✓ Union positioned in contact with the intermediate casing flange.

- ✓ ~ 39 min of engine operation in 4 phases
- ✓ No fuel leak during the entire phases
- ✓ Displacement of the union during the 2nd phase (~3 mm)

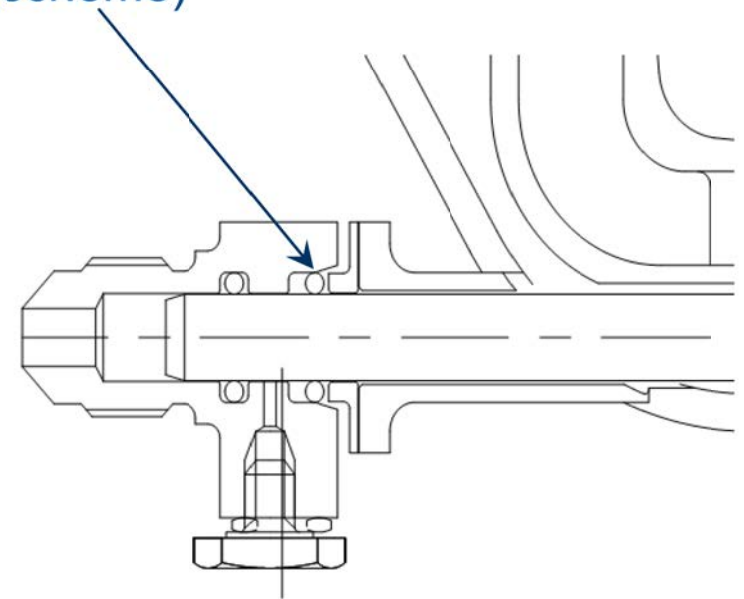
Test #2

➤ Configuration : (what happens if one O-ring is barely in contact)

- ✓ Seals installed with grease (as specified)..
- ✓ 1 Screw (located on the upper position) diameter 3mm and length which allowed a free axial displacement of the union up to 9 mm
- ✓ Union positioned with one ring in chamfer. (scheme)

- ✓ No fuel leak during the engine start
- ✓ Ejection after 2 min 24 sec of the union and pipe
- ✓ Uncommanded engine shut down without fluctuation

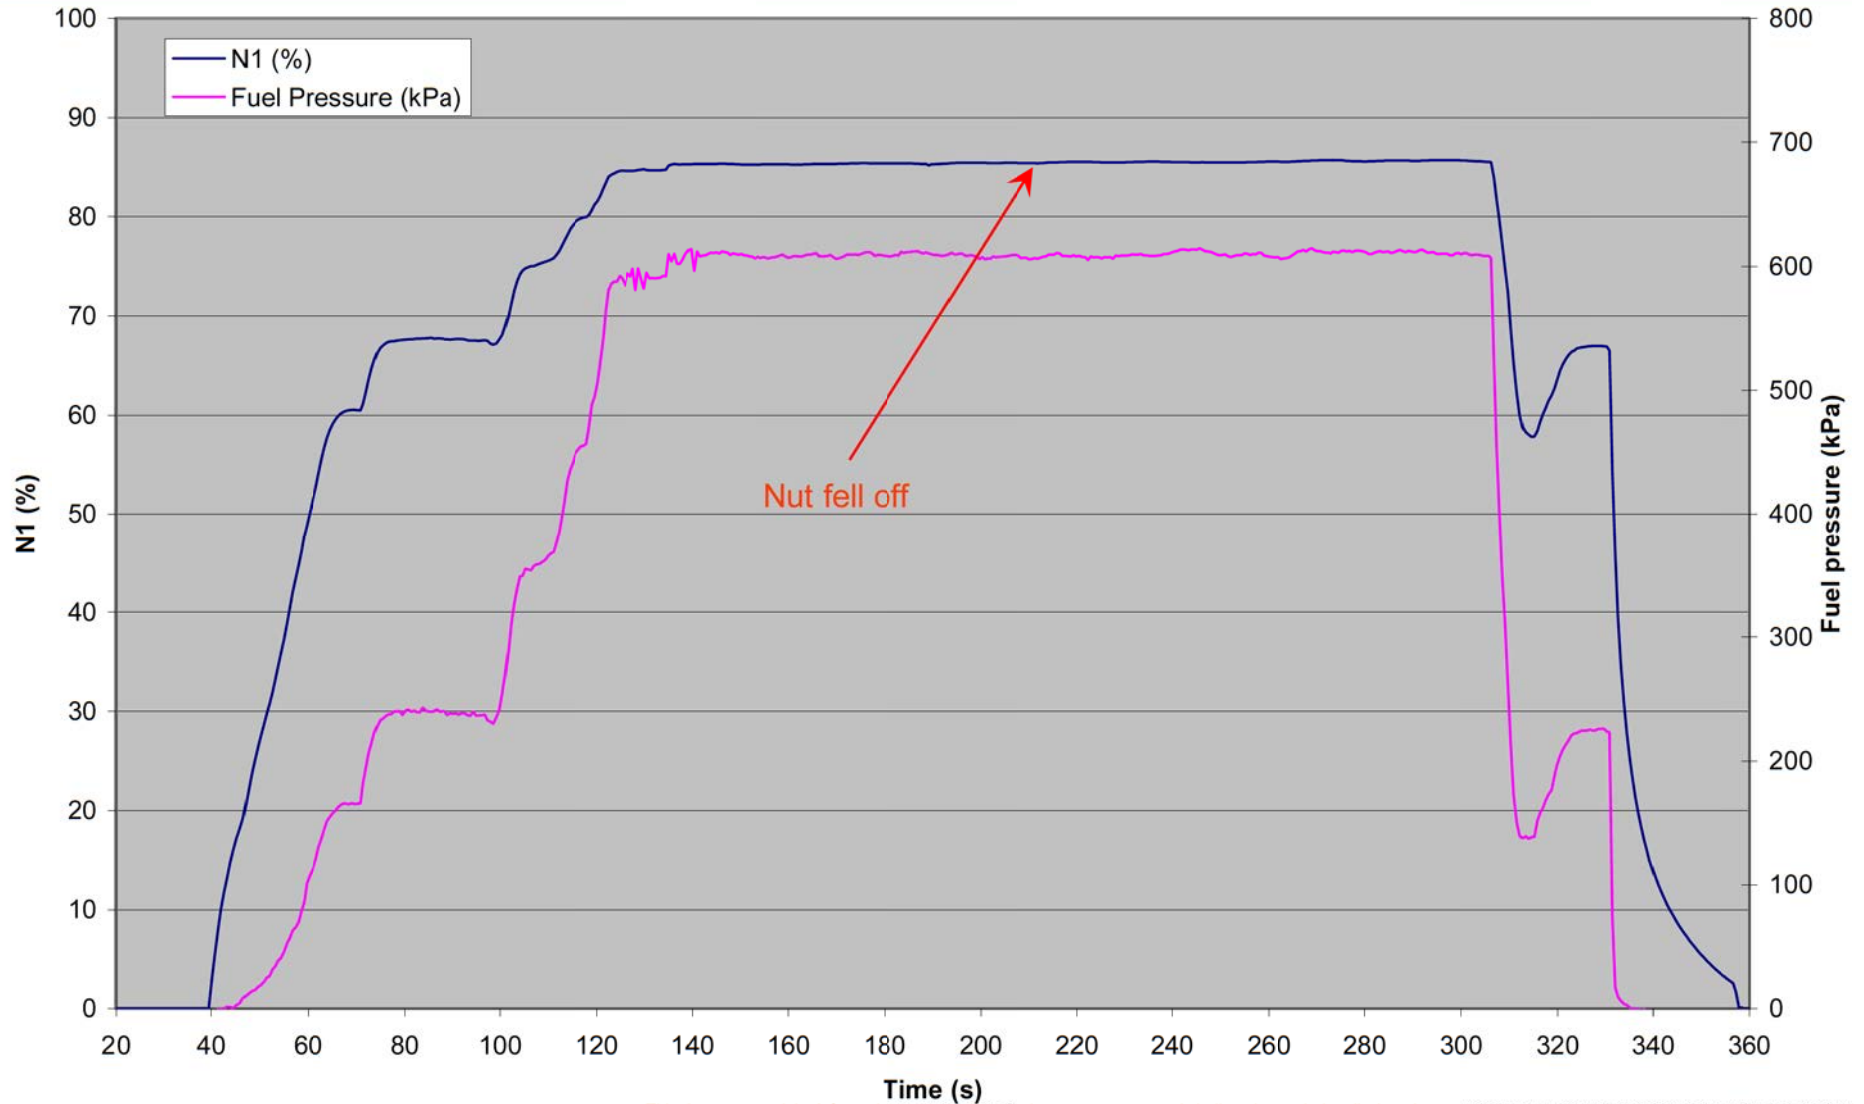
Test #3

- ✓ No fuel leak during the engine start
- ✓ Lower nut fell off after 3 min 32 s of operation
- ✓ Upper screw and nut vibrated (erratic movements) but did not fall off
- ✓ Slight displacement of the union
- ✓ No leak

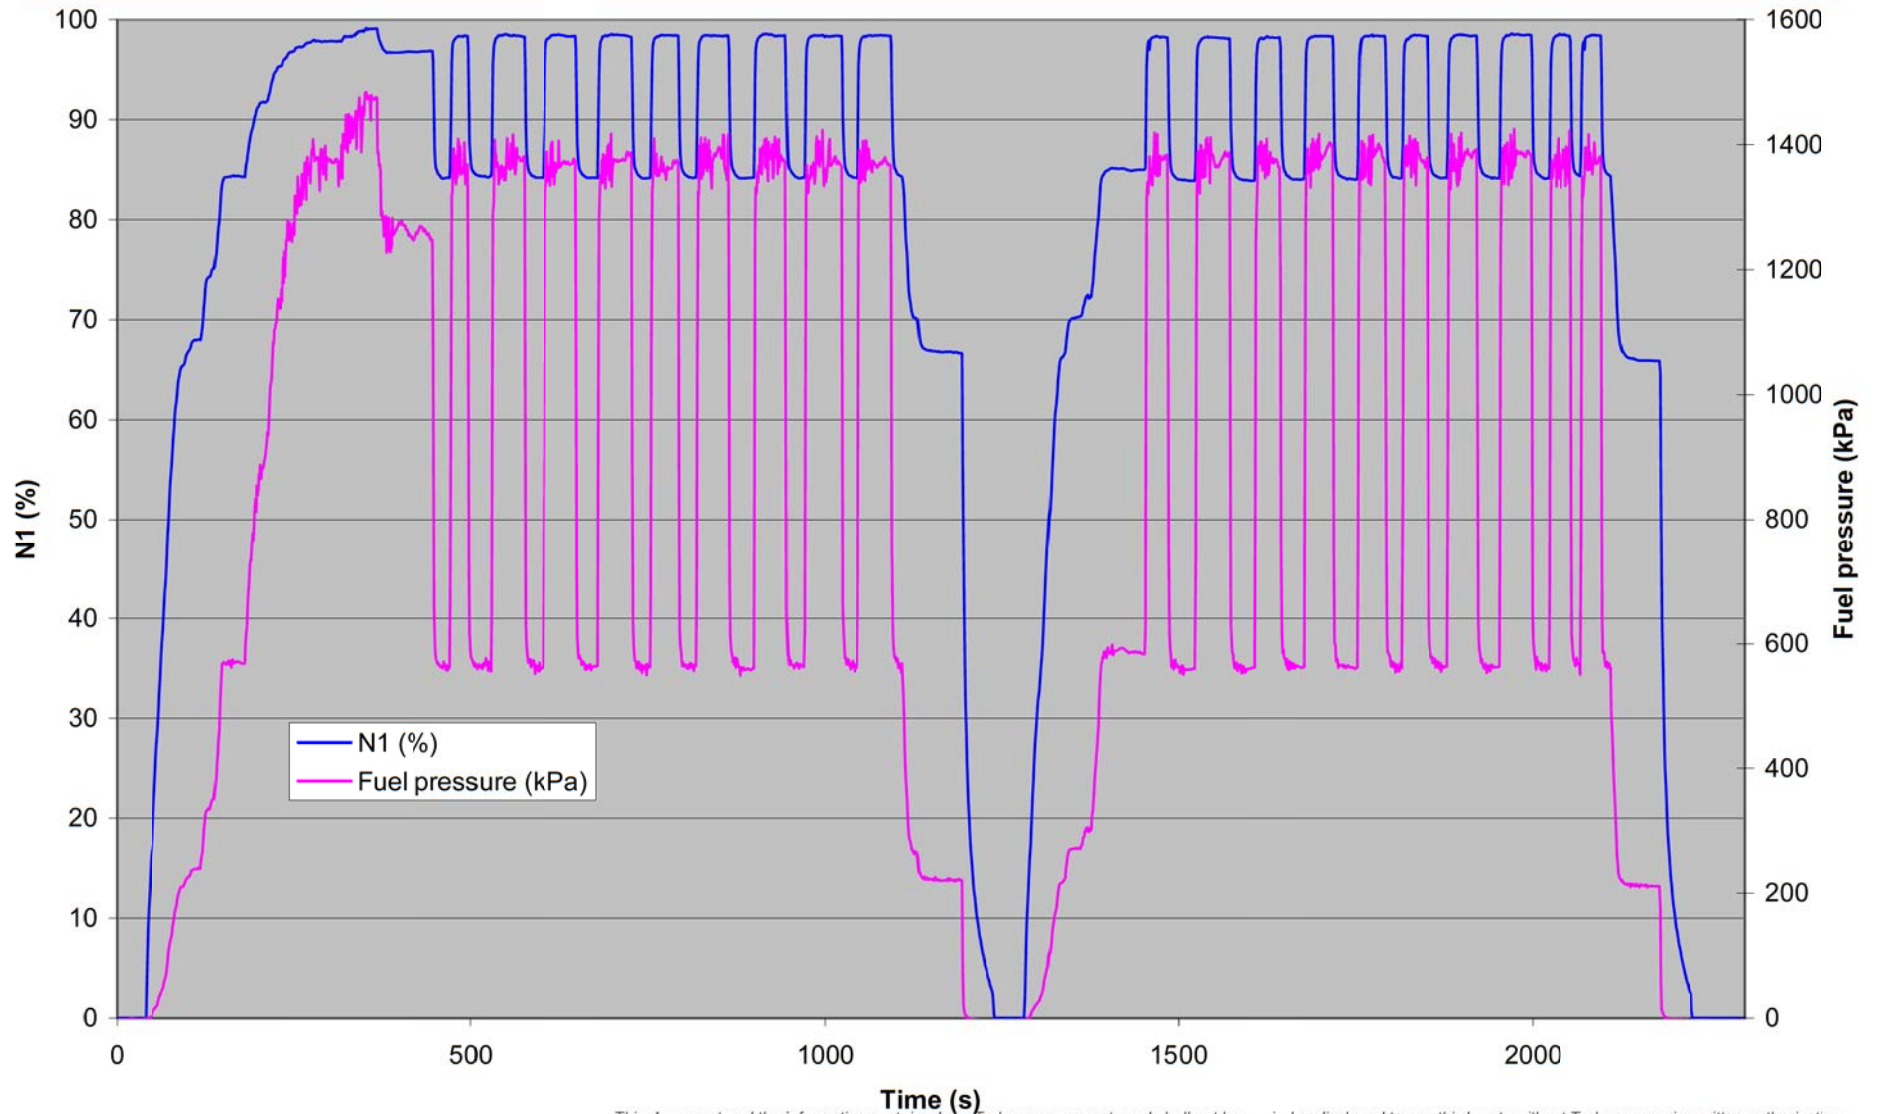
Test #4

- ✓ ~20 min of engine operation
- ✓ No fuel leak
- ✓ Screw and nut did not fall off during this phase

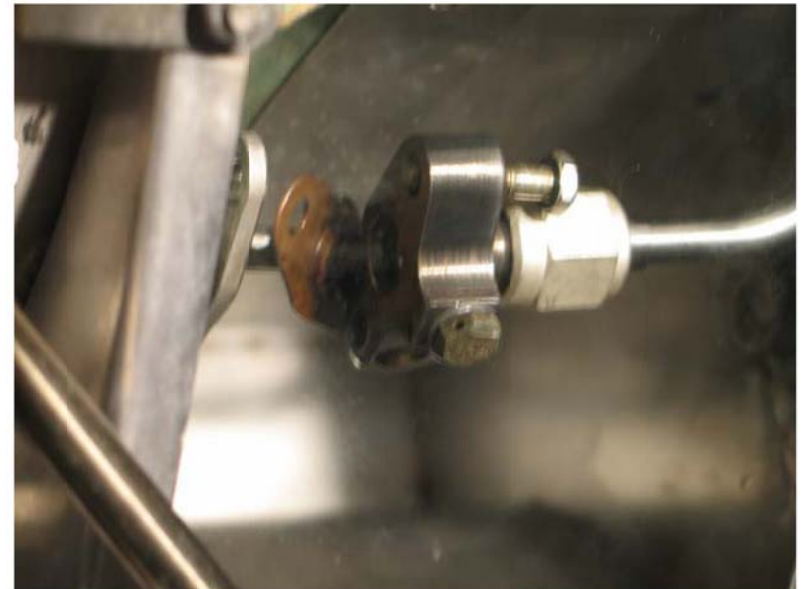
Test #5

- ✓ 1 Screw diameter 4 mm (the serial one) at the upper position. Screwed but not tightened (return to phase 4 configuration)
- ✓ Union positioned near contact with the intermediate casing flange

- ✓ No fuel leak during the engine start
- ✓ Nut fell off during the starting phase
- ✓ Vibratory behaviour of the screw during the engine acceleration
- ✓ Ejection of the union pipe and screw and uncommanded engine shut down without fluctuation
