**NATIONAL TRANSPORTATION SAFETY BOARD**  
**Office of Aviation Safety**  
**Washington, D.C. 20594**

**Airworthiness Group Chairman's Factual Report**

**NTSB No: DCA12FA024**

Operator: AAR Airlift Corporation  
Aircraft: Bell 214ST, Registration Number N5748M  
Location: 7 miles south of Camp Bastion, Helmund Province, Afghanistan  
Date: January 16, 2012  
Time: 1045 local time<sup>1</sup> (0615 coordinated universal time)

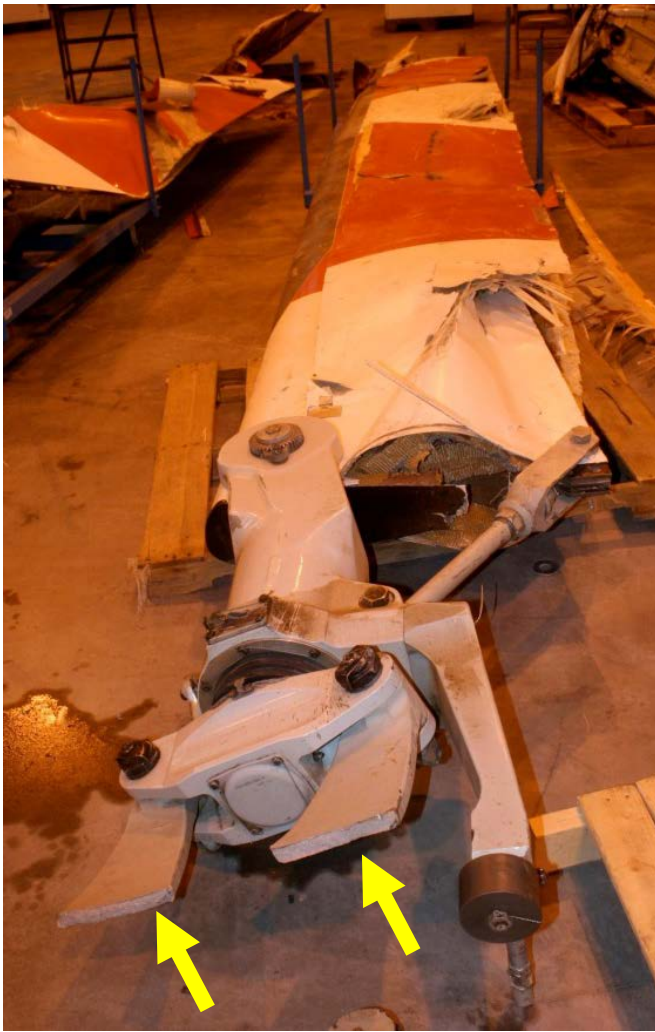
Both of the main rotor blades were recovered from the accident site. Both blades were received with permanent marker labeling on their respective pitch horns, with one blade labeled "white" and the second blade labeled "red". Both main rotor blades were substantially damaged, but their respective pitch horns, drag braces, and grip and spindle assemblies remained installed with damage consistent with scuffing from ground impact (**Photos 2 and 3**). The bearing and clevis ends of both pitch change links remained attached to the pitch horns with all attachment hardware intact. The pitch change links were fractured at the upper end of the tube assembly. Both main rotor blade spindles remained attached to their respective yoke flanges. All four yoke flanges were fractured, with the fractured ends were slightly bent upward. Examination of the yoke fracture surfaces revealed features consistent with overstress failure.

**Photo2. The red main rotor blade. Arrows indicate yoke flange fractures.**

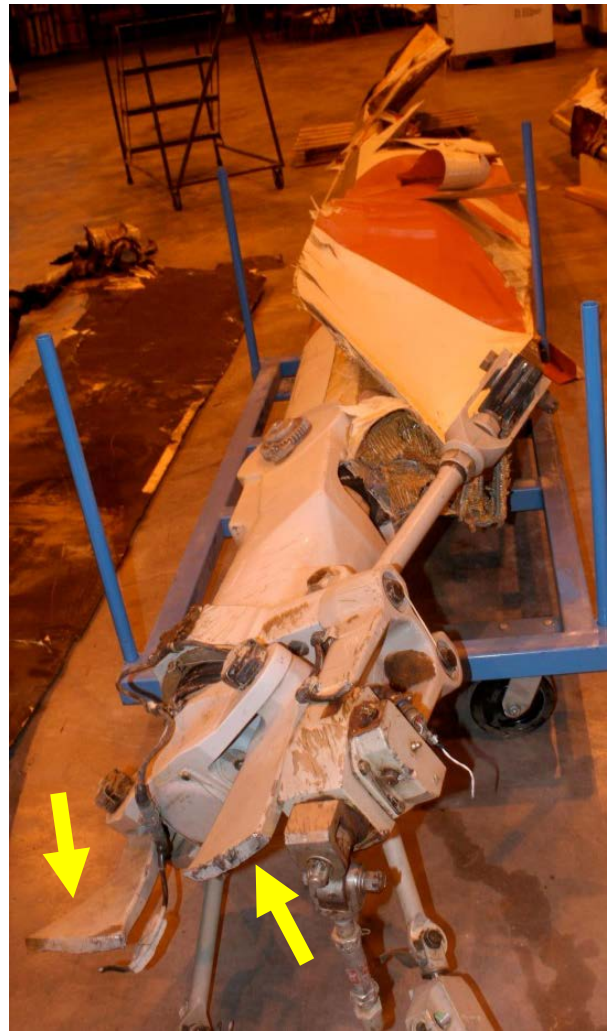
The 'white' main rotor blade had its tip cap still installed. The blade contained multiple fractures in its honeycomb core and fiberglass skin throughout the span of the blade consistent with impact forces. The blade had evidence of blue and black paint transfer marks<sup>3</sup> in the chordwise direction, from the leading edge to the trailing edge, about 24 inches in width in the spanwise direction (**Photo 4**). Impact damage was seen on the leading edge of the blade about 12 inches from the spanwise measurement reference point<sup>4</sup>. A small section of the underside of the leading edge abrasion strip was missing at the impact location (**Photo 5**); a section of the leading edge abrasion strip of similar size and shape to the aforementioned missing section was found lodged in a fractured section of the elevator spar (**Photo 6**). Both coning restraint links remained attached to the blade spindle but fractured, with fracture surfaces exhibiting features consistent with overstress failure.

**Photo3. The white main rotor blade. Arrows indicate yoke flange fractures.**

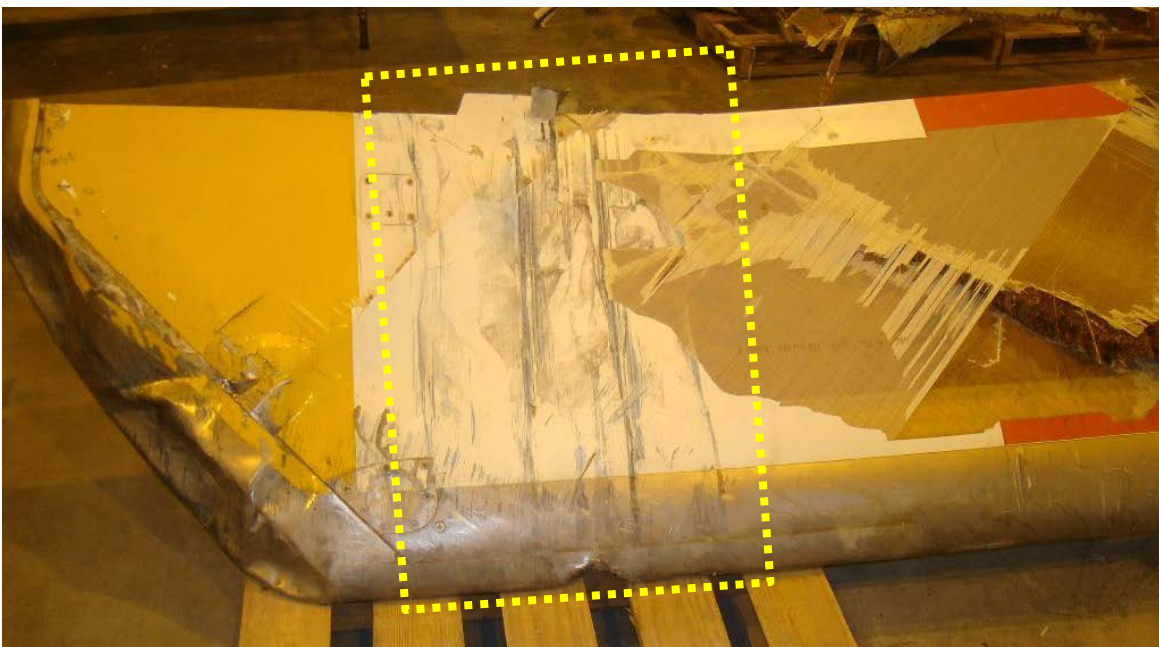
**Photo 4. Blue and black paint transfer marks on the top surface of the white main rotor blade.**

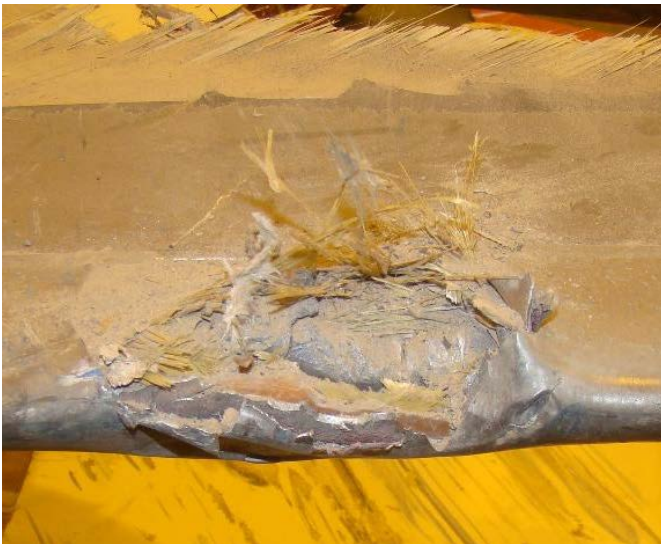
**Photo 5. The white main rotor blade's leading edge abrasion strip with missing piece.**

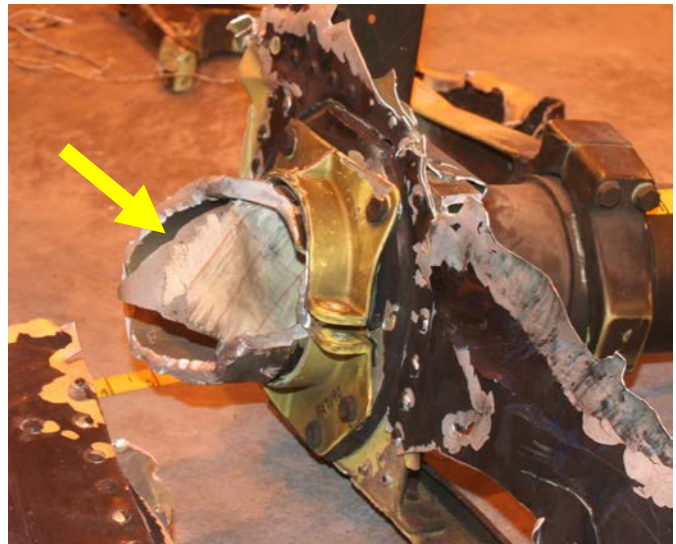
**Photo 6. Leading edge abrasion strip piece found in the tailboom elevator spar (see arrow).**

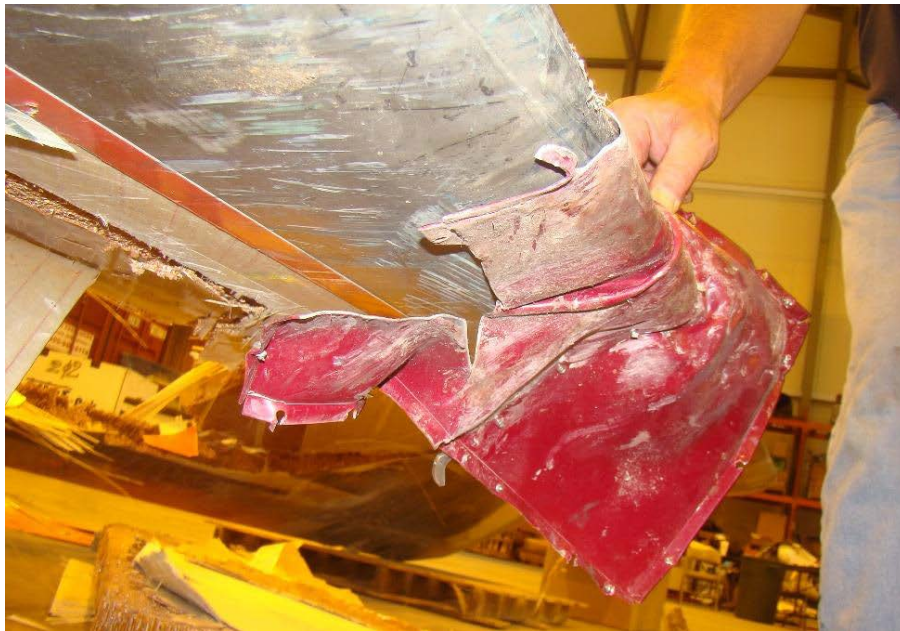
The 'red' main rotor blade tip cap was not installed on the blade, but the tip cap was recovered from the accident site and was observed to be substantially deformed. The tip weight remained inside the blade. Similar to the 'white' blade, the 'red' blade contained multiple fractures in its honeycomb core and fiberglass skin throughout the span of the blade. Furthermore, the 'red' blade also exhibited blue and black paint transfer marks at about 84 inches from the spanwise measurement reference point. Impact damage similar to the 'white' blade was observed at the blade leading edge approximately 24 inches from the spanwise measurement reference point. There was also a high concentration of maroon paint transfer marks that started at about 36 inches from the spanwise measurement reference point and ended at about 72 inches from the reference point. The helicopter battery cover, painted in maroon, was recovered from the accident site and was observed to be deformed in the shape of a main rotor blade leading edge (**Photo 7**). Only one coning restraint link remained attached to the blade spindle; examination of its fracture surfaces revealed signatures consistent with overstress failure.

**Photo 7. Deformed helicopter battery cover (placed over the ‘red’ main rotor blade leading edge).**

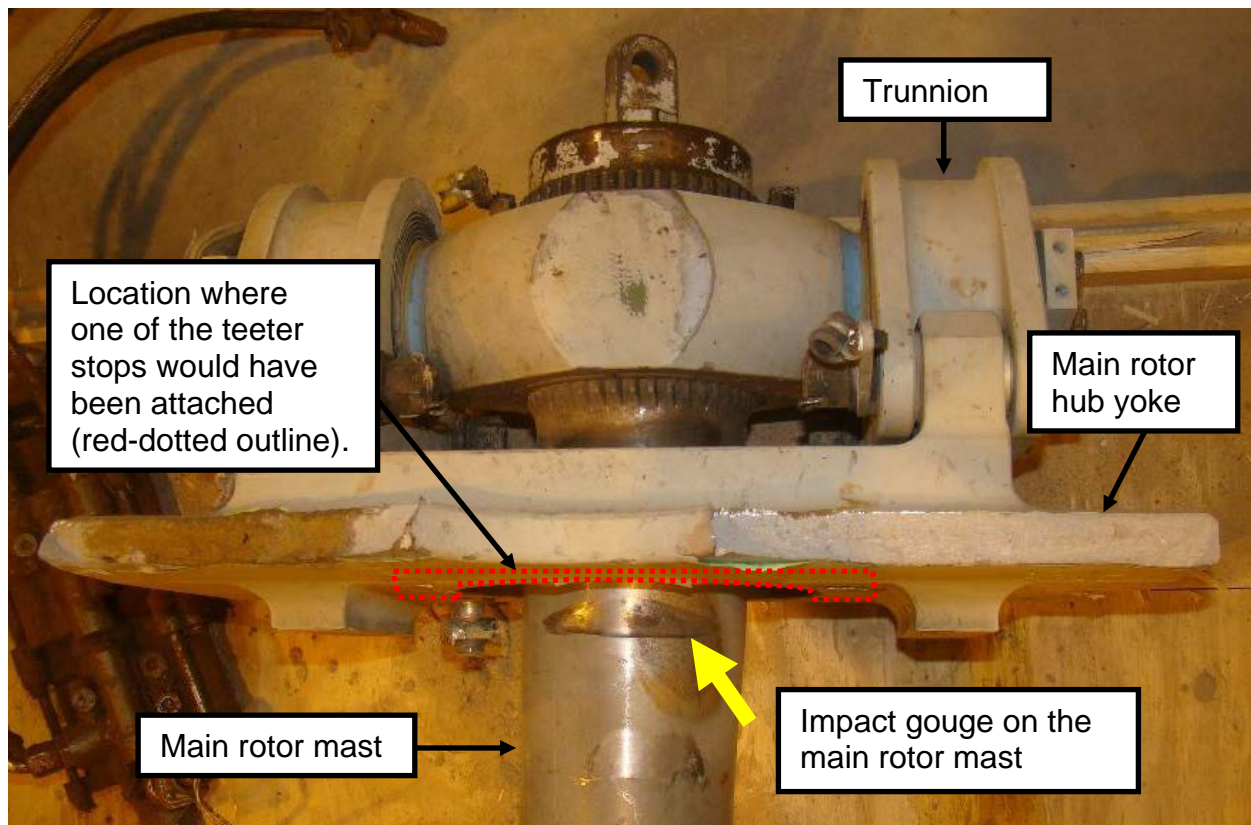
On the visible portions of the main rotor mast, evidence of two areas with impact damage was found 180° opposite of each other and aligned with the flapping direction of main rotor hub; the impact damage was matched to impact damage seen on the inner surface of the teetering yoke (**Photos 8 and 9**). The teeter stops were not recovered with the yoke. The impact damage on the main rotor mast contained characteristics consistent with mast bumping.<sup>5</sup> The remaining visible portions of the main rotor mast extending up to the main rotor hub did not exhibit unusual damage aside from those consistent with ground impact forces. The trunnion assembly and the mast nut were found installed and intact.

**Photo 8. Impact gouge on the main rotor mast.**

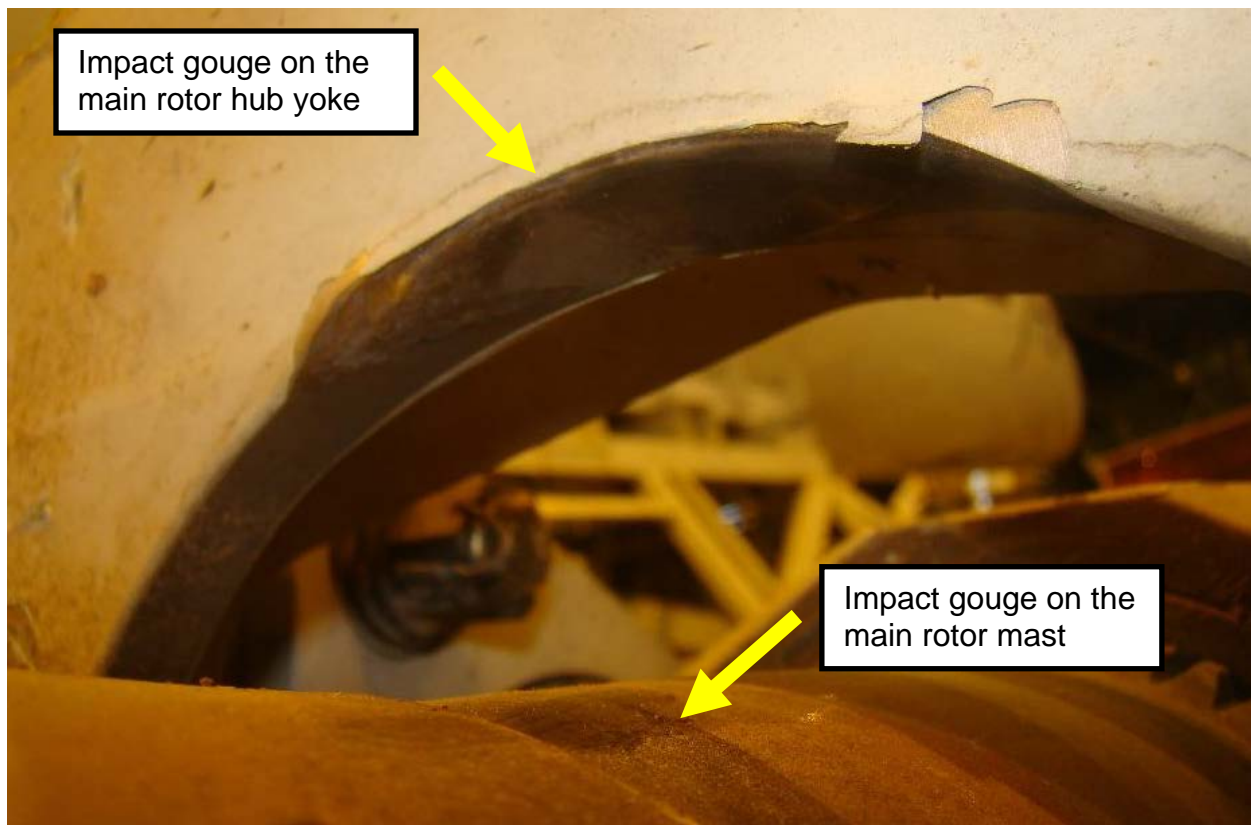
**Photo 9. Corresponding impact gouges on the main rotor hub yoke (upper arrow). Impact gouge on the main rotor mast is also visible (lower arrow).**

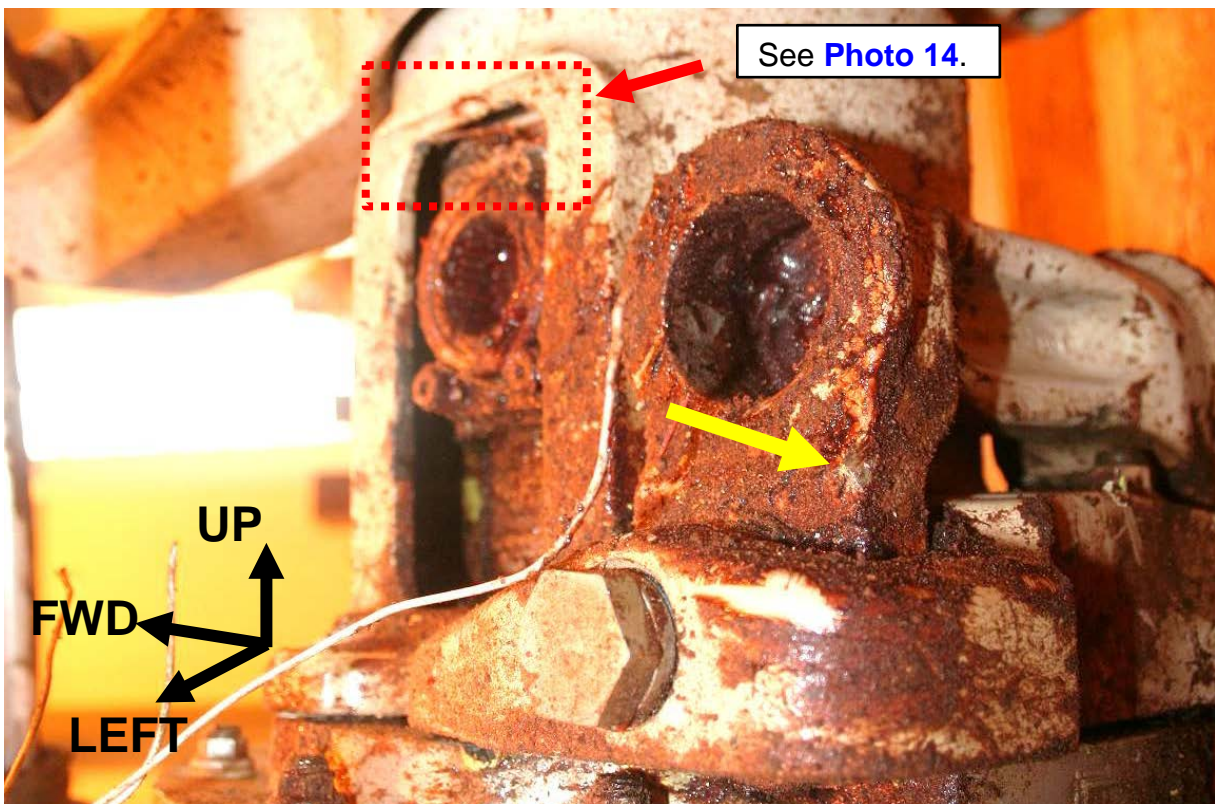
The idler link was found to have two impact marks on the left and right sides of its outboard-facing edges in similar locations (**Photos 12 and 13 – yellow arrows**). The impact mark on the left side of the idler link was observed to be smaller than that of the right. According to BHT engineering, the impact marks on the idler link were consistent with an over-travel of the collective lever arm in the direction of an upward movement of the collective sleeve. The impact mark on the idler link's right side was matched to damage found on the recovered collective lever arm; thus the only recovered collective lever arm was identified as the right collective lever arm. The idler link bearings were not found installed within the link and were not recovered with the wreckage. On the swashplate support assembly, impact marks were seen on the upper edge of both sides of the window (**Photos 14 and 15**). These impact marks matched damage seen on the upper two of the four bolts used to secure the bearing assemblies on both sides of the collective sleeve; the damaged bolt heads exhibited a downward bend. On the left side bearing assembly, the upper left bolt head was discovered to have sheared off completely. According to BHT engineering, the impact marks observed on the upper edge of the swashplate support assembly window is consistent with an over-travel of the collective sleeve in the upward direction. Both left and right bearing assemblies on collective sleeve contained their respective bearings, with the right bearing assembly exhibiting significant deformation and damage while the left bearing assembly exhibited little damage.

Photo 12. Impact mark on the left side of idler link (yellow arrow).

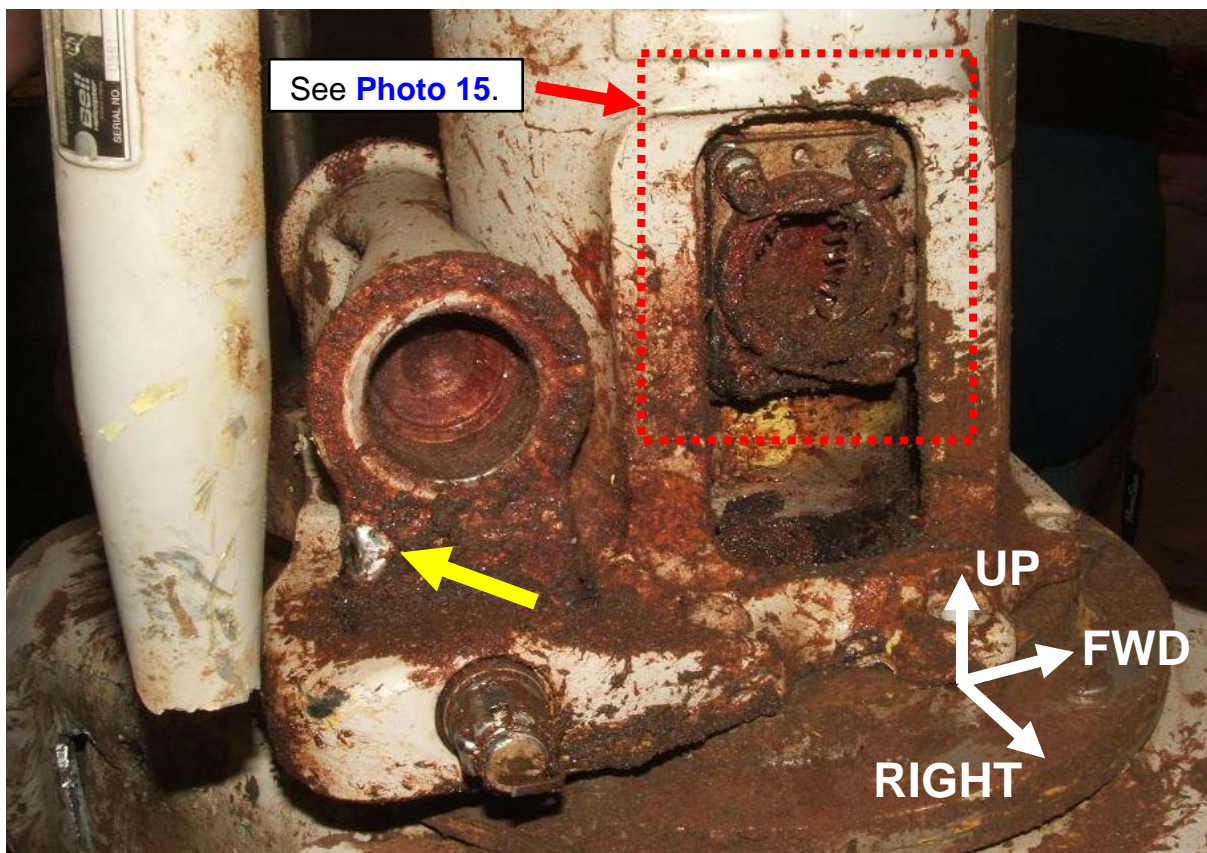
Photo 13. Impact mark on right side of idler link (yellow arrow).

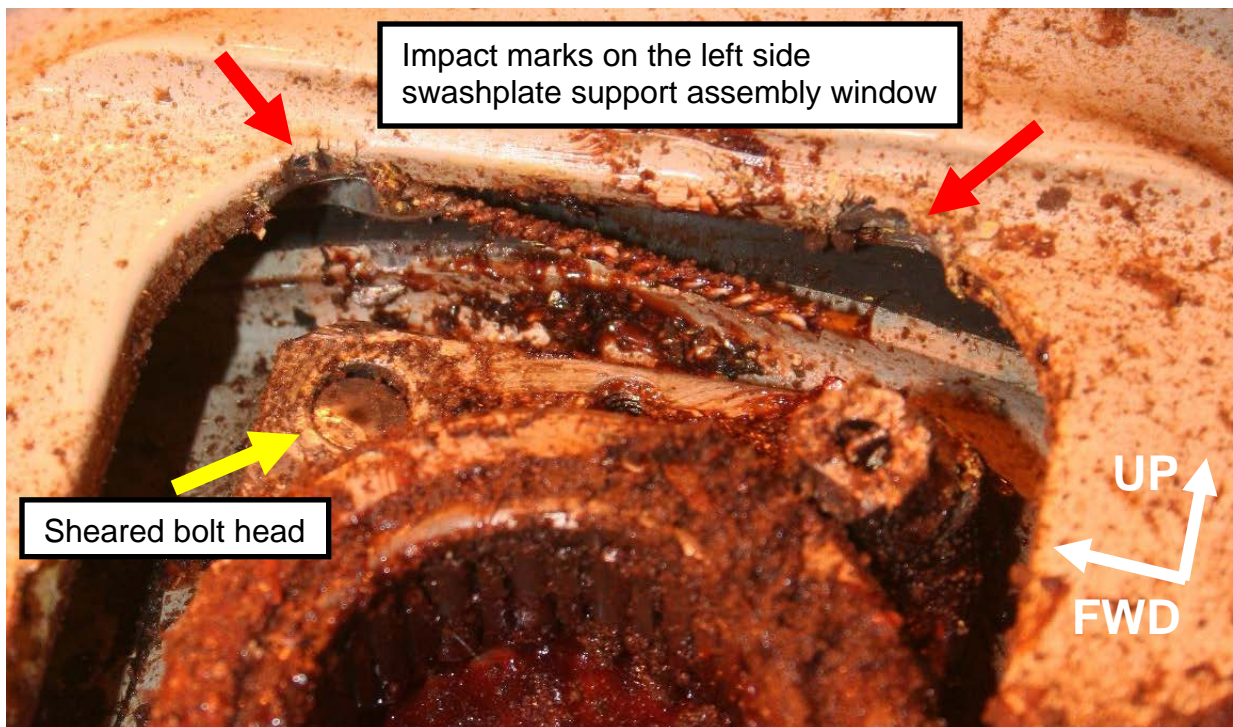
**Photo 14. Impact marks (upper two arrows) and sheared bolt head (lower left arrow) on the left side of the swashplate support assembly window. A portion of the undamaged bearing is visible.**

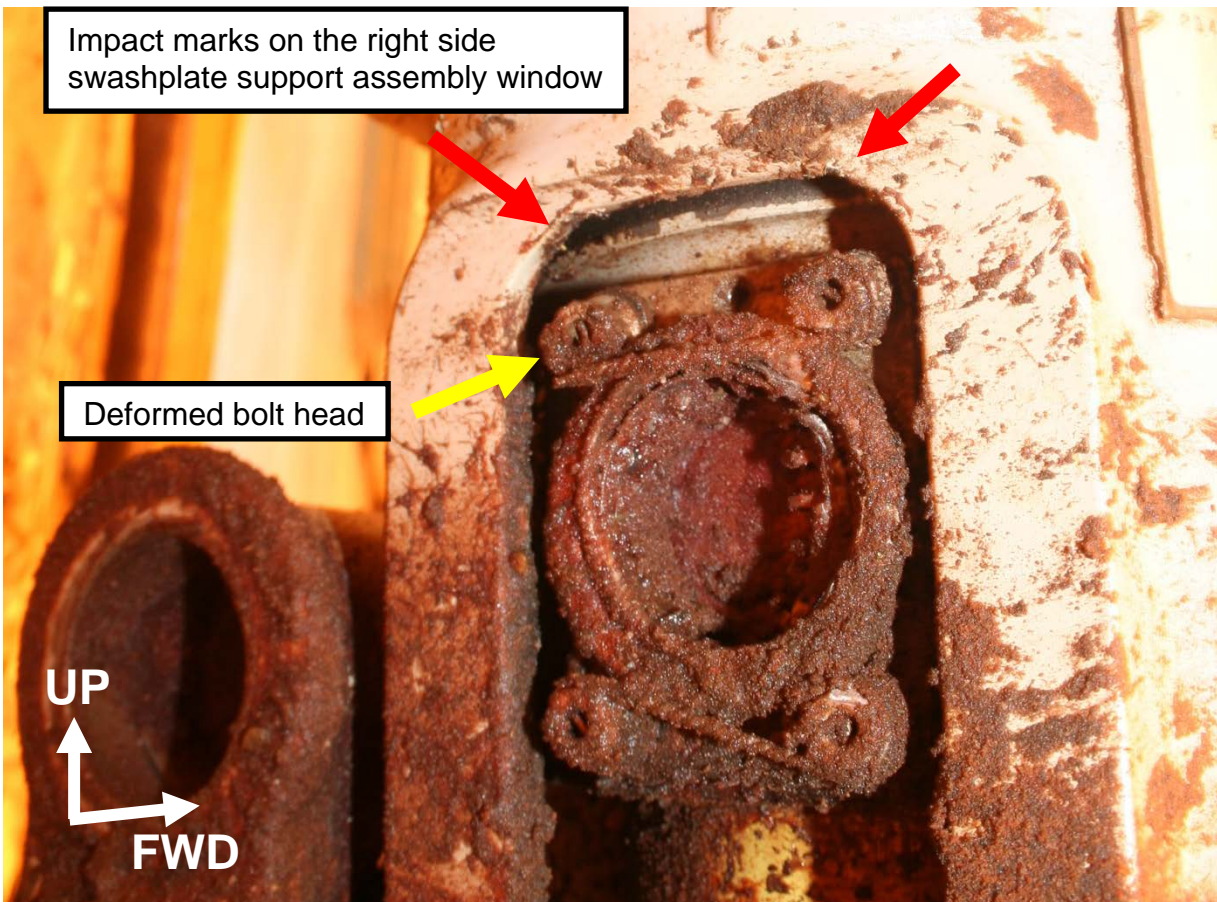
**Photo 15. Impact marks (upper two arrows) of the bolts on the right side of the swashplate support assembly window. The damaged and deformed bearing is also visible.**

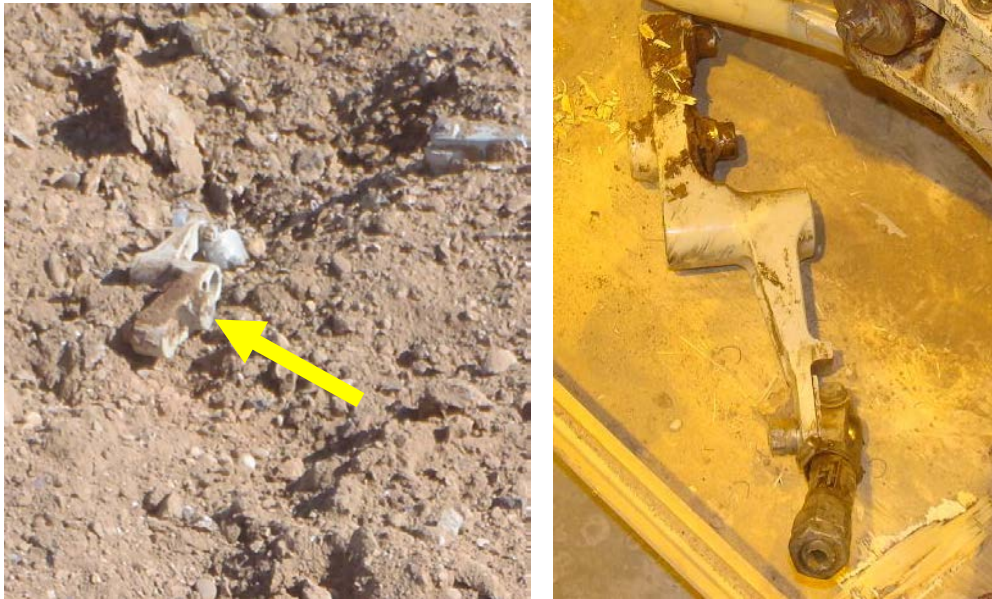
Photographs from the accident site showed the collective lever assembly was not attached when the wreckage was recovered and that only one collective lever arm was recovered and photographed at the accident site (**Photo 17**). The recovered collective lever arm was determined to be the right-side collective lever arm based on an impact mark matched to that of an impact mark on the right-side of the idler link (**Photo 18**). The left collective lever arm and the bolts and washers that secure the two lever arms together (**Figure 3, Indices 2 through 7**) were not recovered. The two mounting pins and the hydraulic actuator's upper rod end remained attached to the right collective lever arm. The bolt securing the upper rod end to the recovered lever arm (**Figure 4, Index 2**) had fractured; only the threaded end of the bolt, the castellated nut, the nut-side washer, and cotter pin (**Figure 4, Indices 3, 4, and 6**) remained installed.

**Photo 17. The collective lever arm in a photo taken at the accident site (left image [image courtesy of USTRANSCOM]) and the collective lever arm from the recovered wreckage (right image).**

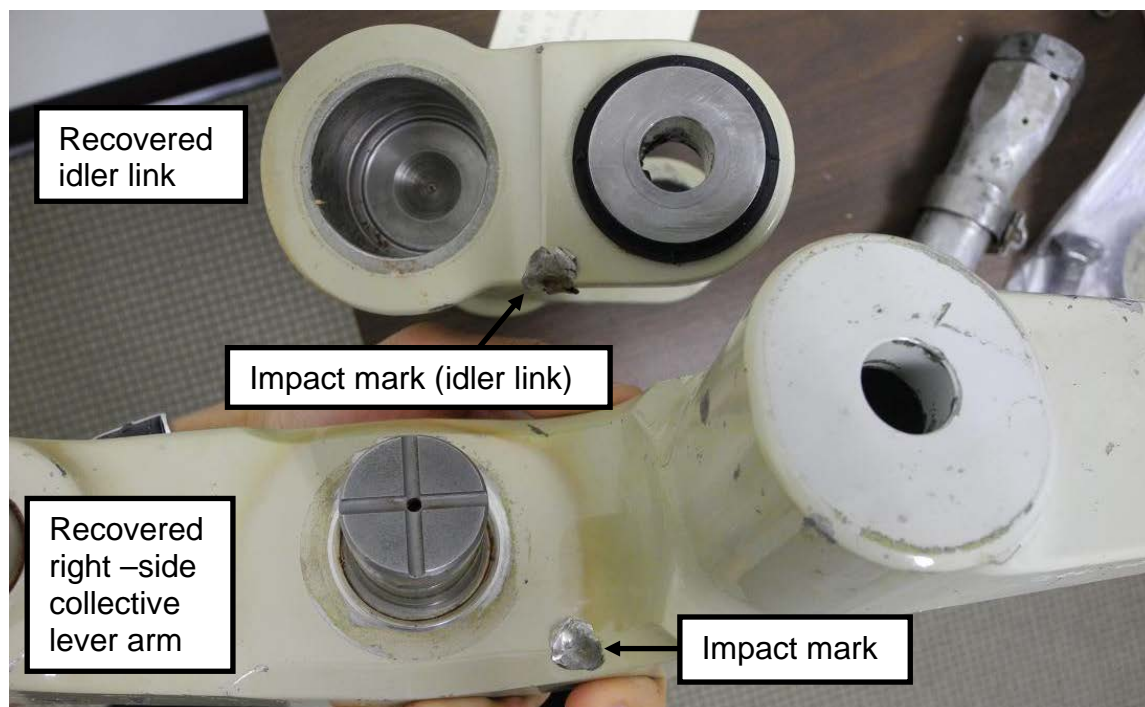
The right collective lever arm, idler link, and collective sleeve bearing assemblies were retained by the NTSB for further examination at the NTSB materials laboratory in Washington, DC. The lab examination of the two bolt holes for the bolts that secure the two lever arms together found evidence of circumferential wear consistent with rubbing by the adjacent washer when the collective lever arms are joined, but found no

indications of hole enlargement or longitudinal wear marks on the inside of bolt hole bores. The damage on the left side of the idler link was characterized as severe material smearing that mirrored damage found on the recovered collective lever arm. The fracture surfaces of the fractured rod end bolt exhibited signatures consistent with overstress failure. The left collective sleeve bearing possessed all of its rollers and was able to spin freely without binding. The right collective sleeve bearing cage was deformed and fractured, with 12 of 19 bearing roller elements missing. For complete details of the examination, see NTSB Materials Laboratory Report 13-031, dated July 17, 2013.

**Photo 18. Impact marks matched between the right-side of the idler link and the received collective lever arm (both parts have been cleaned).**

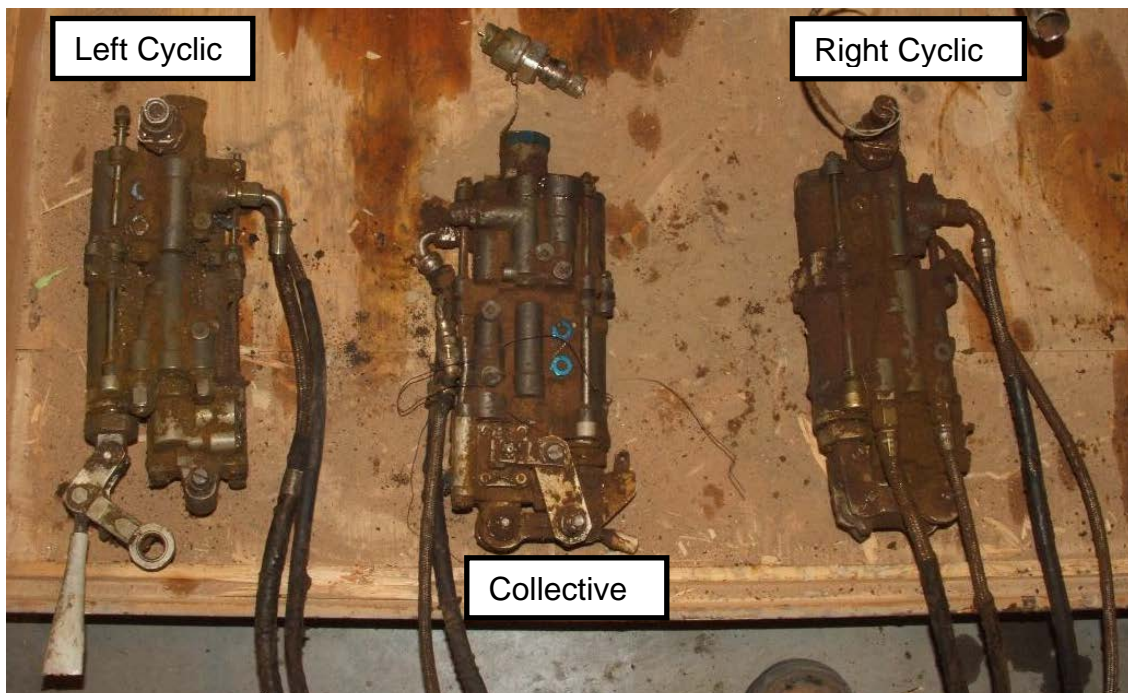
**Photo 19. The left cyclic (left), collective (center), and right cyclic (right) hydraulic actuator units.**

Disassembly of the right cyclic hydraulic actuator manifold revealed no discrepancies of its internal components. Examination and disassembly of the output piston revealed a bearing housing retainer mount with multiple fractures, with the fracture surfaces exhibiting signatures consistent with overstress failure. The working surfaces of the lower and upper output pistons exhibited wear typically seen due to time in service. Examination of the remainder of the damage observed on the output piston and actuator was consistent with impact damage.

Disassembly of the left cyclic hydraulic actuator manifold revealed the servo spools had fractured with signatures consistent with overstress failure; the remainder of the internal components revealed no discrepancies. Examination and disassembly of the output piston revealed the lower outer cylinder had fractured, with the fracture surfaces exhibiting signatures consistent with overstress failure. The working surfaces of the lower and upper output pistons exhibited wear typically seen due to time in service. Examination of the remainder of the damage observed on the output piston and actuator was consistent with impact damage.

Disassembly of the collective hydraulic actuator manifold revealed no discrepancies of its internal components. A fracture was observed on the bearing housing retainer mount, with the fracture surfaces exhibiting signatures consistent with overstress failure. The lower piston was bent about 14.7 inches from the bearing housing. The upper piston exhibited a fracture about 1.2 inches from the upper rod end's lower jam nut; the fracture surface revealed signatures consistent with overstress failure. Examination of the remainder of the damage observed on the output piston and actuator was consistent with impact damage.

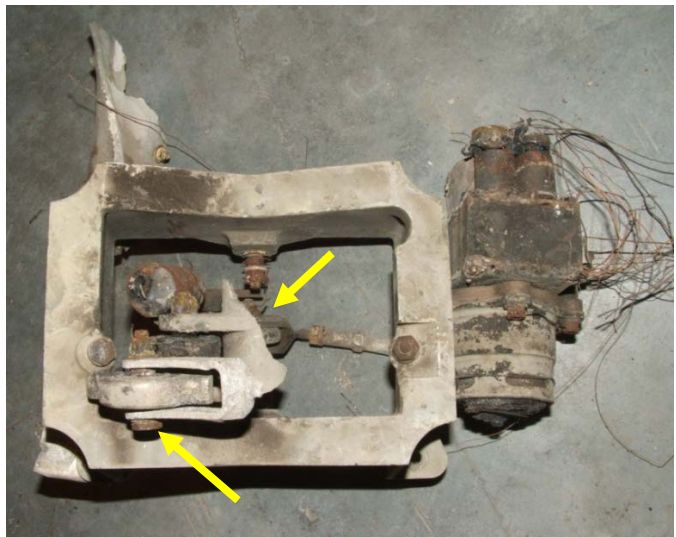
assembly's output control tube was found installed on the walking beam with the associated attachment hardware in place (**Photo 24**). The clevis connection for the SCAS assembly's input control tube was found attached to the SCAS idler (**Photo 24**). The other SCAS assembly was incomplete as recovered: the connecting rod between the drive and centering assembly and the walking beam was bent but intact with all attachment hardware in place (**Photo 25**). The clevis connection for the SCAS assembly's output control tube was attached to the walking beam with the associated attachment hardware in place (**Photo 26**). However, the idler had fractured and the section of the idler which was connected to the input control tube was not recovered. All fracture surfaces examined on both SCAS assemblies showed signatures of overstress failures with no evidence of fatigue fractures.

**Photo 26.** The clevis connection on the walking beam (lower arrow) from the incomplete SCAS assembly. The idler was observed to be fractured (upper arrow).

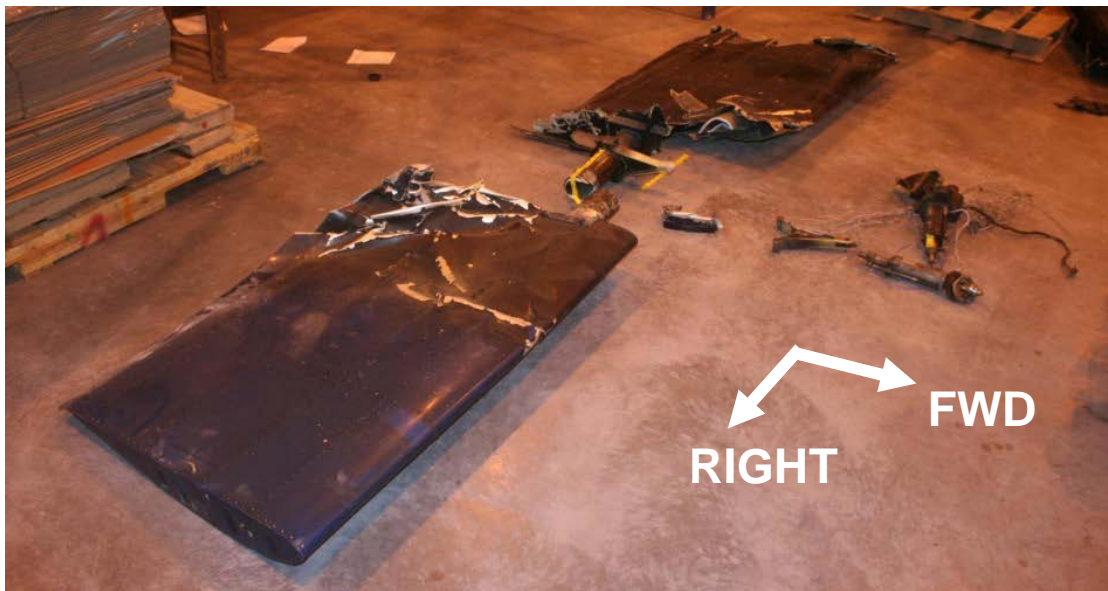
Both elevator flight control surfaces, both elevator electrical actuators, both elevator pitch horns, and the elevator spar were recovered from the accident site (**Photo 29**). The elevator spar had fractured at two locations, approximately 7 inches outboard to the left and right of the left elevator horn. A piece of the 'white' main rotor blade leading edge abrasion strip was found lodged in the left-side fracture of the elevator spar (**Photo 6**); the left elevator pitch horn and clamp was still attached to this spar section. The right elevator pitch horn was recovered in the wreckage debris and contained a portion of the rod end from the fractured elevator electrical actuator. All examined fracture surfaces exhibited signatures consistent with overstress failure. A section of the right elevator spar support with a stop fitting was retained for further examination at the NTSB materials laboratory in Washington, DC. The lab examination found evidence consistent with impact forces. For complete details of the lab findings, see NTSB Materials Laboratory Report 13-031, dated July 17, 2013.

**Photo 29. Recovered pieces of the elevator system.**

The right elevator's inboard aft corner was significantly bent upward and outboard in a near-45° angle with impact damage consistent with a main rotor blade contact. The remainder of the right elevator's surfaces remained wholly intact. The majority of the left elevator's inboard and outboard ends were separated at almost a 45° angle with signatures consistent with main rotor blade contact. All examined fracture surfaces exhibited features consistent with overstress failures with no evidence of fatigue.

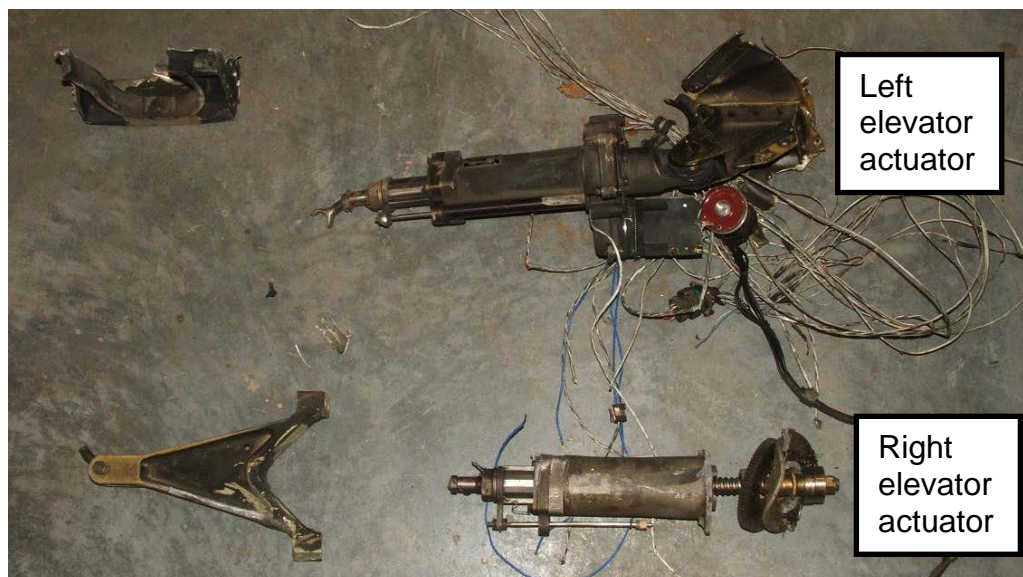
The left elevator electrical actuator was recovered mostly intact with only a fractured rod end (**Photo 30**). The right elevator electrical actuator was fractured and missing its control unit (linear transducer), servomotor, tailboom support mounting flanges, and elevator horn-side rod end. The left and right elevator electrical actuators were sent to BHT for further examination. The findings of this examination are located in section 5.2 of this report.

**Photo 30. Left (top) and right (bottom) elevator electrical actuators.**

The fracture surfaces of the right elevator electrical actuator exhibited signatures consistent with overstress failure. The right elevator electrical actuator's ball screw assembly was no longer held in place and could be moved inside its housing. The right elevator electrical actuator was sent to BHT facilities in Fort Worth, TX for further examination, but no additional information could be gathered from the recovered components.

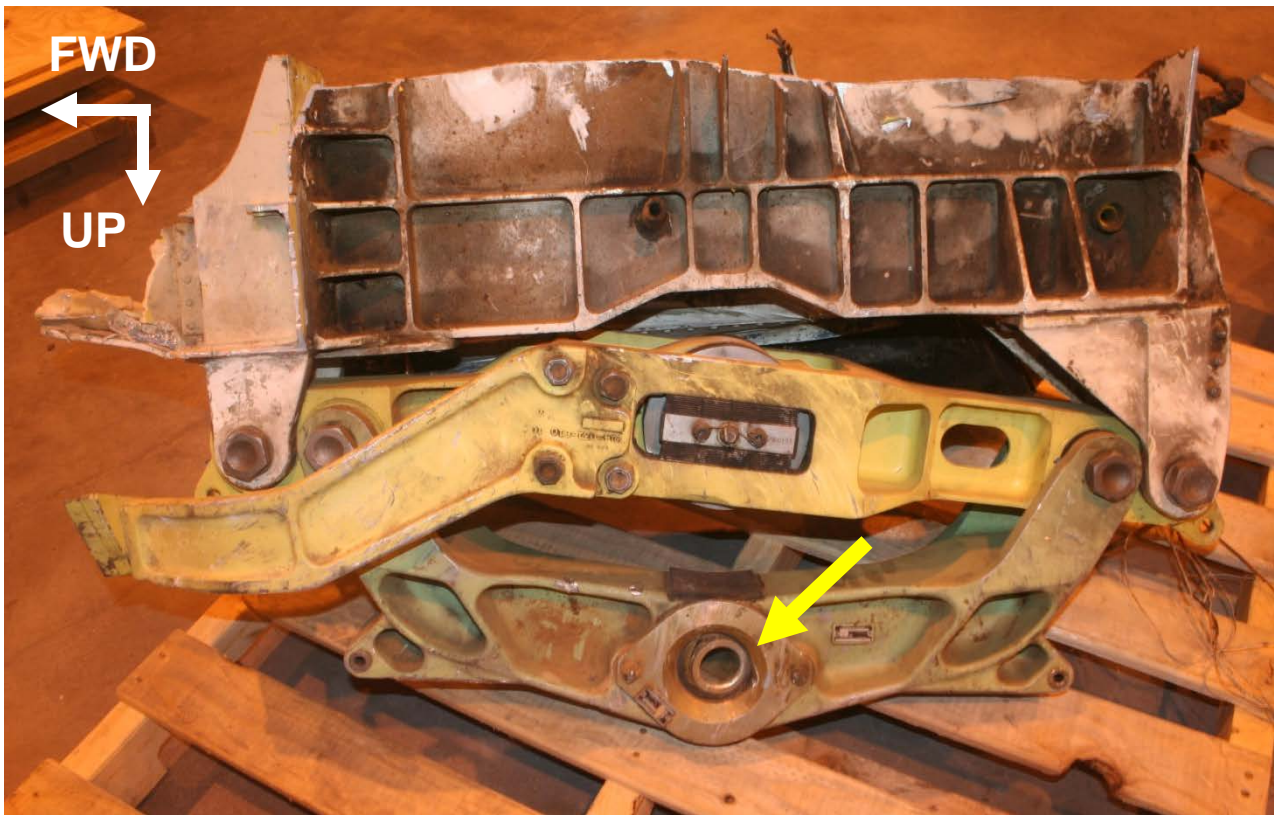
Both left and right transmission nodal beam support assemblies were recovered from the accident site. A portion of the transmission pylon was still attached to each nodal beam support, with the fracture surfaces on the remnant transmission pylon exhibiting signatures consistent with overstress failure. The spherical bearing in the left nodal beam in which the spindle is installed was observed to be biased in the aft direction, with a gouge seen in the bearing support in the aft direction (**Photo 32**). The

**Photo 32. Left nodal beam support assembly for the main transmission. The arrow points to the spherical bearing with the aft-ward bias as recovered.**

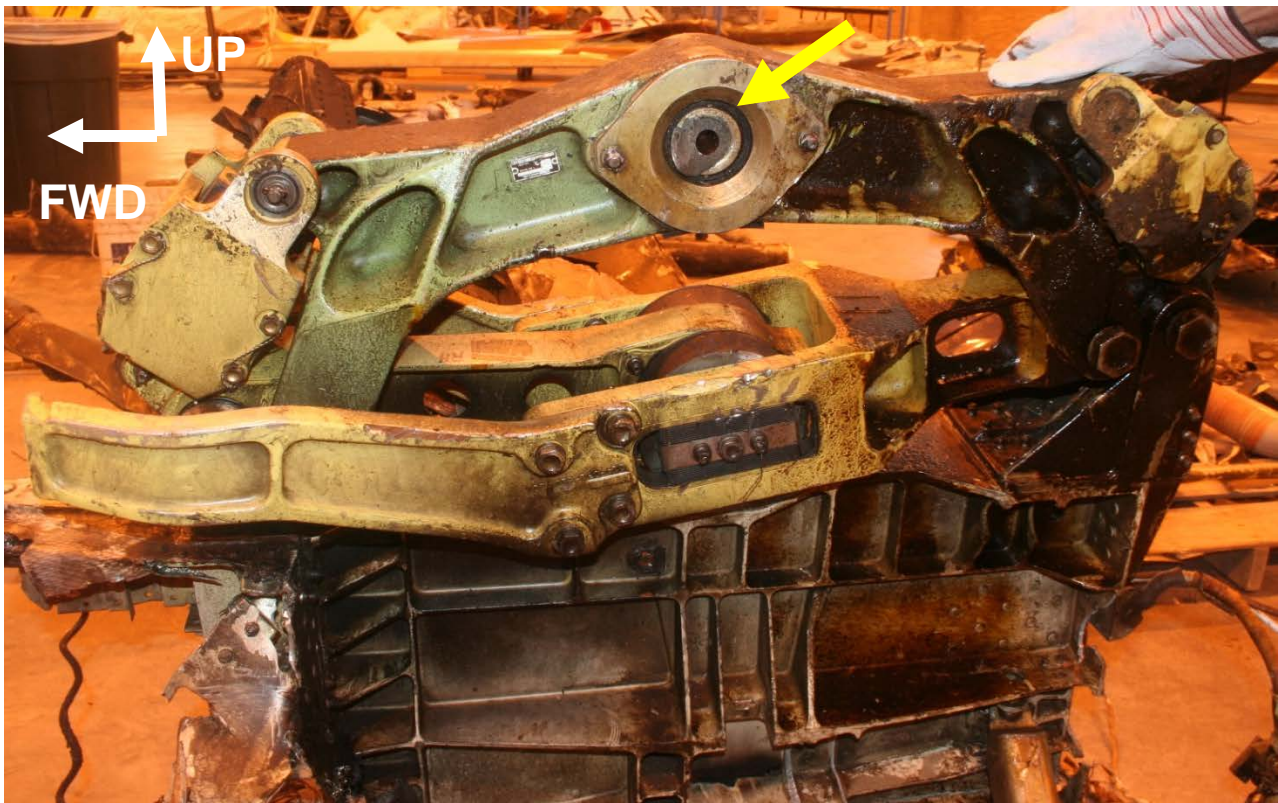
right nodal beam spherical bearing still contained a fractured portion of the transmission mounting spindle (**Photo 33**). Examination of the right transmission mounting spindle still installed on the main transmission revealed the fracture surface to mirror that of the piece found in the right nodal beam (**Photo 34**). Both fracture surfaces exhibited signatures consistent with overstress failure. The retaining hardware for the right spindle was found in place in the right nodal beam. The left transmission mounting spindle remained installed and intact on the main transmission (**Photo 35**). The retaining hardware for the left spindle was located in the wreckage and retained by the NTSB for further examination at the NTSB materials laboratory in Washington, DC. Lab examination found the damage to the hardware was consistent with the bolt being pulled outward while the threads were still engaged. For complete details of the lab findings, see NTSB Materials Laboratory Report 13-031, dated July 17, 2013.

**Photo 33. Right nodal beam support assembly for the main transmission. The arrow points to the fractured portion of the transmission mounting spindle found within the spherical bearing.**

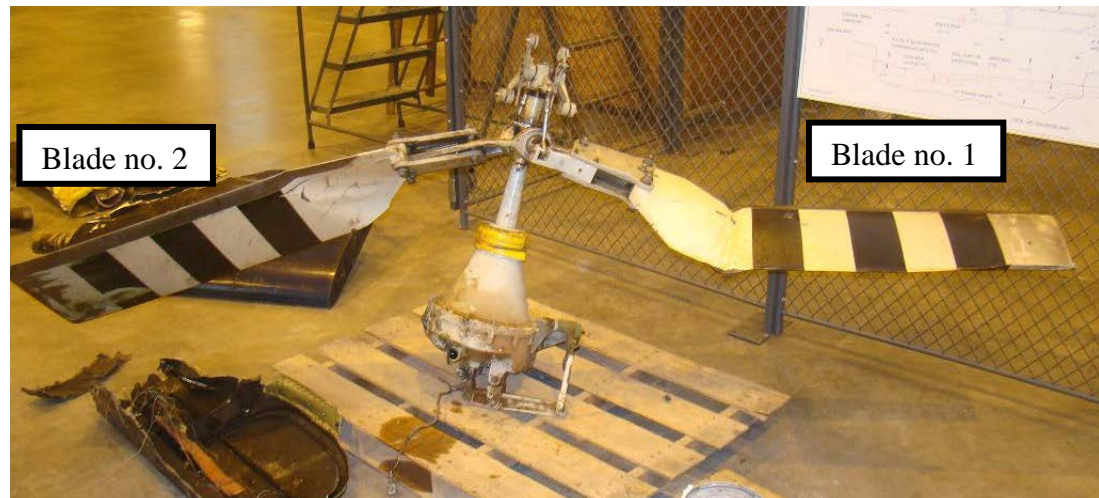
The majority of the tail rotor hub and blades remained intact and attached to the tail rotor gearbox (**Photo 38**). Blade no. 1<sup>8</sup> was bent about its chord approximately 10 inches from where the blade attaches to the plate assembly. Blade no. 2 was partially fractured along the chordwise direction approximately 10 inches from where the blade attaches to the plate assembly. The fracture extended forward approximately 11 inches from the trailing edge.

**Photo 38. Tail rotor gearbox with tail rotor blades installed.**

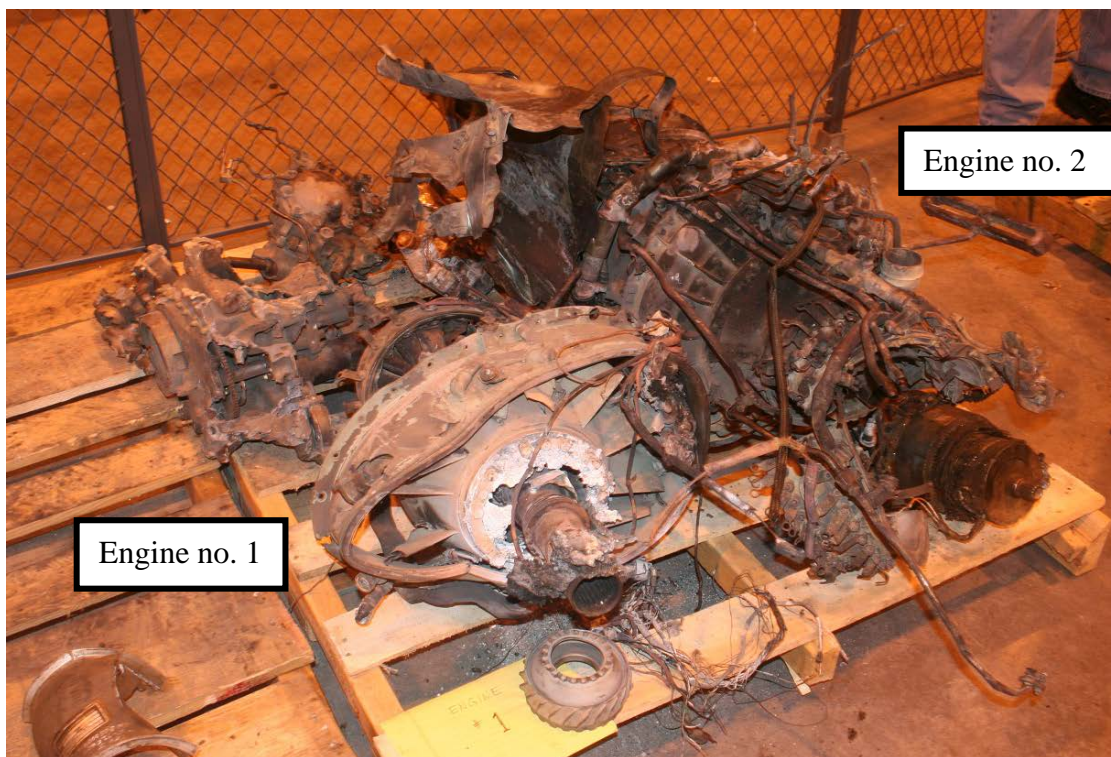
Both engines were recovered from the accident site and had sustained severe fire damage, particularly to the mainframe, electronic control unit (ECU), and accessory gearbox (AGB), all of which are located on the forward end of the engine (**Photo 41**). The no. 1 engine exhibited significant impact damage to the swirl frame at the front of the engine and the turbine casing and exhaust frame at the aft of the engine. Both engines had separated where the mainframe aft flange mates with the compressor casting forward flange, allowing visual inspection of the compressor. Additionally, some of the blisks<sup>9</sup> were found loose in the wreckage debris. The blades of both engines' stage 1 blisks exhibited damage in the form of large nicks, cuts, and tip bending in the direction opposite of normal rotation. The blades of both engines' stage 2 blisks were all separated at their root; these blades were not recovered from the accident site. The majority of the remaining blades of both engines' stage 3 and 4 blisks were bent over in the direction opposite of normal rotation. Many of the remaining compressor stator vanes in both engines were observed to be bent over in the direction of normal rotation. Of the stage 4 power turbine blades that were visible in both engines, all observed blades were separated at the blade root; these blades were not recovered from the accident site. The hydromechanical [fuel control] unit (HMU) of each engine had separated from the AGB, and the variable geometry (VG) actuation system that connects the HMU to the variable compressor stator vanes was destroyed.

**Photo 41. Components from both engines recovered from the accident site.**
