**NATIONAL TRANSPORTATION SAFETY BOARD**  
**Office of Aviation Safety**  
**Washington, D.C. 20594**

**Airworthiness Group Chairman's Factual Report**

**NTSB No: DCA12FA024**

Operator: AAR Airlift Corporation  
Aircraft: Bell 214ST, Registration Number N5748M  
Location: 7 miles south of Camp Bastion, Helmund Province, Afghanistan  
Date: January 16, 2012  
Time: 1045 local time<sup>1</sup> (0615 coordinated universal time)

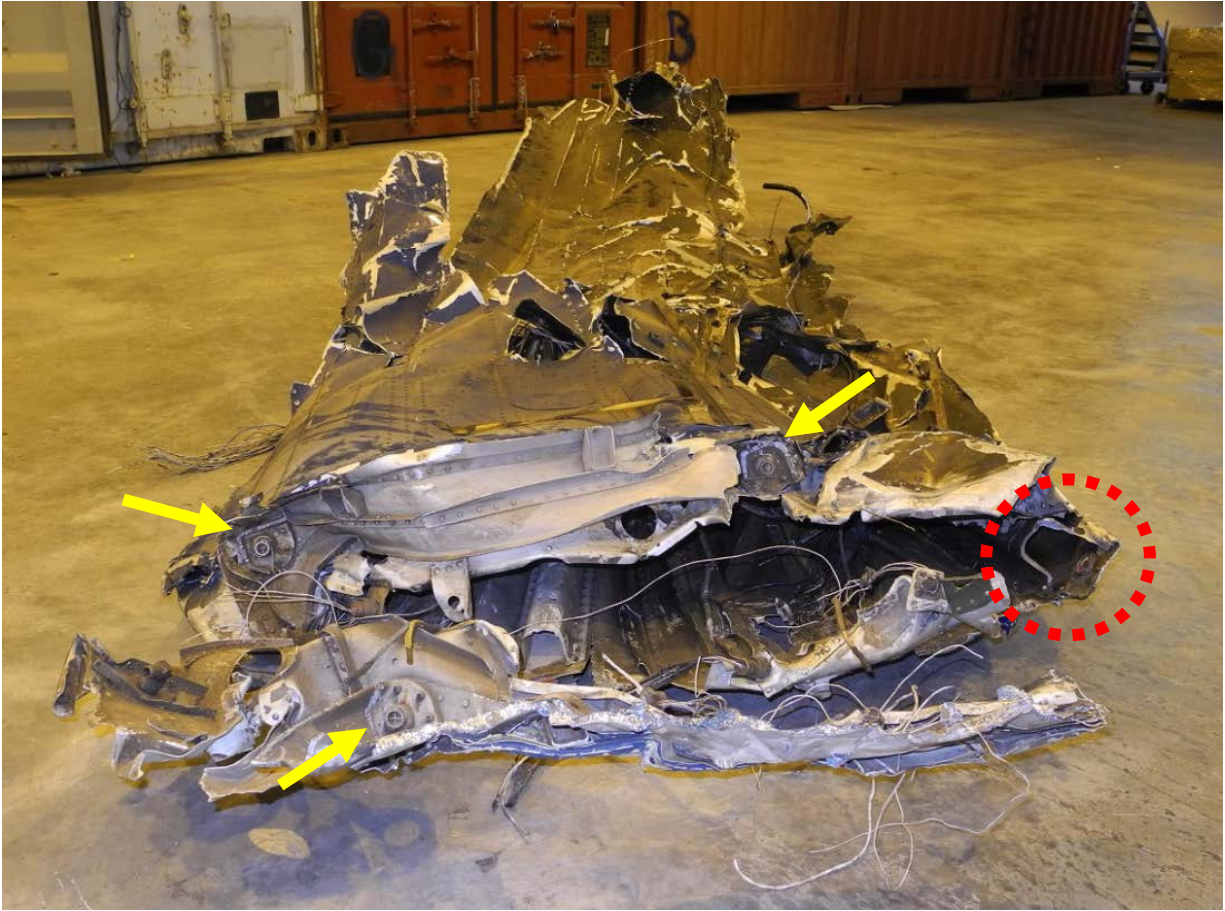
Members of the Airworthiness Group convened at the NTSB Training Center on September 30, 2013 to re-examine the tailboom wreckage. The focus of the examination was to verify the damage to the tailboom attachment fittings. Of the four tailboom attachment fittings, three (upper-right, lower-left, and lower-right) remained attached to the tailboom and were fractured forward of the attachment point (**Photo 42**). The three attachment fittings still contained their respective attaching hardware. The fourth

(upper-left) attachment fitting had fractured aft of the attachment point. All examined fitting fracture surfaces exhibited features consistent with failure from overstress.

**Photo 42. Three of the four tailboom attachment fittings with attaching hardware present (yellow arrows) and the fractured fourth attachment point (red circle).**
