NATIONAL TRANSPORTATION SAFETY BOARD

AIRWORTHINES GROUP CHAIRMAN'S FACTUAL REPORT

NTSB Accident Number: DCA07MA003
Location: Manhattan, New York
Date: October 11, 2006
Time of Accident: Approximately 1442 Eastern Daylight Time
Aircraft: Cirrus SR20

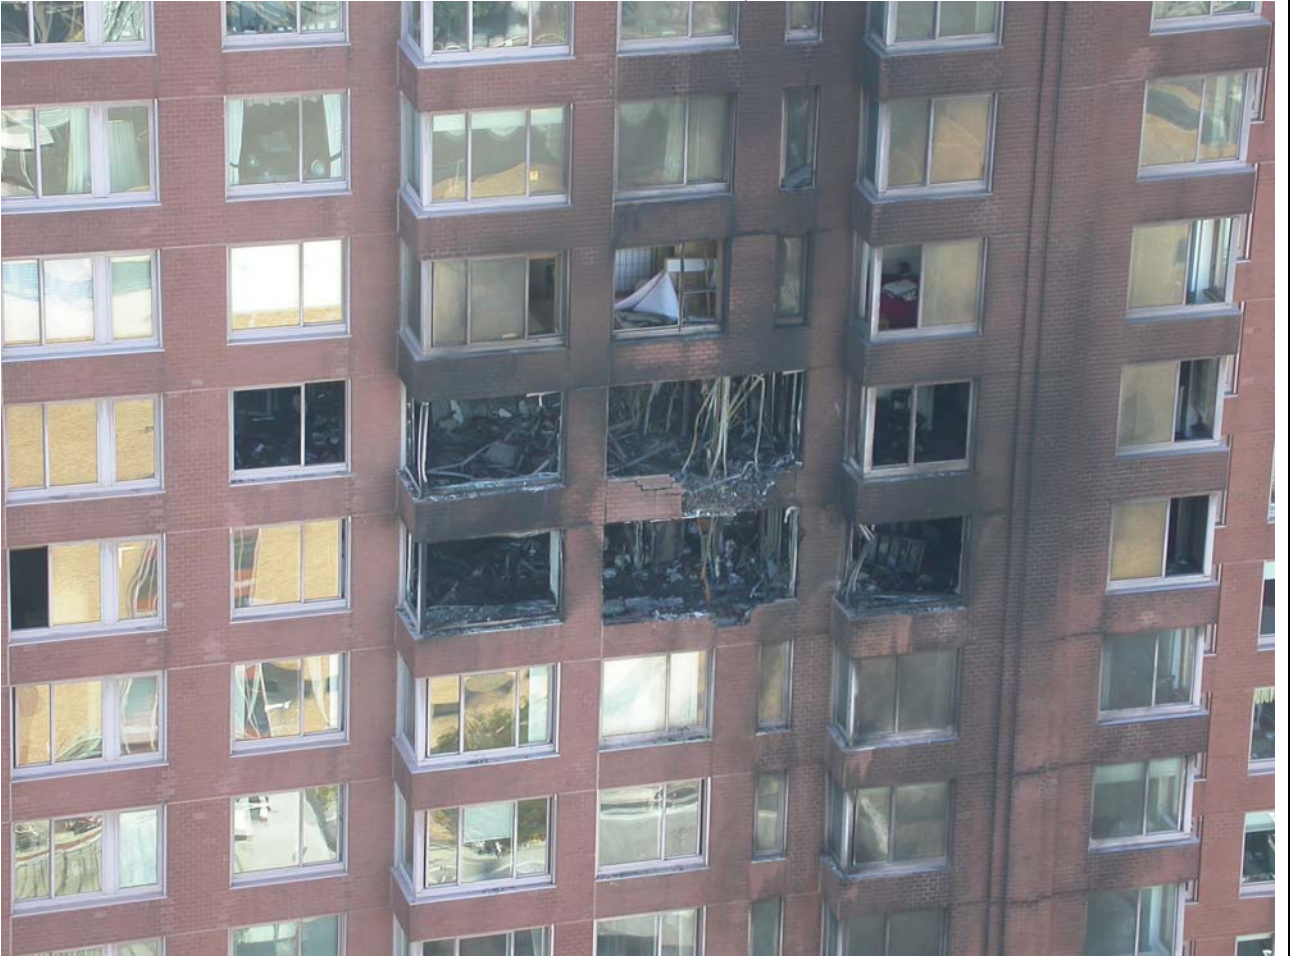
Figure 3

Airplane N929CD impacted into the vicinity of the 32nd and 33rd floor (**Figure 2**, and **Figure 3**) of the North face of the Belaire Condominiums located at 524 East 72nd Street¹. See attachment 1 for a diagram of the building. The airplane's engine, propeller, right portion of the engine mount and the nose landing gear strut (without wheel assembly) came to rest inside apartment 40 A/B/G² (32nd floor) (**Figure 4**).

View of the 32nd and 33 floor on the North face of the Beldaire Condominiums located at 524 East 72nd Street Manhattan, New York.

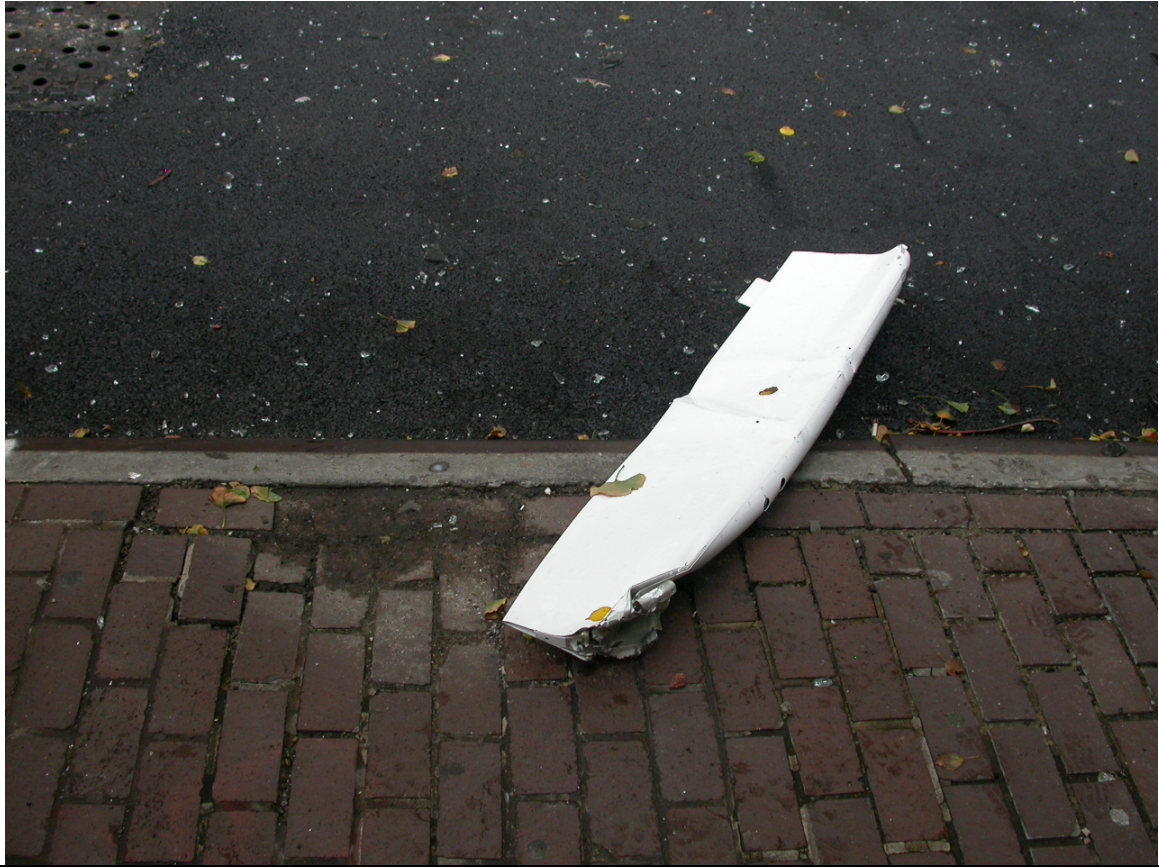
Figure 8

The right aileron was located on the street approximately 90 feet at 355 degrees from the main wreckage (**Figure 8**). An examination of the aileron revealed that it exhibited buckling and mechanical damage. The right aileron actuation pulley was located within the main debris field. The right aileron actuation rotated freely. It remained attached to a portion of the right aft sheer web. The attachment hardware, cable ball swage, and ball swage safety remained in place.

Aircraft N929CD right aileron

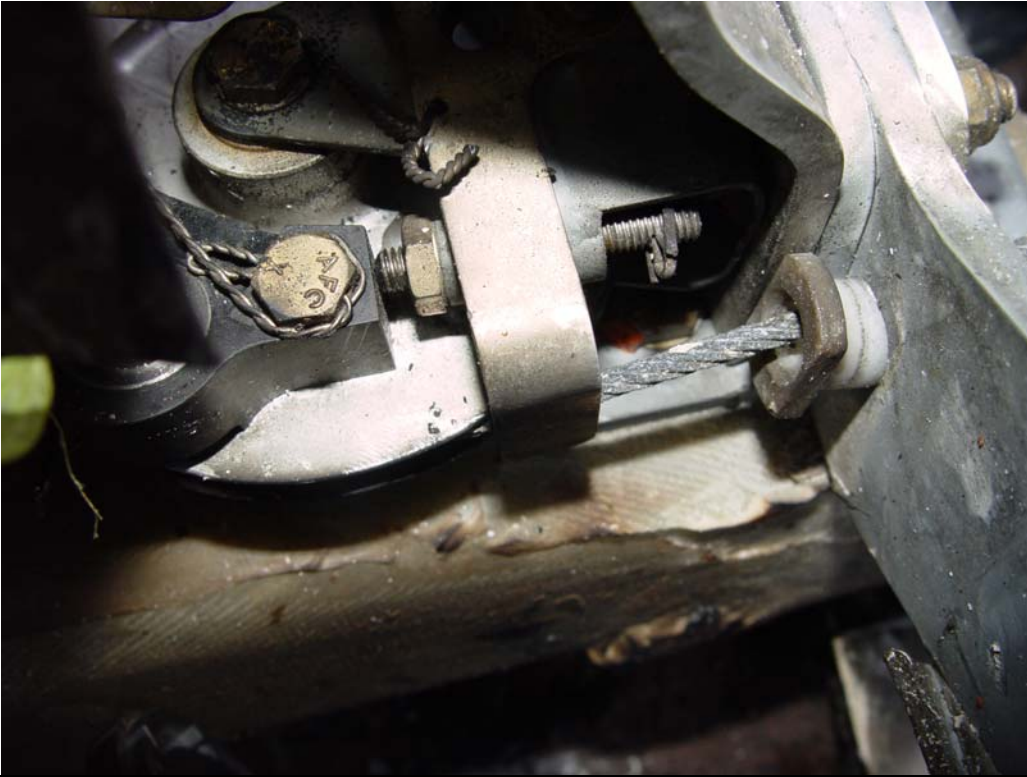
Figure 9

The left aileron was located on the sidewalk within the main debris field. The left aileron remained attached to the inboard hinge. The left aileron actuation arm remained engaged to the actuation pulley. The left aileron actuation pulley's bearing block was located against its lower aileron stop (**Figure 9**, and **Figure 10**). The roll trim cartridge and roll trim motor remained attached to aileron actuation pulley (**Figure 11**, and **Figure 12**).

Aircraft N929CD - Left aileron showing position of actuation pulley

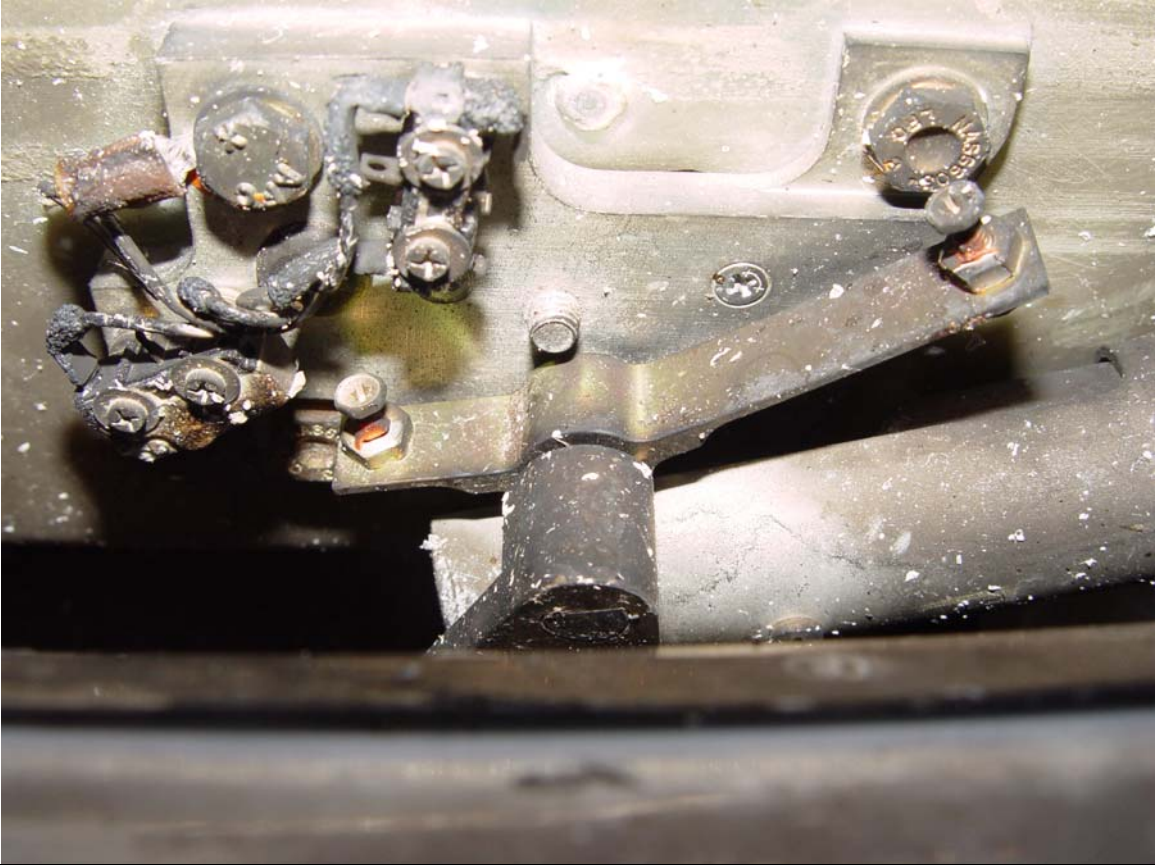
Figure 11

Aircraft N929CD - Left aileron showing position of roll trim motor

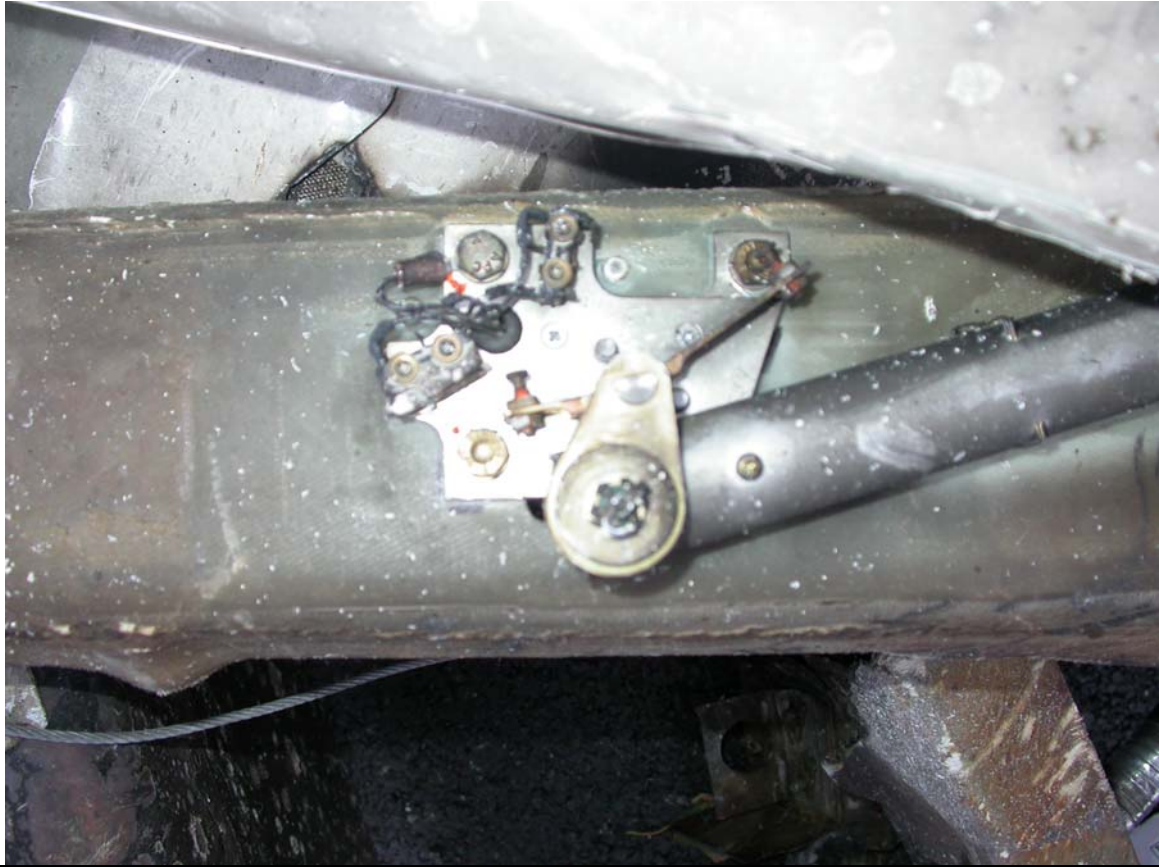
Figure 12

Aircraft N929CD - Left Aileron showing position of roll trim motor

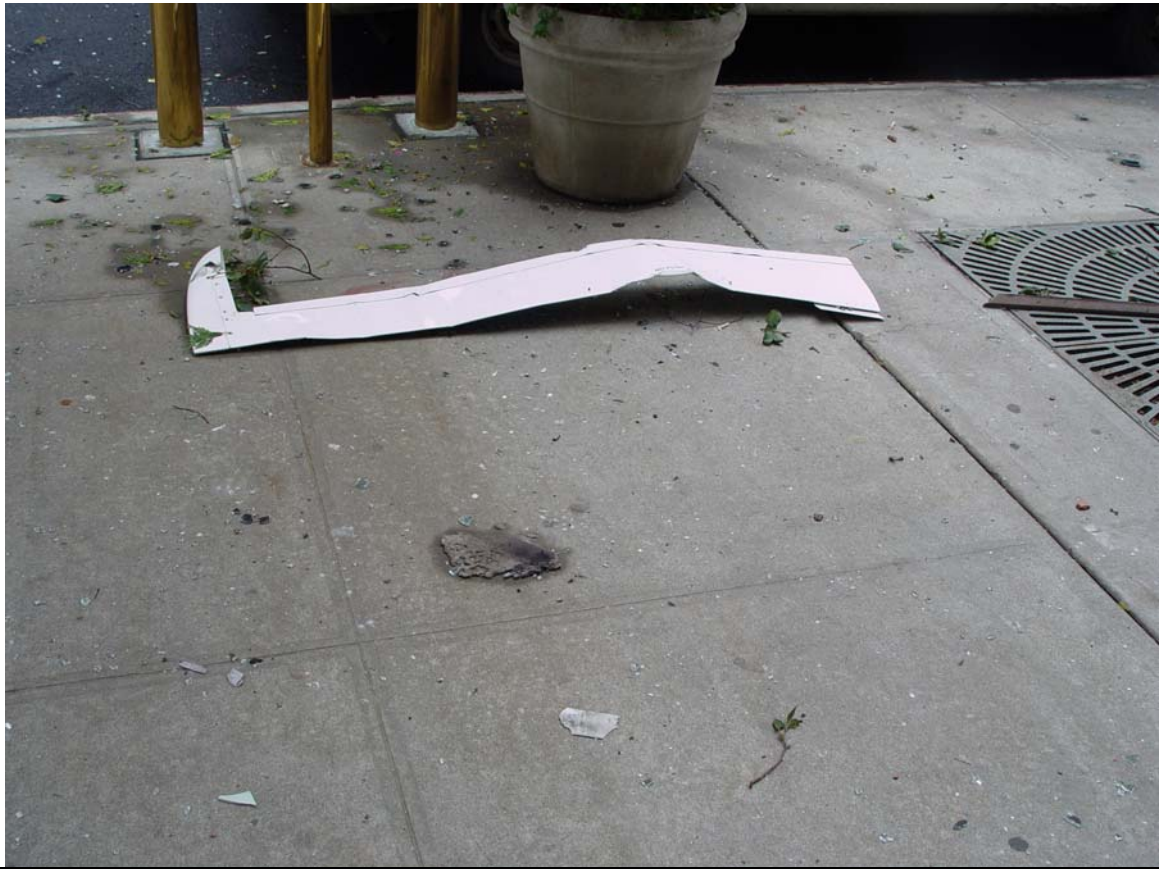
The left elevator was located on the sidewalk approximately 100 feet to the west of the main wreckage; it exhibited mechanical damage ([Figure 15](#)). The right elevator was located within the main debris field; it exhibited thermal and mechanical damage. The outboard section of the right elevator, approximately 2-feet in length, remained attached to the horizontal stabilizer, which was mostly consumed in the post crash fire.

Figure 15
Aircraft N929CD left elevator

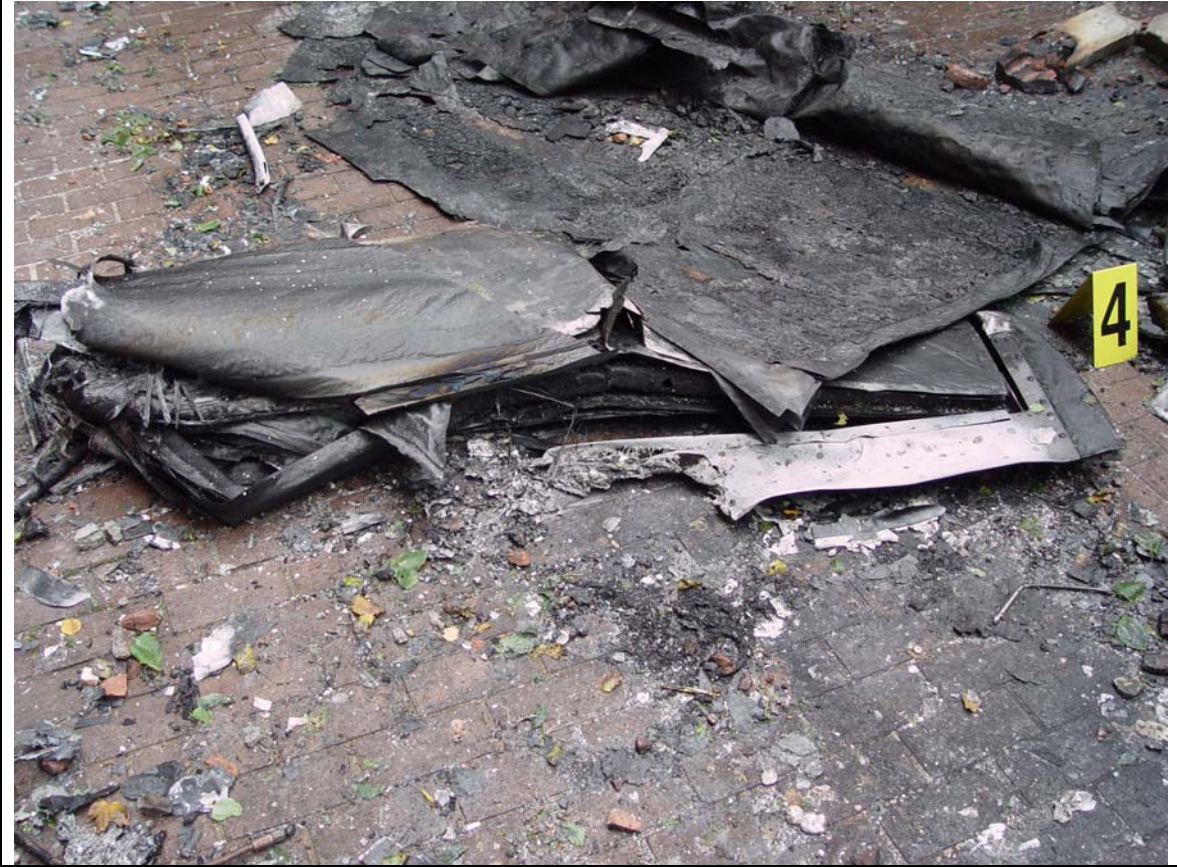
Figure 16
Aircraft N929CD right elevator

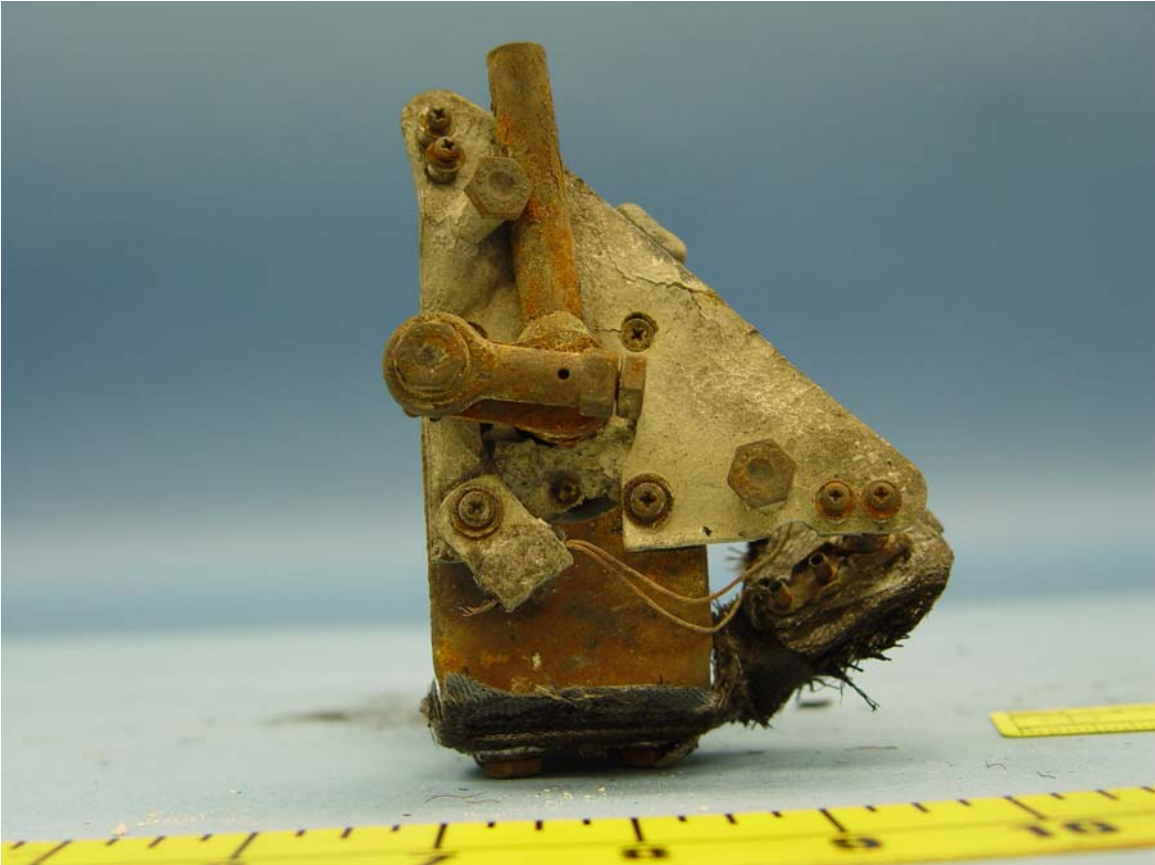
Figure 17

The pitch trim cartridge was not located. The fractured pitch trim rod end remained attached to the pitch trim motor. The pitch-trim motor was found within the main wreckage separated from the pitch trim cartridge and surrounding structure. The pitch trim motor was removed from the wreckage and sent to the National Transportation Safety Board (NTSB) Materials Laboratory for an exterior visual examination. The examination indicated that the position of the actuation arm was positioned approximately full up. (Figure 17). The position of the actuation arm was documented and compared to an exemplar pitch-trim electric trim motor (Figure 18) and then provided to Cirrus Design for further analysis.

Pitch Trim Motor removed from airplane N929CD and photographed at the National Transportation Safety Board.

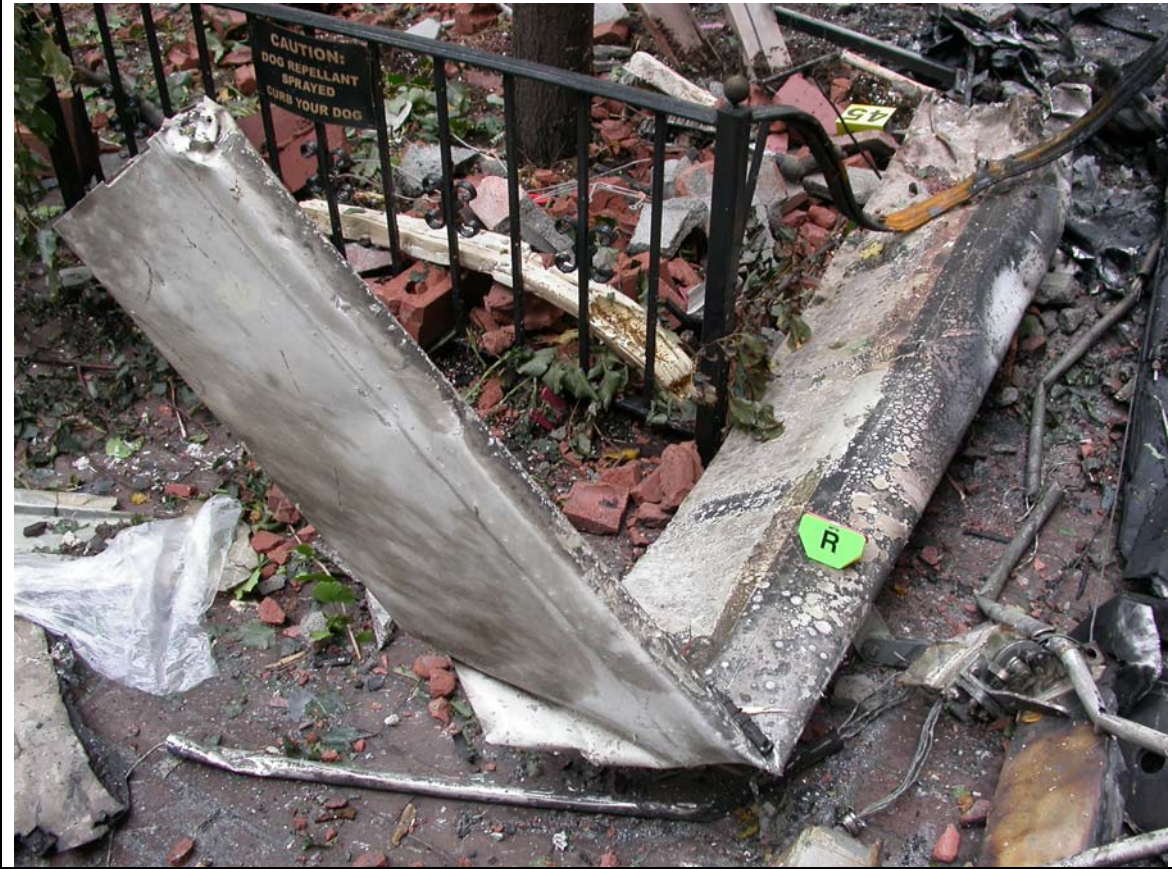
Figure 22

The left flap was located within the main wreckage debris field; it exhibited mechanical damage. The right flap was located within the main wreckage debris field. The right flap exhibited leading edge impact damage. The right flap was buckled upward approximately 90 degrees, at a point 3-feet in from the outboard end (Figure 22).

Aircraft N929CD View of right flap

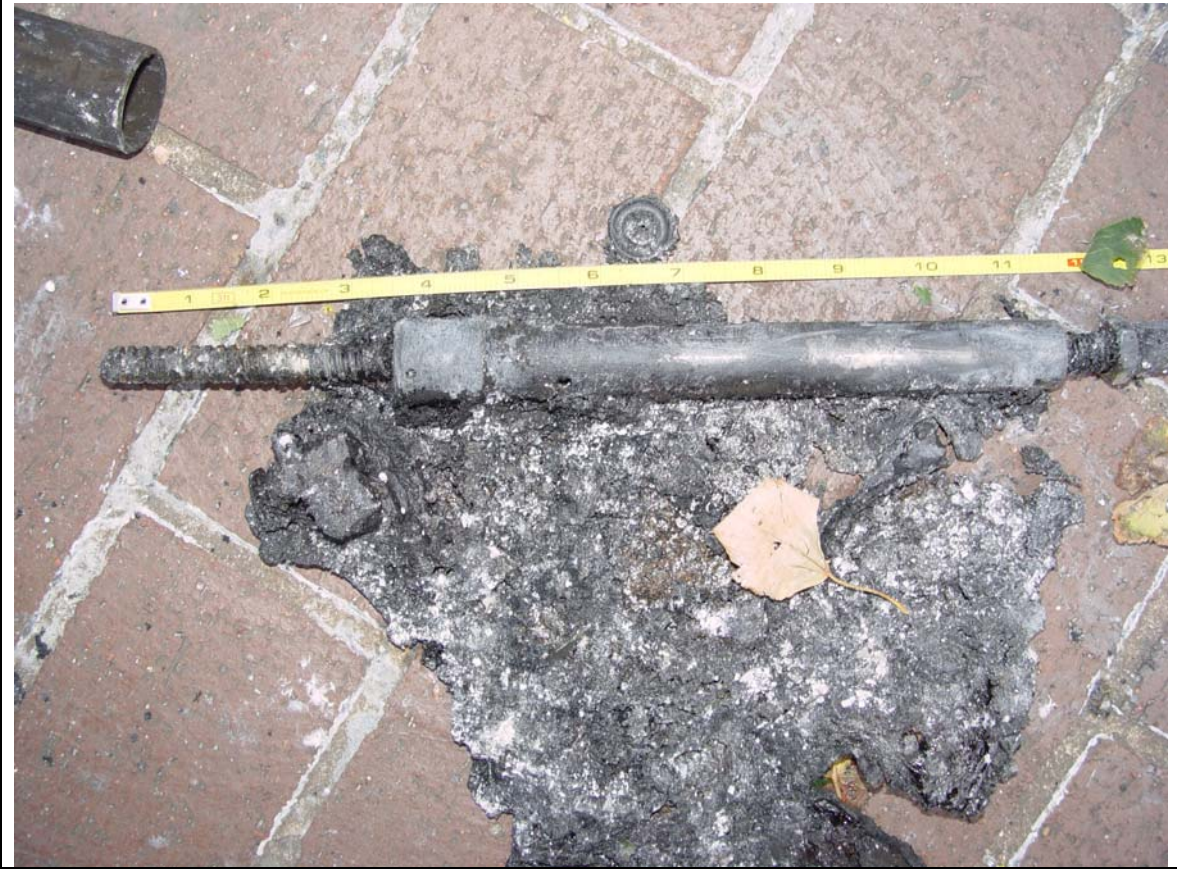
Figure 23

The linear flap actuator was located within the main wreckage debris field. The actuator was found separated into three sections (Figure 23). These sections were removed from the main wreckage and placed on a piece of paper, aligned and

Linear flap actuator as found at the accident site

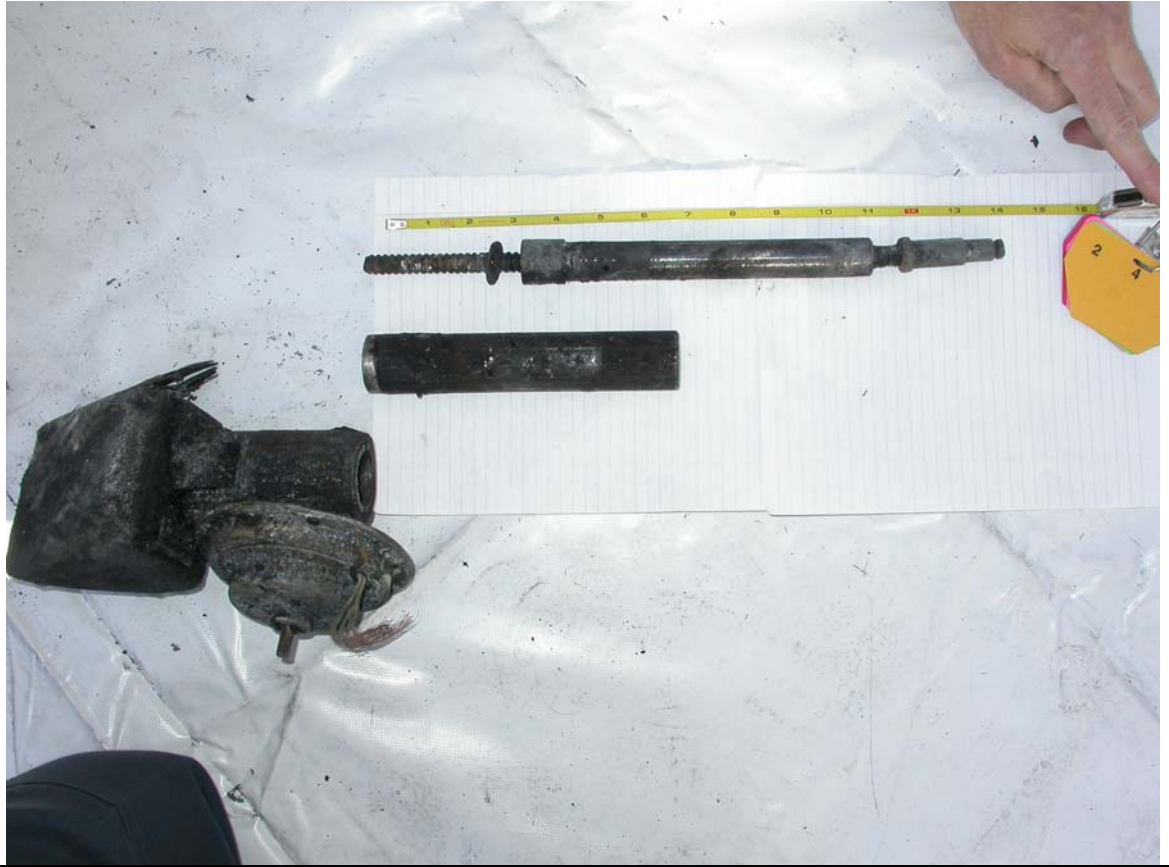
Figure 24

photographed (**Figure 24**). An examination of the three pieces revealed that the actuator position was consistent with the flaps at the zero or “full up” position.

Three sections of the linear flap actuator placed adjacent to each other at the accident site.

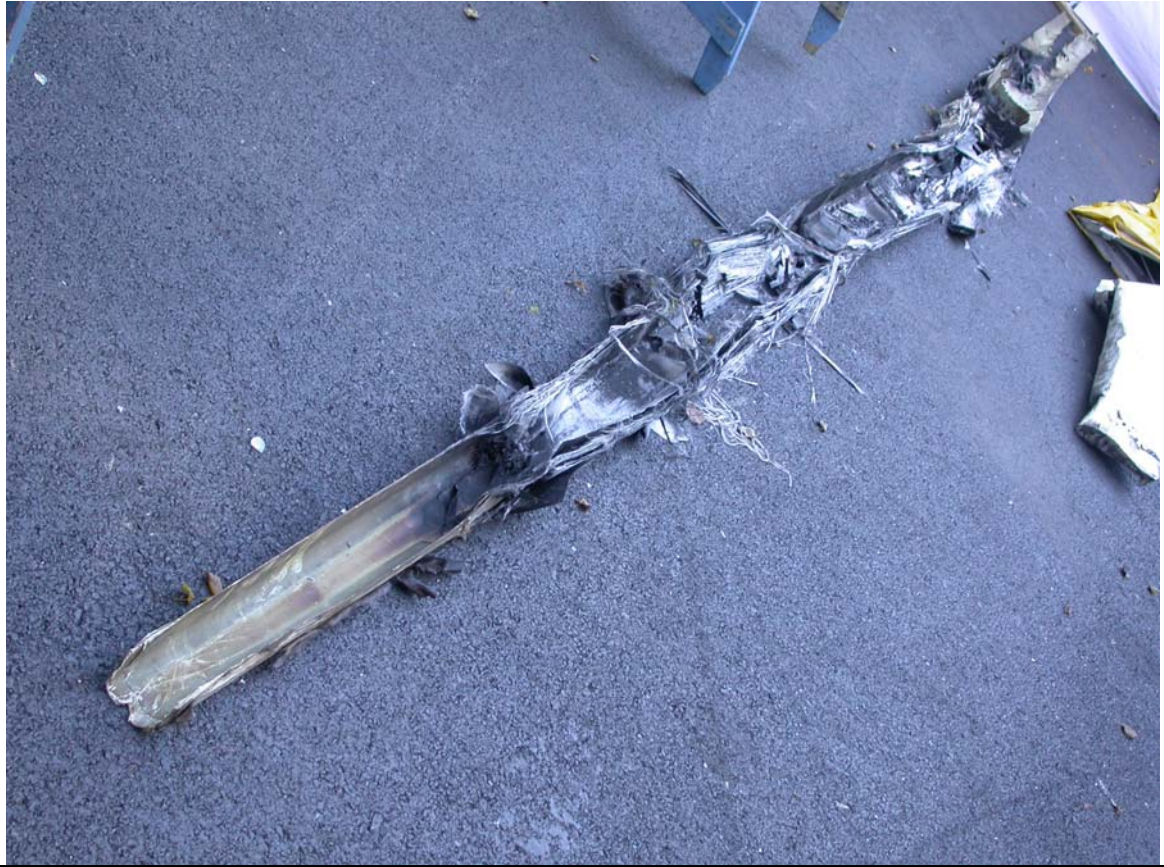
The main wing spar was located within the main debris field on the sidewalk (**Figure 25**). The wing spar was removed from the wreckage and placed in the street for examination (**Figure 26**). A visual examination revealed that the spar face was fractured from the right tip, inboard approximately 9 feet (**Figure 27**). The right tip of the spar was not thermally damaged. The center section and the left wing side of the spar were thermally damaged but remained intact.

Figure 26
Wing Spar in street

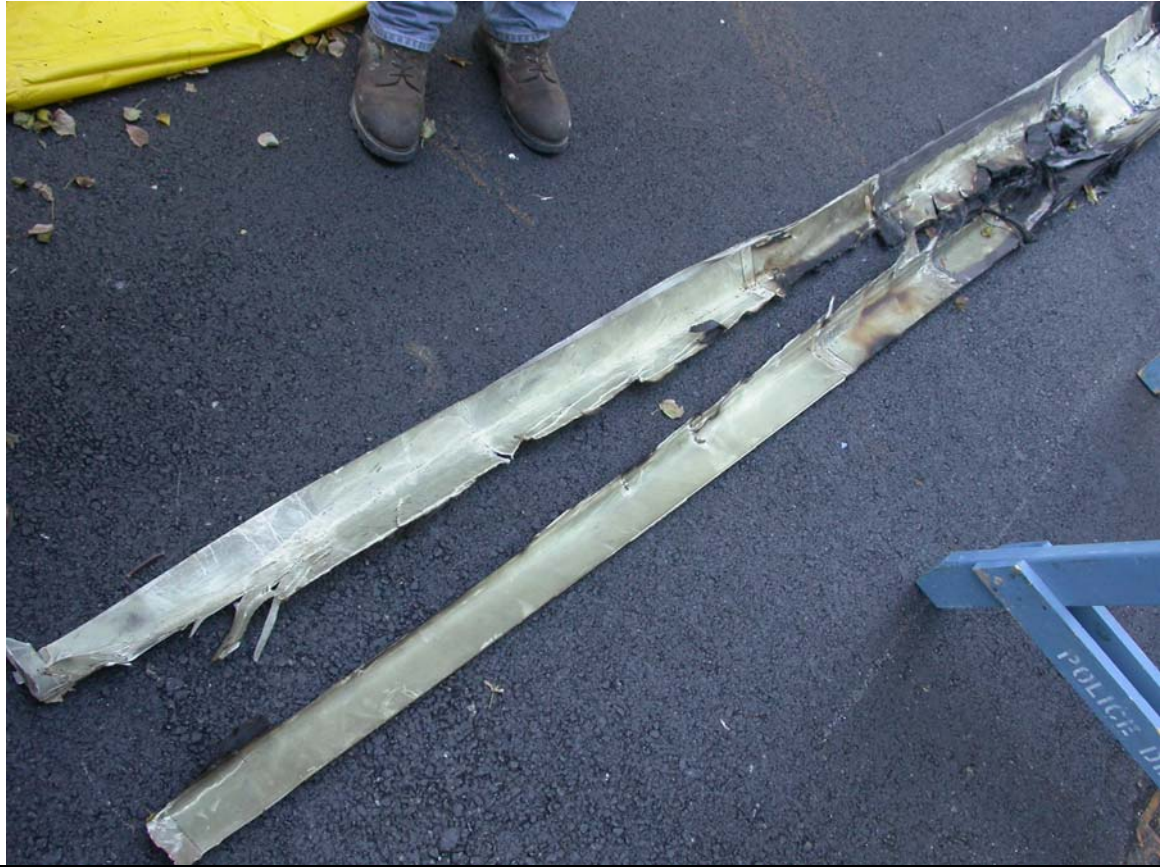
Figure 27

Photograph of Wing Spar showing split

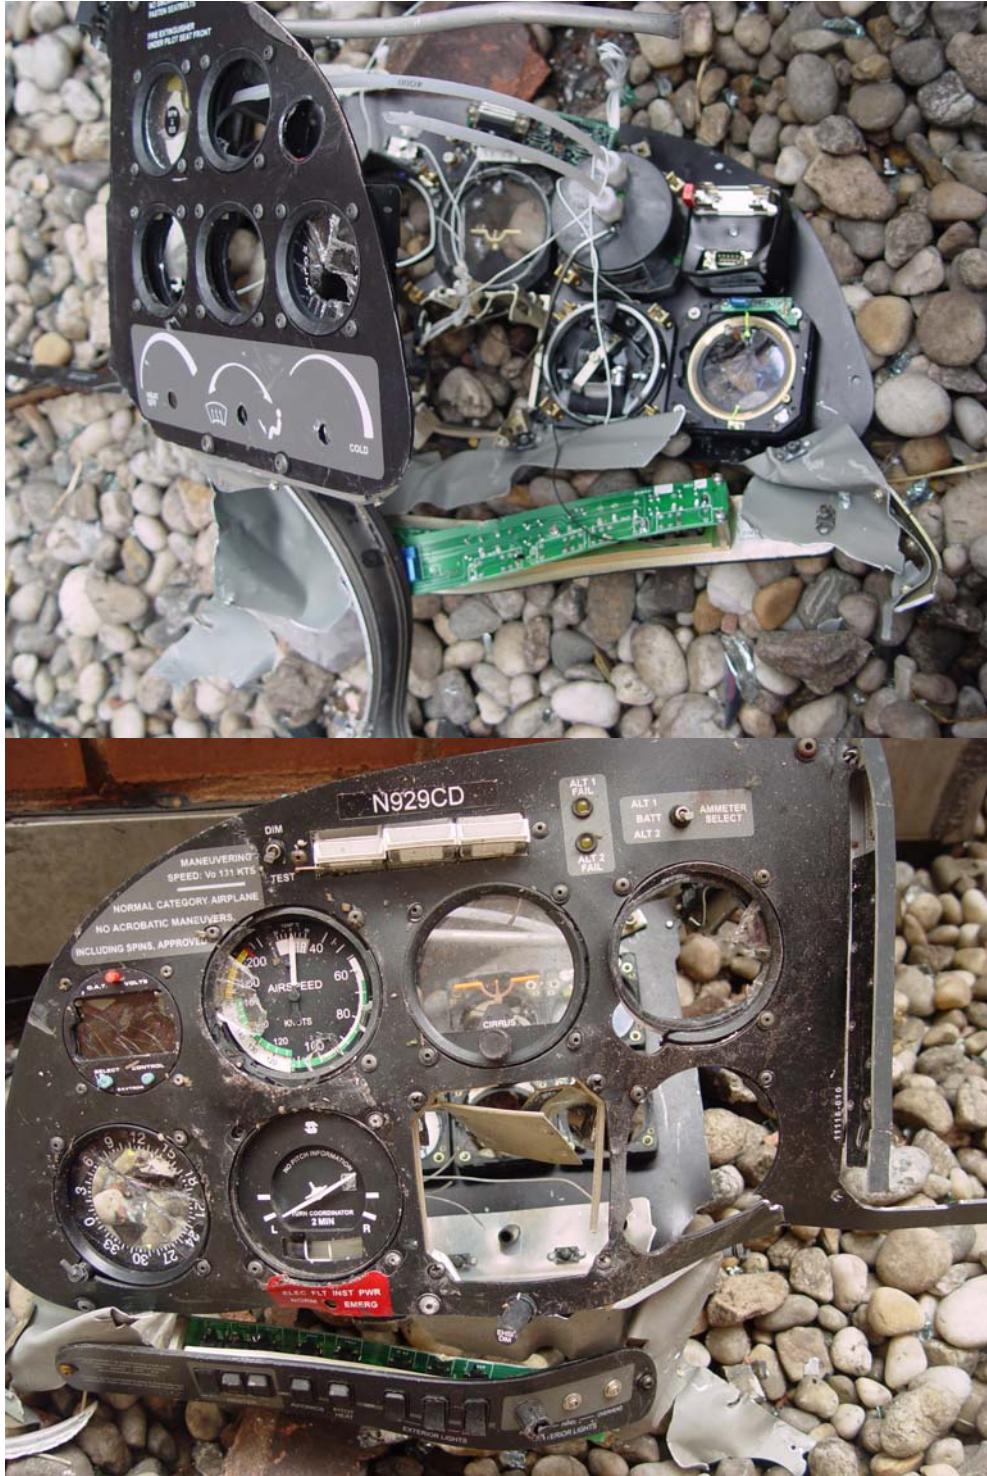
The multifunction display, all the right side indicators were separated from the panel. The only instruments that remained in the panel were the airspeed indicator, turn rate coordinator, and the HSI. The faceplate of the turn coordinator remained in the display panel and indicated approximately one (1) needle width past a standard rate left turn. The HSI/RMI navigational display was found

mechanically damaged; its faceplate was missing and was not located. The unit exhibited impact damage. (Figure 30)

Figure 30
Aircraft N929CD instrument panel

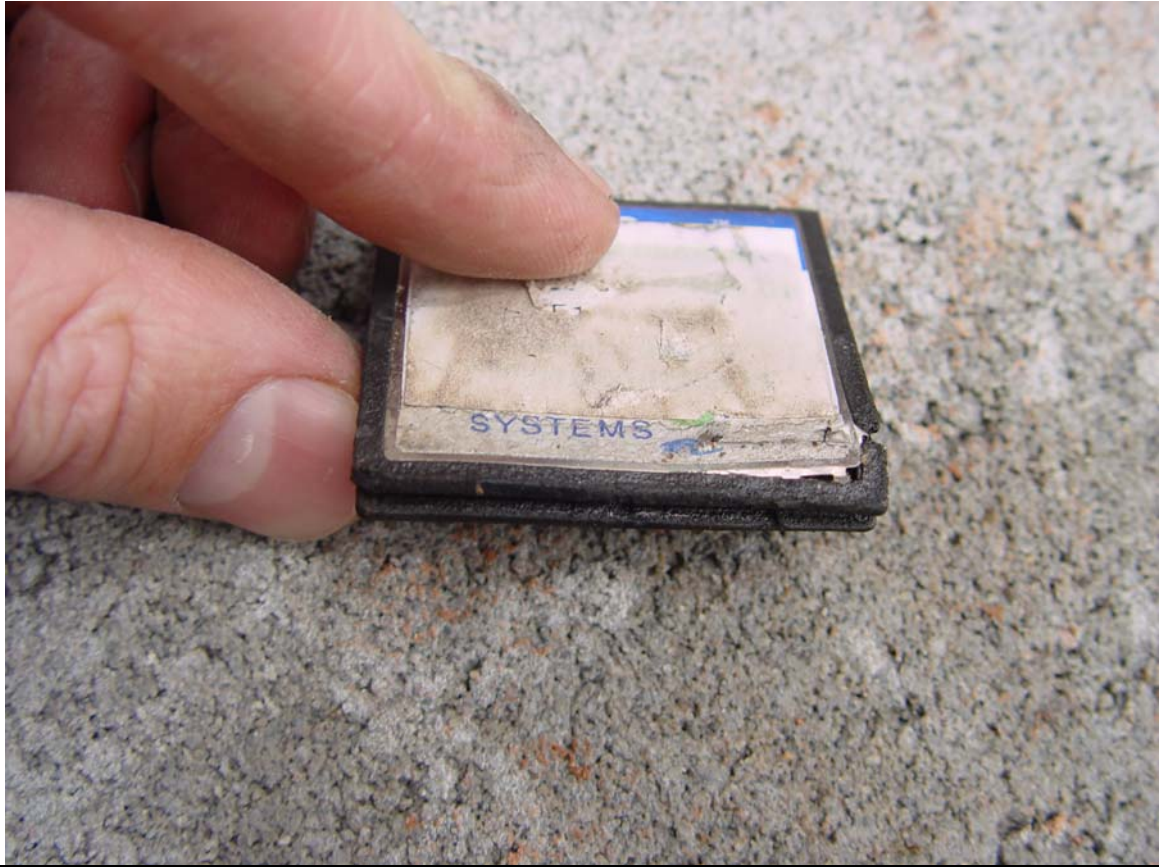
Figure 31

The multifunction display (MFD) was located resting on the third floor terrace; it exhibited mechanical damage. The flash memory module was located inside the case, but separated from its port (Figure 31). The module exhibited mechanical and thermal damage. It was removed from the accident site and shipped to the NTSB for examination.

Flash Memory module from MFD

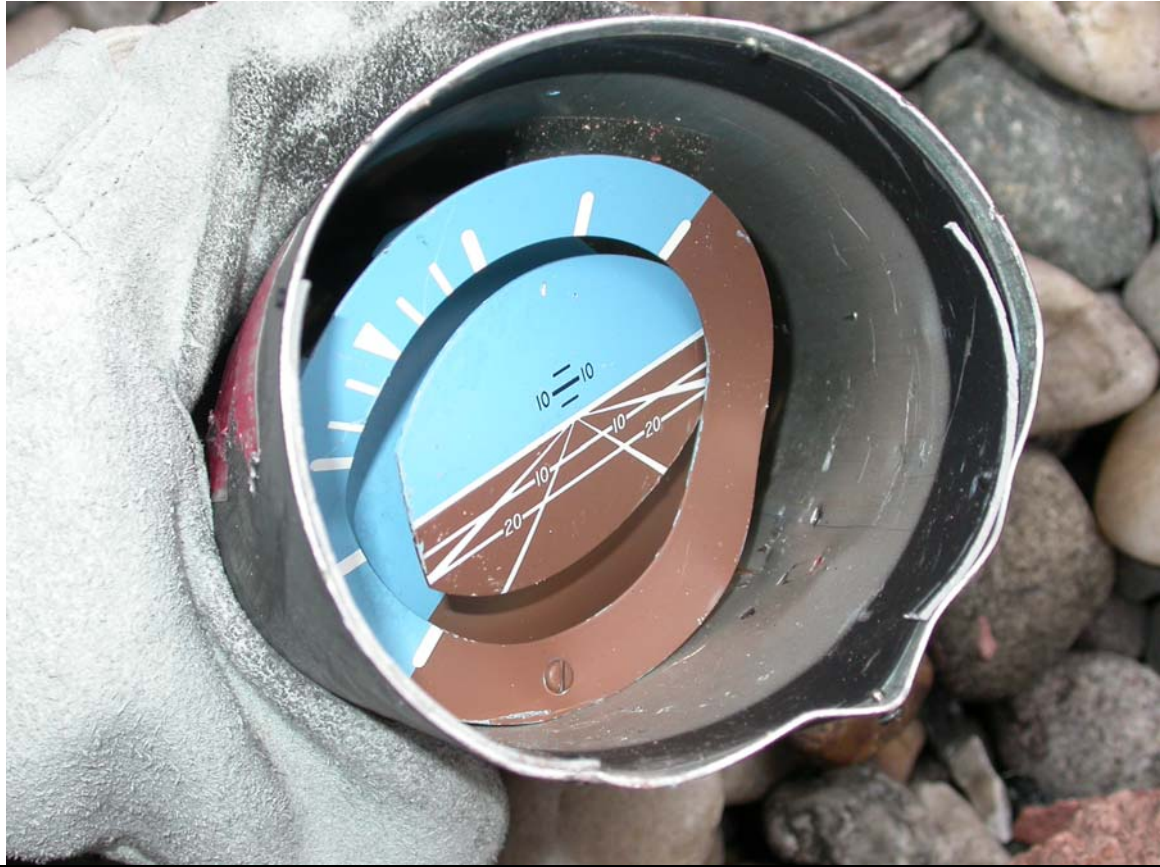
Figure 32

The attitude indicator was separated from the instrument panel; it exhibited mechanical damage. As initially found, the majority of the components (Yoke assembly, Rotor, housing, mask assembly, and indice ring) remained inside the can (Figure 32). Upon picking the unit up, all components fell out of the can assembly. The internal components were placed on a cement block and photographed (Figure 33, and Figure 34). The bezel assembly and airplane indicator remained within the instrument panel (Figure 36).

On November 8, 2006, the NTSB and two representatives from Cirrus Design Corporation conducted an examination of the attitude indicator. The objective of the examination was to determine the flight attitude and if the indicator was operational at the time of impact. The examination of the attitude indicator confirmed the rotational scoring within the rotor housing. Due to the impact damage, the attitude at the time of impact could not be determined.

Attitude Indicator shown in its case.

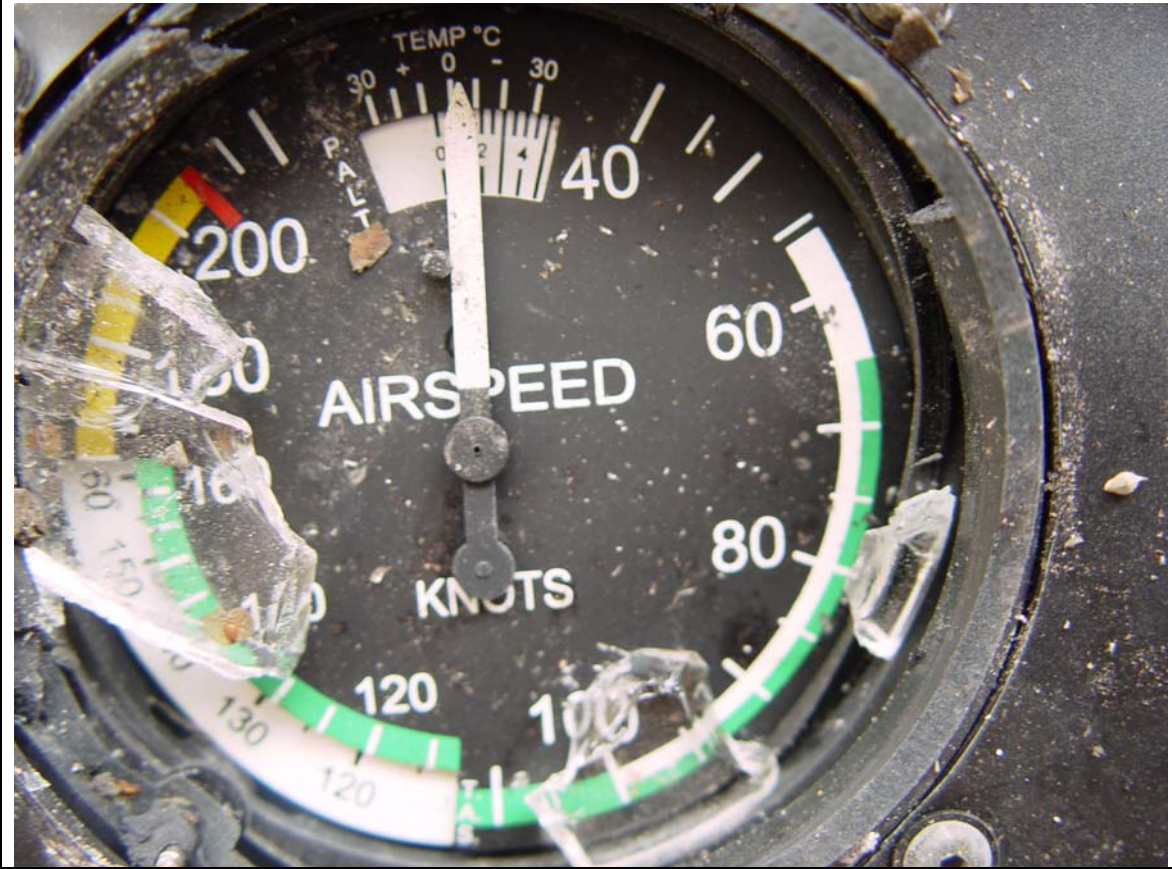
The airspeed indicator was separated from the instrument panel; it indicated 0.0 knots. The unit sustained impact damage and exhibited mechanical damage (Figure 35).

Figure 35
Airspeed Indicator

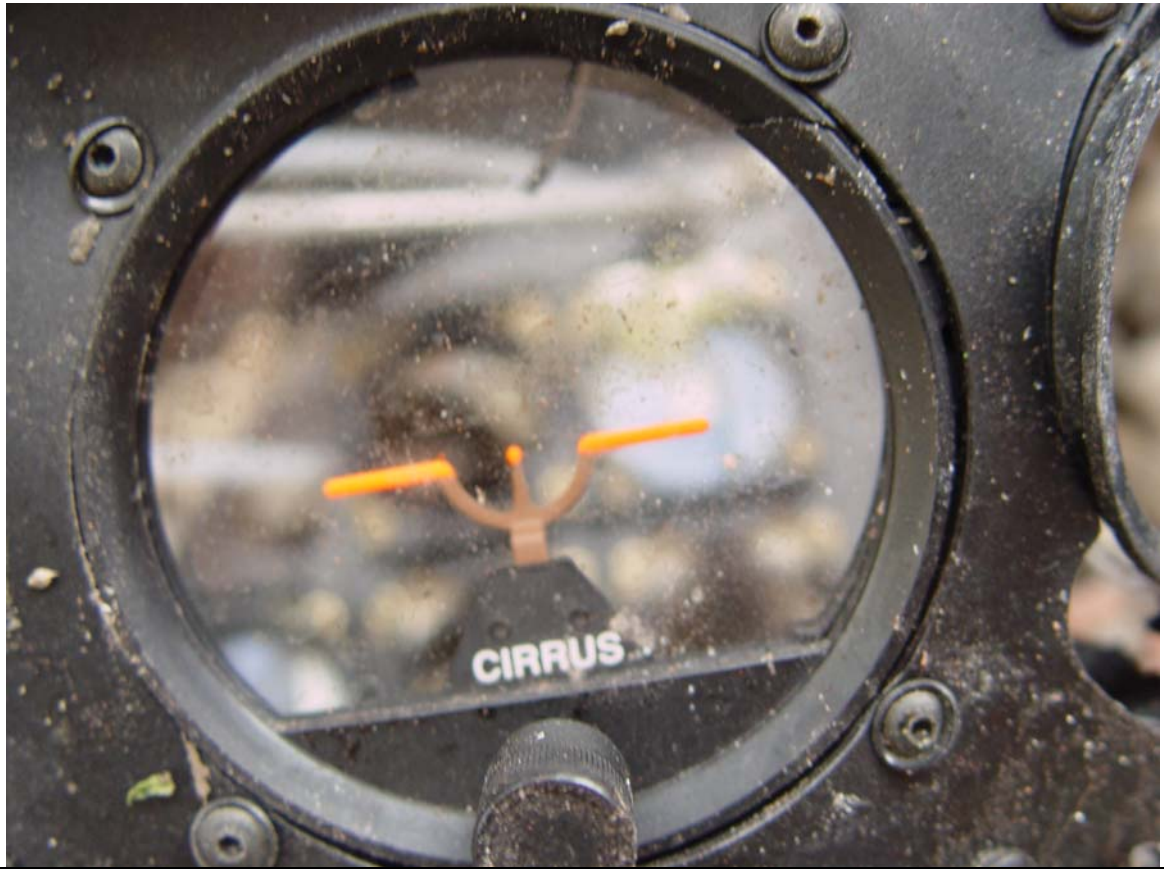
Figure 36

Attitude Indicator within instrument panel

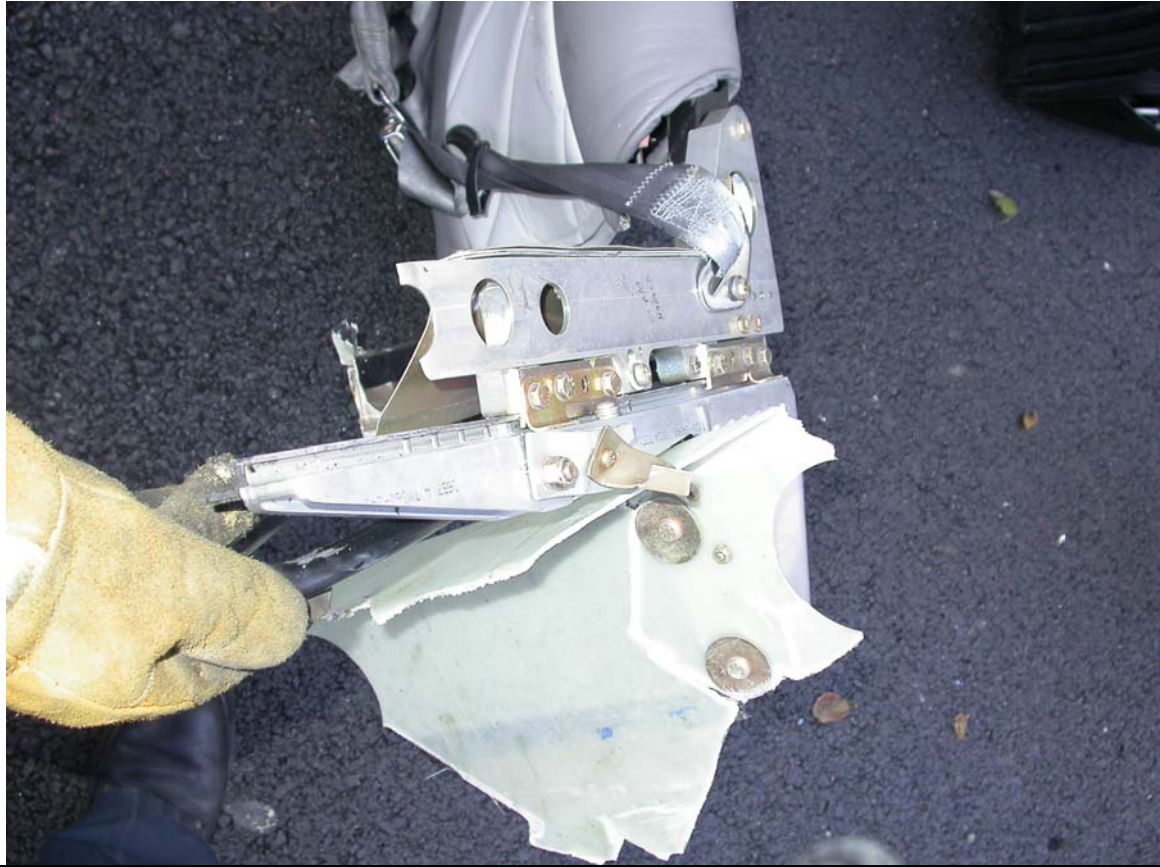
The left and right front seats were located within the main debris field. The left front seat was destroyed by the post crash fire. The right front seat was separated from the fuselage. The right front seat exhibited impact damage. The right front seat's inboard seat track remained attached to the seat frame (**Figure 37**). The right front seat's energy absorption module exhibited impact damage and was separated from the right seat frame. Approximately 75 percent of the right front seat's energy absorption module was measured at less than 0.5 inches in thickness.

Figure 37
Right Front Seat

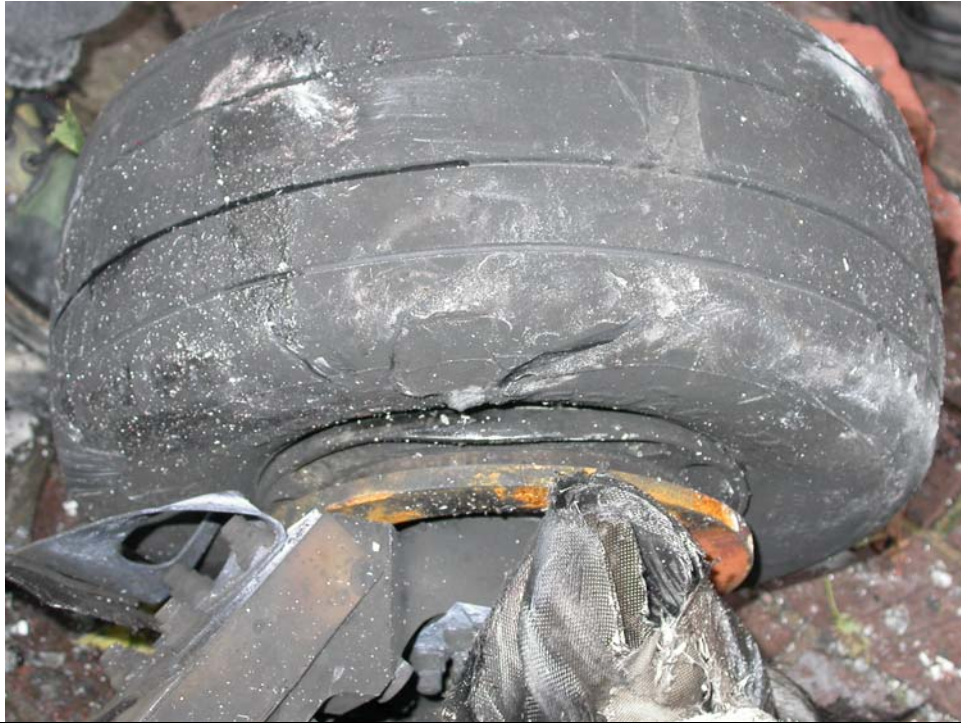
Figure 38

Both the left and right main landing gear assemblies were separated from their respective attachment points and were located in the debris field. A visual examination of the tire and wheel assembly from the left main landing gear revealed that the wheel was mechanically damaged (flat spot) (**Figure 38**).

Left Main Gear Wheel Showing Flat Spot
