NATIONAL TRANSPORTATION SAFETY BOARD

AIRWORTHINES GROUP CHAIRMAN'S FACTUAL REPORT

NTSB Accident Number: DCA07MA003
Location: Manhattan, New York
Date: October 11, 2006
Time of Accident: Approximately 1442 Eastern Daylight Time
Aircraft: Cirrus SR20

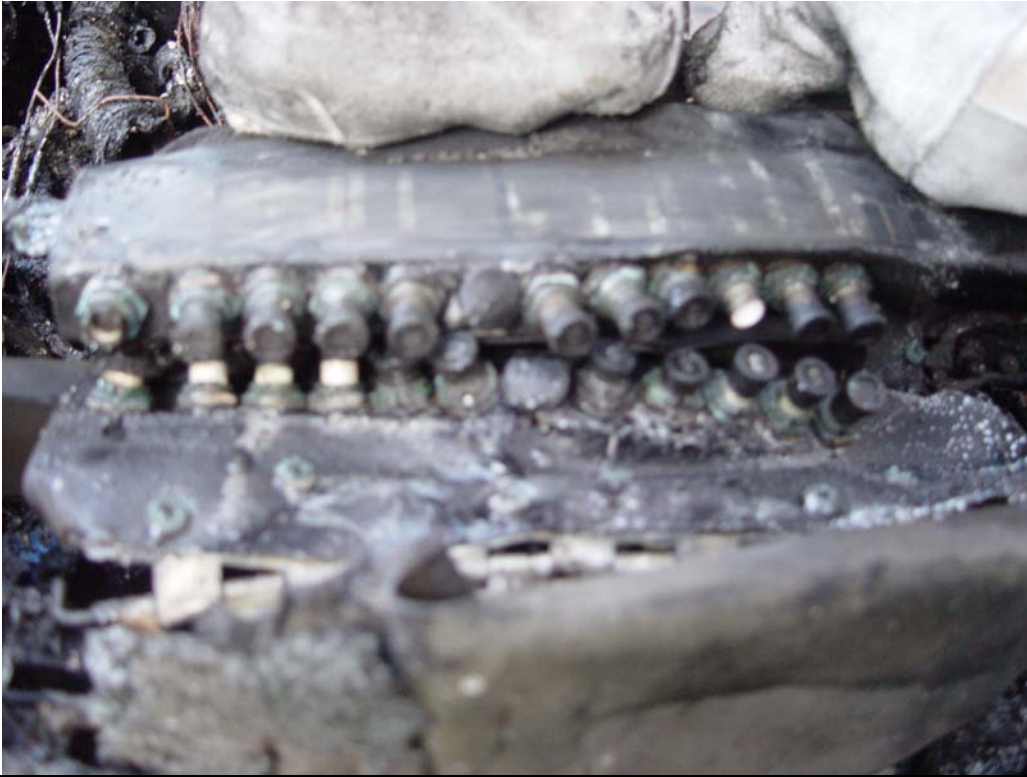
Figure 39

The circuit breaker panel was located within the main debris field, it was found crushed (folded) with the majority of the circuit breakers open ([Figure 39](#)).

Airplane N929CD circuit breaker panel
