**AIRWORTHINESS GROUP CHAIRMAN'S FACTUAL REPORT**

**CEN13FA192**

**Sikorsky Aircraft Corporation Tail Gearbox Materials Engineering  
Report No. MER-MI1308142 (8 Pages)**

# Materials Engineering Report S-76 Tail Rotor Gearbox Components from Mishap, ERA 369

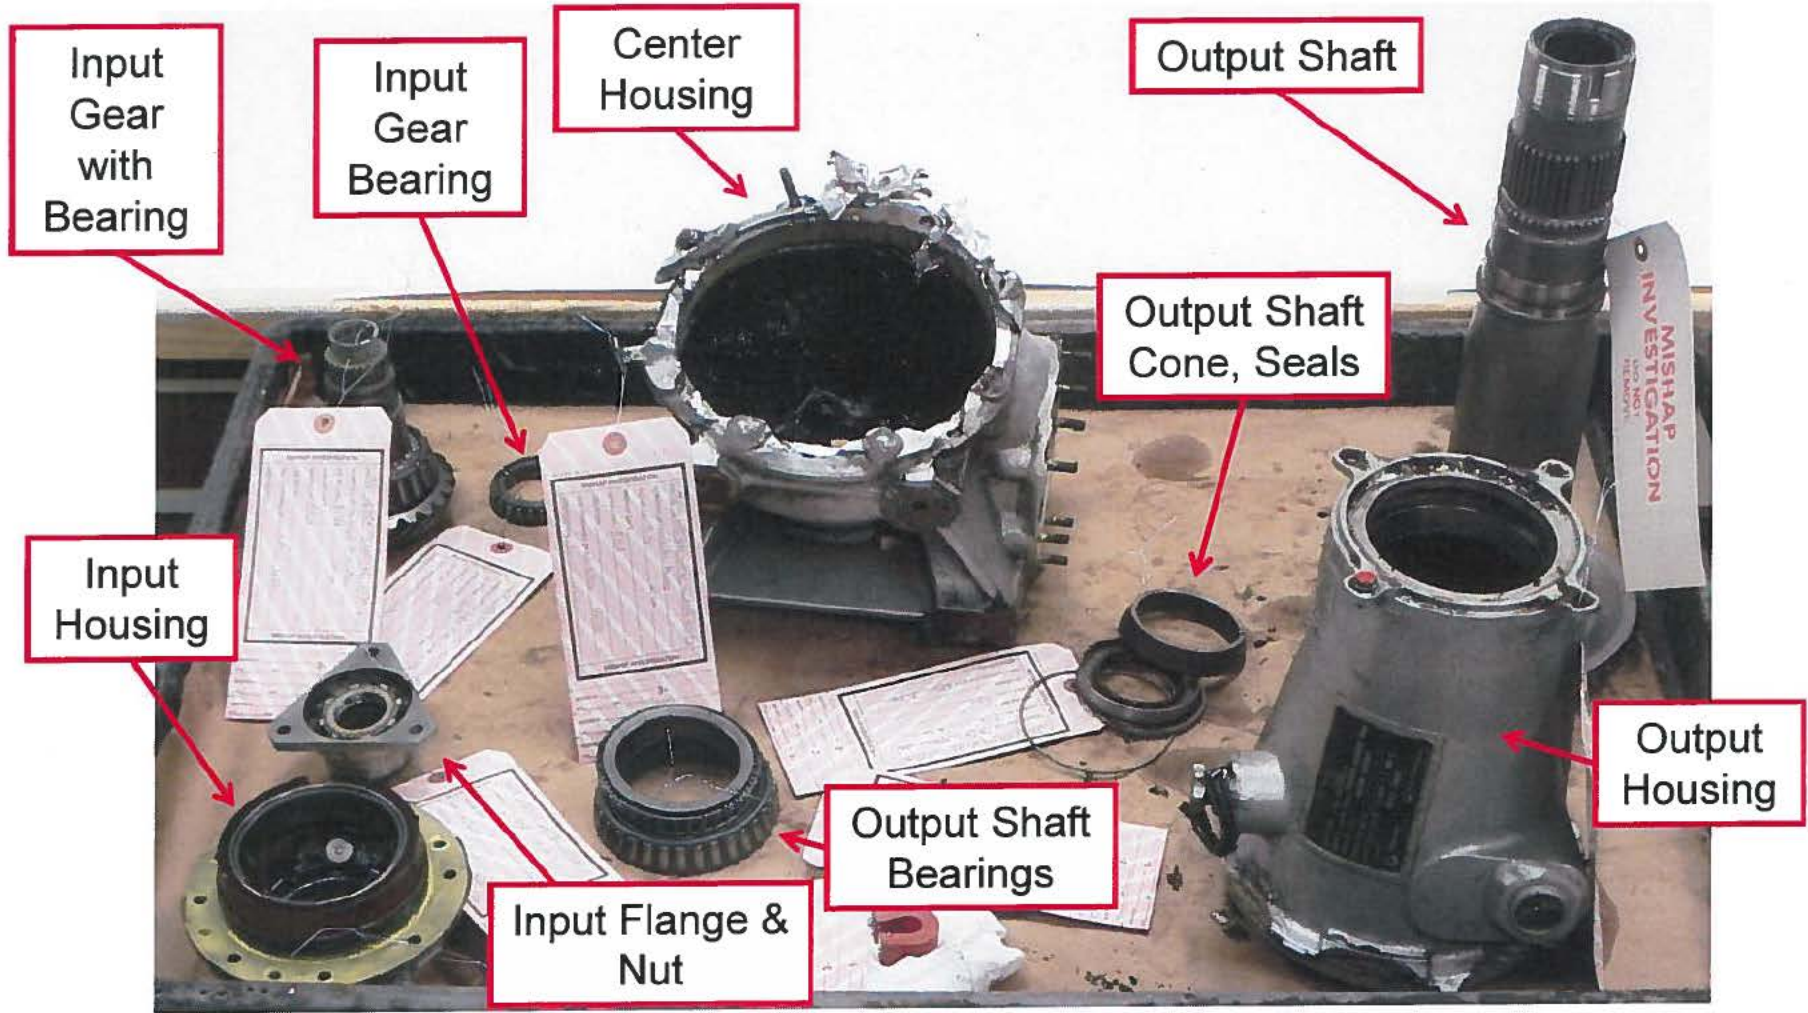
**Observations** – Appearance of as-disassembled Tail Gear Box components.

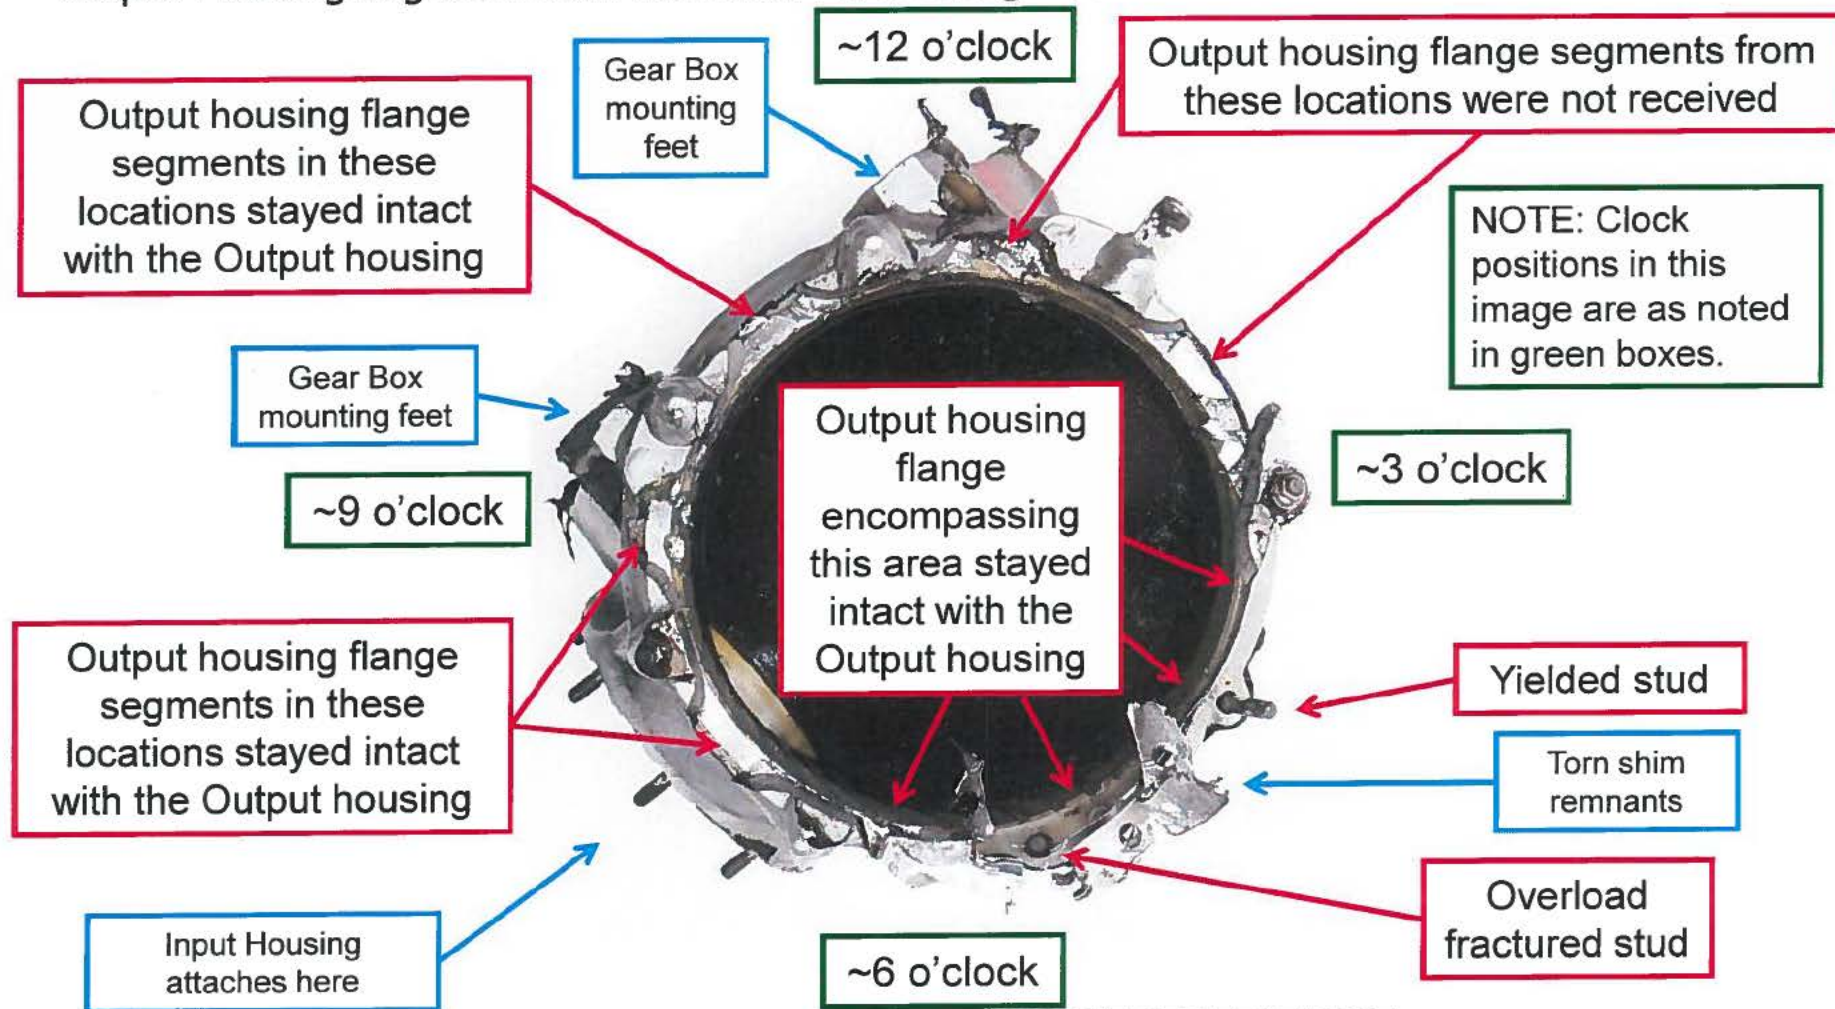
**Observations** – Tail Gear Box Center Housing, looking inboard, with several fractured Output Housing segments still attached. All housing fractures were overload.

- All fractures were overload, and are considered to have been the result of the mishap. There was no evidence of fatigue cracking.
- Along with the fractures, all other visible damage to the subject components appeared to have been the result of the mishap.
- There were no indications of any pre-existing anomalies with the subject components prior to the mishap.

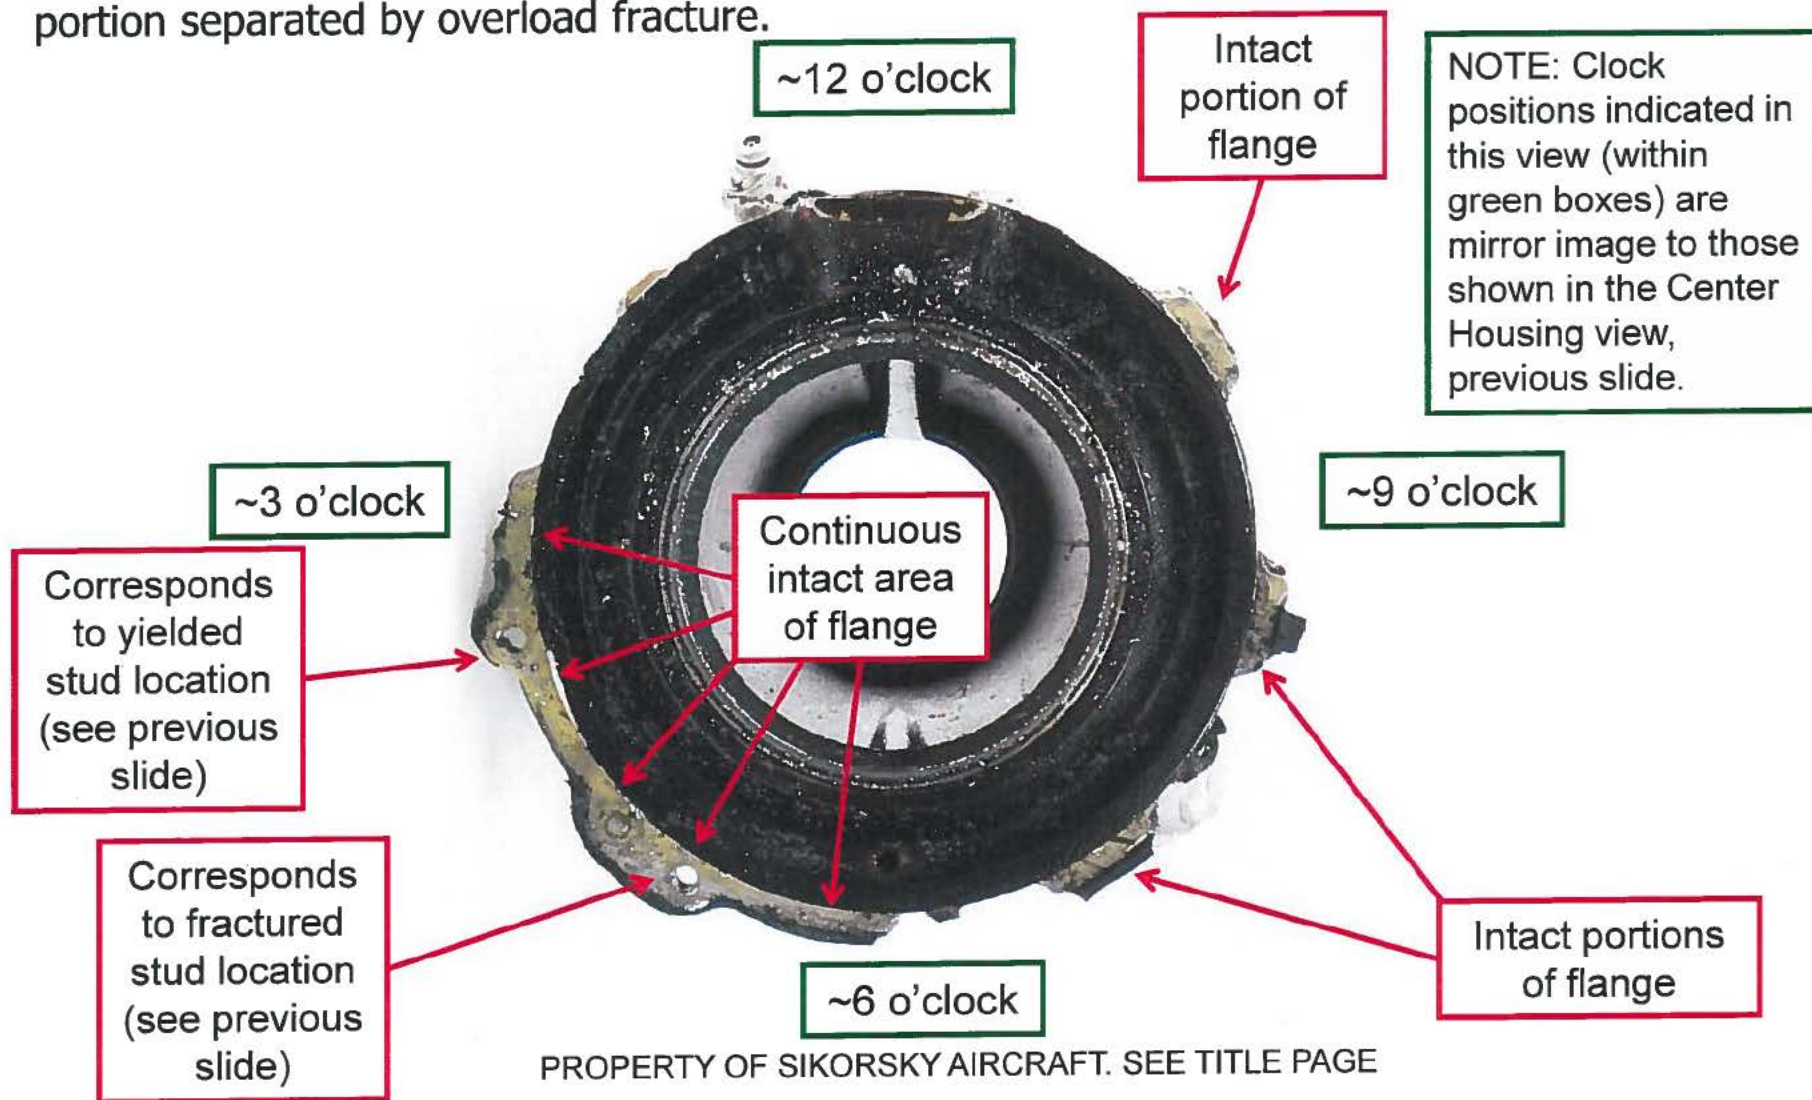
**Observations** – Tail Gear Box Output Housing, looking outboard, with much of the flange portion separated by overload fracture.

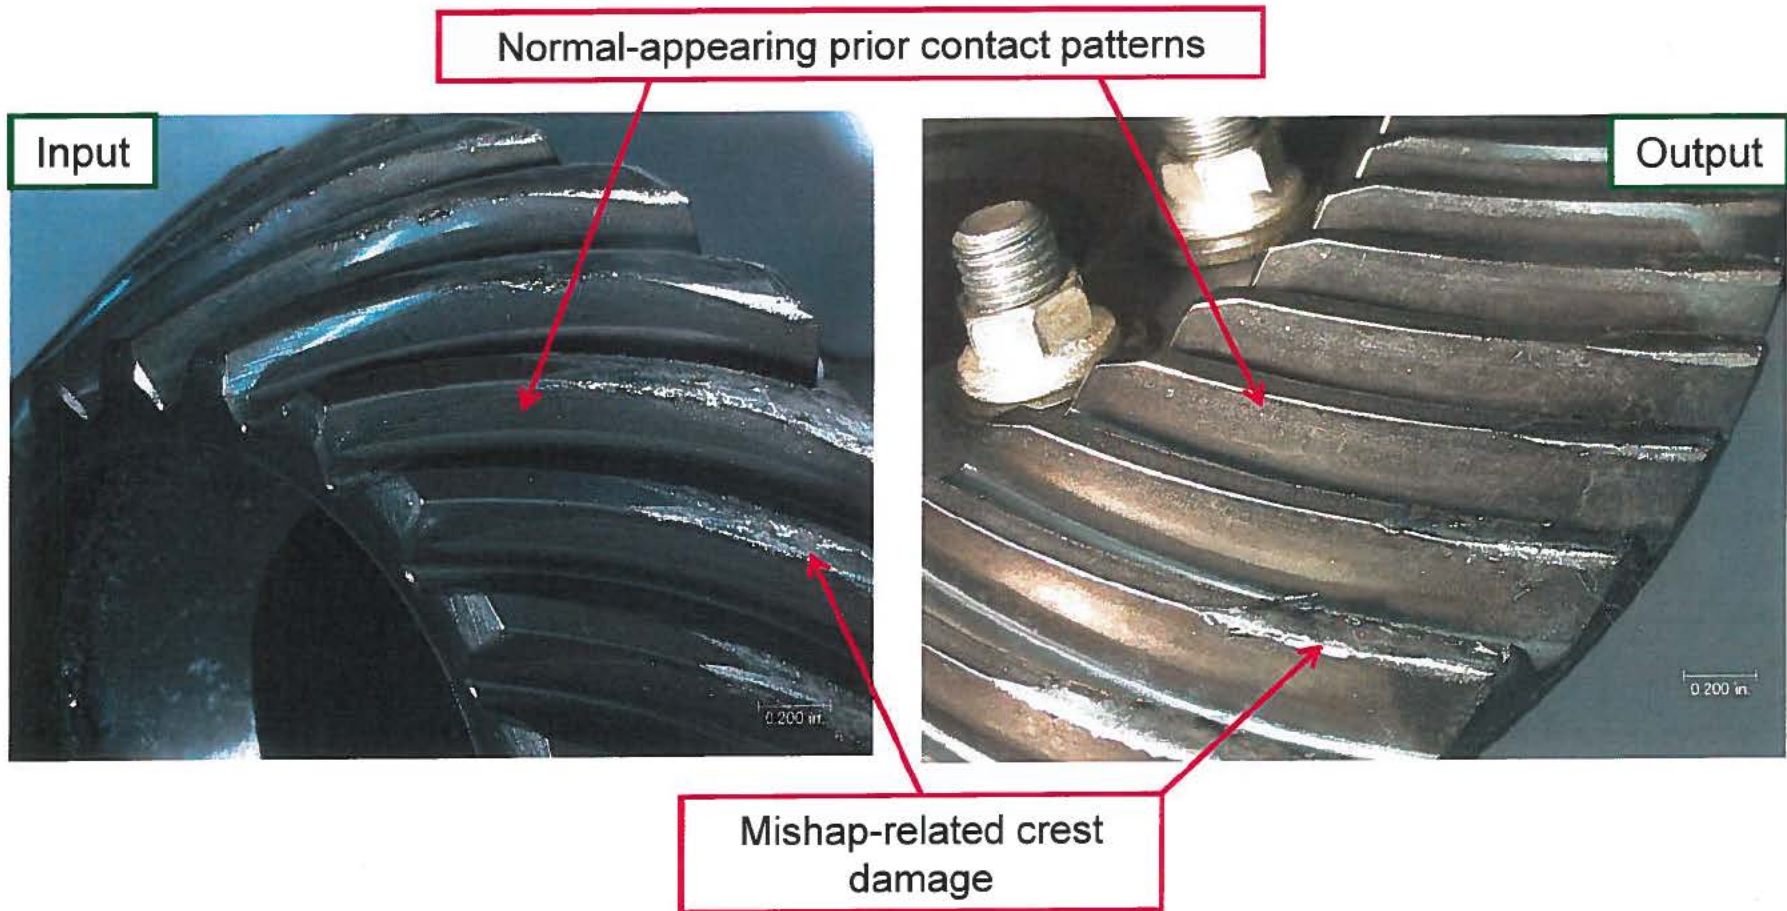
**Observations** – Input and Output Bevel Gear teeth had normal-appearing, centered contact patterns. Crest damage appeared to have been sustained during separation of Output Housing from Center Housing.

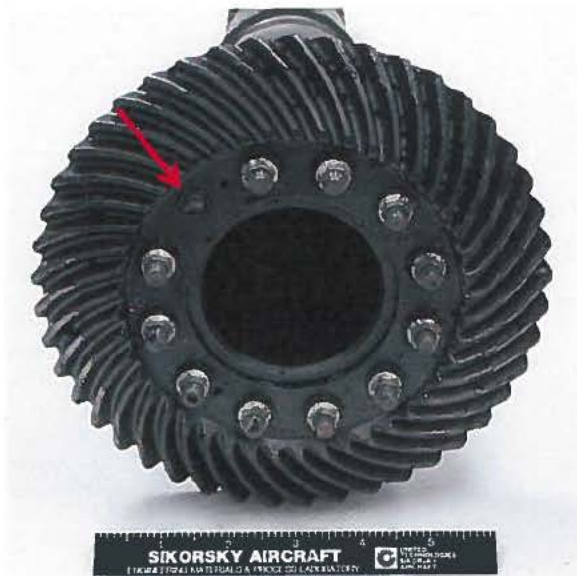
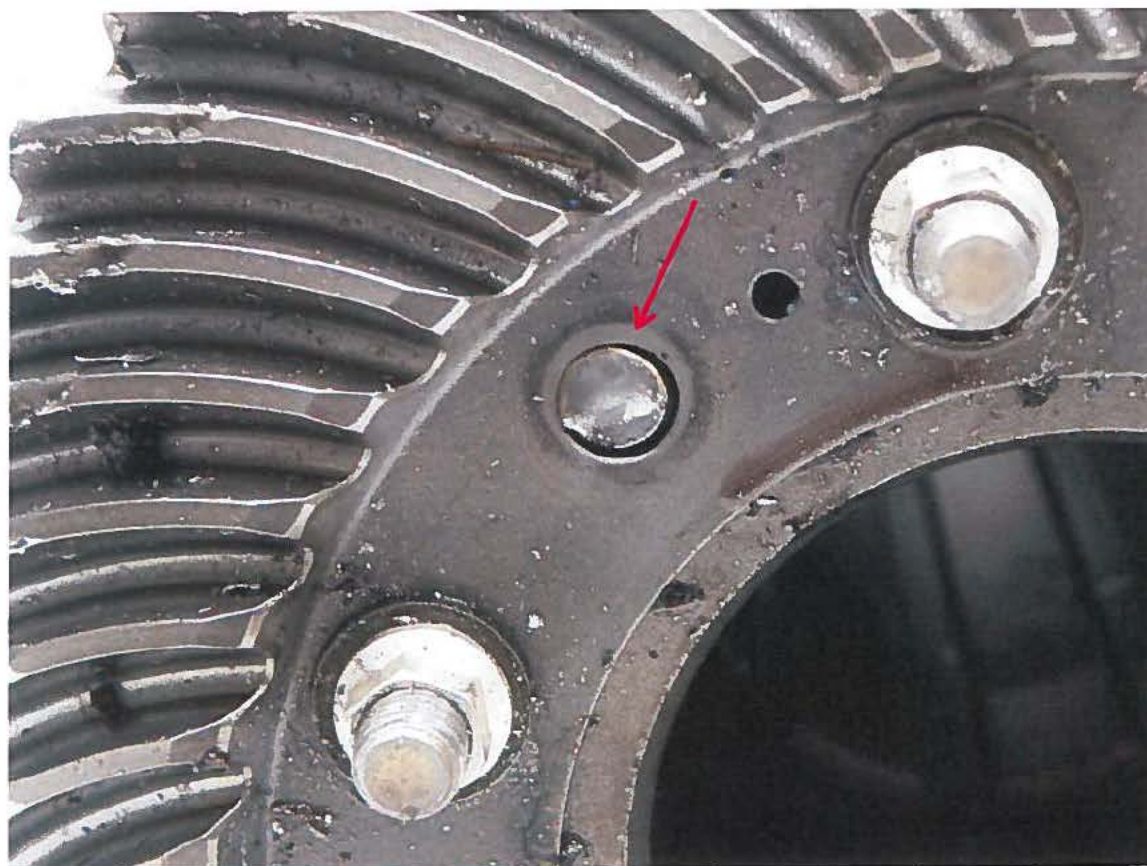
**Observations** – Output Bevel Gear to Output Shaft bolted connection had one overload fractured bolt. The shank portion and nut were not received.
