ATTACHMENT 6

AIRWORTHINESS GROUP CHAIRMAN'S FACTUAL REPORT

CEN13FA192

Bell Helicopter Broussard Work Order S76T-137-00708 (71 Pages)

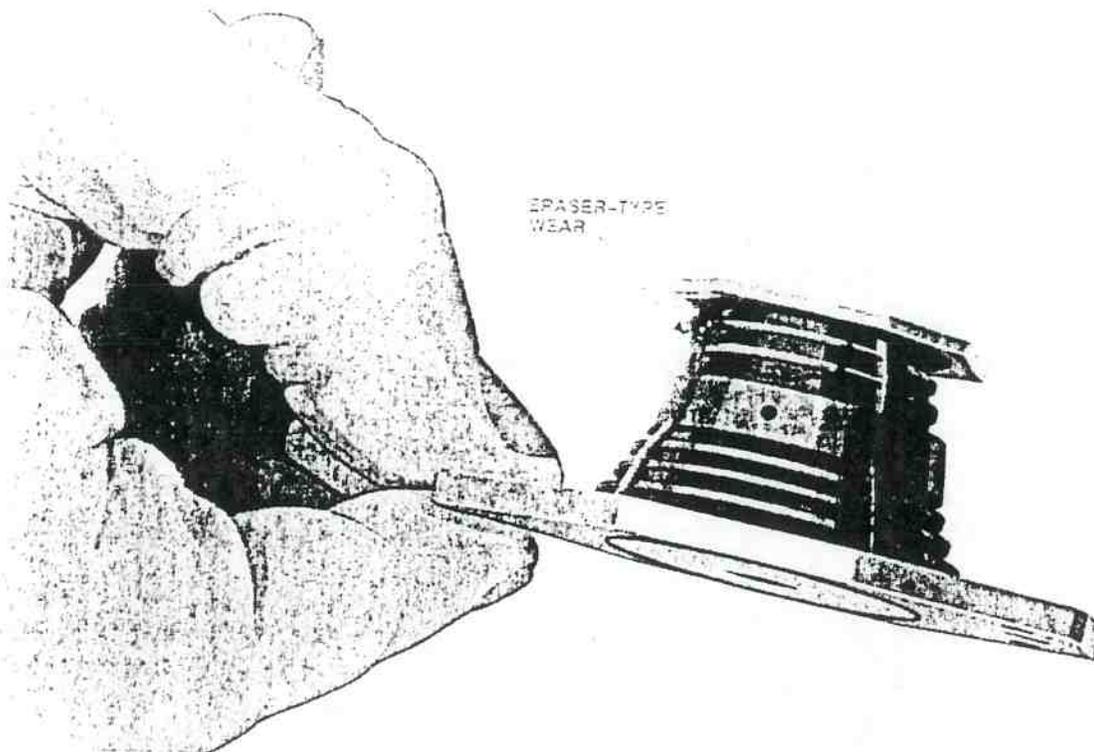
NOTE: The term "eraser-type" is used to describe the wear of elastomeric bearings because of the resemblance to the result of using a soft eraser. This pile-up of shredded rubber is typical of the wear of the elastomeric bearings (Figure 201).

Snubber - Example of Eraser-Type Wear (None Acceptable)
Figure 201

(1) At 1500-hour inspection interval, remove pivot bearings and do a visual inspection. The principal area susceptible to elastomer wear is in the elastomer layer closest to the blade spar. Replace snubbers showing eraser-type wear (Figure 201). Also inspect for separation in the bearing by deflecting the bearing as shown in Figure 202. Replace snubber if any separation is detected.

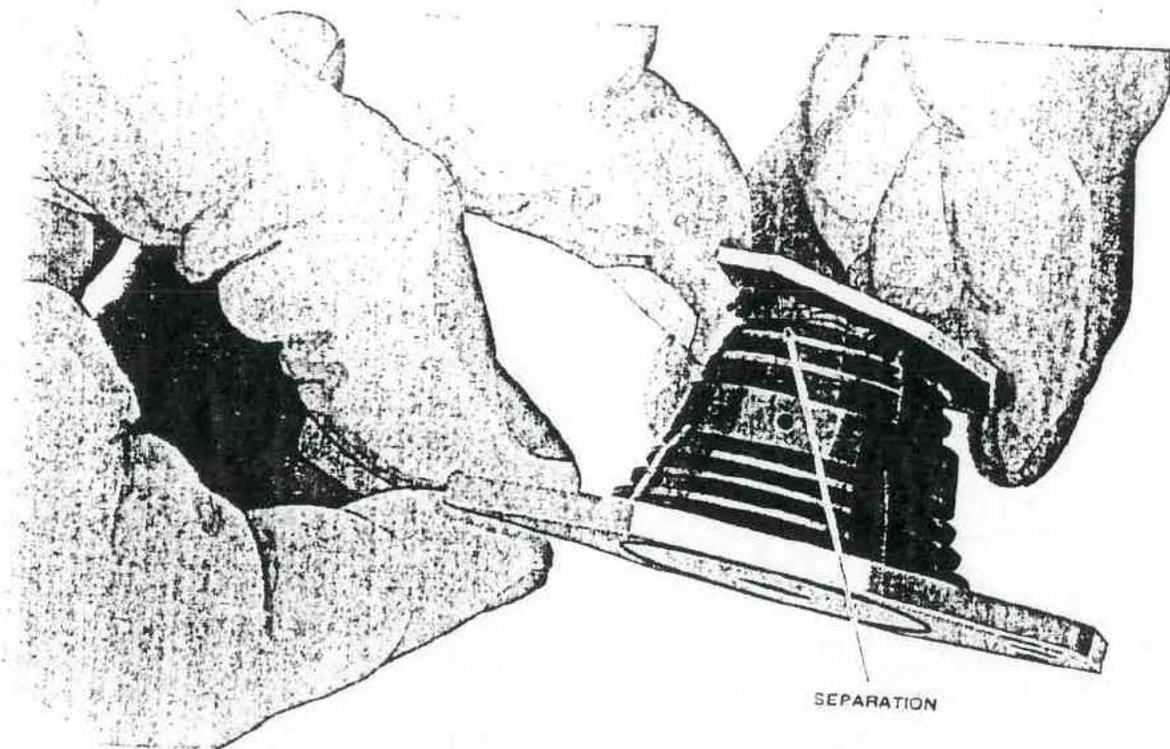
Snubber - Separation of Small Endplate (None Acceptable)
Figure 202

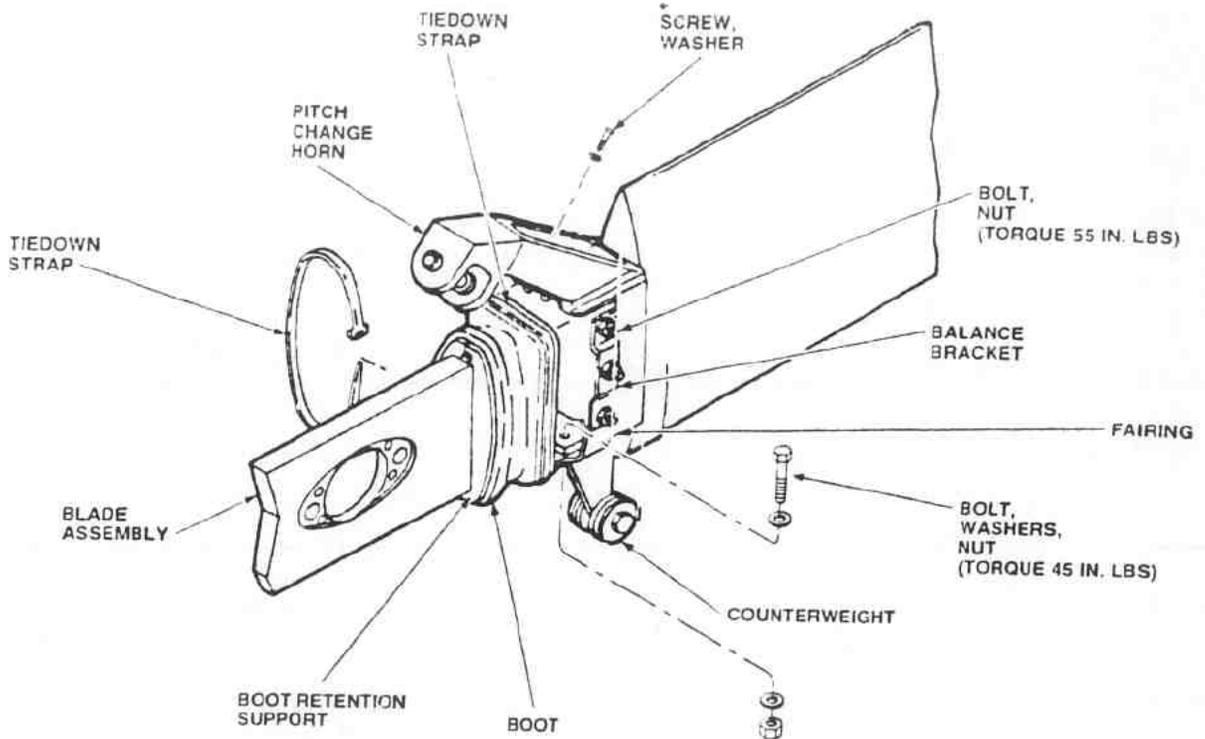
Tail Rotor Blade Boot and Fairing - Replacement
Figure 203

B. Replacement Boot (Figure 203).

C. Replacement Fairing (Figure 203).

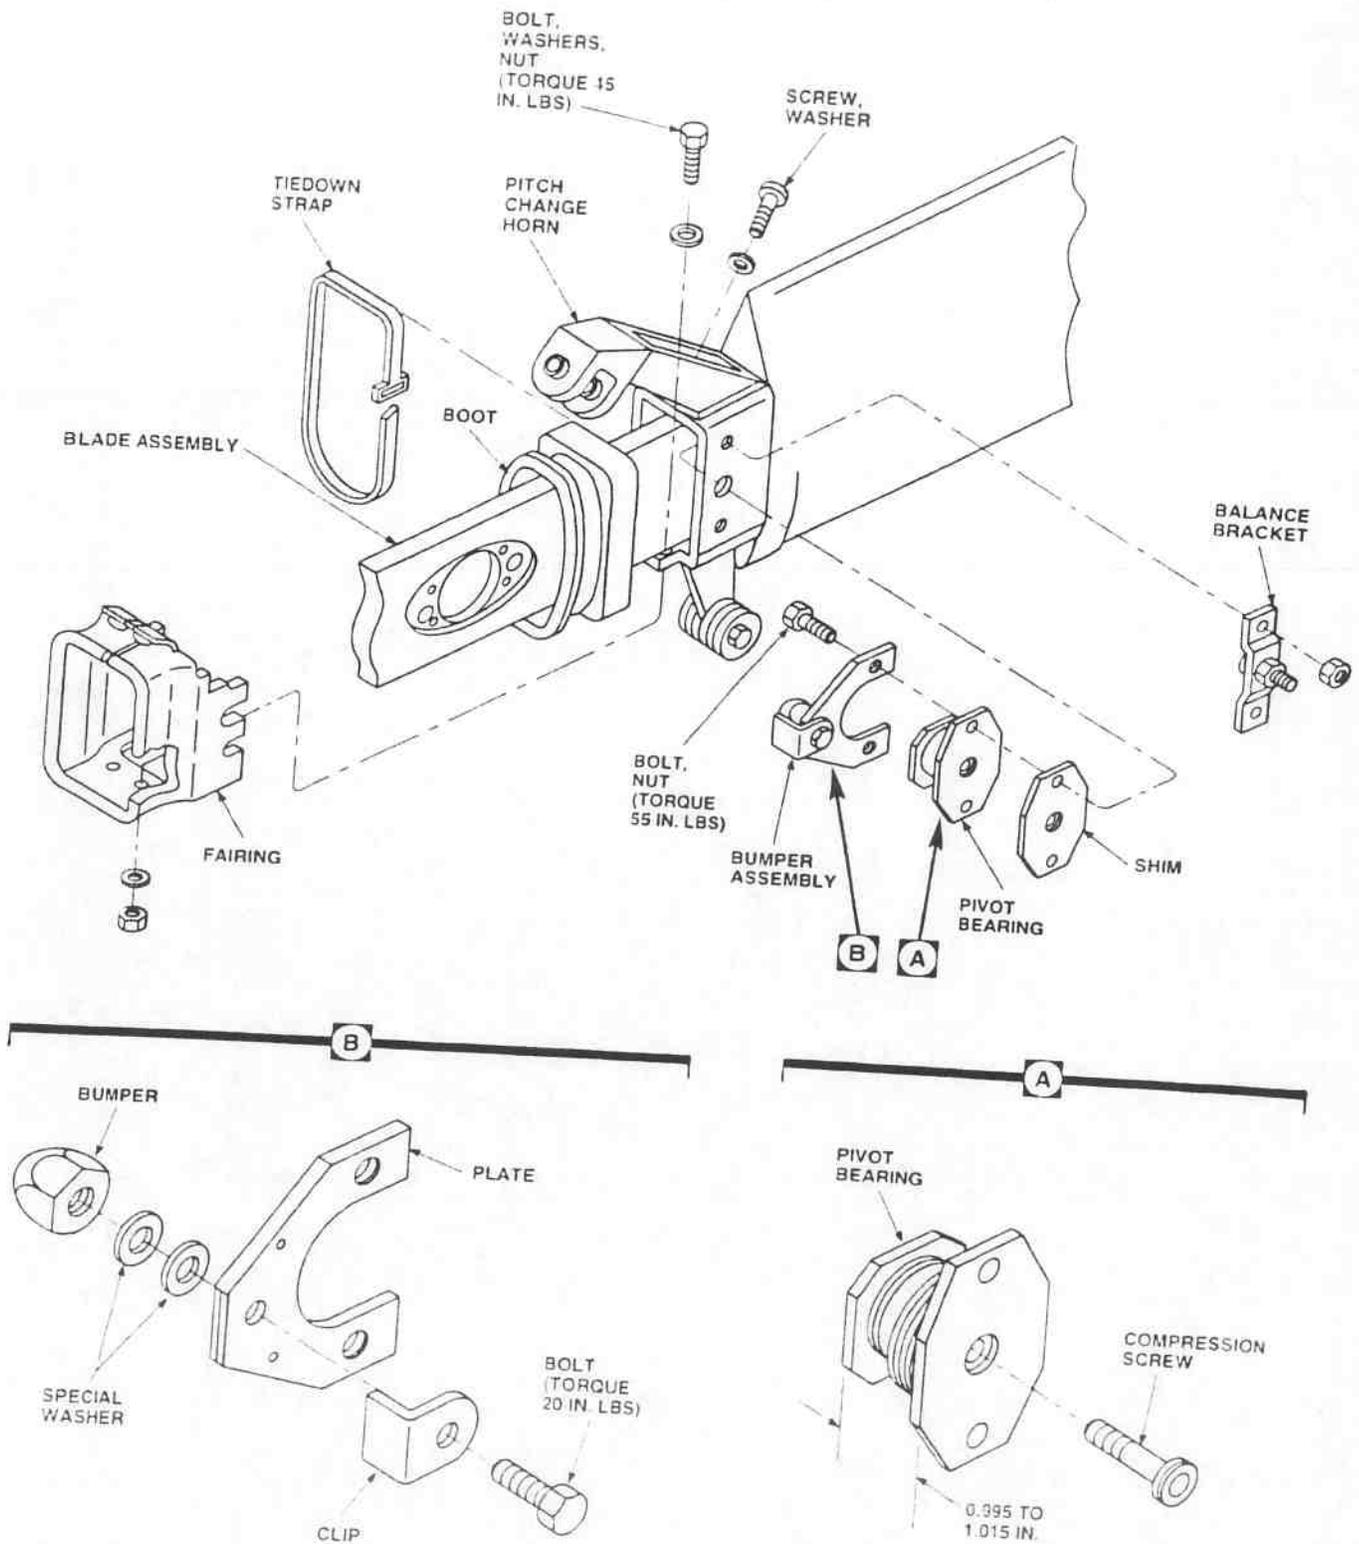
Fail Rotor Blade Pivot Bearing - Replacement
Figure 201

D. Replacement Pivot Bearing (Figure 204).

NOTE: Replacement instructions are the same for all pivot bearings. If any pivot bearing needs replacement, the pivot bearing next to it must also be replaced.

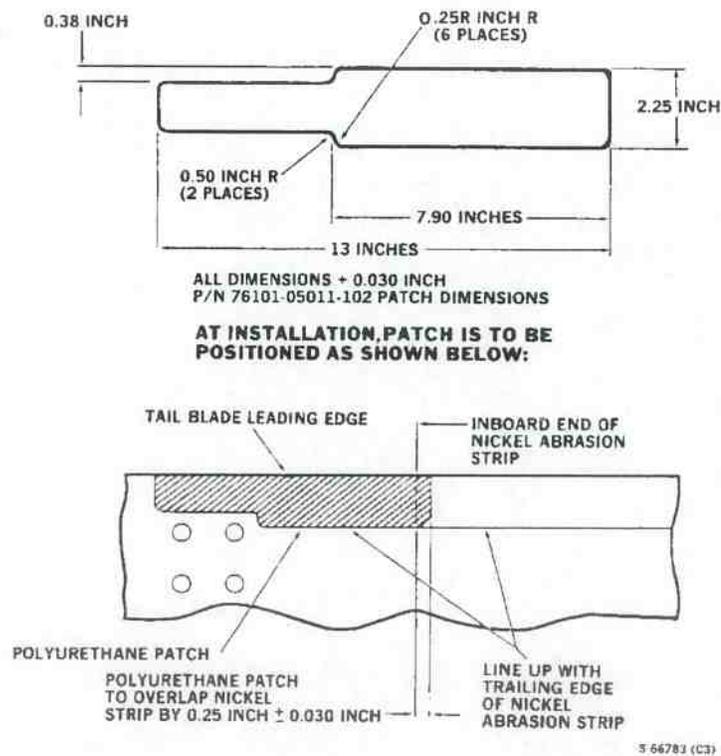
Figure 4-9. Polyurethane Patch Dimensions and Positioning

- a. Mask repair area at least $\frac{1}{4}$ inch on all sides of polyurethane patch interface area as shown in Figure 4-9.
