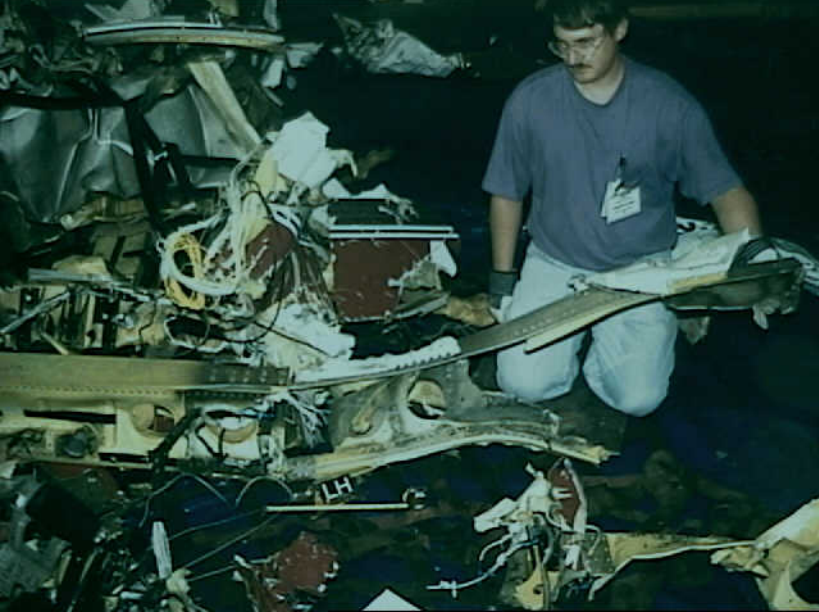
Airworthiness - Photo 11. Close-up view of the upper spar cap fitting of the wing carry-through section where it mates with the left wing spar. Note rearward direction of fractures. (NTSB-I12)
