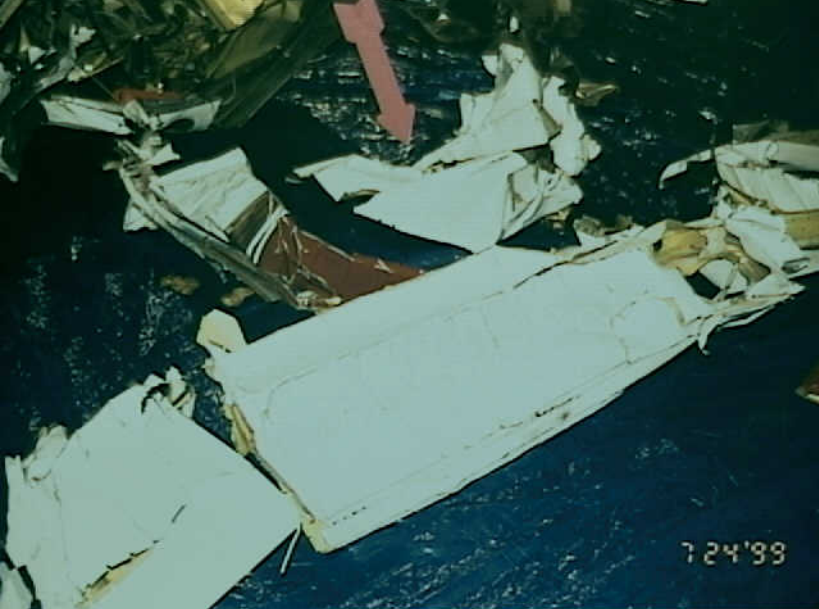
Airworthiness - Photo 15. View of the damage to the bottom structure of the aft-facing passenger seats in row
