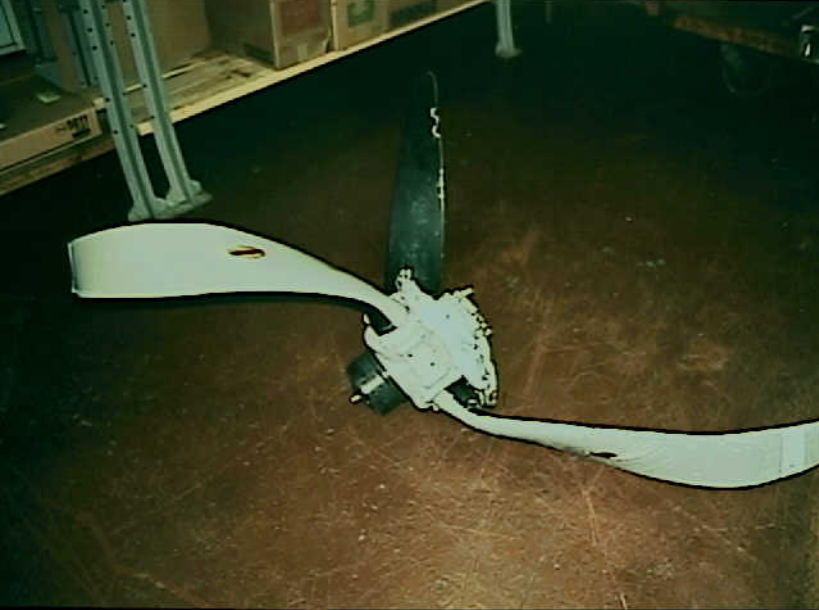
Airworthiness - Photo 24. View of all three propeller blades after removal from hub by investigators. Note "S" bending, chordwise scratching, and leading edge gouging. Also note two impressions in leading edge of blade no. 1 (denoted by arrow). (NTSB-CC)
