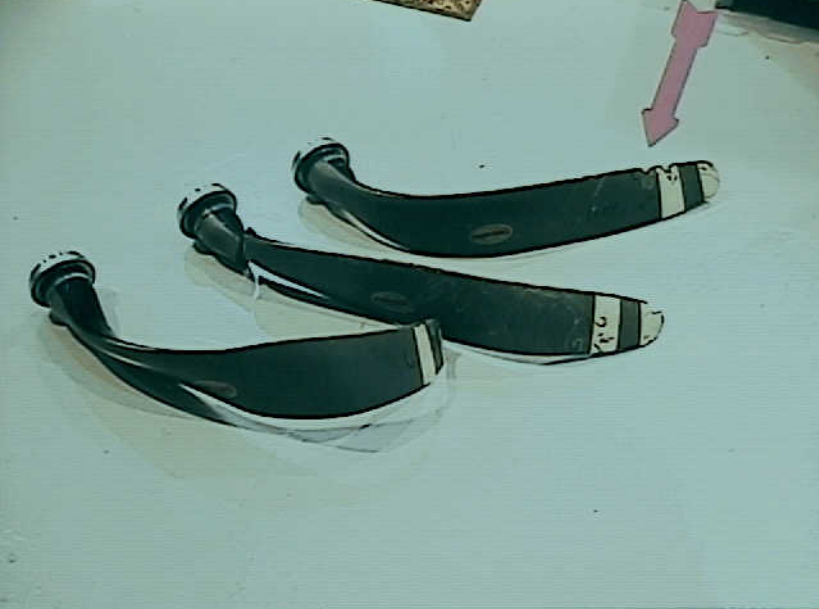
Airworthiness - Photo 25. Close-up view of leading edge damage of propeller blade no. 1. (NTSB-CC)
