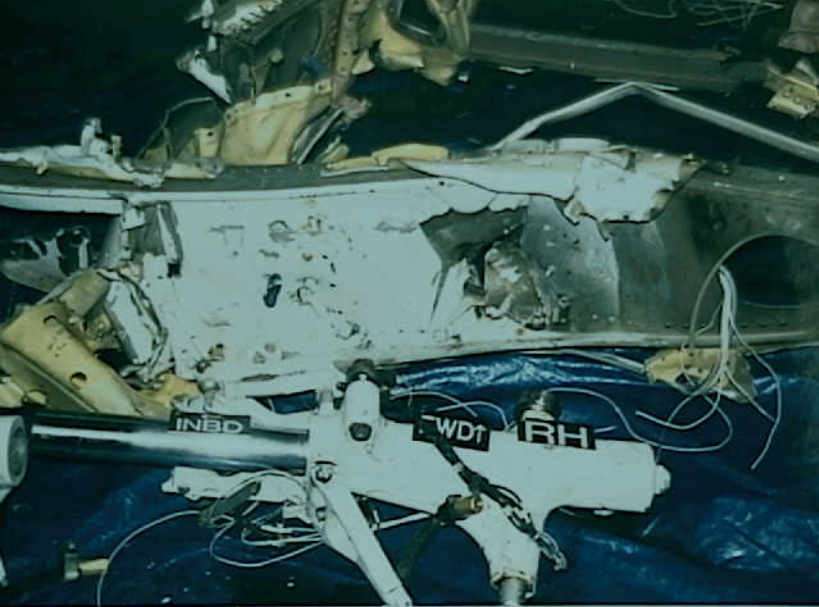
Airworthiness - Photo 8. View of right wing damage (view from forward looking aft). Note that the entire length of the wing spar was recovered. (NTSB-C3)
