**AIRWORTHINESS GROUP CHAIRMAN'S FACTUAL REPORT
ATTACHMENT III: Honeywell, Inc. (Engine) Teardown
Report No. 21-11090**

**Sunjet Aviation, Inc.
Mina, South Dakota
October 25, 1999**

**TEARDOWN REPORT
OF TWO TFE731-2-2B TURBOFAN ENGINES
SERIAL NUMBERS P-74264 AND P-74265**

21-11090

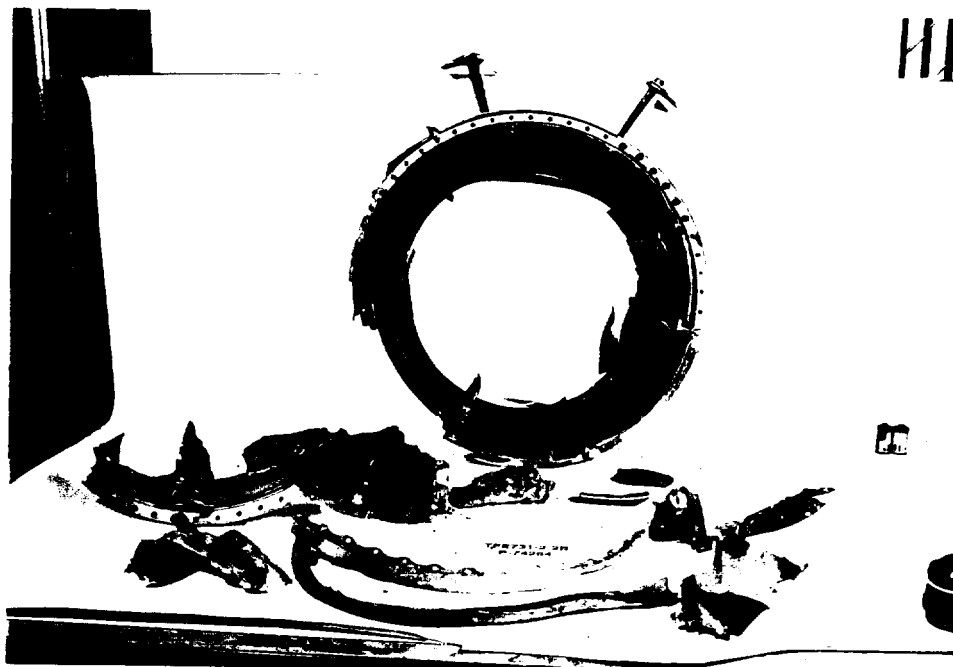
Figure 14. (Photo No. 28-15) Damaged Main Mount.

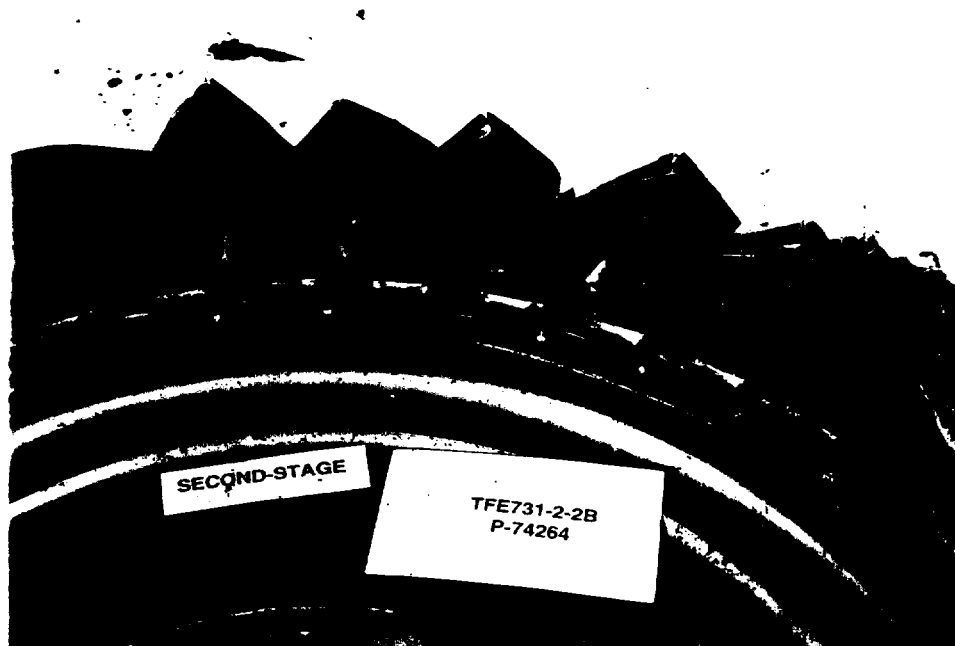
- The leading-edge and trailing-edge of all of the rotor blades were damaged (Figures 23 through 26).
- There was a blade-tip rub on all of the rotor blades, in the area adjacent to the blade-tip shroud. The blade-tip shroud was not returned with the engine.

Figure 25. (Photo No. 36-30) Damaged Second-Stage LP Compressor Rotor Blades, with Platform Rub.

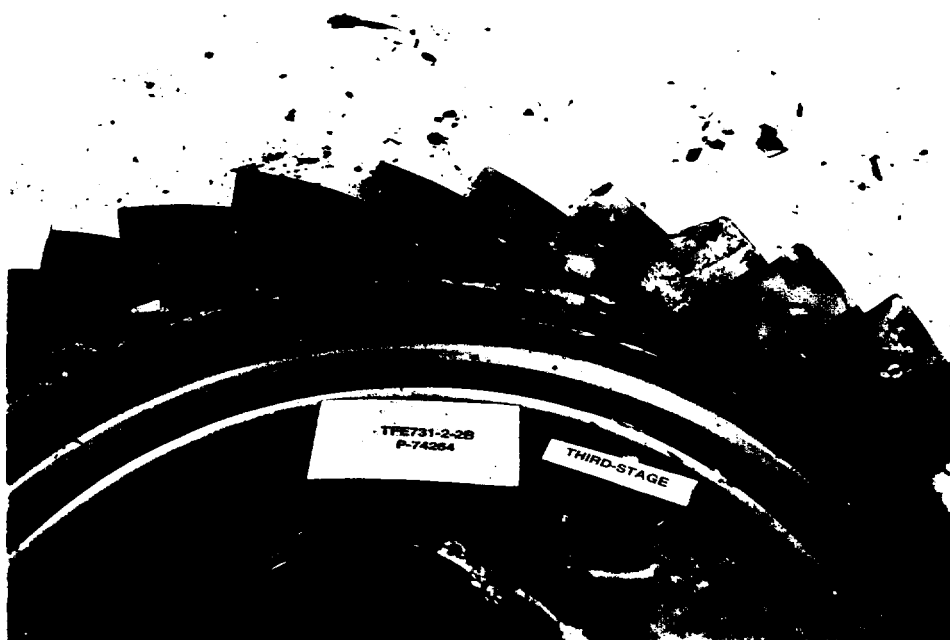
- All of the rotor blades were bent opposite to the direction of rotation (Figures 31 and 32).
 - The leading-edge and trailing-edge of all of the rotor blades were damaged (Figures 31 through 33).

Figure 33. (Photo No. 33-6) Platform Rub, and Damaged Third-Stage Compressor Blades.

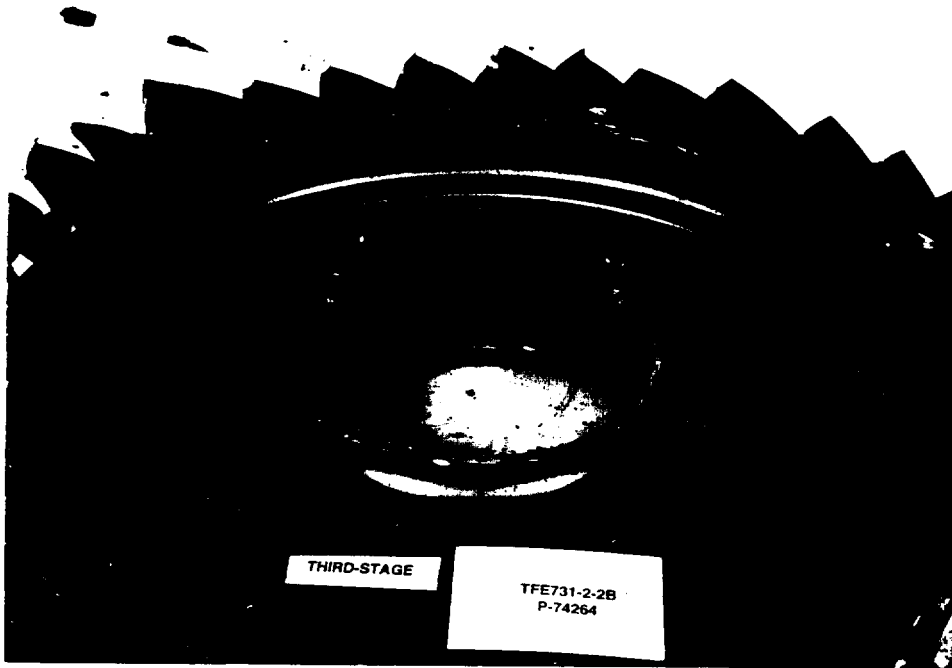
- A 200-degree section of the forward Curvic coupling flange was broken off, and the remaining coupling teeth were damaged (Figure 35). The aft Curvic coupling teeth were damaged (Figure 37).

Figure 35. (Photo No. 36-36) Damaged Curvic Coupling.

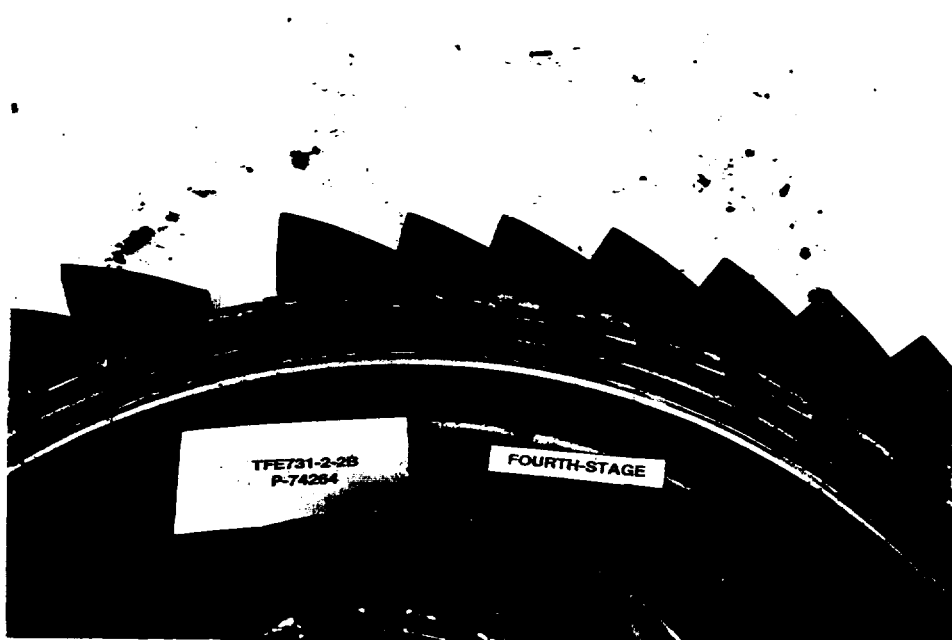
- Twenty-seven rotor blades were intentionally displaced (Figures 37 and 38), while removing the assembly, which was wedged in place.
 - The leading-edge and trailing-edge of some of the rotor blades were damaged (Figures 37 through 40).

Figure 39. (Photo No. 33-21) Platform Rub on the Fourth-Stage LP Compressor Blades.

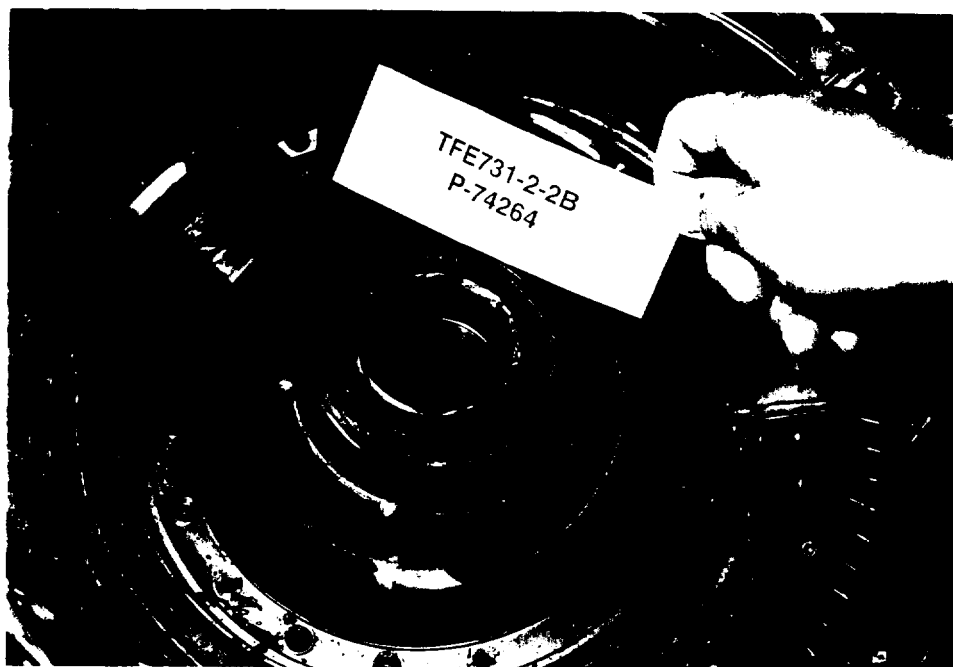
- The aft shaft was fractured (Figure 44) and separated from the forward flange/coupling (Figure 42). The outside diameter (OD) of the aft shaft displayed rotational score marks (Figures 44 and 45), with corresponding rotational score marks on the inside diameter (ID) of the HP shaft (Figures 43 and 46).

Figure 43. (Photo No. 33-14) Scored No. 4 Bearing Housing, Scored HP Shaft, and Damaged Fourth-Stage Stator Vanes.

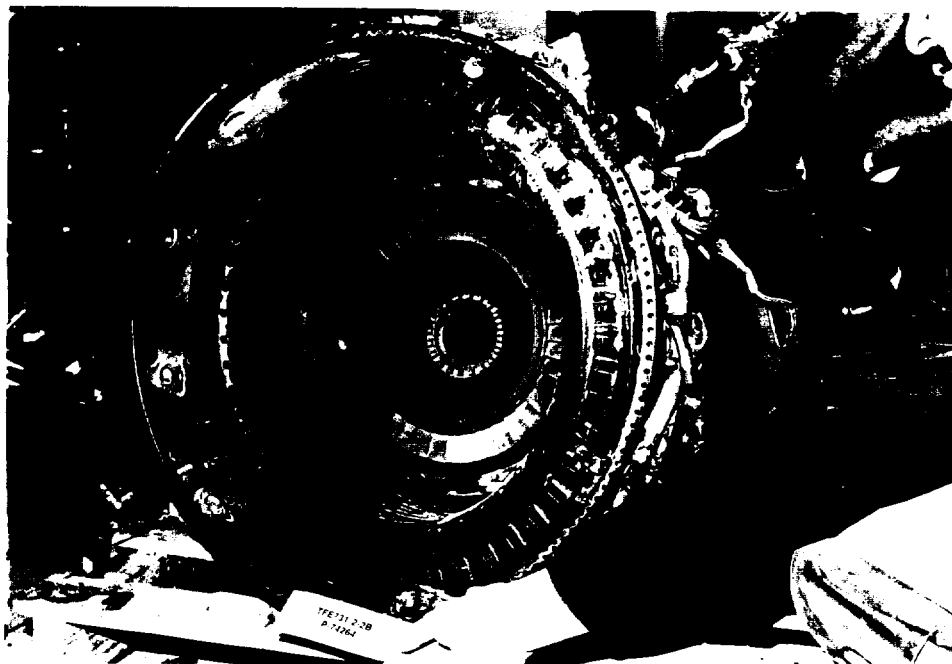
- (a) Fuel manifold assembly:
 - One hose assembly was broken (Figure 52).
 - Six fuel nozzle housings were broken at the combustion chamber liner interface (Figure 65).
 - The fuel nozzle tips and the fuel nozzle shrouds were not disassembled.
- (b) Igniter plugs:
 - Not disassembled.
- (c) Outer transition liner:
 - Not disassembled.
 - The honeycomb seal was very heavily worn.
- (d) Inner transition liner:
 - Not disassembled.
- (e) Combustion chamber liner:
 - There was a white-colored substance on portions of the dome and the inner skirt of the combustion chamber liner (Figure 66).
- (f) Combustion chamber case:
 - Sheet metal displayed compression wrinkles through 360 degrees (Figures 6 and 52).
 - There was debris between the combustion chamber case and the combustion chamber liner (Figure 66).

Figure 65. (Photo No. 29-29) Broken Fuel Nozzle Housings, and HP Turbine Nozzle.

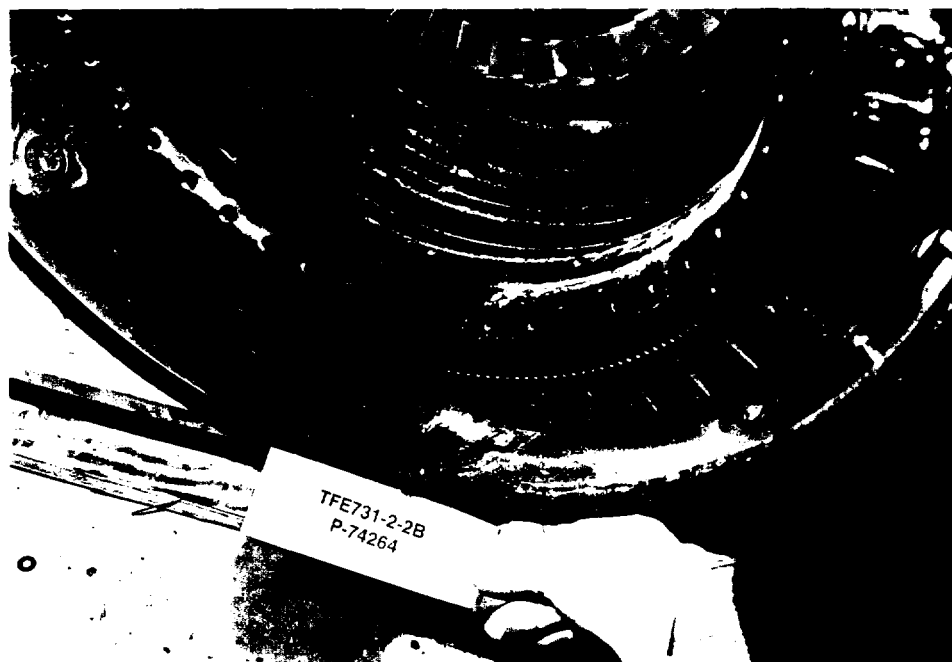
Figure 66. (Photo No. 29-28) White Substance on the Combustion Chamber Liner, and Debris on the Combustion Chamber Case.

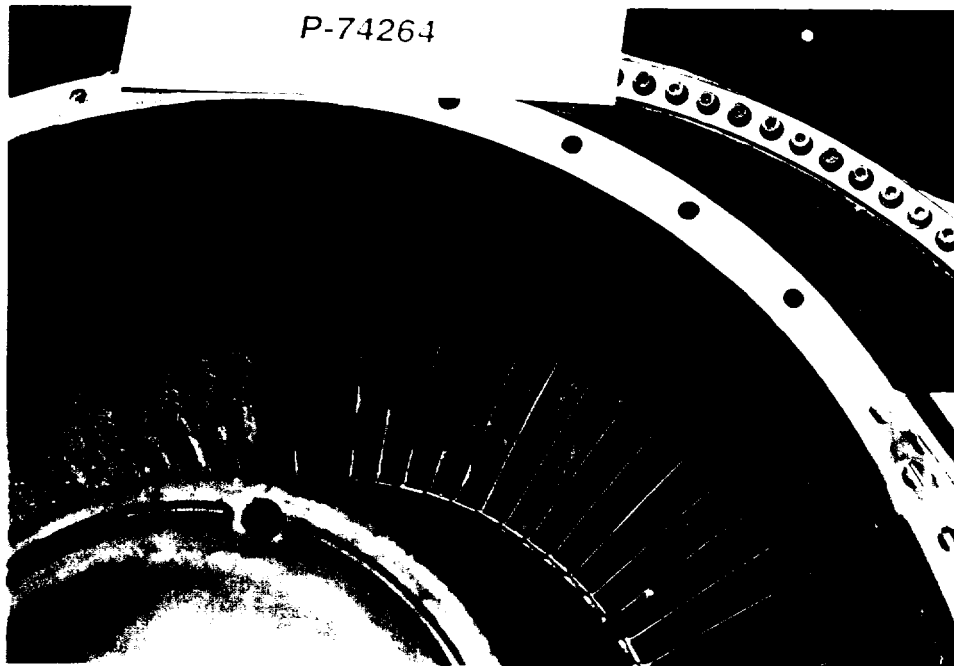
Figure 105. (Photo No. 32-34) Bent Third-Stage LP Turbine Rotor Blades.

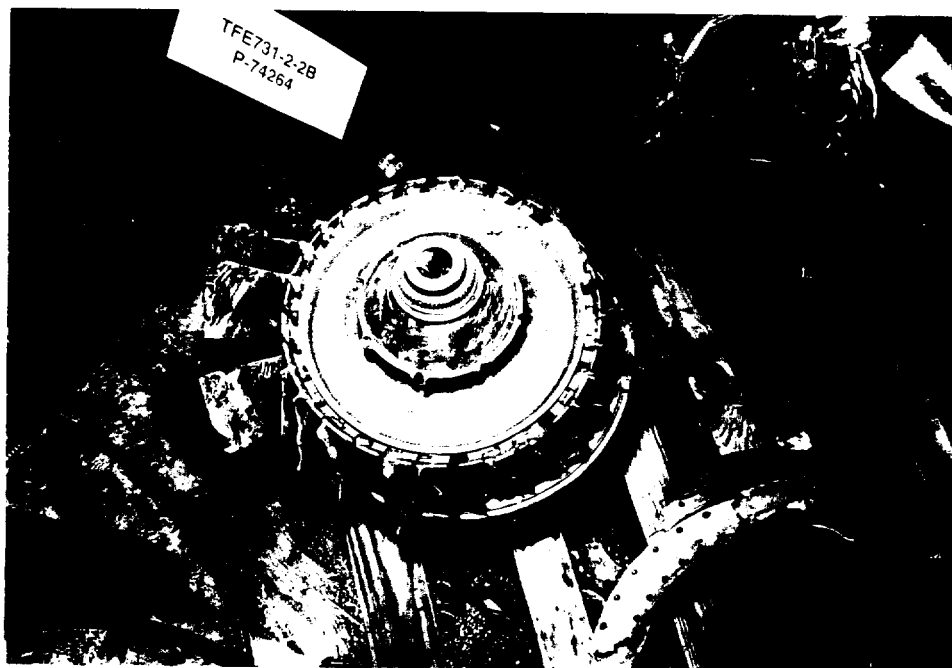
Figure 135. (Photo No. 30-5) Bent and Broken Fan Blades.
(Part of Engine S/N P-74265 - S/N P-74264 On Placard In Photo Is In Error.)

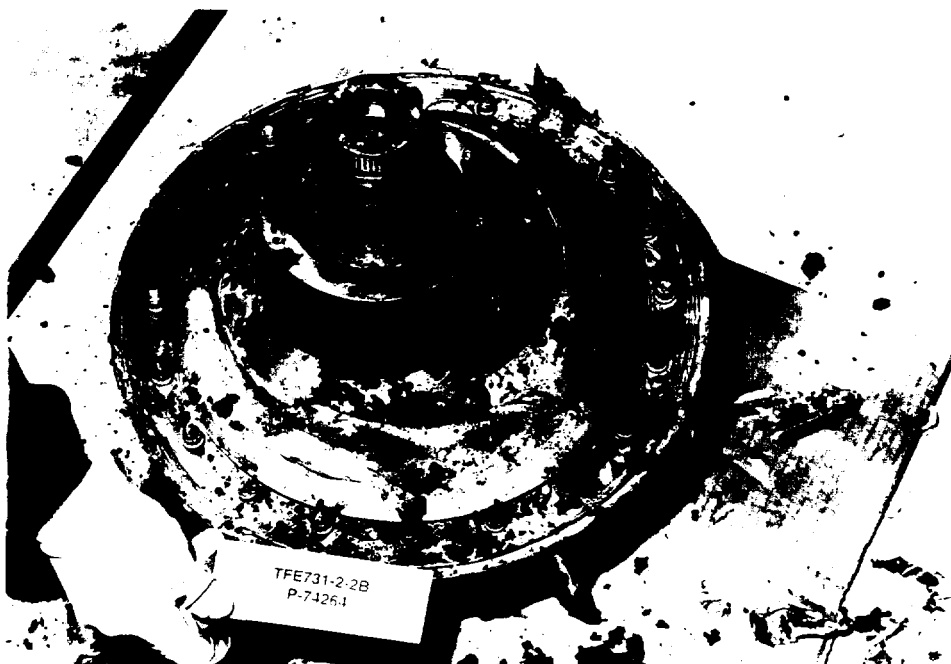
**Figure 137. (Photo No. 33-28) Fractured Fan Support Housing.
(Part of Engine S/N P-74265 - S/N P-74264 On Placard In Photo Is In Error.)**

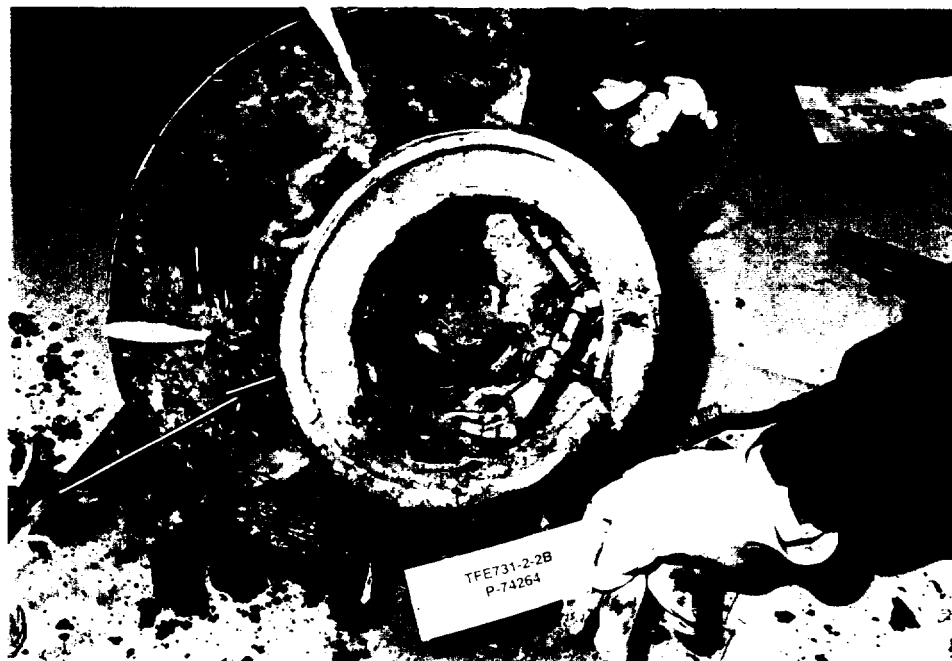
Figure 139. (Photo No. 33-30) Planetary Gear Assembly, and Main Mount Fragment with Score Marks. (Part of Engine S/N P-74265 - S/N P-74264 On Placard In Photo Is In Error.)

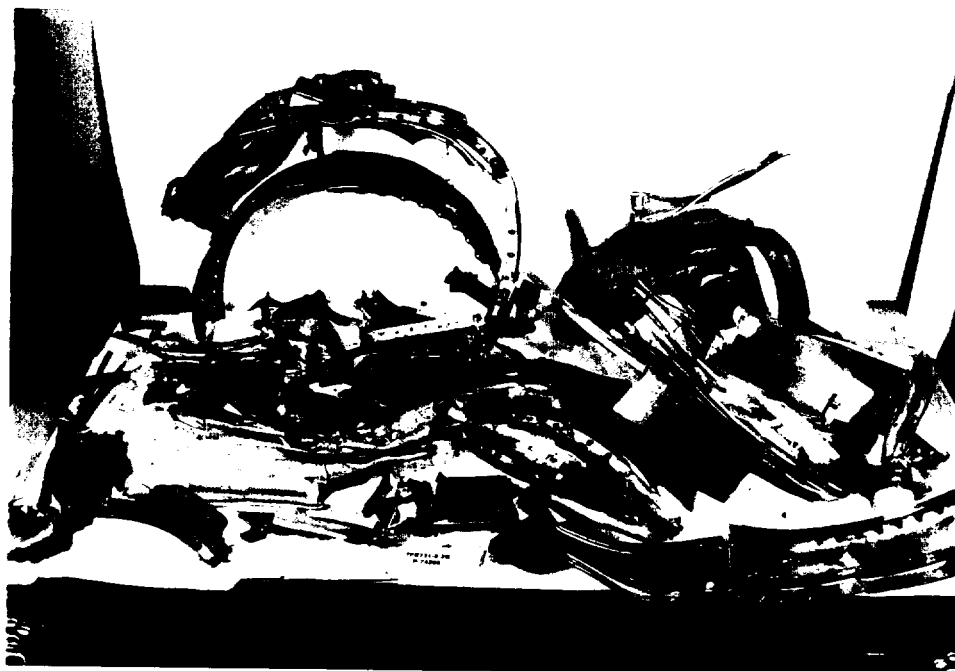
Figure 141. (Photo No. 42-12) Damaged Main Mount.

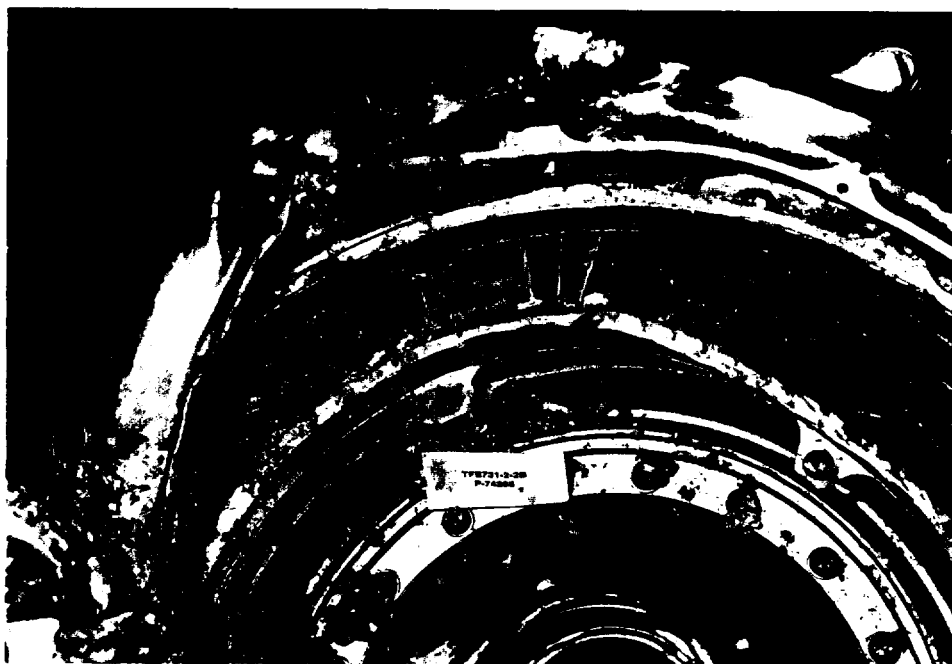
Figure 172. (Photo No. 42-4) Damaged Fourth-Stage LP Compressor Stator, with Scored Inner Vane Support.

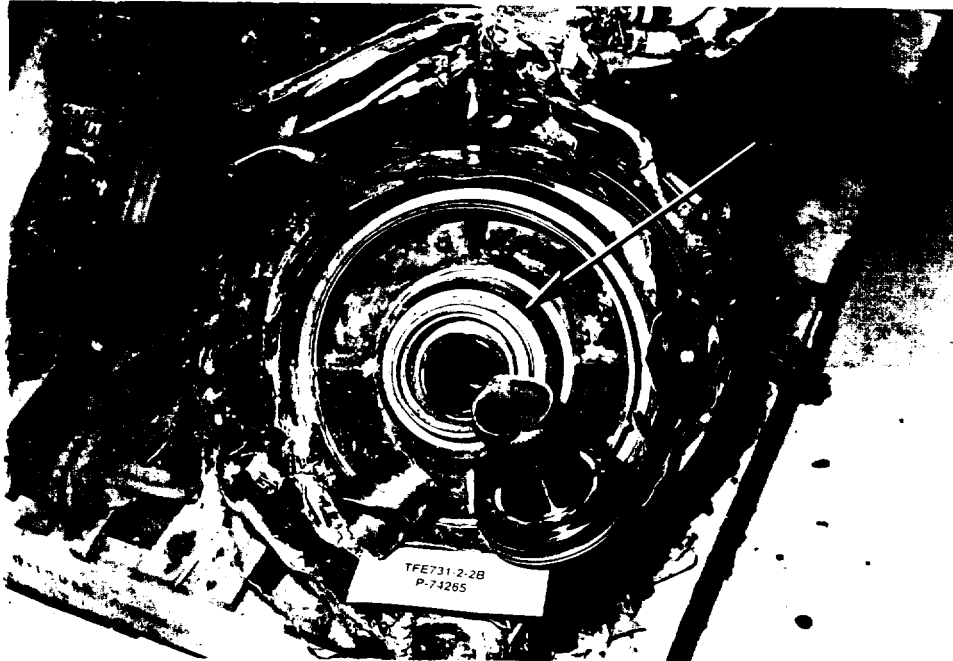
Figure 179. (Photo No. 45-36) Damaged Compressor Housing, with Score Marks, and Broken HP Shaft.

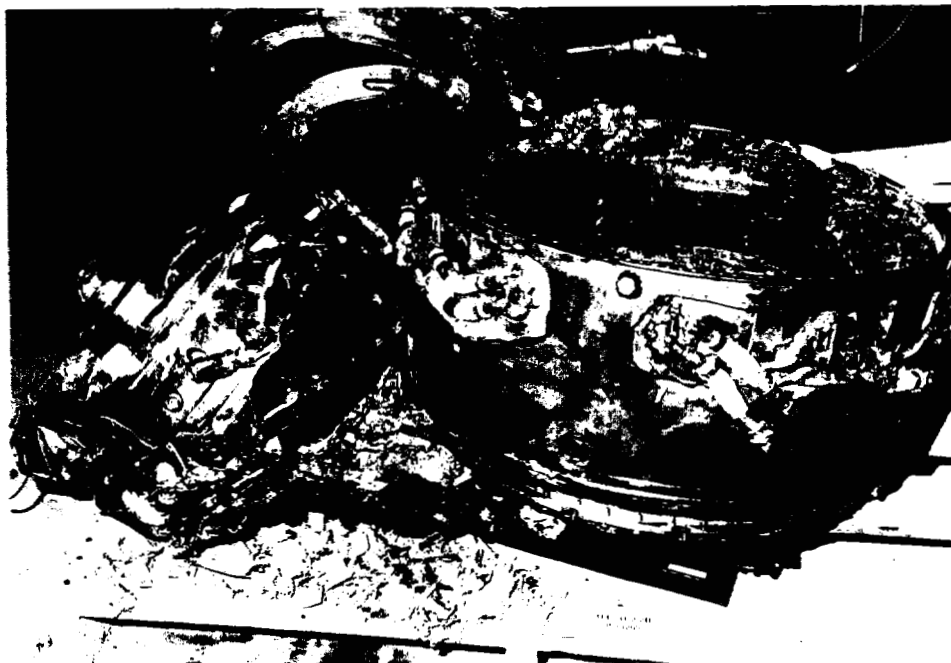
Figure 186. (Photo No. 40-35) Damage to the Combustion Section.

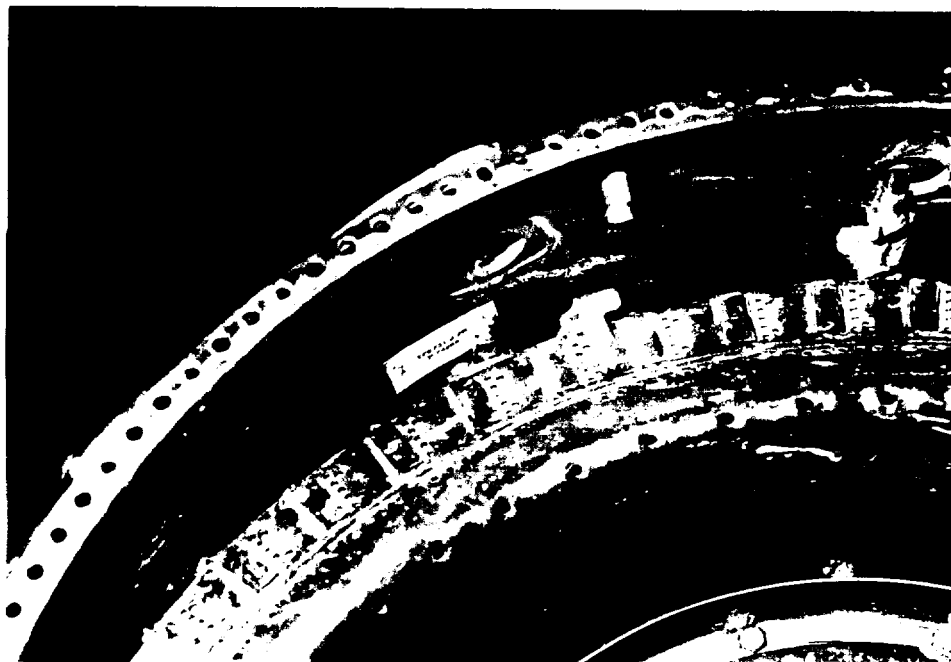
Figure 187. (Photo No. 40-36) Broken Fuel Nozzle Housing.

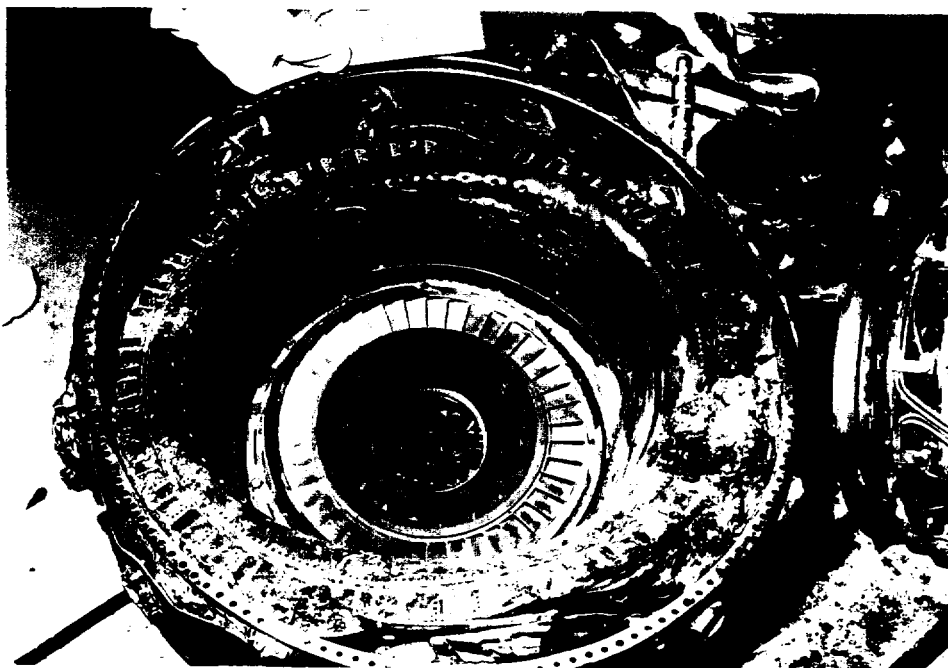
Figure 189. (Photo No. 38-6) Damaged Combustion Chamber.

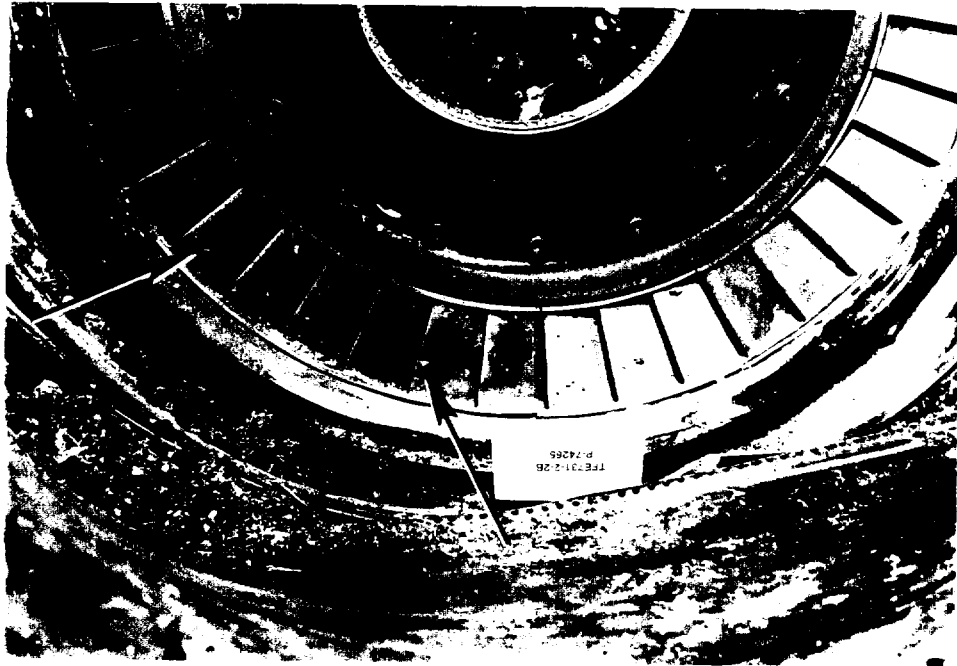
Figure 199. (Photo No. 40-33) Metal-Spray Deposits on the HP Turbine Stator Vanes.

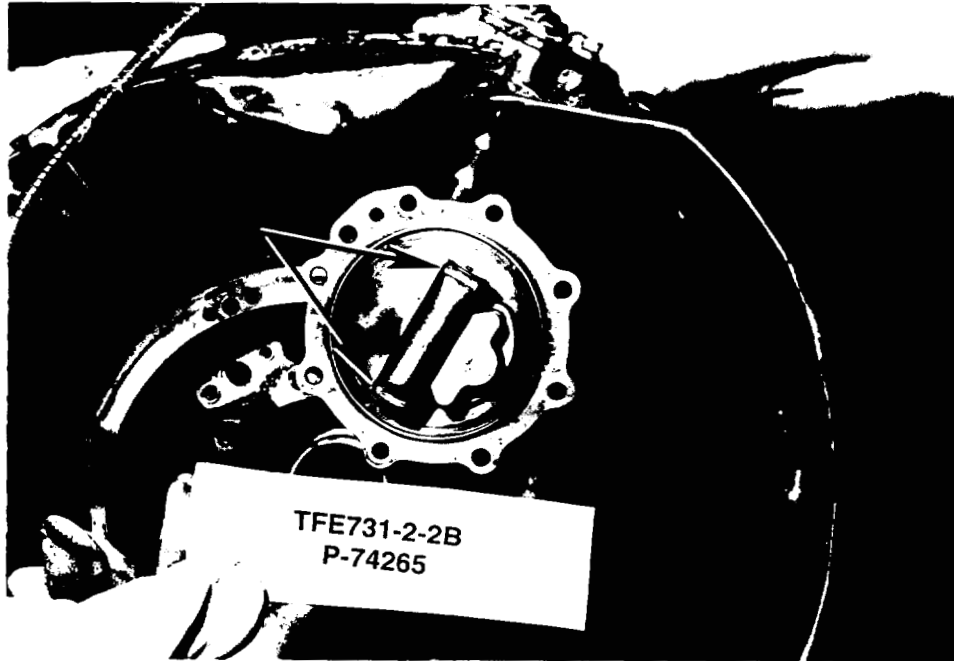
Figure 205. (Photo No. 38-9) Contact Marks on the N1 Monopole.

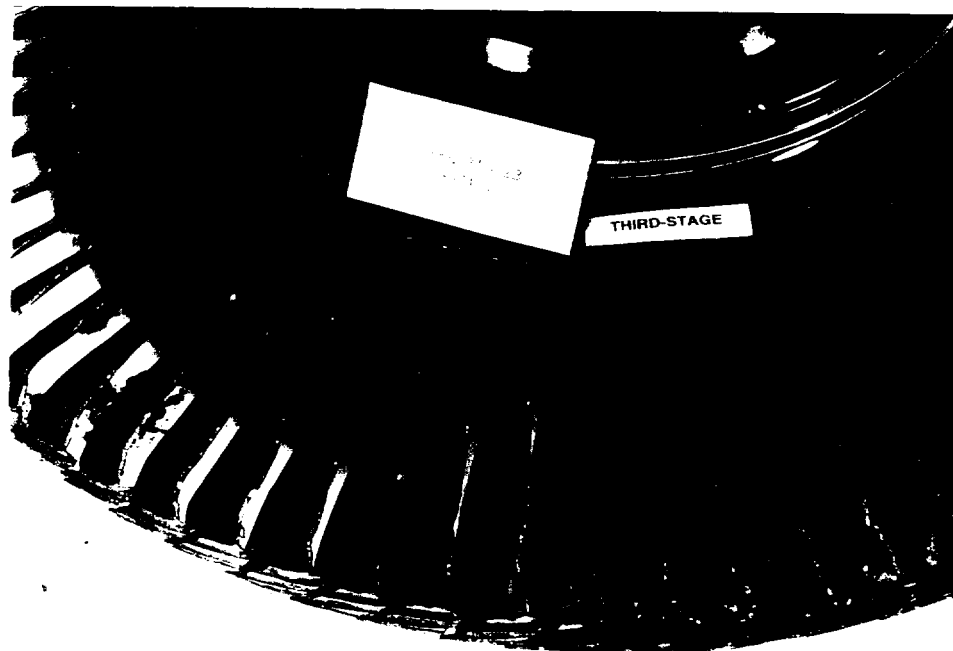
Figure 233. (Photo No. 42-31) Damaged Third-Stage LP Turbine Rotor Blades.

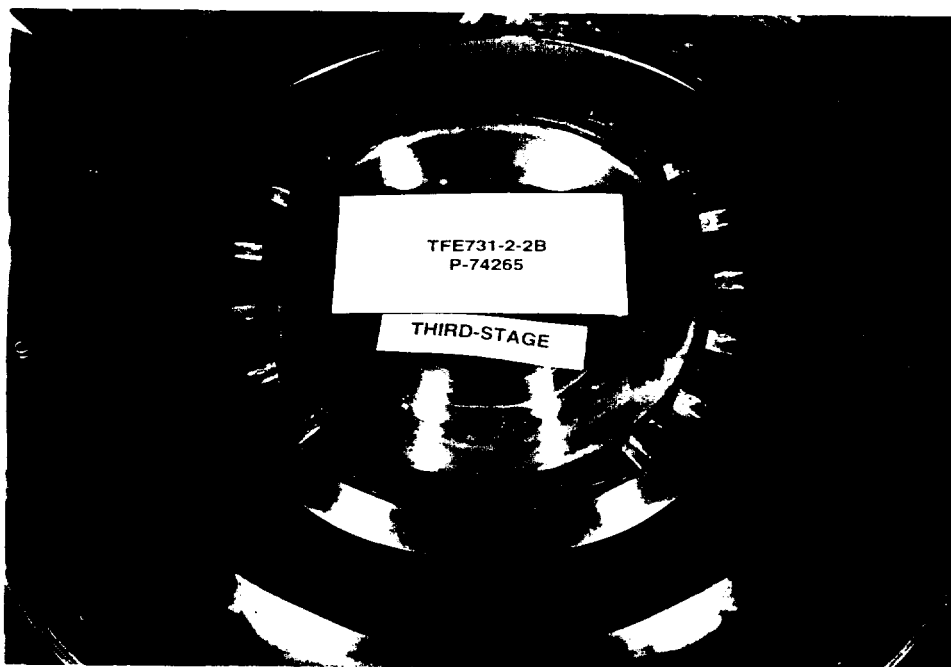
Figure 237. (Photo No. 42-32) Damaged Curvic Coupling Teeth.

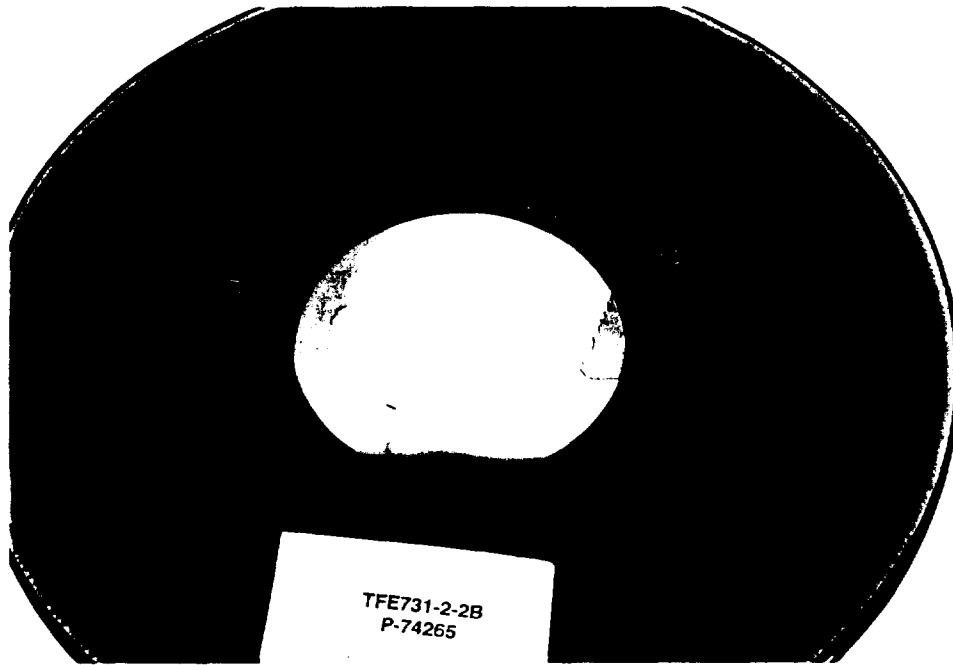
Figure 247. (Photo No. 45-22) Damaged LP Rotating Seal Forward Curvic Coupling Teeth.

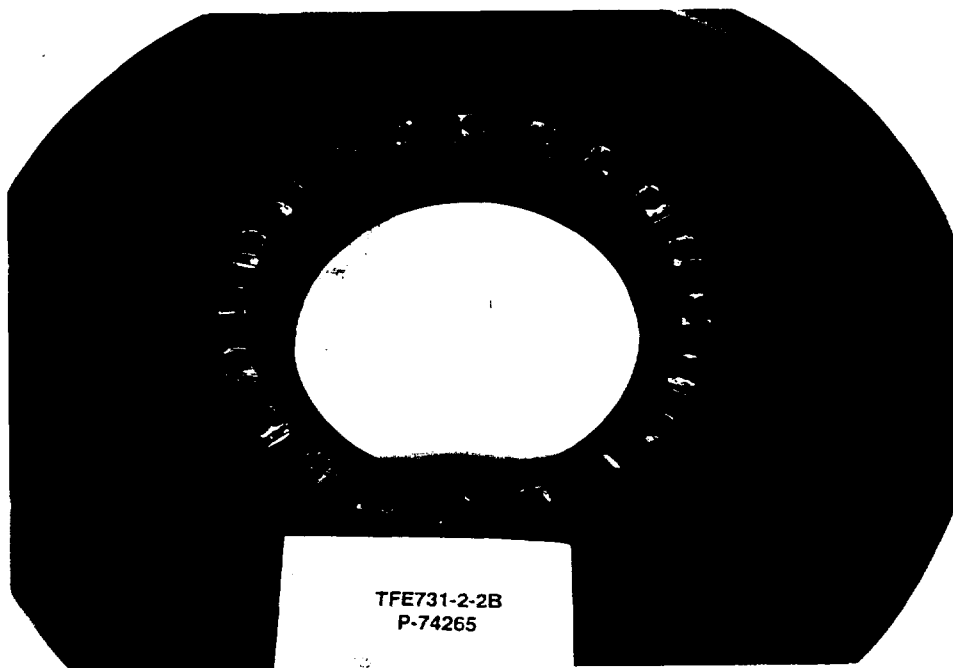
Figure 248. (Photo No. 45-23) Damaged LP Rotating Seal Aft Curvic Coupling Teeth.
