AIRWORTHINESS GROUP CHAIRMAN'S REPORT

CEN09MA142

ADDENDUM 1

Operator: Empire Airlines, Inc.
Location: Lubbock, TX
Date: January 27, 2009
Time: 0437 central standard time
Aircraft: N902FX, ATR-42-320

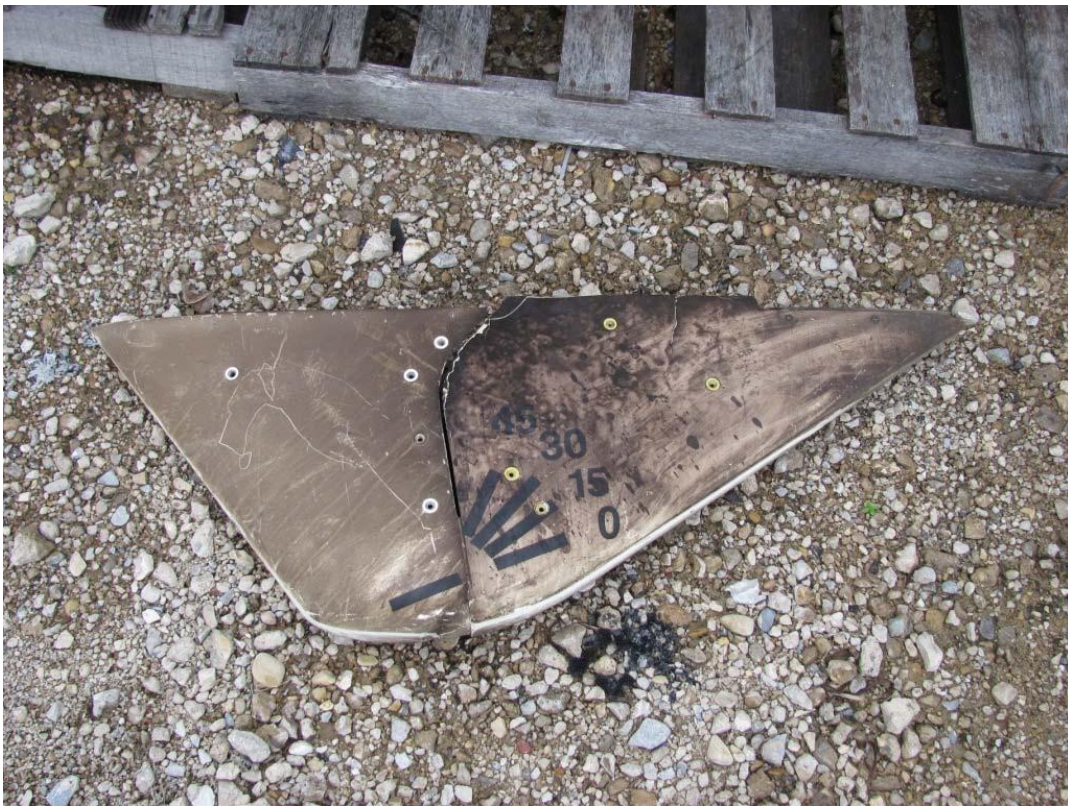
Photo 1. Flap Position Fairing

The flap position fairing on the left wing was documented. The left wing markings were sooted. The right wing fairing was consumed in the post-impact fire. The cockpit switch to activate the wing lights was in the “ON” position.
