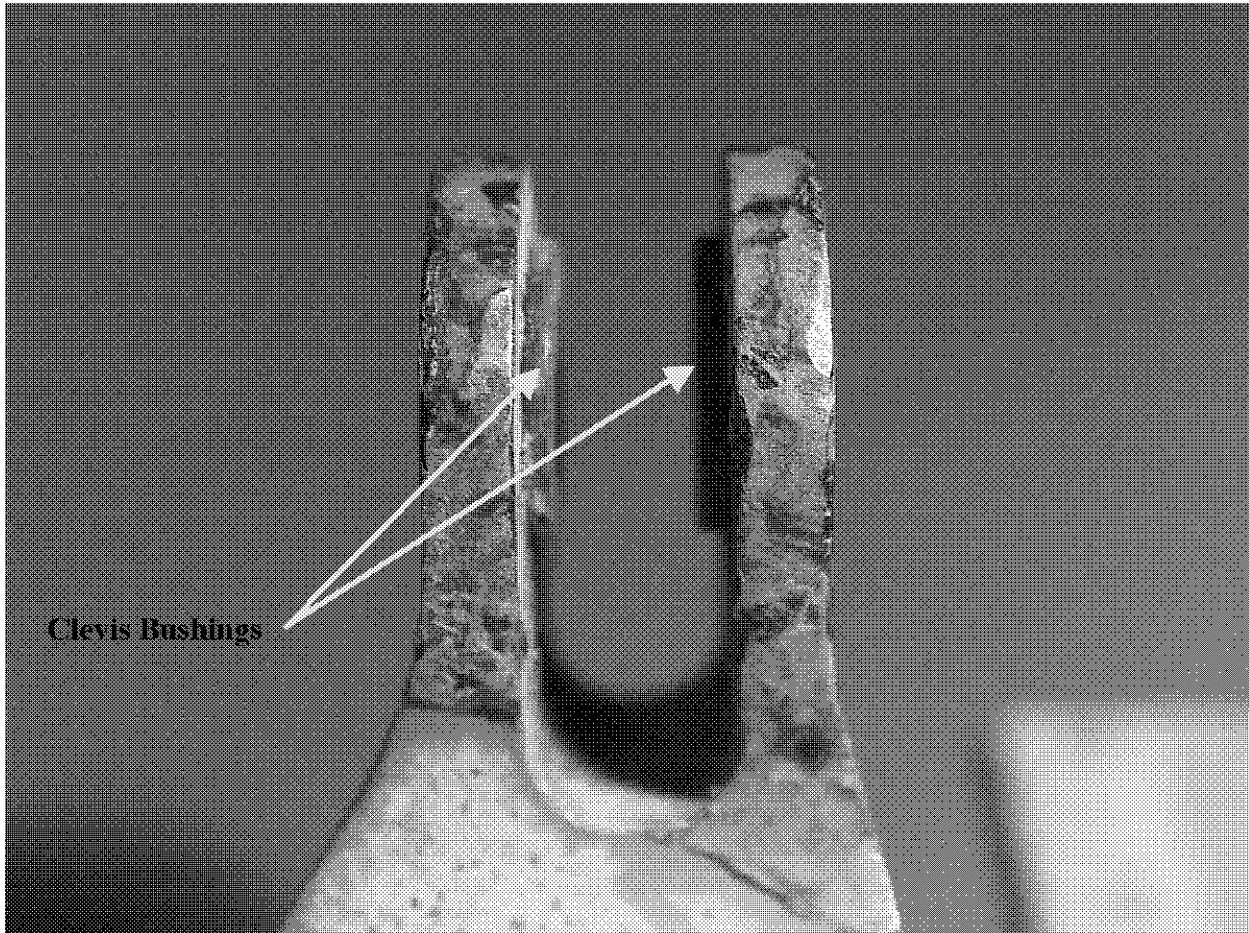
Photo 6: Close up of the R/H Control Tab Crank (clevis) Fitting. View looking aft.
Note the contact damage on the forward face of each clevis lug.
