DOCKET No.: SA-521
EXHIBIT No. 7E

AIRWORTHINESS GROUP CHAIRMAN'S FACTUAL REPORT
ATTACHMENT IV: Douglas SB No. 27-262

Bulletin 27-262

FLIGHT CONTROLS - Elevator And Tab - Modify Elevator Geared Tab Mechanism.

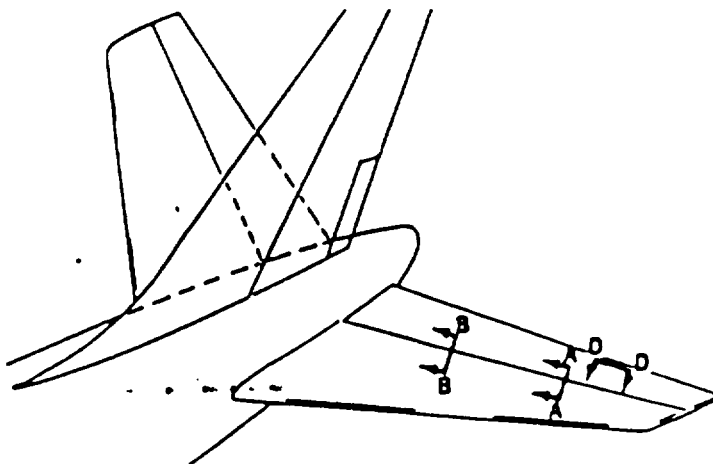
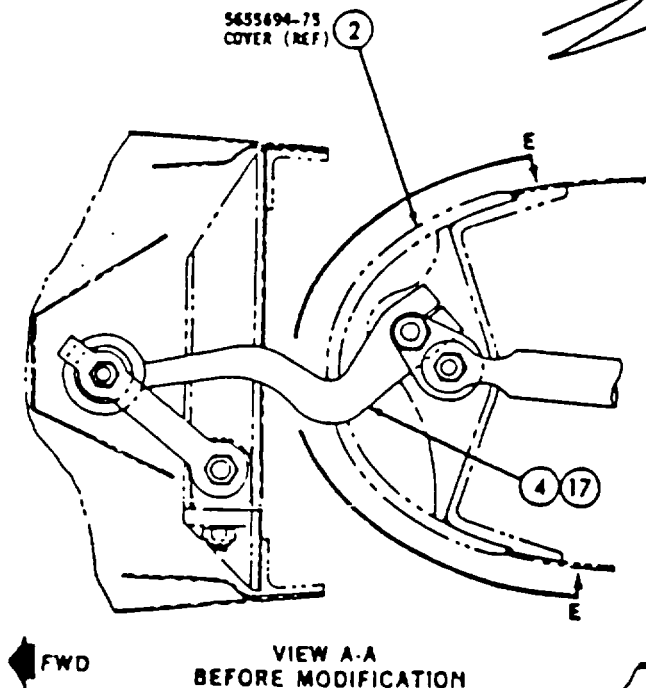
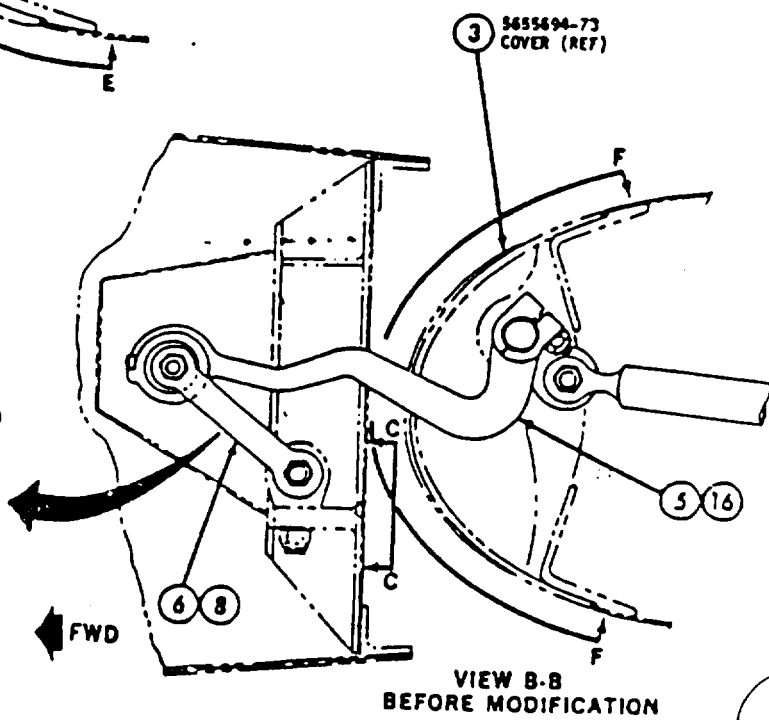
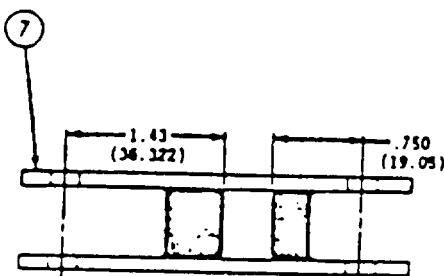
FIGURE 1 (SHEET 2 OF 7)

One operator reported one instance that during takeoff, at approximately 80 knots, the aircraft became uncontrollable in a nose-up direction resulting in an aborted takeoff. Investigation revealed that the left elevator inboard and outboard geared tab drive crank assemblies had failed. Further, it was noted that the elevator gust lock crank assembly had failed. It is suspected that failure of the geared tab crank assemblies occurred when the aircraft was parked in high gusty winds with the gust lock not engaged.

- ① (NOT SHOWN) REMOVE AND RETAIN ELEVATOR AND ATTACHING PARTS. (SEE MM CHAPTER 27-30-1, PARAGRAPH ENTITLED "REMOVAL/INSTALLATION ELEVATOR.")
- ② REMOVE AND RETAIN 5655694-75 COVER AND ATTACHING PARTS AT STATION X=192.250. (SEE VIEW A-A.)

- ③ REMOVE AND RETAIN 5655694-73 COVER AND ATTACHING PARTS AT STATION X=112.188. (SEE VIEW B-B.)
- ④ REMOVE AND RETAIN 4710542 ARM ASSEMBLY AND ATTACHING PARTS. (SEE VIEW A-A.)

- ⑤ REMOVE AND RETAIN 4710541 CRANK ASSEMBLY AND ATTACHING PARTS. (SEE VIEW B-B.)
- ⑥ REMOVE AND RETAIN 2710493-501 OR -503 LINK AND ALL ATTACHING PARTS, EXCEPT MS24665-151 COTTER PIN.

- ⑦ MODIFY LINK BY REMOVING MATERIAL AS SHOWN. REIDENTIFY AS 2710493-505 PER OPERATOR'S SHOP PRACTICE.
- ⑧ INSTALL MODIFIED AND REIDENTIFIED 2710493-505 LINK USING RETAINED ATTACHING PARTS AND NEW MS24665-151 COTTER PIN.

- ⑨ CHAMFER FITTING AT STATION X=112.188 AS SHOWN. (SEE VIEW C-C.)
- ⑩ ENLARGE CUTOUT IN ELEVATOR FORWARD SPAR AT STATION X=221.000 TO DIMENSIONS SHOWN. (SEE VIEW D-D.)
