NATIONAL TRANSPORTATION SAFETY BOARD

AIRWORTHINESS GROUP CHAIRMAN'S FACTUAL REPORT

A. ACCIDENT: DCA00MA026

Location: Rancho Cordova, CA
Date: February 16, 2000
Time: 1951 Pacific Standard Time
Aircraft: Emery Worldwide Airlines Flight 17, Douglas Model DC8-71F, N8079U

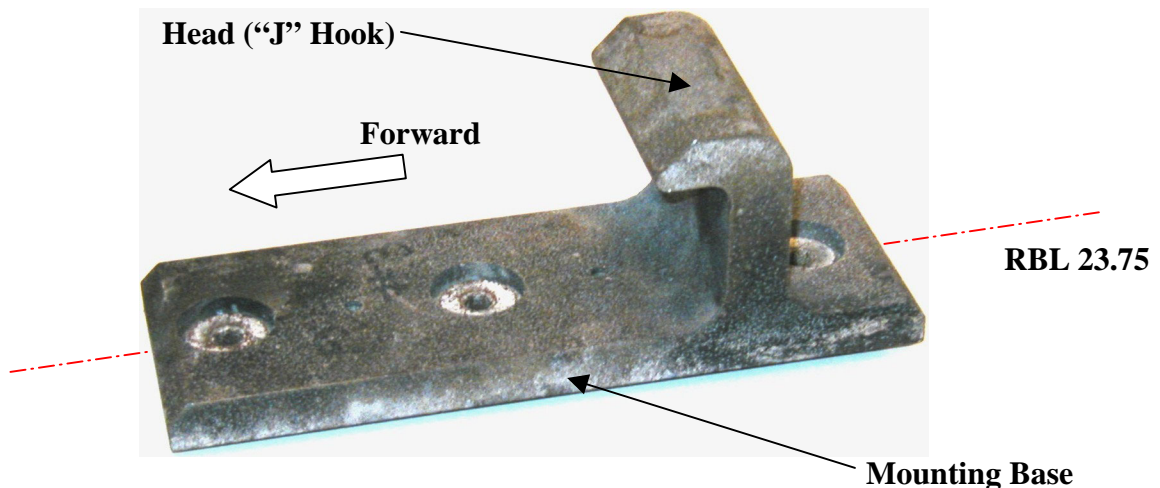
Figure I: Aft Cargo Stop, F.S. 1701, RBL 23.75

The aft stop, normally mounted to the seat track at RBL 23.75, was recovered intact and in good overall condition, however, separated from its seat track, that had been consumed by fire. The aft stop was discolored by soot and exhibited light scratches on the top of its head in the longitudinal (i.e. fore /aft) direction. See Figure I below.

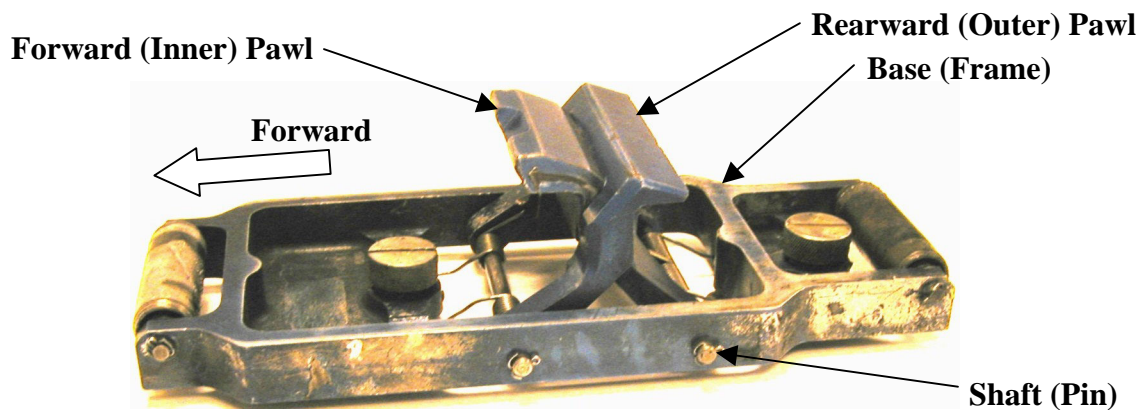
Figure II: Cargo Lock, "Up and Locked"

Refer to Figures II & III (below), for digital photographs of an undamaged cargo lock recovered from N8079U (unidentified location), shown in its up and locked position (Figure II), and when stowed (Figure III).

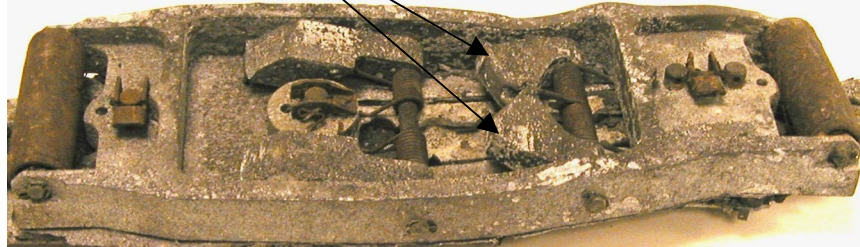
Figure IV: Cargo Lock, “Fractured Inner Pawl (Legs)”

Note: According to Boeing, structural loads in excess of 1.5g's, acting upon the cargo locks (aft of the main deck cargo door)⁶ in the forward direction; typically result in the bending of the inner and outer pawl shafts, followed by the deformation of the base frame surrounding the shafts, and thereafter by the tensile failure of the inner pawl leg(s) if the loads are extreme enough. Whereas, loads in excess of 1.5g's, acting upon the same cargo locks, in the rearward direction, typically result only in the bending of the inner and outer pawl shafts and /or the deformation of the base frame surrounding the shafts. Conversely, the cargo locks installed forward of the main deck cargo door, i.e. between positions No. 1 and 2, are reversed to facilitate cargo loading /unloading operations from position No.1. Thus, the failure of these cargo locks would also be reversed with respect to the direction of loading.

Refer to Figure IV (below), for a digital photograph of a cargo lock (installation location unknown) where both inner pawl legs were found fractured, consistent with the description provided by Boeing for failures in the forward direction. Note: The missing inner pawl body

was not recovered with the rest of the cargo lock, and was therefore presumed destroyed by the post crash fire.

**Inner Pawl Fractures,
(2) Locations**

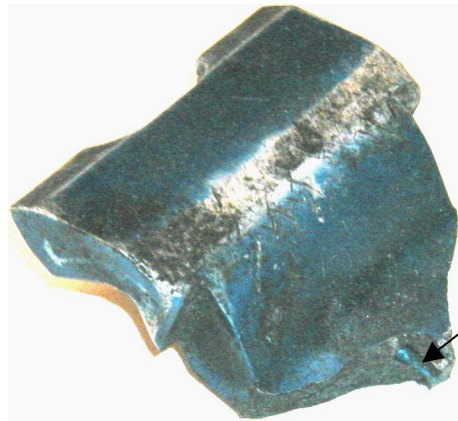
Figure V: Cargo Lock, “Inner Pawl (Body)”

Refer to Figure V (below), for a digital photograph of a cargo lock inner pawl (body), that was recovered separately (installation location unknown) and fractured similarly to the cargo lock shown in Figure IV.
