NATIONAL TRANSPORTATION SAFETY BOARD

AIRWORTHINESS GROUP CHAIRMAN'S FACTUAL REPORT

AIRWORTHINESS GROUP CHAIRMAN'S REPORT
CEN09MA142

Operator: Empire Airlines, Inc.
Location: Lubbock, TX
Date: January 27, 2009
Time: 0437 central standard time
Aircraft: N902FX, ATR-42-320

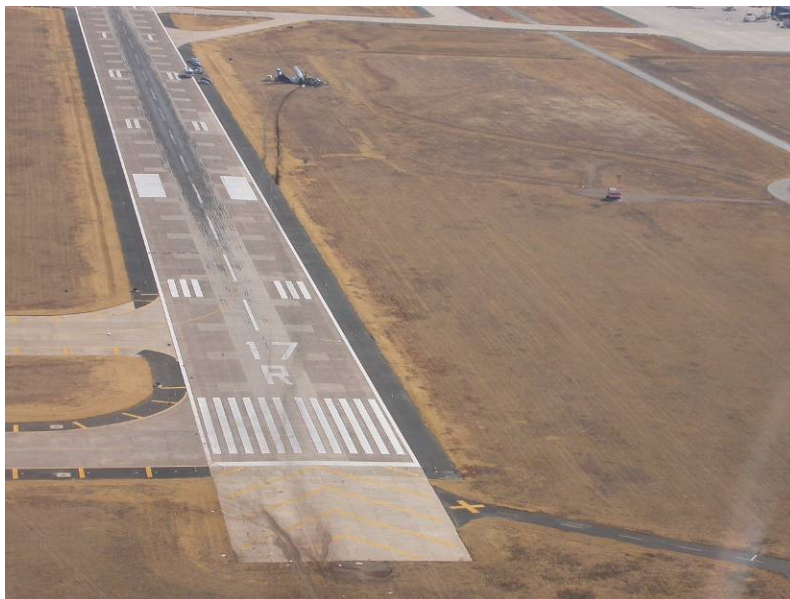
Photo 1. Aerial View of Accident Site

The initial impact point was characterized by two ground scars consistent with touchdown of the right main landing gear. It was located 17 feet east of the extended runway centerline, midway between the last and second to last series of the approach lighting system. The two scars ran parallel to each other on a 170 degree magnetic heading, measuring 16 inches from center to center, 8 feet long, and about 0.5 inches deep.

The second impact point and its subsequent (main) ground scars began 8 feet south of the end point of the initial impact scars and were continuous for 279 feet to the north edge of the runway overrun, intersecting it 38 feet east of the runway centerline. The first 13 feet of the ground scar was characterized as a trench, beginning about 1 foot wide, deepening to about 1 foot deep and widening to about 2 feet. The remainder of this scar consisted of flattened grass and mild soil disruption to the edge of the runway overrun.

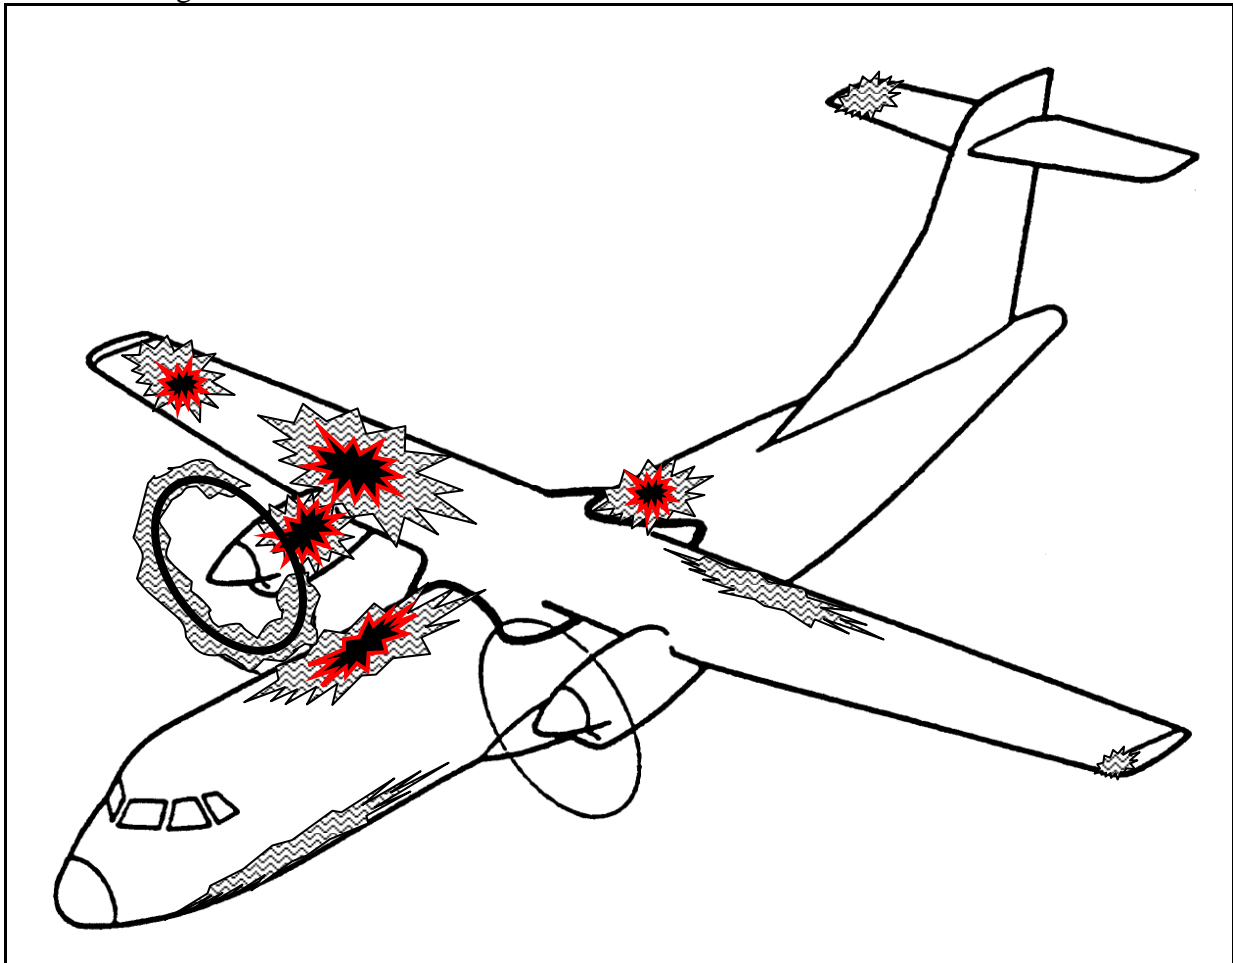
Figure 1. Damage Distribution Topside (Provided by ATR)

The wreckage was documented at the accident scene. The majority of the wreckage remained intact, although it had sustained impact and fire damage. Overall damage is outlined in Figures 1 and 2.

Deformations, fire contamination

Cracks and perforations

Cracks and perforations in areas also exposed to fire and severely damaged due to overheating

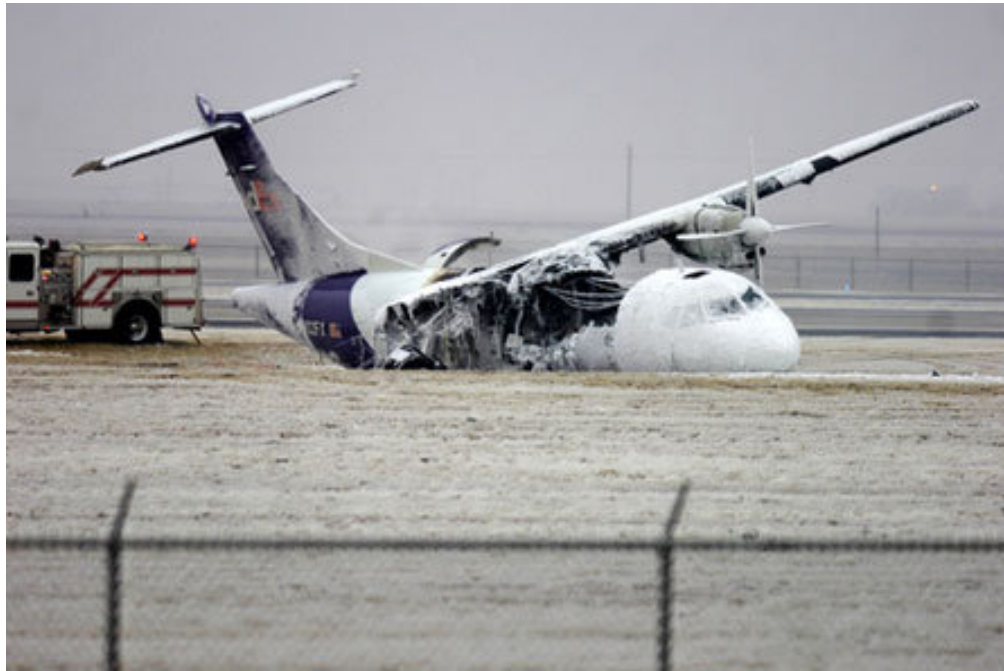
Photo 2. Accident Site (Provided by FAA)

The airplane was resting on its fuselage nose section and leaning to the right, with the nose landing gear embedded in the belly of the forward fuselage section. The nose landing gear wheels and nose landing gear sliding leg were identified in the initial debris field at the runway threshold. The right main landing gear fitting, side brace fitting, strut fittings, and struts were identified in the initial debris field at the beginning of the runway. The left main landing gear remained attached to the fuselage.

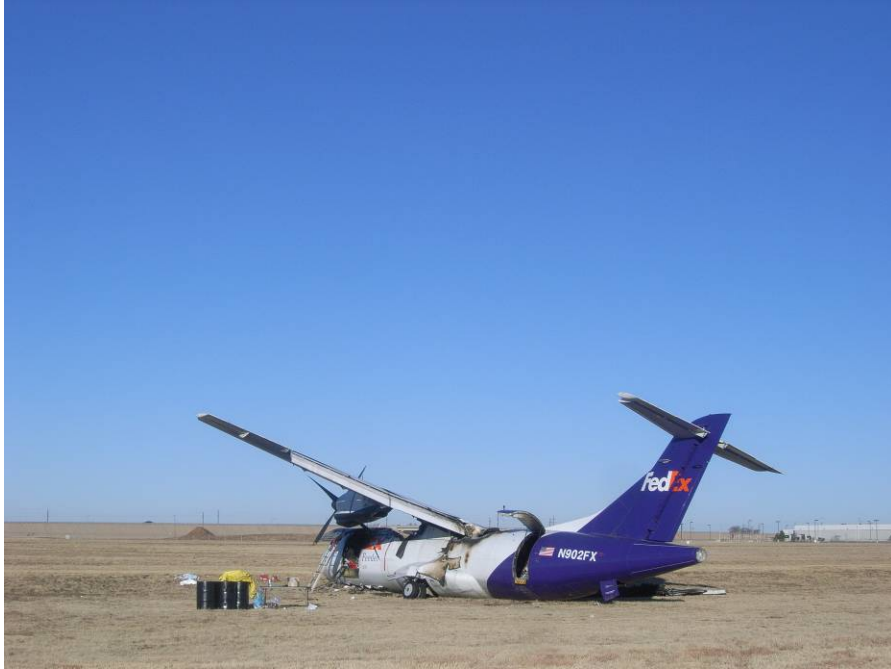
Photo 3. Left Side

The lower forward fuselage was severely crushed from frame 1 aft to approximately frame 7 on the right side. From frame 7 to frame 21, it was crushed on both sides. There was evidence of scoring marks and skin buckling damage. The right lateral upper panels and crown panels between frames 16 and 25 and from the floor line on the right side to stringer 4 on the left side were entirely destroyed by fire. The cargo door on the left forward side of the fuselage and the surrounding frame and structure sustained minimal damage and the door functioned normally when operated. The six cockpit windows were intact and showed no evidence of damage other than the discoloration marks from the fire.

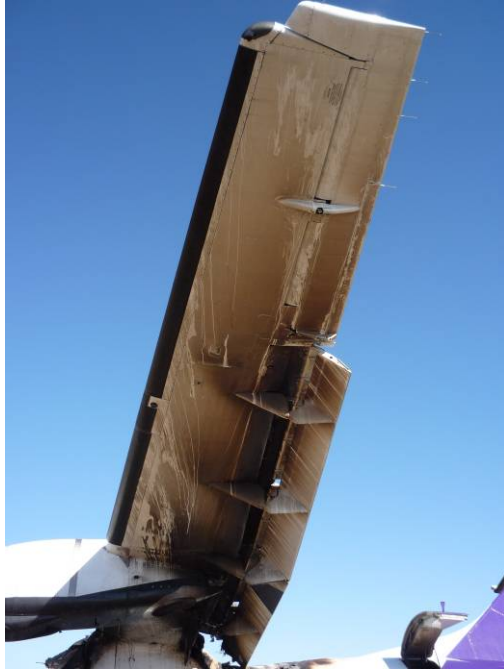
Photo 5. Left Wing

The left wing outer wing box remained undamaged other than paint discolorations and burn damage at the trailing edge panels/flaps between rib 13 and rib 23. The strobe light transparency sustained impact damage. The leading edge boots and ice detector system remained in relatively good condition.

The left center wing box was intact with no damage, except for sooting. The trailing edge panels from rib 4 to rib 23 were deformed and sustained fire damage.

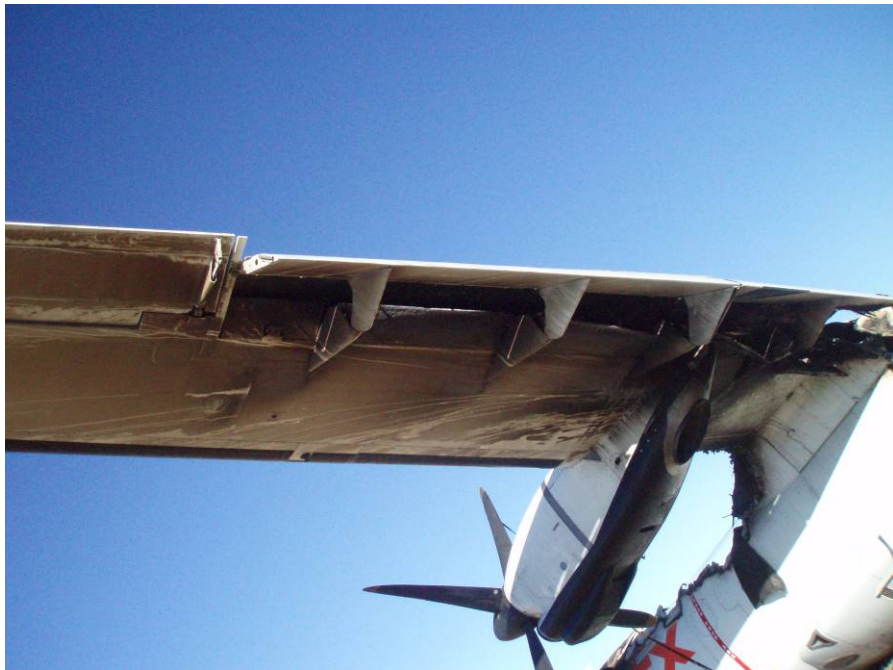
Photo 6. Left Wing Inboard

The left flaps had been exposed to fire and the trailing edge panels were severely burnt and deformed with the composite fibers exposed. Both flaps were in the fully extended position and the hydraulic circuit had been opened in several areas. The connecting strut between the inboard and outboard flaps was structurally intact and connected to its respective attachment points. Both actuators were burnt, but remained attached to the wing. The inboard actuator was leaking.

The flaps remained attached to the wing, but the inboard flap separated from its inboard hinge. The inboard flap arm/beam connection failed at rib 4 and the flap beam was deformed and cracked. Visual inspection revealed no additional damage to the left flaps and after the torque tube and actuators were disconnected, both flaps were manually extended and retracted.

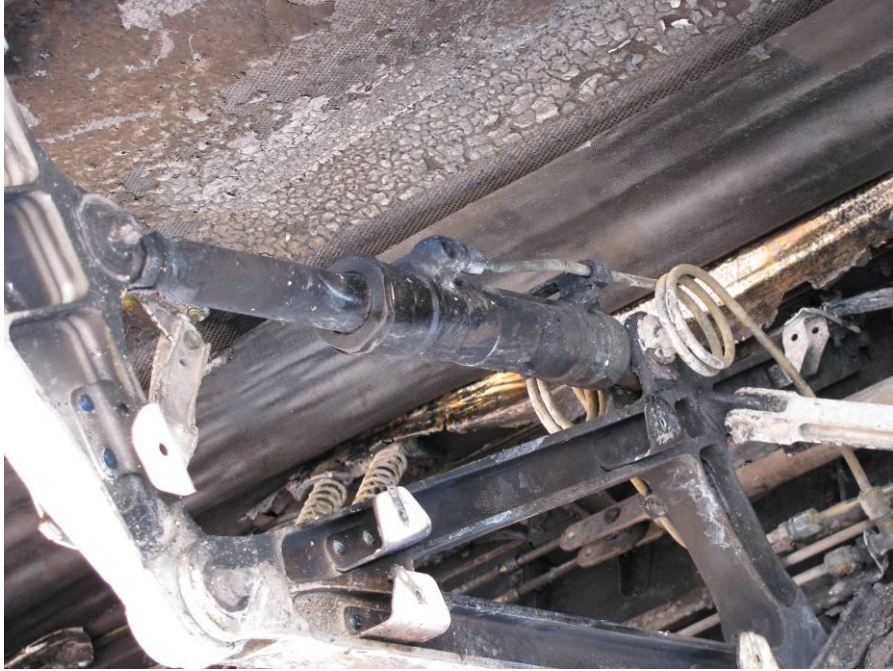
Photo 7. Left Outboard Flap Actuator

The extension of the piston rod for the left outboard actuator was 206 millimeters (mm). Free movement of the bearing was observed for the spherical bearing of the rod end, and was in conformity with acceptance criteria. Free movement was also observed on the spherical bearing of the body. The piston extension for the left inboard actuator was 197 mm. Both spherical bearings were in conformity with acceptance criteria.

The left actuators were filled with hydraulic fluid and then installed onto a test bench. No leak was observed on the left outboard actuator, and a slight leak was observed on the left inboard actuator at a hydraulic line fitting. The left actuators were placed on a tension machine, and two successive cycles of compression and tension were performed.

A modified leak test was developed. The left actuators were cleaned and placed in a container of hydraulic fluid and vacuum chamber. They were then placed on a test bench, and loads up to 700 daN were applied. The left outboard actuator showed no leakage, and the left inboard actuator showed minimal leakage. Investigators noted that a small hydraulic leak had developed at the hydraulic transfer tube fitting at the body end.

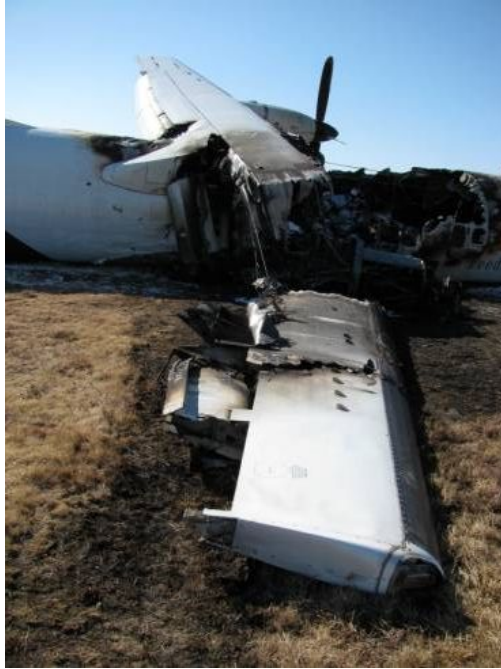
Photo 9. Right Wing

The right wing was fractured and partially destroyed due to fire. The right engine was resting on the ground. Half sections of the right hand inboard and outboard flaps were destroyed by fire. The left hand inboard flap inboard hinge and all right hand flap hinges were broken. The right hand outboard flap actuator was fully retracted while the three remaining actuators of the left hand and right hand flaps were found in the fully extended position.

The right wing outer wing box was fractured at rib 15, and from rib 13 to rib 15 had been destroyed by fire. The right outboard wing section was also fractured and burnt between rib 23 and rib 24. The edge of the fuel tank is located at rib 22 and the fuel tank venting device is located between rib 22 and 23. The fracture occurred just after rib 23. Both sections of the outer wing box remained attached by the forward spar, internal wing structures, and the lower panel. The upper panel between rib 24 and rib 30 showed evidence of skin wrinkling. The leading edge section from rib 22 to the wing tip was undamaged. The flap hinge/beam underneath the wing at rib 21 and its fairings were still in position, but burnt, deformed, and cracked. On the lower portion of the right outboard wing, there was minimal scraping (fore and aft), and damage was localized to small areas. On the remaining sections of the leading edge, there was no evidence of direct frontal impact. The portions of leading edge boots that remained sustained fire damage.

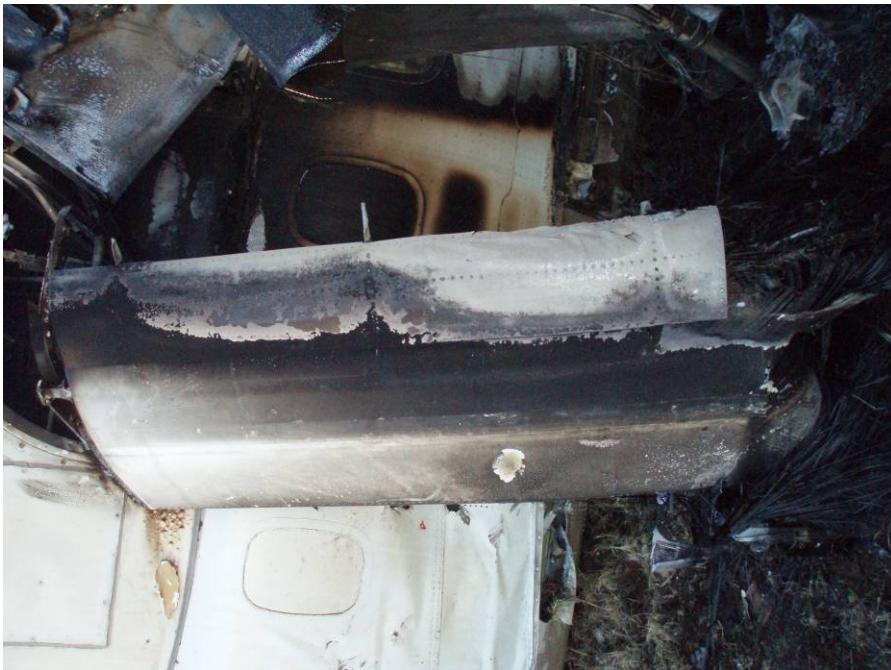
Photo 10. Right Wing Half Inboard Section of Inboard Flap

The right flap inboard section was hanging from the wing attached from its inboard hinge, but separated from its mid and outboard hinges. The outboard portion of the inboard flap was destroyed by fire. The actuator was hanging and still attached by the hydraulic lines to the rear spar. The actuator was fully extended and bent. The inboard and outboard flap arms at wing rib 13 and the interconnecting strut were not identified, other than small melted pieces.

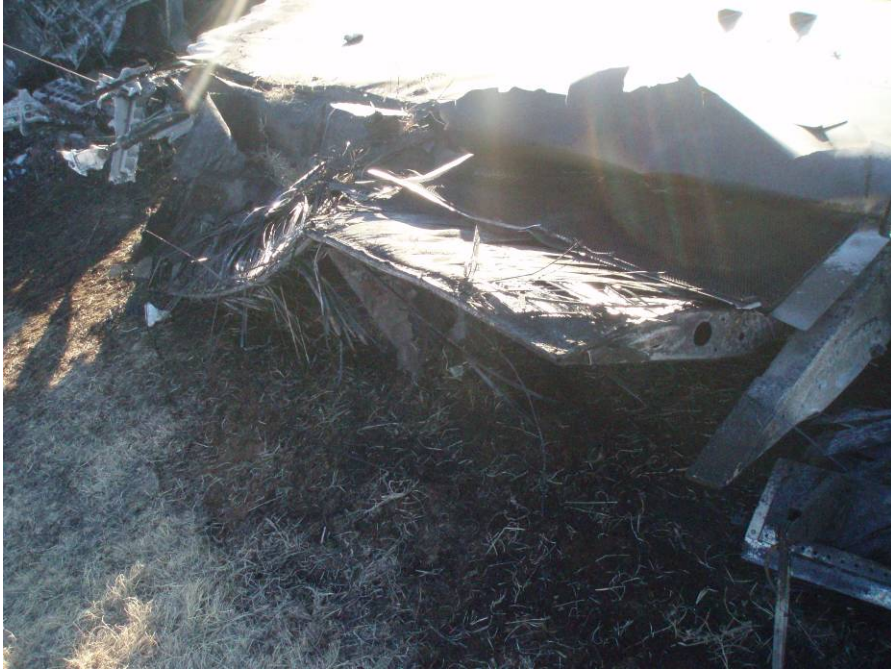
Photo 11. Right Outboard Portion of Outboard Flap

The outboard flap half outboard section was resting on the ground and partially attached to the outer-wing box. The inboard section of the outboard flap was destroyed by fire. The outboard actuator remained attached to the wing rear spar by a fractured section of the beam as well as a fractured section of the flap arm. The outboard actuator of the outboard right flap was in a fully retracted position.

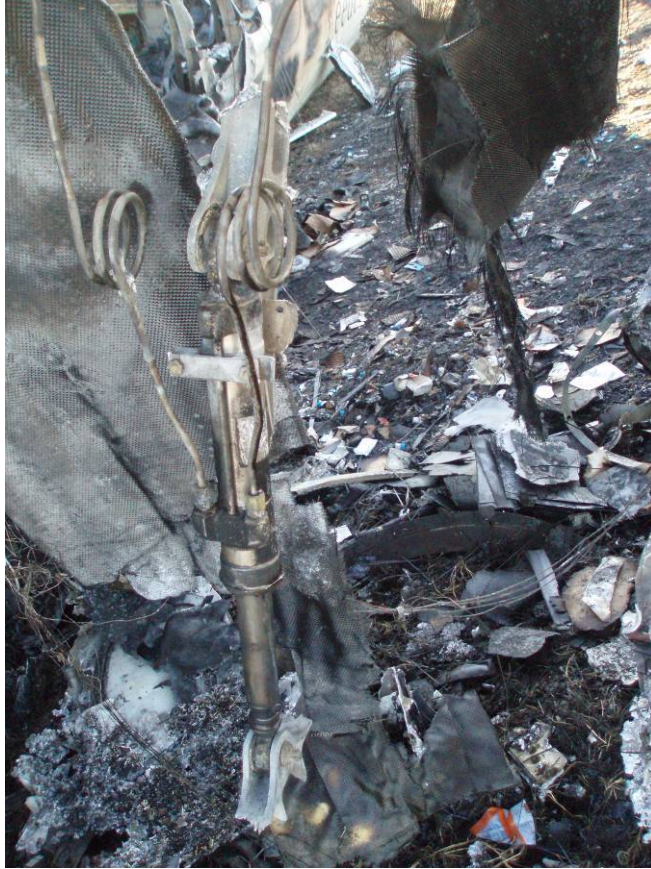
Photo 13. Right Wing Inboard Flap Actuator

The right actuators were placed on the tension machine under dynamic load and no movement was obtained from either piston. The right outboard actuator was placed on the tension machine, and a static load from 100-500 deca newtons (daN) was applied. No movement was obtained. The right inboard actuator was bent. Therefore its installation on the bench required adaptation and after the first load application (up to 80 daN), it was decided not to increase the load further. Due to the lack of movement of the right actuators and the external seal damage, no leak test could be performed. cursory examination of the right outboard actuator revealed that the small chamber fitting connector appeared completely obstructed. A sample of the material was obtained for analysis.²⁰

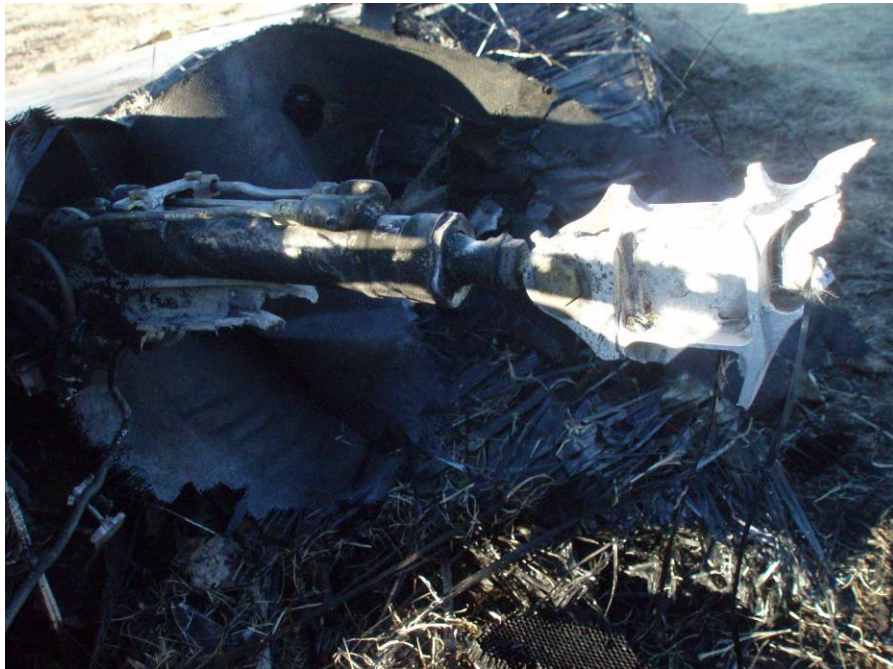
Photo 14. Right Wing Outboard Flap Actuator

The piston extension for the right outboard actuator was 70 mm. The spherical bearing was removed during the attachment axis removal, and no torque was measured. The spherical bearing of the body was jammed, but its internal ring was free in the attachment axis direction. The piston rod extension for the right inboard actuator was 206 mm. A free movement of the spherical bearing of the rod end was observed. The spherical bearing of the body was jammed.

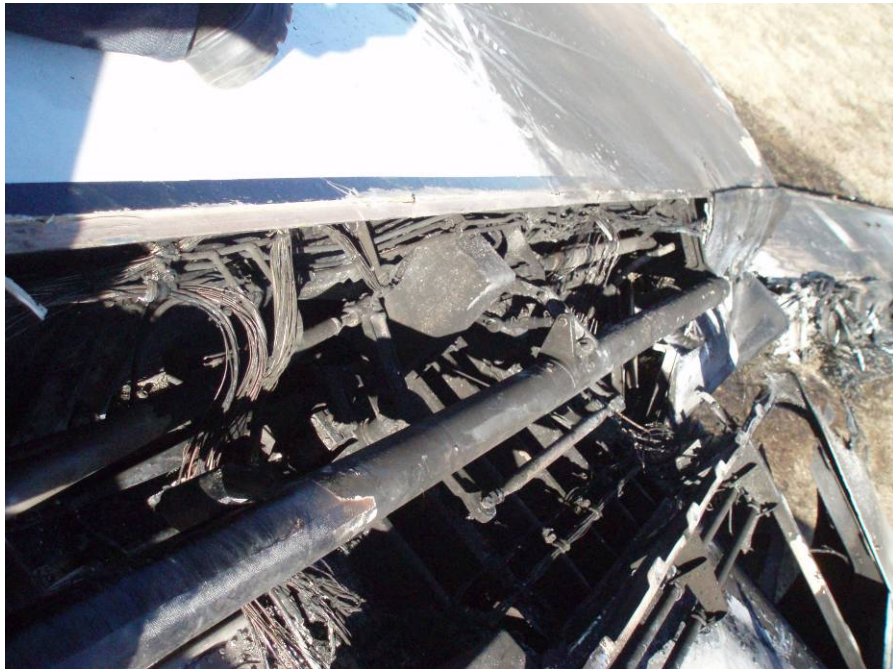
Photo 15. Flap Interconnect Torque Tube

The flap interconnecting torque tube, electro-hydraulic flap valve, the flap position feedback unit, and the flap asymmetry detector sustained burn damage, but all remained structurally intact and connected to their respective attachment points with the exception of the torque tube rods, which were both broken.

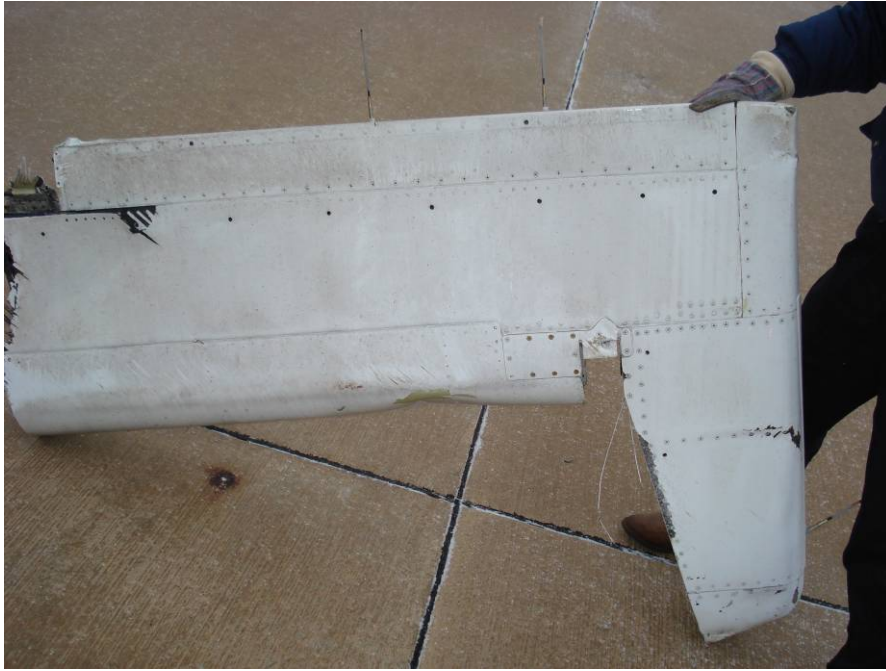
Photo 19. Outboard Right Aileron (Provided by FAA)

The outboard half of the right aileron separated from the wing and found at the runway threshold, with the horn crushed. Examination of the remaining flight control surfaces and control mechanisms confirmed that they were intact and connected to their respective attachment points.

The right aileron outboard half was separated from the wing and found at the runway threshold. FAA inspectors that responded to the accident reported finding ice adhering to the underside of the control surface. The aileron horn leading edge was crushed. The aileron trim tab was still attached to the remaining section of the aileron attached to the wing. The outboard hinge was not on the aileron and found trapped into the wing rear spar. The aileron separated just after the mid hinge. On the inboard half section of the aileron, the mid hinge fitting was still in place. The inboard hinge fitting was broken at

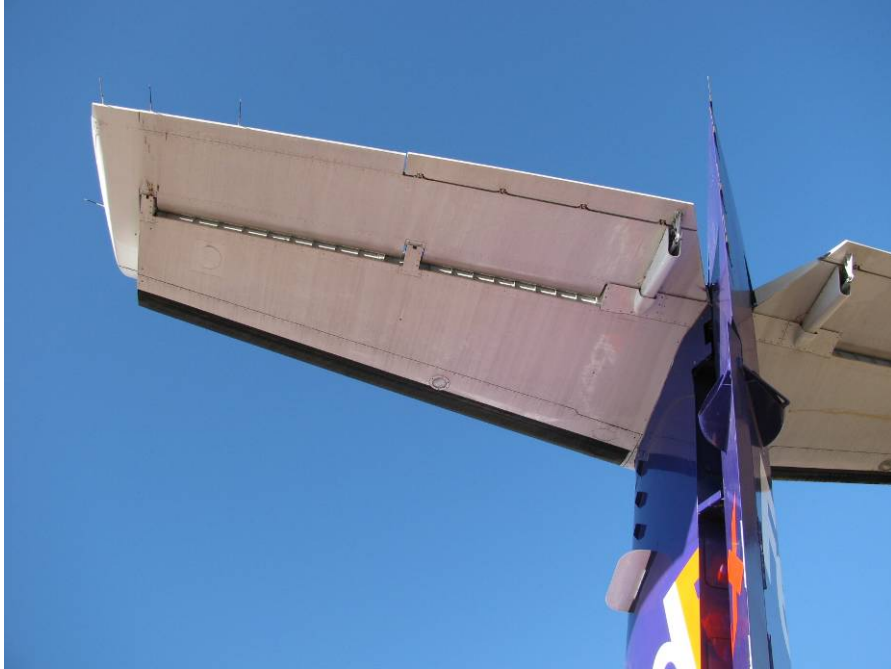
Photo 21. Left Horizontal Stabilizer and Elevator

There was no evidence of damage to the empennage section of the aircraft, except paint discolorations and burn traces at the right horizontal stabilizer tip and the right elevator horn, which had been exposed to fire. The vertical and horizontal stabilizer remained attached to the airplane, and showed no evidence of impact damage. The entire assembly of the vertical and horizontal stabilizer appeared to be very slightly rotated right about the longitudinal axis of the airplane.

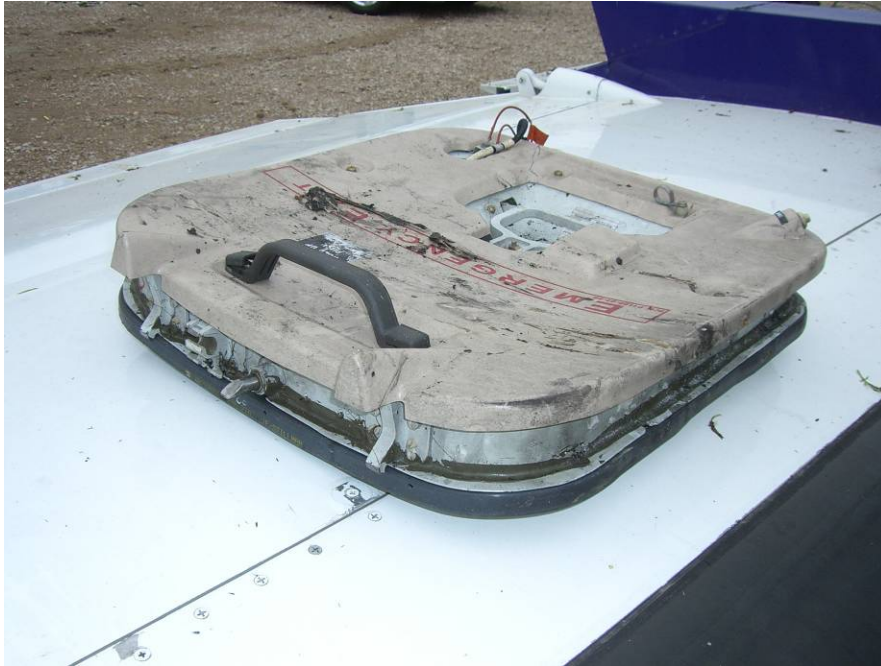
Photo 23. Escape Hatch

The doors on the airplane were examined. The entry and cargo doors opened and closed using the inner and outer handles. The escape hatch door had been opened by the first officer during the accident, and was found loose within the recovered wreckage. The

inner and outer handles worked when manually actuated, and no anomalies were noted with the hatch.

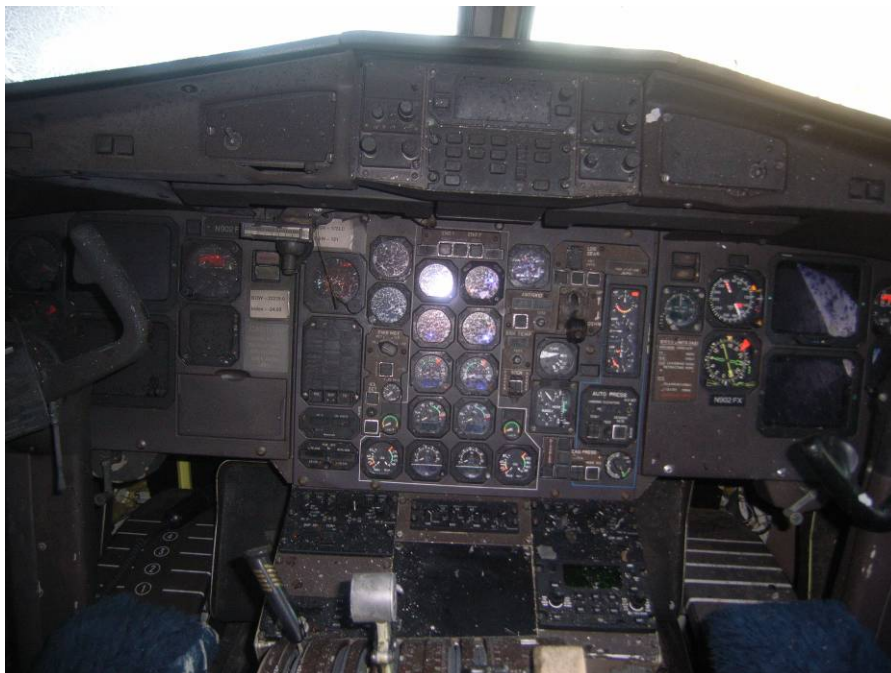
Photo 24. Cockpit

The cockpit sustained thermal damage and the surfaces were sooted. The readings are documented in the attachments for Section 3, item 3.2 Cockpit Documentation.

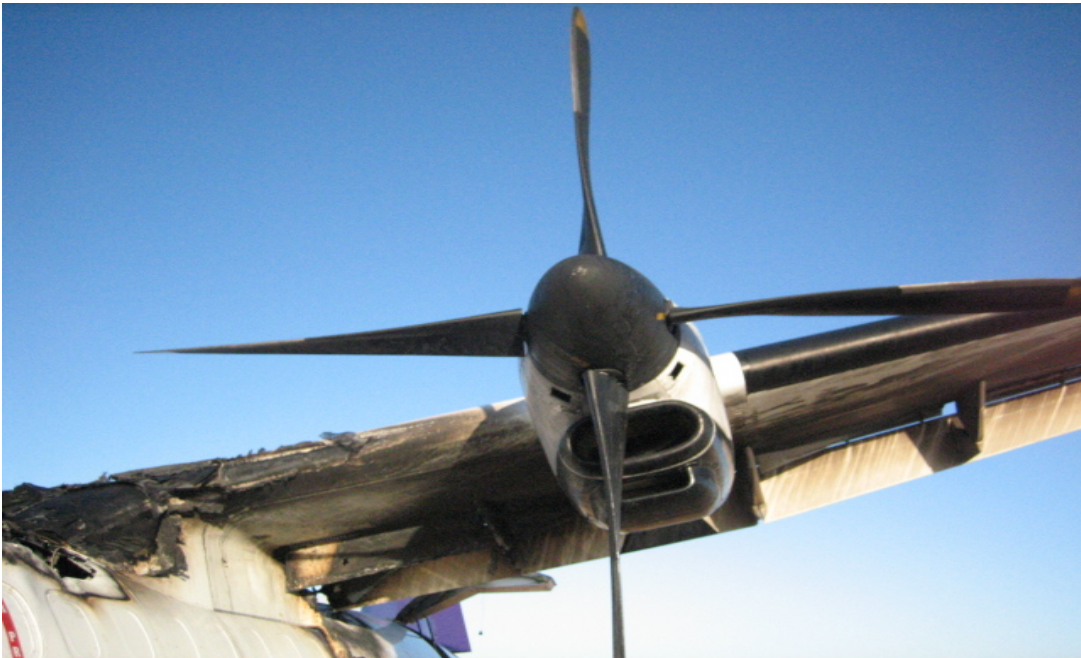
Photo 25. Left Powerplant

The number 1 engine, SN 120623, was visually examined from the ground. It remained attached to the left wing. The propeller rotated freely and minimal damage was noted to the propeller blades.

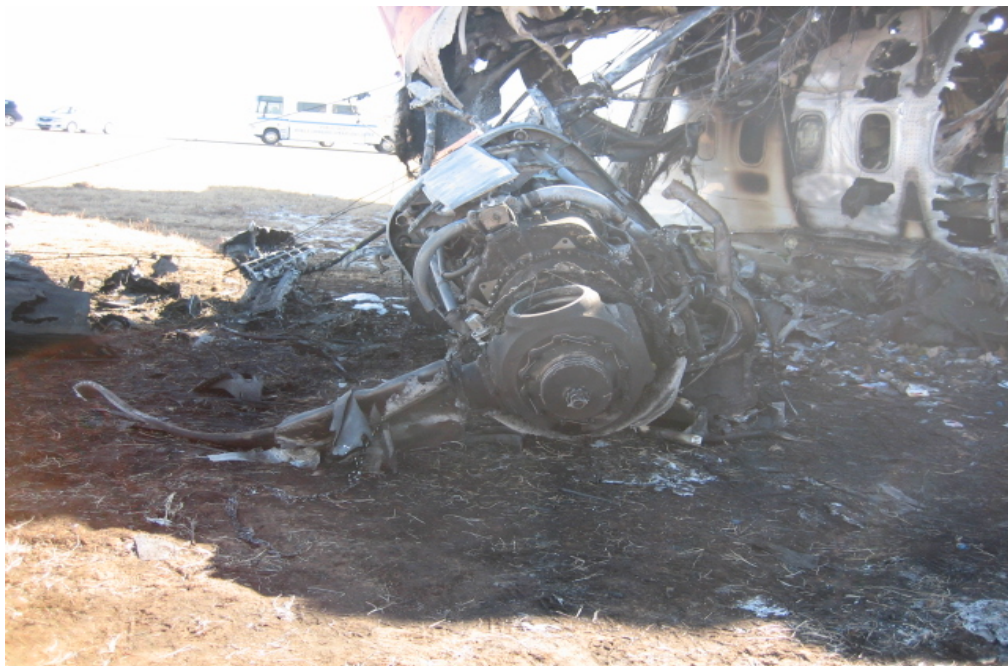
Photo 26. Right Powerplant

The number 2 engine, SN 121043, was examined. The right engine came to rest on its right side and sustained extensive thermal damage. All of the accessories remained attached to the engine. Extensive damage was noted to the hub assembly. One propeller blade remained attached and the other three blades were located in the debris field leading up to the main wreckage. The reduction gearbox remained attached to the inlet case; however, the rear inlet case had separated from the flange "C" low-pressure diffuser case. Blade damage was noted at the last stage of the power turbine.
