Docket No. SA-533

CEN09MA142 Section 4

Attachment 4.1 Honeywell Testing

Re: NTSB ID: CEN09MA142, N902FX, ATR 42-320, Equipment examination at Honeywell (Wichita, Kansas)

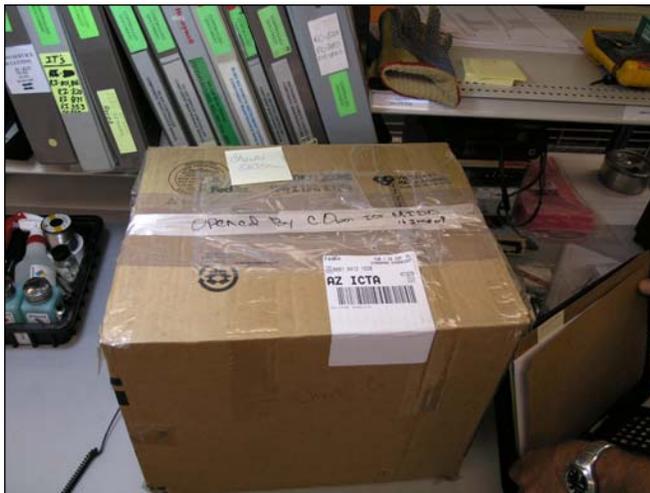
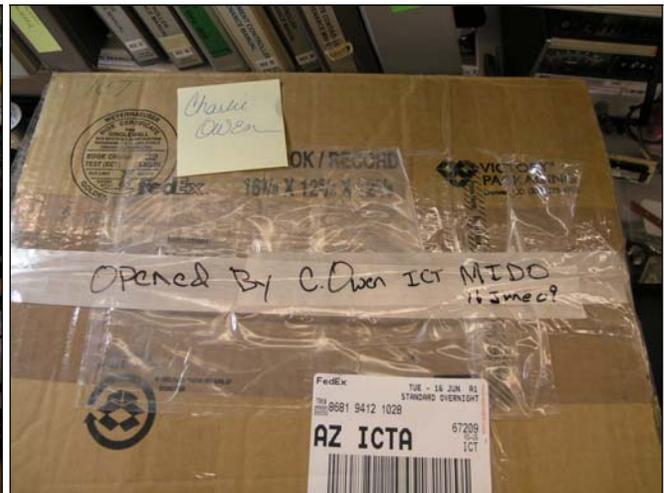
Equipment as received -- container was previously opened by the FAA

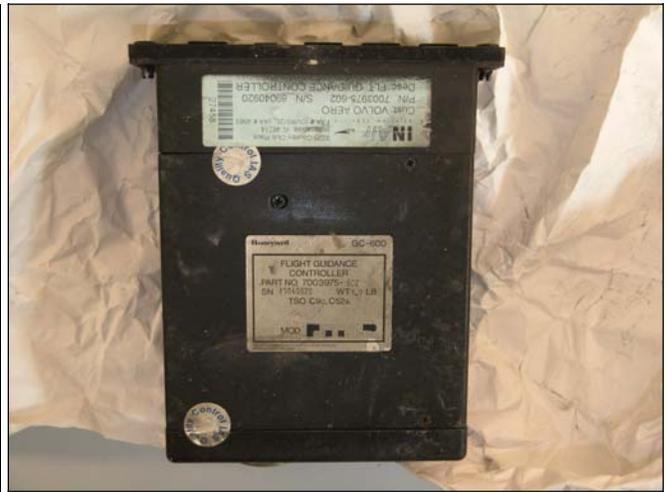
GC-600: top view, unit seals intact

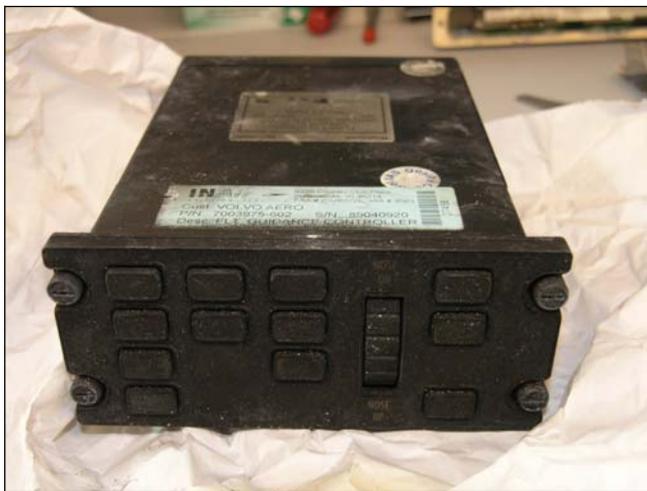
Unit is covered with a black-sooty substance consistent with smoke/fire exposure. The faceplate and button identification was not readable as a result of the soot/foreign material coverage. The unit was connected to test equipment and subjected to final acceptance testing. All lamps were good and the unit passed all acceptance tests. A copy of the test report is located in appendix A.

GC-600: faceplate soot covered

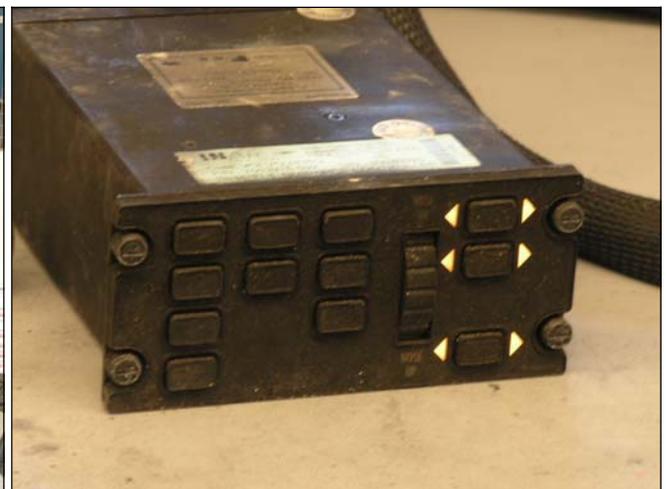
GC-600 final acceptance testing in process

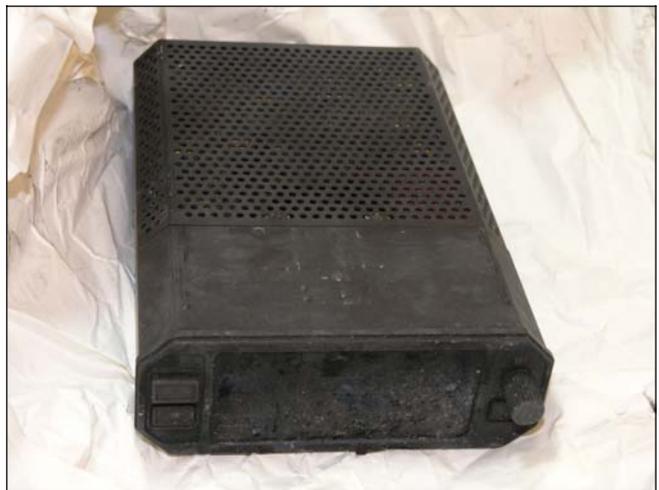
Unit is covered with a black-sooty substance consistent with smoke/fire exposure. The faceplate and button identification was not readable as received. The faceplate and buttons were cleaned using isopropyl alcohol to allow viewing. The unit was subjected to final acceptance testing and the following non-conformances were noted:

ID-802: front and top view

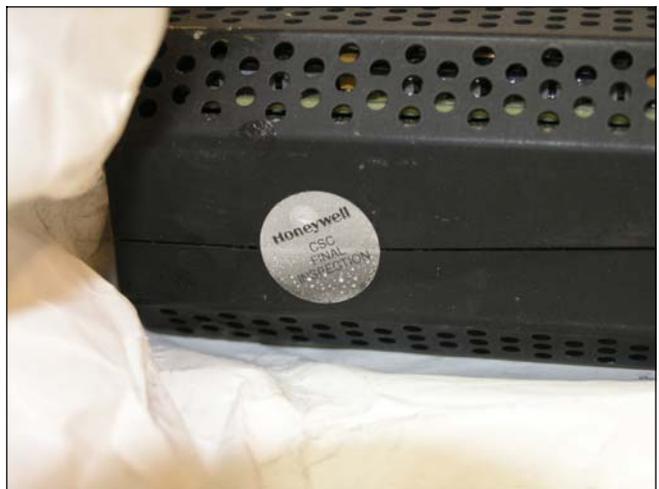
ID-802: seal intact

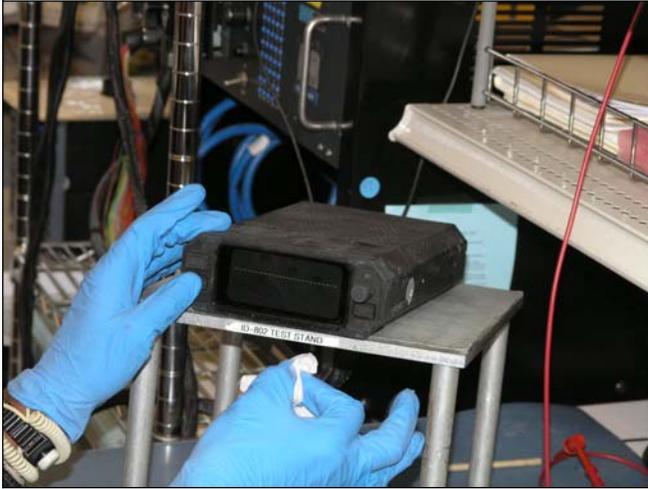
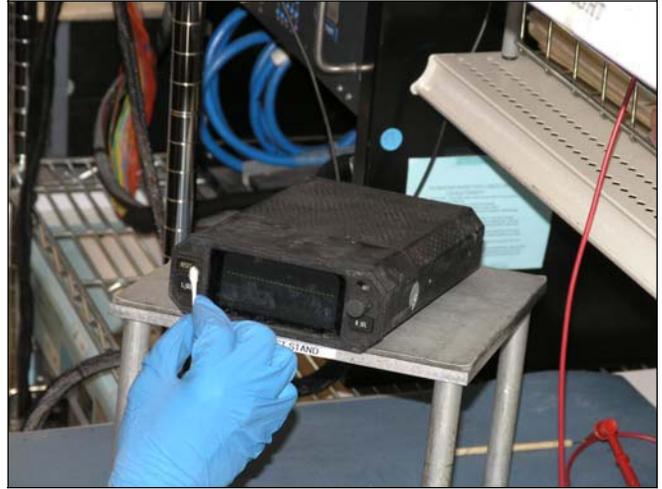
ID-802: cleaning screen and button faces using isopropyl alcohol

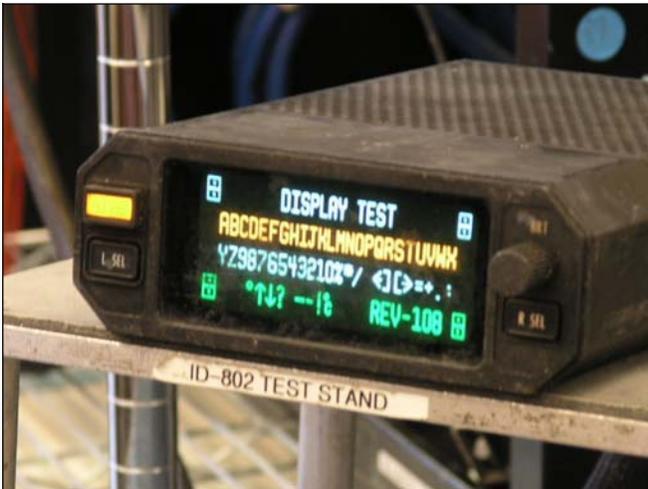
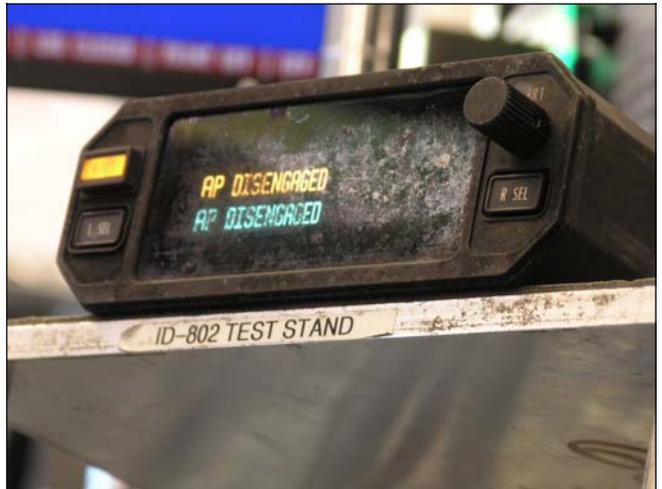
- The screen calibration tests fail to meet specification (color/brightness/raster/alignment). However, the information presented on the display was very clear and readable.
- No backlighting present for the two left buttons (RESET, L SEL).
- Both lamps intermittent for the RESET annunciation (tapping button causes lamps to come on...or go off). Possible contact problem attributed to the soot and foreign material present.
- Logic test failed, Test 12.4 (Reset Strap Low). During this test, the RESET lamp failed to illuminate as a result of the intermittent lamp condition noted above.
- Logic test failed, Test 12.5 (Check Reset Low). During this test, the reset lamp was to extinguish and the message on the display was to change to dashes (message remained on the screen). Retesting yielded the same result.

ID-802: final acceptance testing in process

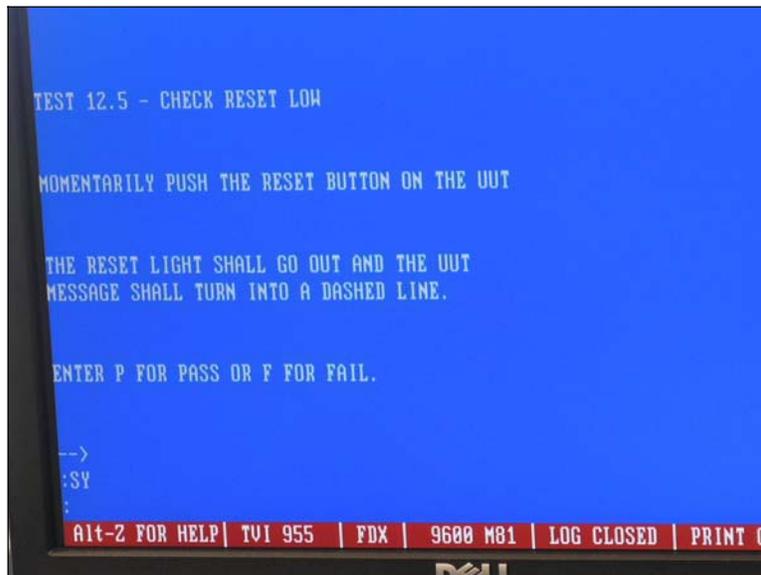
The ID-802 Advisory Display provides the capability for the flight control system to request data from the pilot in addition to providing system mode and annunciation. The ID-802 has no impact on autopilot engage/disengage function. Therefore, the failures noted above would not inhibit the flight crew from engaging or disengaging the autopilot. As a result, determining the source of the failures was unwarranted at this time. A copy of the test report is located in appendix B.

ID-802: unit failed test 12.5
