NATIONAL TRANSPORTATION SAFETY BOARD

Group Chairman's Factual Report

WPR11MA454

Attachment 10 – Technical Orders
(30 pages)

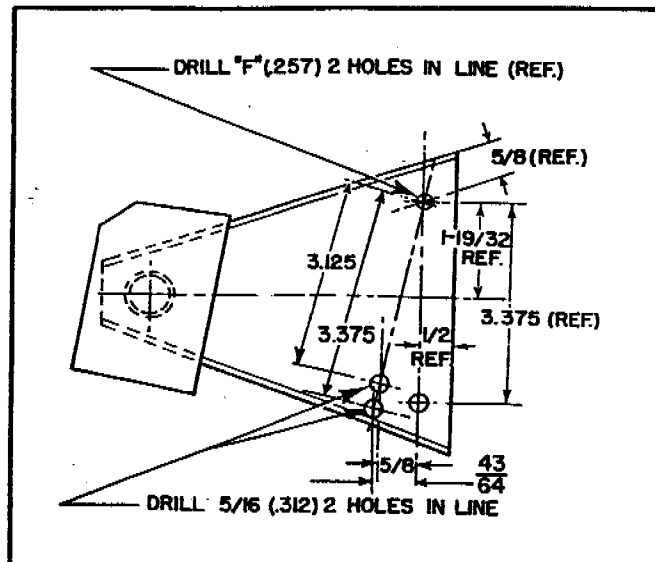
Figure 4B - View Showing Location of Additional Hole to Be Drilled in the Elevator Inertia Weight Assembly for Use on P-51B, P-51C, and F-6C Airplanes if Lower Hole in Bell Crank Has Been Drilled 3-3/8 Inches From Upper Hole

NOTE If the hole referred to in paragraph 2.f.(2) has been drilled at a point 3-3/8 inches below the top hole (figure 3) in attempting compliance with previous instructions contained in T. O. No. 01-60J-29, dated 18 September 1944, it will be necessary to locate

the lower hole in the steel sheets of the inertia weight as shown in figure 4B.

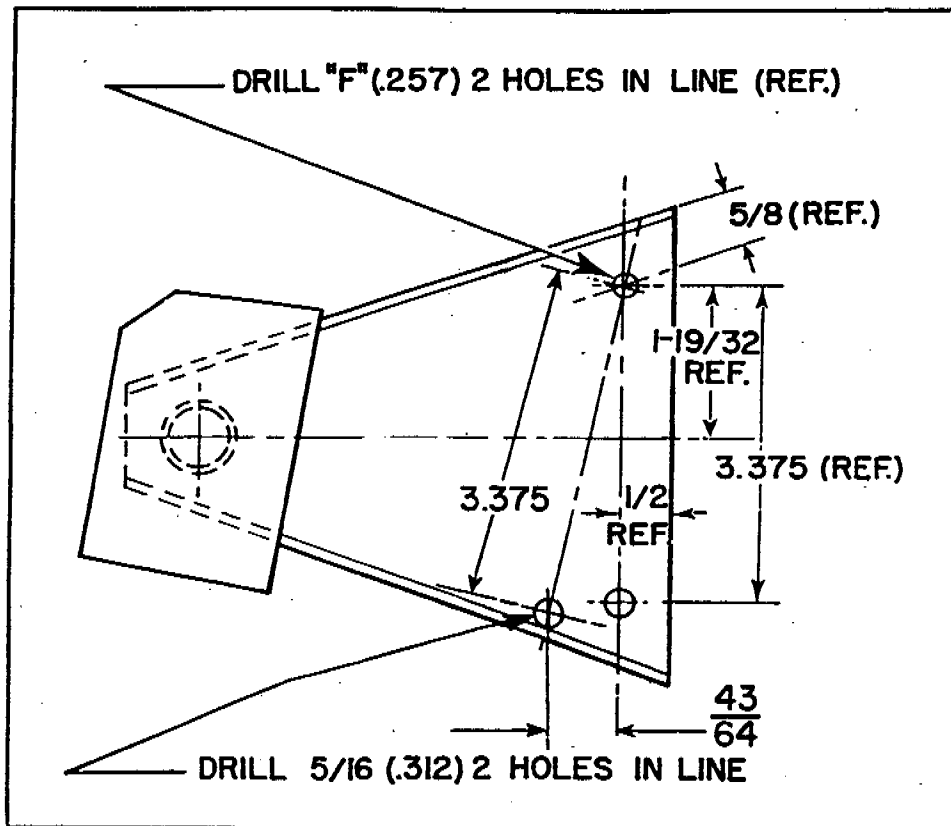
Figure 4B - View Showing Location of Additional Hole to Be Drilled in the Elevator Inertia Weight Assembly for Use on P-51B, P-51C, and F-6C Airplanes if Lower Hole in Bell Crank Has Been Drilled 3-3/8 Inches From Upper Hole

1. Figure 4B of T. O. No. 01-60-90, dated 20 November 1944, is corrected as follows:

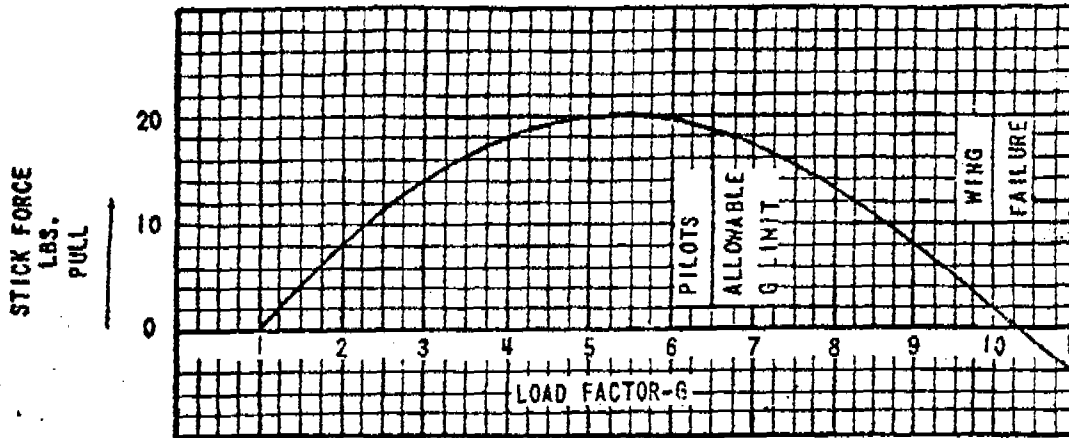
Diagram 1 - Center of Gravity at 26.4 Percent Mean Aerodynamic Chord
(Center of Gravity Position Does not Cause Stick Force Reversal)

over the elevators is affected when the "G" acceleration applied to the airplane is increased the stick forces tend to lighten and reverse. This tendency in-

creases or augments the stick force reversal tendency caused by aft center of gravity location. The following diagrams illustrate the effects of both:
